School Assessment Report

School: Grady High School

Report: Nov 04, 2014

School Name: Grady High School

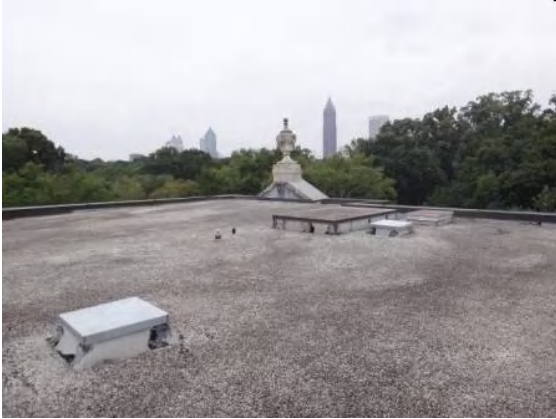
Analysis: The system age is either beyond expected life or does not meet its intended performance under the Guidelines. The system may be in service and functioning but it is recommended to be replaced due to probable increased condition budget needs, the potential failure of its components, or in order to meet the performance Guidelines for this system. The system was installed in 1955. It has a 30-year service life which expired in 1985.

Location: 1924_1950 Bldg 501.1_501.5

Distress: Inadequate

Notes: Several roof areas have no interior access. Those provided are safety hazards due to ladder riser heights, available depth and relationship to adjacent roof planes.

Recomm.: The system should be replaced.

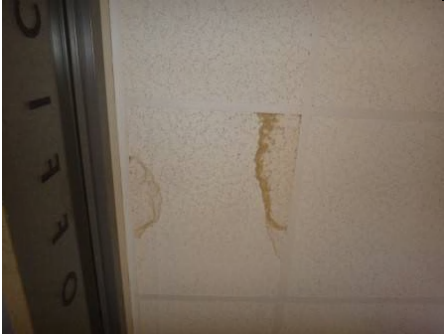
Analysis: The system age is either beyond expected life or does not meet its intended performance under the Guidelines. The system may be in service and functioning but it is recommended to be replaced due to probable increased condition budget needs, the potential failure of its components, or in order to meet the performance Guidelines for this system. The system was installed in 1952. It has a 20-year service life which expired in 1972.

Location: 1924_1950 Bldg 501.1_501.5
Distress: Beyond Expected Life
Category: Deferred Maintenance
Priority: 3 - Necessary (Years 2-5)
Correction: Renew System
Qty: 1-Ea.
Condition Budget: \$29,120

Recomm.: The system should be replaced.

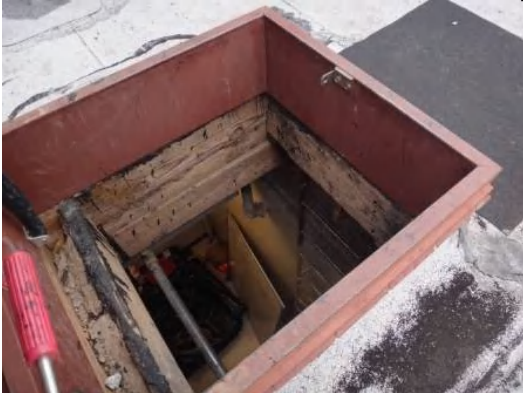
Analysis: The system age is either beyond expected life or does not meet its intended performance under the Guidelines. The system may be in service and functioning but it is recommended to be replaced due to probable increased condition budget needs, the potential failure of its components, or in order to meet the performance Guidelines for this system. The system was installed in 1938. It has a 30-year service life which expired in 1968.

Location: 1938 Bldg 503.4

Distress: Failing

Notes: Roof hatch/ladder assembly is dangerous and poses a safety hazard.

Recomm.: The system should be replaced.

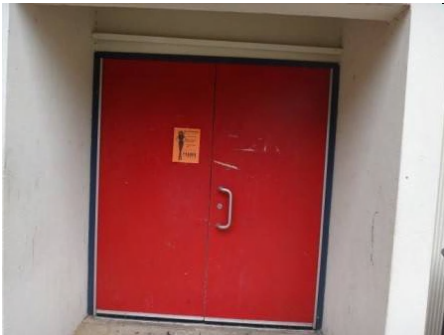
Analysis: The system age is either beyond expected life or does not meet its intended performance under the Guidelines. The system may be in service and functioning but it is recommended to be replaced due to probable increased condition budget needs, the potential failure of its components, or in order to meet the performance Guidelines for this system. The system was installed in 1983. It has a 30-year service life. However, in the assessment, it was found to be currently deficient.

Location: 1972 Bldg 505.7
Distress: Beyond Expected Life
Category: Deferred Maintenance
Priority: 3 - Necessary (Years 2-5)
Correction: Renew System
Qty: 1-Ea.
Condition Budget: \$32,998

Recomm.: The system should be replaced.

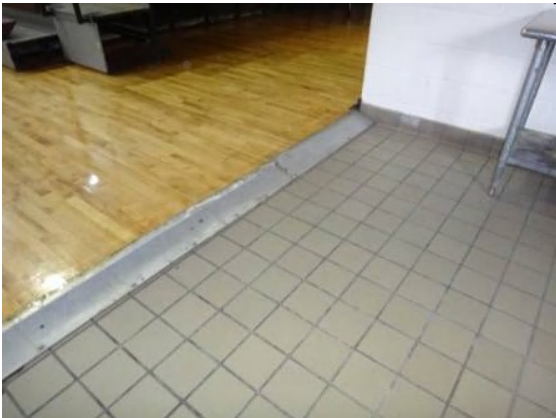
Analysis: The system is in use and functioning with an estimated remaining service life as indicated in the report section "Condition/Replacement Budget Detail". The system was installed in 2012. It has a 20-year service life. However, in the assessment, it was found to be currently deficient.

Location: 1972 Bldg 505.7
Material: Floor Finishes
Distress: Beyond Expected Life
Category: Deferred Maintenance
Priority: 3 - Necessary (Years 2-5)
Notes: Although the gymnasium (wood) floor was recently replaced, V.C.T. in the remainder of the building is outdated and in need of replacement.
Correction: Replace floor finishes (SF)
Qty: 4,000-S.F.
Condition Budget: \$40,418

Recomm.: The system should be replaced.

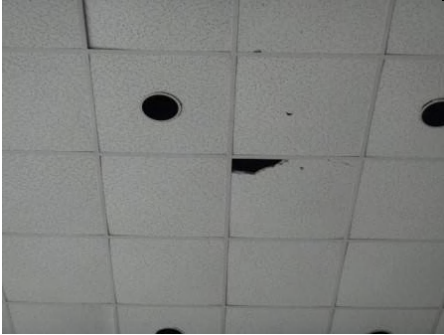
Analysis: The system age is either beyond expected life or does not meet its intended performance under the Guidelines. The system may be in service and functioning but it is recommended to be replaced due to probable increased condition budget needs, the potential failure of its components, or in order to meet the performance Guidelines for this system. The system was installed in 1990. It has a 20-year service life which expired in 2010.

Location: 1972 Bldg 505.7
Distress: Beyond Expected Life
Category: Deferred Maintenance
Priority: 3 - Necessary (Years 2-5)
Correction: Renew System
Qty: 1-Ea.
Condition Budget: \$128,817

Recomm.: The system should be replaced.

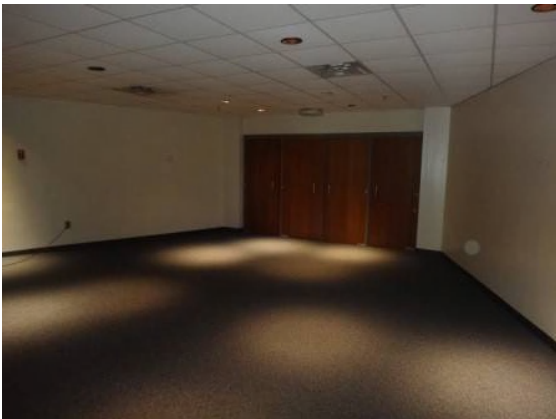
Analysis: The system is in use and functioning with an estimated remaining service life as indicated in the report section "Condition/Replacement Budget Detail". The system was installed in 2004. It has a 20-year service life. However, in the assessment, it was found to be currently deficient.

Location: 1985 Bldg 501.6
Material: Floor Finishes
Distress: Beyond Expected Life
Category: Deferred Maintenance
Priority: 3 - Necessary (Years 2-5)
Notes: Although new carpet is installed within the auditorium, the surrounding spaces within the facility have extremely worn and damaged flooring in need of replacement.
Correction: Replace floor finishes (SF)
Qty: 12,445-S.F.
Condition Budget: \$95,800

Recomm.: The system should be replaced.

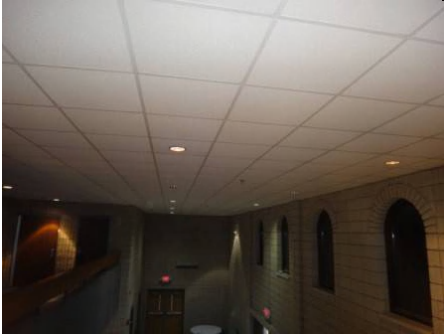
Analysis: The system age is either beyond expected life or does not meet its intended performance under the Guidelines. The system may be in service and functioning but it is recommended to be replaced due to probable increased condition budget needs, the potential failure of its components, or in order to meet the performance Guidelines for this system. The system was installed in 1985. It has a 20-year service life which expired in 2005.

Location: 1985 Bldg 501.6
Distress: Beyond Expected Life
Category: Deferred Maintenance
Priority: 3 - Necessary (Years 2-5)
Correction: Renew System
Qty: 1-Ea.
Condition Budget: \$217,769

Recomm.: The system should be replaced.

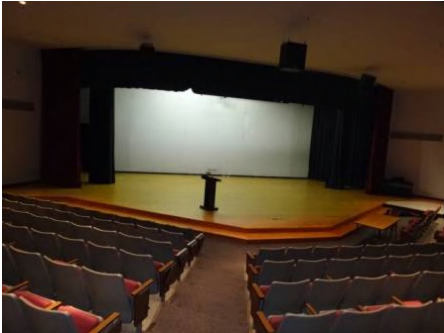
Analysis: The system age is either beyond expected life or does not meet its intended performance under the Guidelines. The system may be in service and functioning but it is recommended to be replaced due to probable increased condition budget needs, the potential failure of its components, or in order to meet the performance Guidelines for this system. The system was installed in 1985. It has a 20-year service life which expired in 2005.

Location: 1985 Bldg 501.6

Recomm.: The system should be replaced.

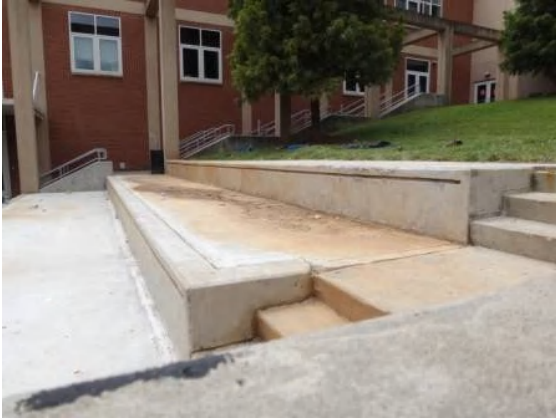
Analysis: The system is in use and functioning with an estimated remaining service life as indicated in the report section "Condition/Replacement Budget Detail". The system was installed in 2004. It has a 35-year service life. However, in the assessment, it was found to be currently deficient.

Location: Site

Recomm.: The system should be replaced.
