Atlanta Public Schools/Charter Schools

# Adamsville Primary School (Kindezi School)

## School Assessment Report

November 10, 2020

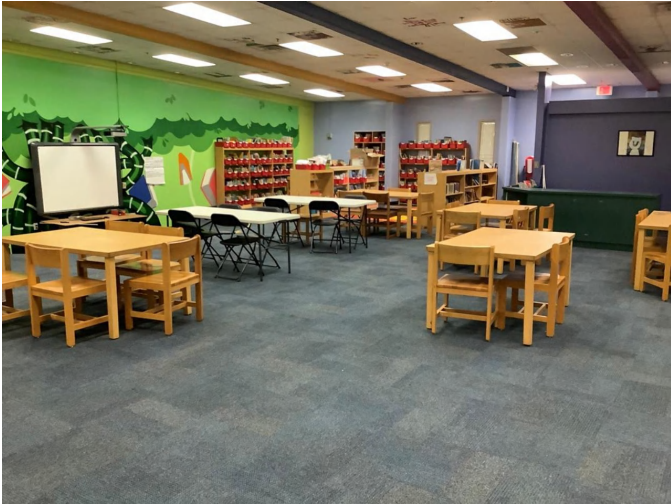
#### System: C3020901 - Carpet

**Location:** Throughout Building  
**Distress:** Beyond Expected Life  
**Category:** Deferred Maintenance  
**Priority:** 3 - Necessary (Years 2-5)  
**Correction:** Renew System  
**Qty:** 10,024.00  
**Unit of Measure:** S.F.  
**Estimate:** \$82,698.00  
**Assessor Name:** Homero Guerrero  
**Date Created:** 12/18/2019

**Notes:** The carpet floor finish is beyond its expected service life, worn and damaged, and is recommended for replacement.

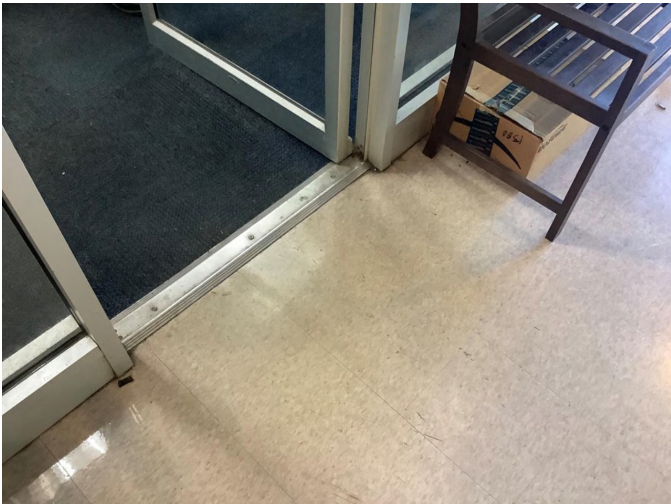
#### System: C3020903 - VCT

**Location:** Throughout Building  
**Distress:** Beyond Expected Life  
**Category:** Deferred Maintenance  
**Priority:** 3 - Necessary (Years 2-5)  
**Correction:** Renew System  
**Qty:** 40,000.00  
**Unit of Measure:** S.F.  
**Estimate:** \$215,760.00  
**Assessor Name:** Homero Guerrero  
**Date Created:** 12/18/2019

**Notes:** The VCT floor finish is beyond its expected service life, worn and damaged, and is recommended for replacement.

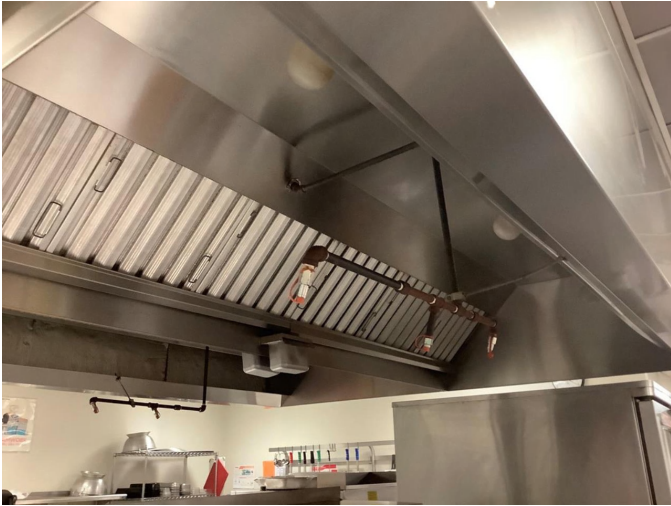
**System: D4090 - Other Fire Protection Systems**

**Location:** Kitchen  
**Distress:** Beyond Expected Life  
**Category:** Deferred Maintenance  
**Priority:** 3 - Necessary (Years 2-5)  
**Correction:** Renew System  
**Qty:** 58,024.00  
**Unit of Measure:** S.F.  
**Estimate:** \$38,934.00  
**Assessor Name:** Homero Guerrero  
**Date Created:** 09/27/2019

**Notes:** This buildings kitchen fire suppression system warrants upgrades based on usage and age. This deficiency provides a budgetary consideration for upgrades.

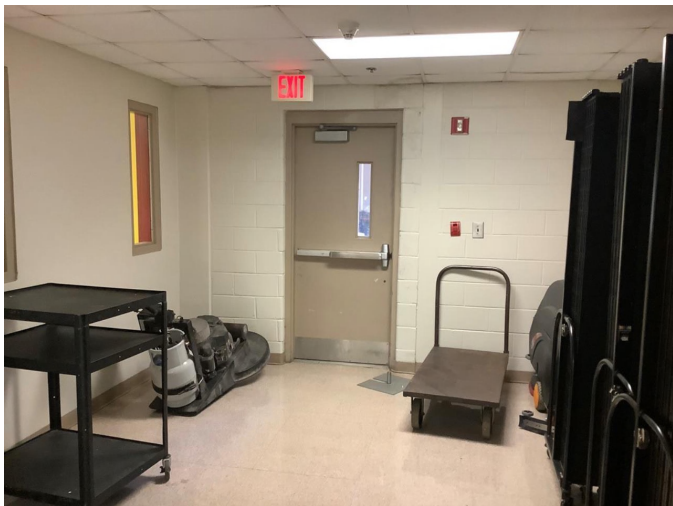
#### System: C3020903 - VCT

**Location:** Throughout Building  
**Distress:** Beyond Expected Life  
**Category:** Deferred Maintenance  
**Priority:** 3 - Necessary (Years 2-5)  
**Correction:** Renew System  
**Qty:** 3,000.00  
**Unit of Measure:** S.F.  
**Estimate:** \$16,182.00  
**Assessor Name:** Homero Guerrero  
**Date Created:** 12/18/2019

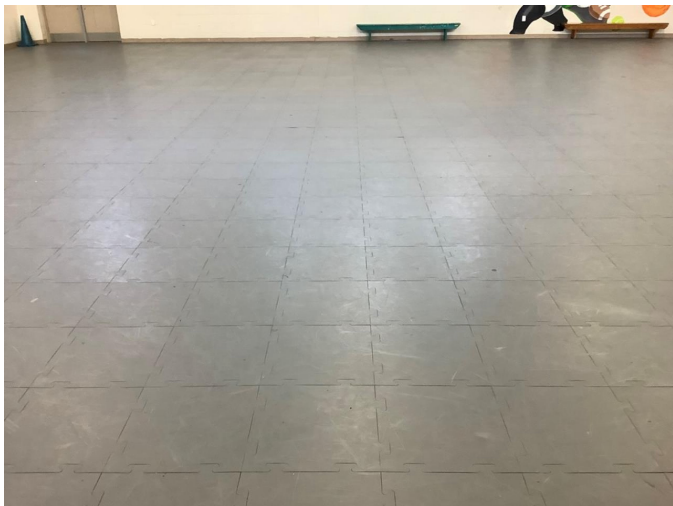
#### System: C3020999 - Other - Rubber or Neoprene

**Location:** Gym  
**Distress:** Beyond Expected Life  
**Category:** Deferred Maintenance  
**Priority:** 3 - Necessary (Years 2-5)  
**Correction:** Renew System  
**Qty:** 13,034.00  
**Unit of Measure:** S.F.  
**Estimate:** \$382,378.00  
**Assessor Name:** Homero Guerrero  
**Date Created:** 01/31/2020

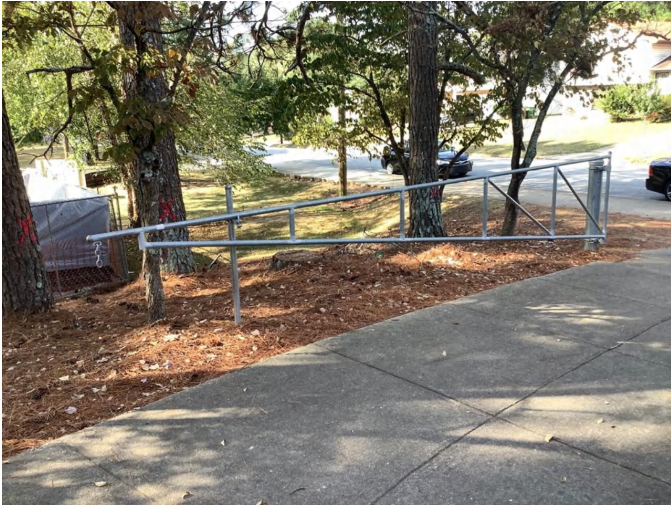
#### **System: G2040105 - Fence & Guardrails**

**Location:** Site  
**Distress:** Beyond Expected Life  
**Category:** Deferred Maintenance  
**Priority:** 3 - Necessary (Years 2-5)  
**Correction:** Renew System  
**Qty:** 75,058.00  
**Unit of Measure:** S.F.  
**Estimate:** \$94,948.00  
**Assessor Name:** Eduardo Lopez  
**Date Created:** 12/18/2019

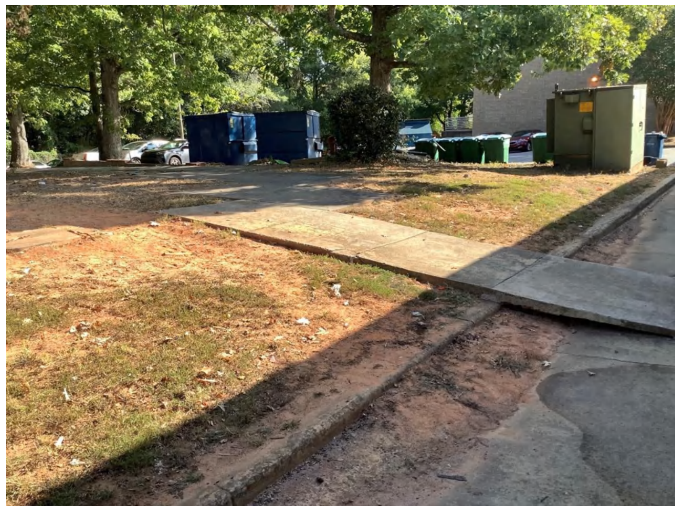
**System: G2040950 - Site Development Other**

**Location:** Loading dock  
**Distress:** Inadequate  
**Category:** Code Compliance  
**Priority:** 3 - Necessary (Years 2-5)  
**Correction:** Build secure trash dumpster enclosure  
**Qty:** 1.00  
**Unit of Measure:** Ea.  
**Estimate:** \$10,670.41  
**Assessor Name:** Eduardo Lopez  
**Date Created:** 12/19/2019
