Atlanta Public Schools/Charter Schools

# Archer High School (Westside Atlanta Charter)

## School Assessment Report

November 10, 2020

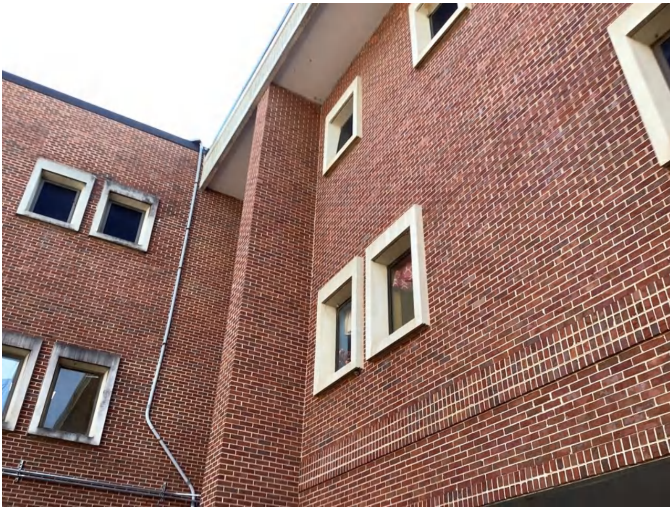
#### System: B2020 - Exterior Windows

**Location:** Exterior windows  
**Distress:** Beyond Expected Life  
**Category:** Deferred Maintenance  
**Priority:** 3 - Necessary (Years 2-5)  
**Correction:** Renew System  
**Qty:** 249,447.00  
**Unit of Measure:** S.F.  
**Estimate:** \$2,359,769.00  
**Assessor Name:** Hayden Collins  
**Date Created:** 02/21/2020

The aluminum frame, operable, single pane windows are aged, not energy efficient, and should be replaced.

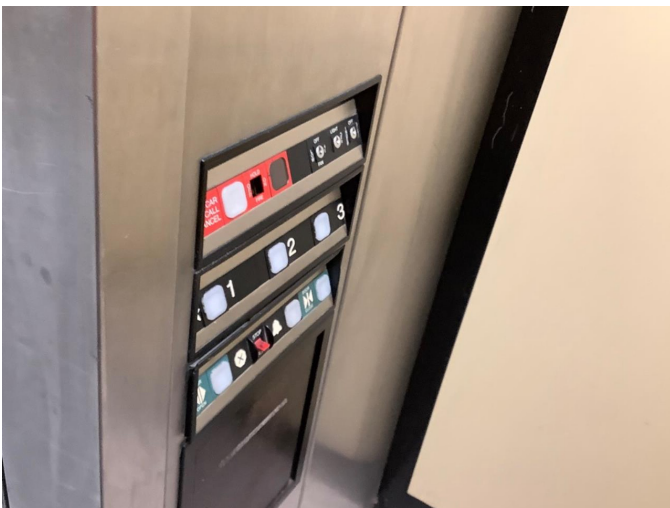
#### System: D1010 - Elevators and Lifts

**Location:** Elevator  
**Distress:** Beyond Expected Life  
**Category:** ADA Compliance  
**Priority:** 3 - Necessary (Years 2-5)  
**Correction:** Renew System  
**Qty:** 249,447.00  
**Unit of Measure:** S.F.  
**Estimate:** \$342,990.00  
**Assessor Name:** Hayden Collins  
**Date Created:** 02/21/2020

. The elevator system has exceeded its life cycle and recommended for upgrade. All aspects of the current ADA standards are expected to be included in the new installation.

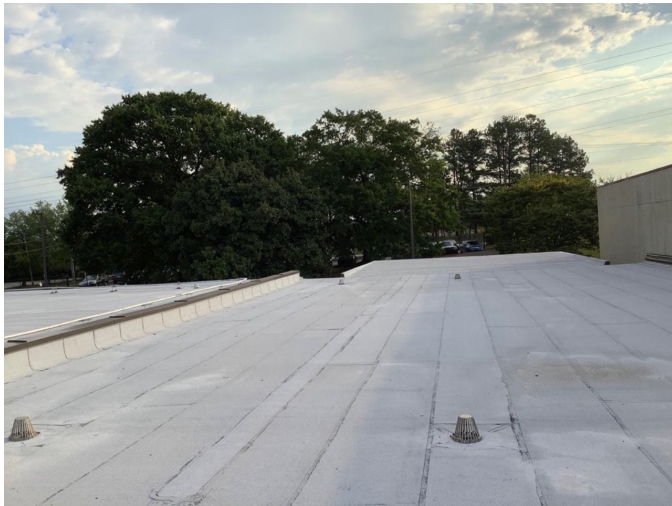
**System: D2040 - Rain Water Drainage**

**Location:** Rooftop  
**Distress:** Beyond Expected Life  
**Category:** Deferred Maintenance  
**Priority:** 3 - Necessary (Years 2-5)  
**Correction:** Renew System  
**Qty:** 249,447.00  
**Unit of Measure:** S.F.  
**Estimate:** \$123,476.00  
**Assessor Name:** Hayden Collins  
**Date Created:** 10/15/2015

**Notes:** The system is beyond its expected service life and should be scheduled for replacement. Roof drainage systems is aged, and should be replaced.

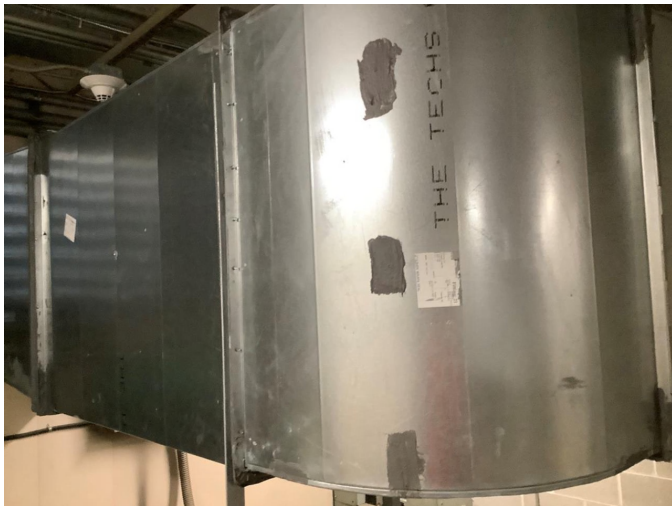
**System: D3040 - Distribution Systems**

**Location:** Throughout Building  
**Distress:** Beyond Expected Life  
**Category:** Deferred Maintenance  
**Priority:** 3 - Necessary (Years 2-5)  
**Correction:** Renew System  
**Qty:** 249,447.00  
**Unit of Measure:** S.F.  
**Estimate:** \$2,952,455.00  
**Assessor Name:** Hayden Collins  
**Date Created:** 10/15/2015

**Notes:** The system is beyond its expected service life and should be scheduled for replacement. Distribution and exhaust systems are aged, and should be replaced.

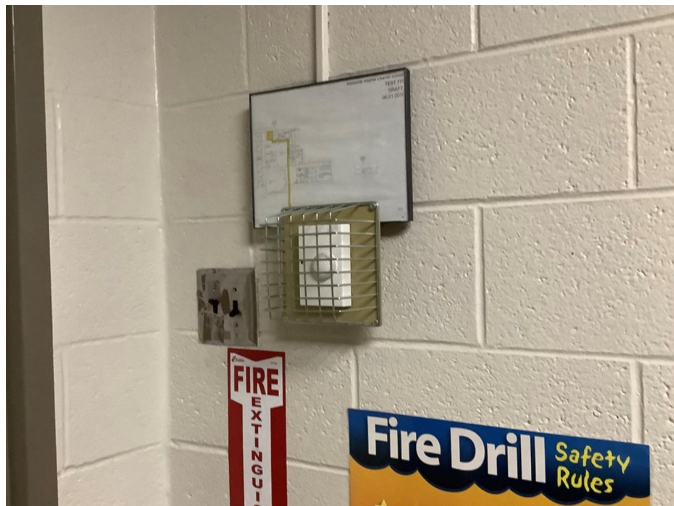
**System: D3060 - Controls & Instrumentation**

**Location:** Throughout Building  
**Distress:** Beyond Expected Life  
**Category:** Deferred Maintenance  
**Priority:** 3 - Necessary (Years 2-5)  
**Correction:** Renew System  
**Qty:** 249,447.00  
**Unit of Measure:** S.F.  
**Estimate:** \$606,406.00  
**Assessor Name:** Hayden Collins  
**Date Created:** 10/15/2015

**Notes:** The system is beyond its expected service life and should be scheduled for replacement. Controls and instrumentation systems are aged, and should be replaced.

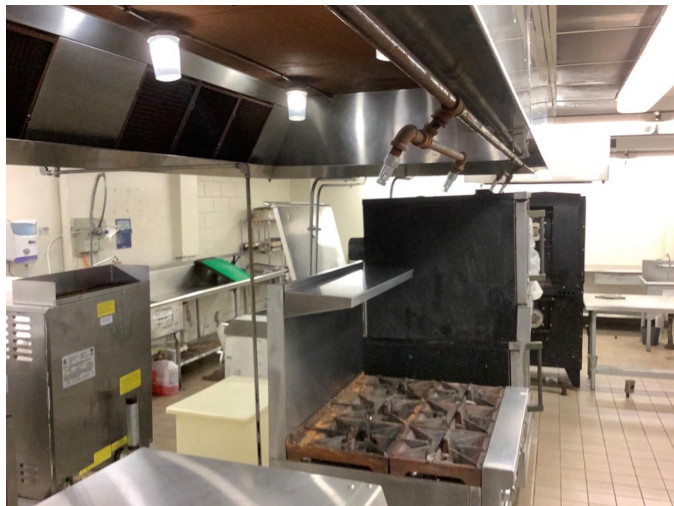
**System: D4090 - Other Fire Protection Systems**

**Location:** Kitchen  
**Distress:** Beyond Expected Life  
**Category:** Deferred Maintenance  
**Priority:** 3 - Necessary (Years 2-5)  
**Correction:** Renew System  
**Qty:** 249,447.00  
**Unit of Measure:** S.F.  
**Estimate:** \$167,379.00  
**Assessor Name:** Hayden Collins  
**Date Created:** 02/21/2020

The system is beyond its expected service life and should be scheduled for replacement. Gaseous fire suppression for kitchen hood is aged, and should be replaced.

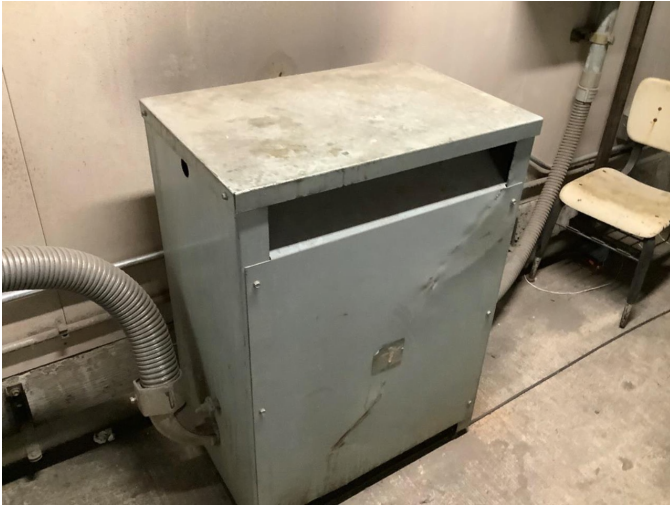
**System: D5010 - Electrical Service/Distribution**

**Location:** Electrical Room  
**Distress:** Beyond Expected Life  
**Category:** Deferred Maintenance  
**Priority:** 3 - Necessary (Years 2-5)  
**Correction:** Renew System  
**Qty:** 249,447.00  
**Unit of Measure:** S.F.  
**Estimate:** \$650,308.00  
**Assessor Name:** Hayden Collins  
**Date Created:** 02/21/2020

The system is beyond its expected service life and should be scheduled for replacement. Electrical service and distribution are aged, and should be replaced.

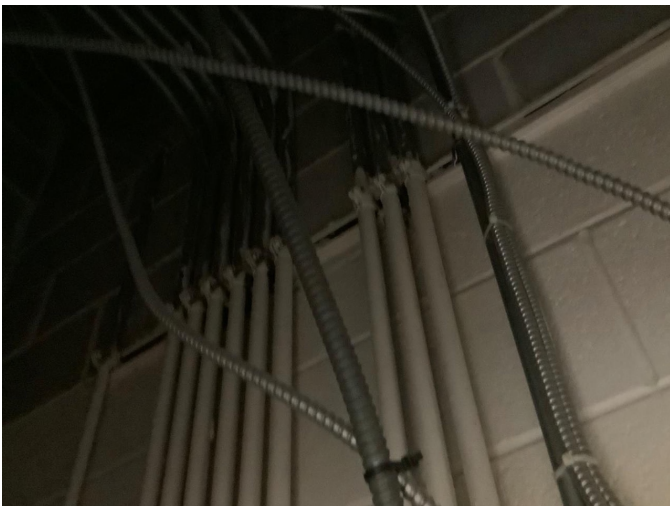
**System: D5020 - Branch Wiring**

**Location:** Throughout building  
**Distress:** Beyond Expected Life  
**Category:** Deferred Maintenance  
**Priority:** 3 - Necessary (Years 2-5)  
**Correction:** Renew System  
**Qty:** 249,447.00  
**Unit of Measure:** S.F.  
**Estimate:** \$1,330,800.00  
**Assessor Name:** Hayden Collins  
**Date Created:** 02/21/2020

The system is beyond its expected service life and should be scheduled for replacement. Branch wiring is aged, and should be replaced.

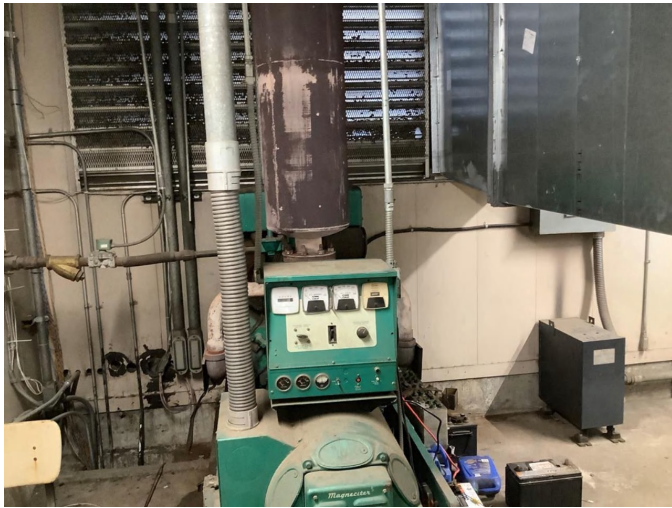
**System: D5090 - Other Electrical Systems**

**Location:** Mechanical Room  
**Distress:** Beyond Expected Life  
**Category:** Deferred Maintenance  
**Priority:** 3 - Necessary (Years 2-5)  
**Correction:** Renew System  
**Qty:** 249,447.00  
**Unit of Measure:** S.F.  
**Estimate:** \$98,781.00  
**Assessor Name:** Hayden Collins  
**Date Created:** 02/21/2020

The system is beyond its expected service life and should be scheduled for replacement. Emergency generator is aged, and should be replaced.

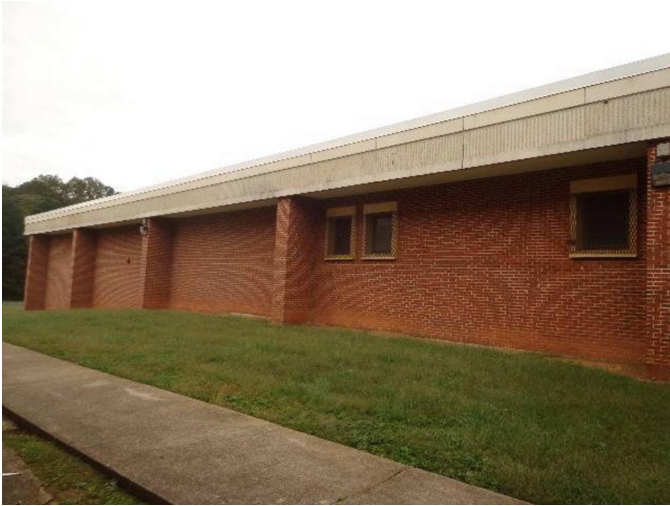
#### System: B2020 - Exterior Windows

**Location:** Throughout building  
**Distress:** Beyond Expected Life  
**Category:** Deferred Maintenance  
**Priority:** 3 - Necessary (Years 2-5)  
**Correction:** Renew System  
**Qty:** 17,201.00  
**Unit of Measure:** S.F.  
**Estimate:** \$23,651.00  
**Assessor Name:** Hayden Collins  
**Date Created:** 02/21/2020

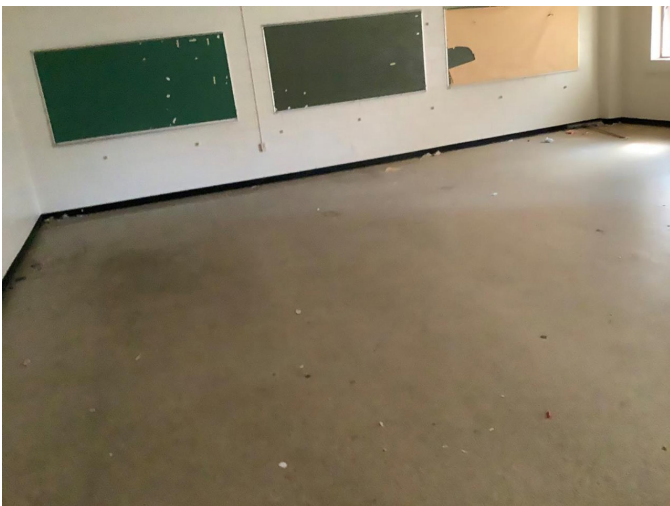
#### System: C1030 - Fittings

**Location:** Old Gym  
**Distress:** Beyond Expected Life  
**Category:** ADA Compliance  
**Priority:** 3 - Necessary (Years 2-5)  
**Correction:** Renew System  
**Qty:** 17,201.00  
**Unit of Measure:** S.F.  
**Estimate:** \$50,519.00  
**Assessor Name:** Jejuan Hall  
**Date Created:** 10/15/2015

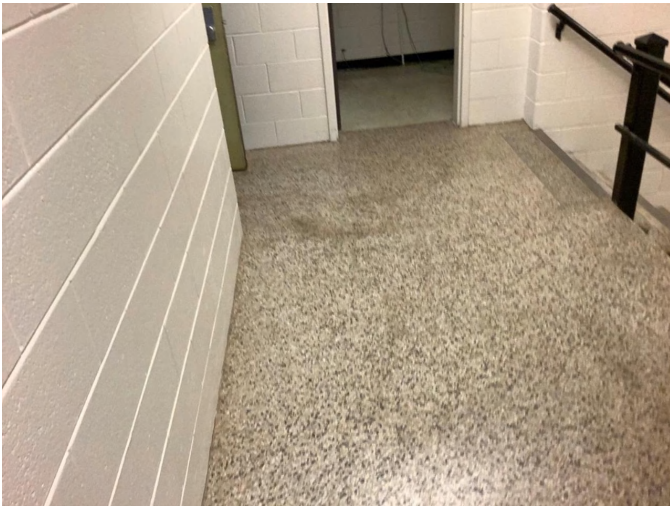
**System: C3020903 - VCT**

**Location:** Old Gym  
**Distress:** Beyond Expected Life  
**Category:** Deferred Maintenance  
**Priority:** 3 - Necessary (Years 2-5)  
**Correction:** Renew System  
**Qty:** 5,639.00  
**Unit of Measure:** S.F.  
**Estimate:** \$30,417.00  
**Assessor Name:** Hayden Collins  
**Date Created:** 12/11/2019

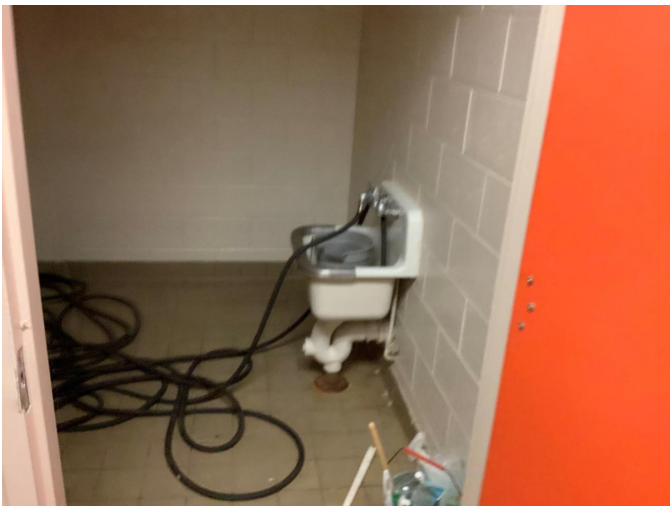
**System: D2010 - Plumbing Fixtures**

**Location:** Old Gym  
**Distress:** Beyond Expected Life  
**Category:** ADA Compliance  
**Priority:** 3 - Necessary (Years 2-5)  
**Correction:** Renew System  
**Qty:** 17,201.00  
**Unit of Measure:** S.F.  
**Estimate:** \$120,527.00  
**Assessor Name:** Jejuan Hall  
**Date Created:** 01/23/2020

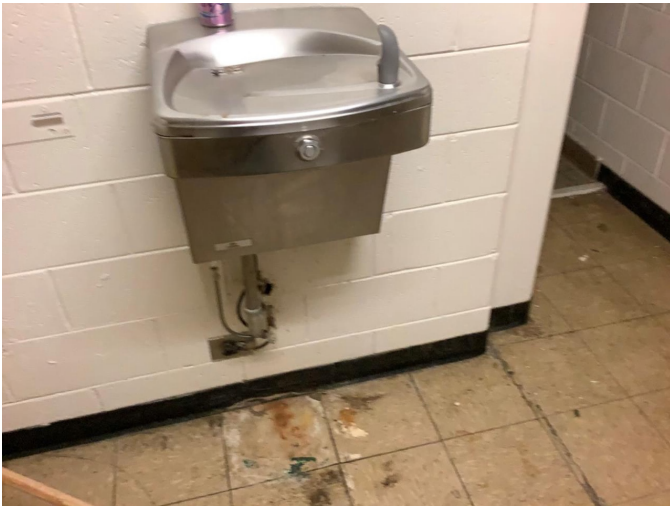
**System: D2020 - Domestic Water Distribution**

**Location:** Old Gym  
**Distress:** Beyond Expected Life  
**Category:** Deferred Maintenance  
**Priority:** 3 - Necessary (Years 2-5)  
**Correction:** Renew System  
**Qty:** 17,201.00  
**Unit of Measure:** S.F.  
**Estimate:** \$13,623.00  
**Assessor Name:** Hayden Collins  
**Date Created:** 01/23/2020

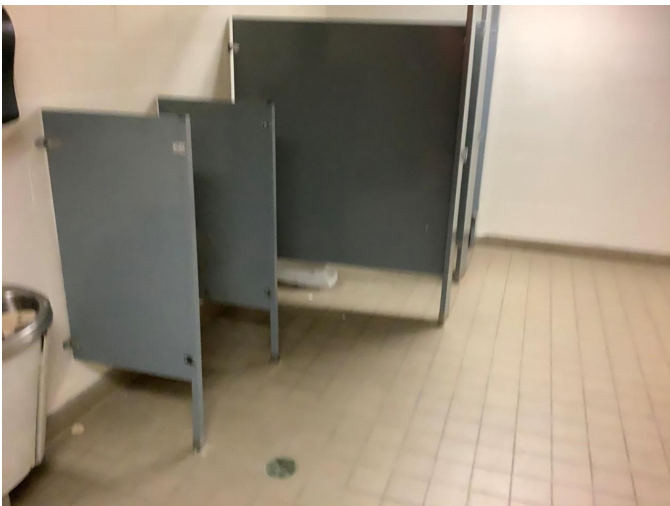
**Location:** bathrooms  
**Distress:** Beyond Expected Life  
**Category:** Deferred Maintenance  
**Priority:** 3 - Necessary (Years 2-5)  
**Correction:** Renew System  
**Qty:** 17,201.00  
**Unit of Measure:** S.F.  
**Estimate:** \$31,977.00  
**Assessor Name:** Hayden Collins  
**Date Created:** 01/23/2020

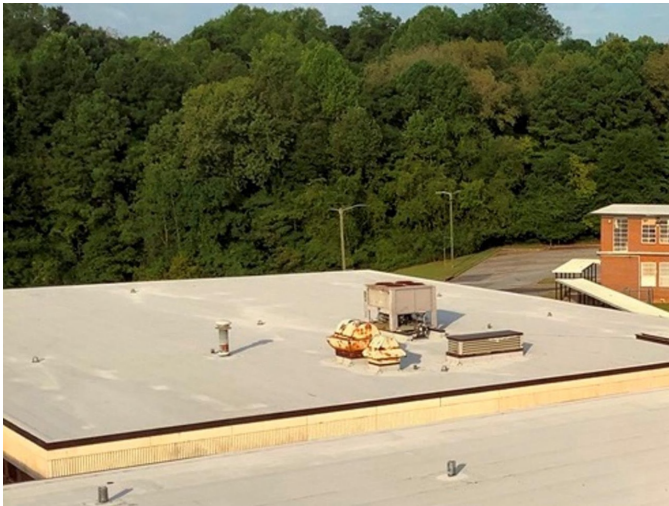
**Location:** Rooftop  
**Distress:** Beyond Expected Life  
**Category:** Deferred Maintenance  
**Priority:** 3 - Necessary (Years 2-5)  
**Correction:** Renew System  
**Qty:** 17,201.00  
**Unit of Measure:** S.F.  
**Estimate:** \$91,957.00  
**Assessor Name:** Hayden Collins  
**Date Created:** 12/11/2019

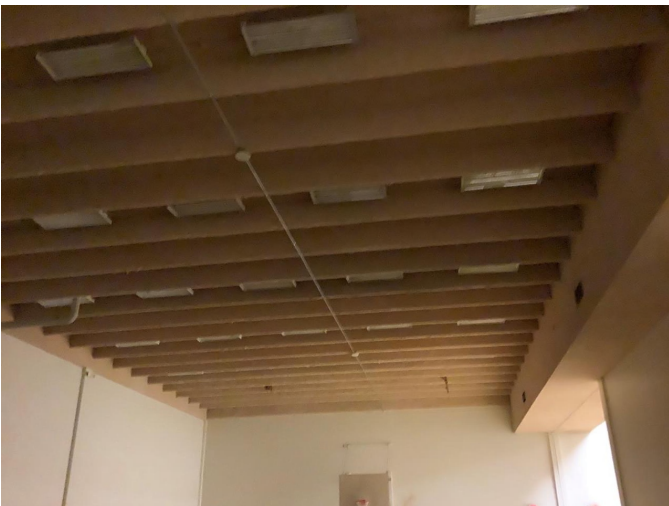
**Location:** Old Gym  
**Distress:** Beyond Expected Life  
**Category:** Deferred Maintenance  
**Priority:** 3 - Necessary (Years 2-5)  
**Correction:** Renew System  
**Qty:** 17,201.00  
**Unit of Measure:** S.F.  
**Estimate:** \$422,319.00  
**Assessor Name:** Hayden Collins  
**Date Created:** 12/11/2019

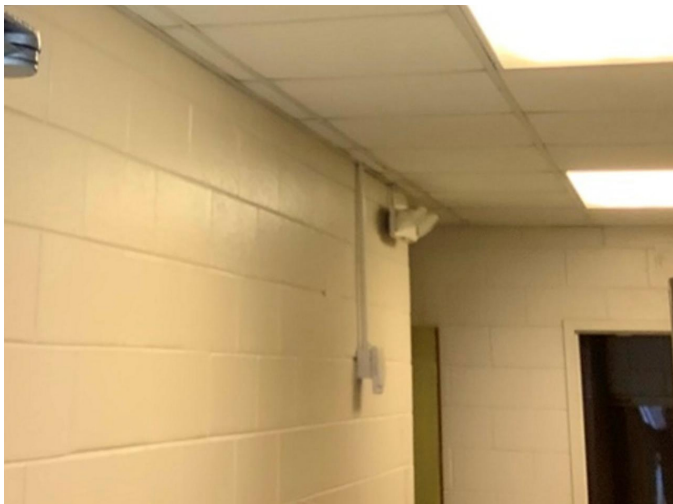
**Location:** Old Gym  
**Distress:** Beyond Expected Life  
**Category:** Deferred Maintenance  
**Priority:** 3 - Necessary (Years 2-5)  
**Correction:** Renew System  
**Qty:** 17,201.00  
**Unit of Measure:** S.F.  
**Estimate:** \$41,626.00  
**Assessor Name:** Hayden Collins  
**Date Created:** 12/11/2019

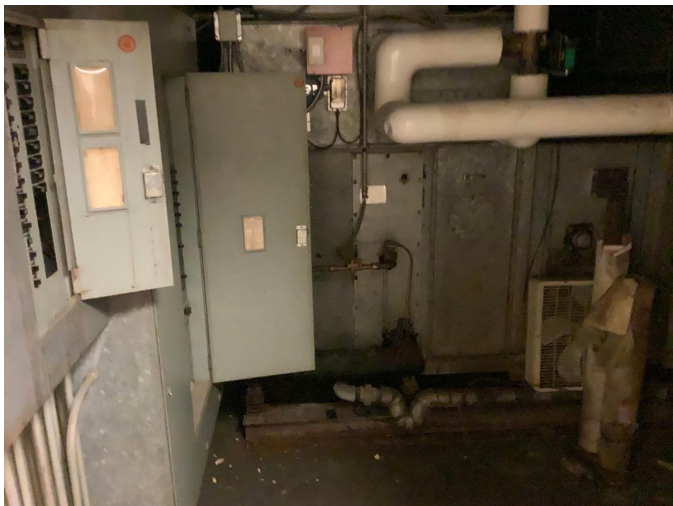
**Location:** Old Gym  
**Distress:** Beyond Expected Life  
**Category:** Deferred Maintenance  
**Priority:** 3 - Necessary (Years 2-5)  
**Correction:** Renew System  
**Qty:** 17,201.00  
**Unit of Measure:** S.F.  
**Estimate:** \$39,924.00  
**Assessor Name:** Hayden Collins  
**Date Created:** 12/11/2019

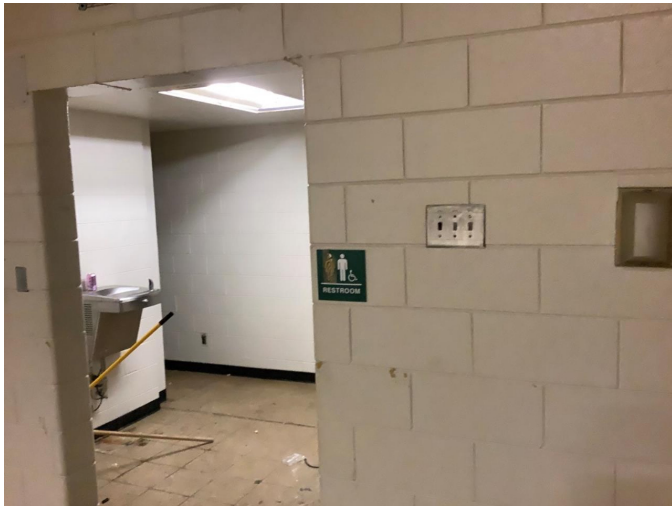
**Location:** Old Gym  
**Distress:** Beyond Expected Life  
**Category:** Deferred Maintenance  
**Priority:** 3 - Necessary (Years 2-5)  
**Correction:** Renew System  
**Qty:** 17,201.00  
**Unit of Measure:** S.F.  
**Estimate:** \$78,523.00  
**Assessor Name:** Hayden Collins  
**Date Created:** 12/11/2019

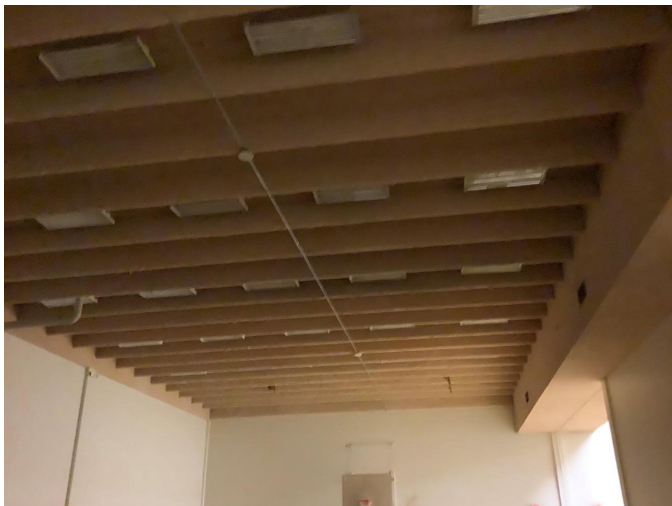
**Location:** Old Gym  
**Distress:** Beyond Expected Life  
**Category:** Deferred Maintenance  
**Priority:** 3 - Necessary (Years 2-5)  
**Correction:** Renew System  
**Qty:** 17,201.00  
**Unit of Measure:** S.F.  
**Estimate:** \$108,229.00  
**Assessor Name:** Hayden Collins  
**Date Created:** 12/11/2019

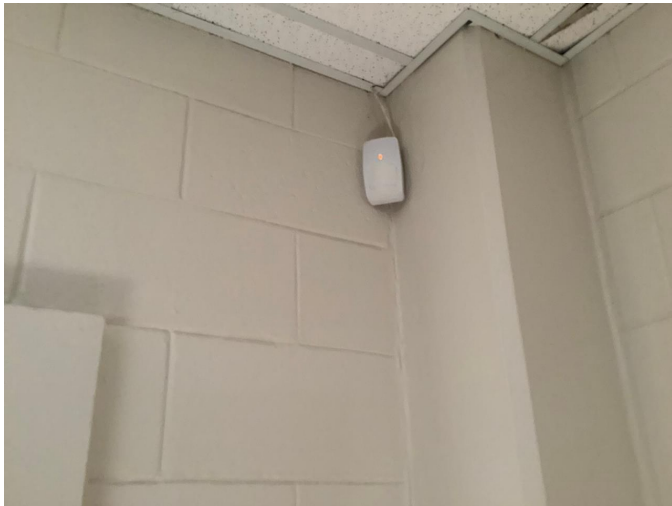
**Location:** Old Gym  
**Distress:** Beyond Expected Life  
**Category:** Deferred Maintenance  
**Priority:** 3 - Necessary (Years 2-5)  
**Correction:** Renew System  
**Qty:** 17,201.00  
**Unit of Measure:** S.F.  
**Estimate:** \$28,571.00  
**Assessor Name:** Hayden Collins  
**Date Created:** 12/11/2019

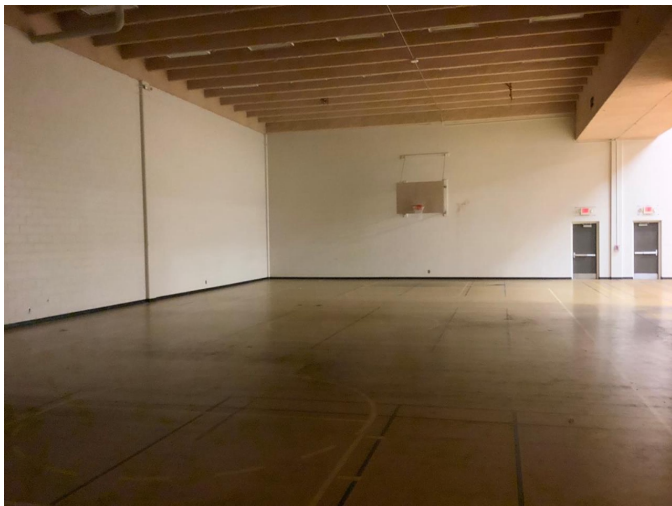
**Location:** Old Gym  
**Distress:** Beyond Expected Life  
**Category:** Deferred Maintenance  
**Priority:** 3 - Necessary (Years 2-5)  
**Correction:** Renew System  
**Qty:** 17,201.00  
**Unit of Measure:** S.F.  
**Estimate:** \$51,844.00  
**Assessor Name:** Hayden Collins  
**Date Created:** 12/11/2019

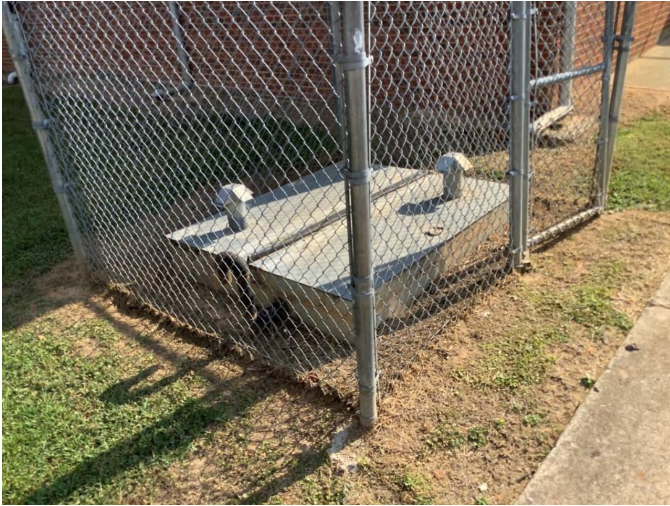
**Location:** Southside of 501a  
**Distress:** Beyond Expected Life  
**Category:** Deferred Maintenance  
**Priority:** 3 - Necessary (Years 2-5)  
**Correction:** Renew System  
**Qty:** 266,648.00  
**Unit of Measure:** S.F.  
**Estimate:** \$319,711.00  
**Assessor Name:** Hayden Collins  
**Date Created:** 10/15/2015

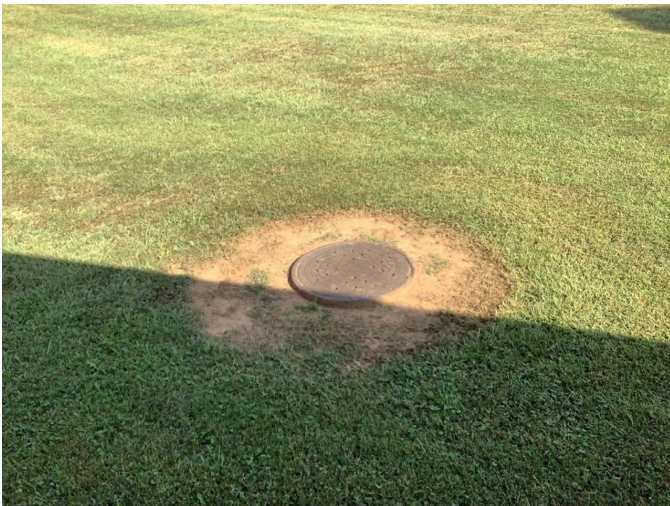
**Location:** Site  
**Distress:** Beyond Expected Life  
**Category:** Deferred Maintenance  
**Priority:** 3 - Necessary (Years 2-5)  
**Correction:** Renew System  
**Qty:** 266,648.00  
**Unit of Measure:** S.F.  
**Estimate:** \$636,489.00  
**Assessor Name:** Hayden Collins  
**Date Created:** 02/21/2020

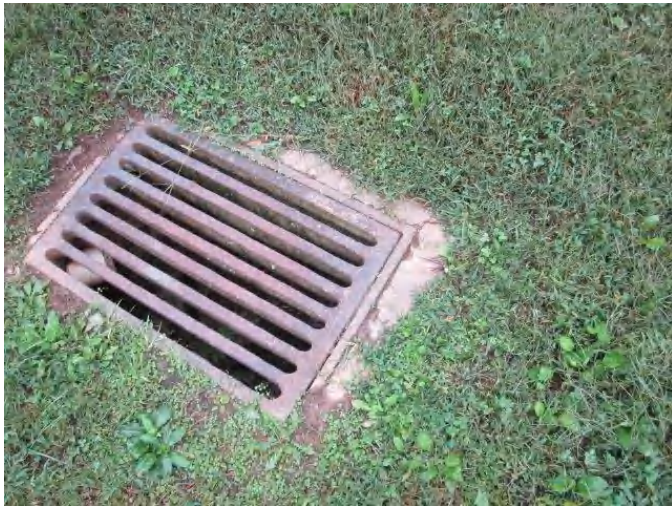
**Location:** south side of campus  
**Distress:** Beyond Expected Life  
**Category:** Deferred Maintenance  
**Priority:** 3 - Necessary (Years 2-5)  
**Correction:** Renew System  
**Qty:** 266,648.00  
**Unit of Measure:** S.F.  
**Estimate:** \$363,708.00  
**Assessor Name:** Hayden Collins  
**Date Created:** 10/15/2015
