Atlanta Public Schools/ Jackson Cluster

Barack and Michelle Obama Academy

School Assessment Report

November 10, 2020

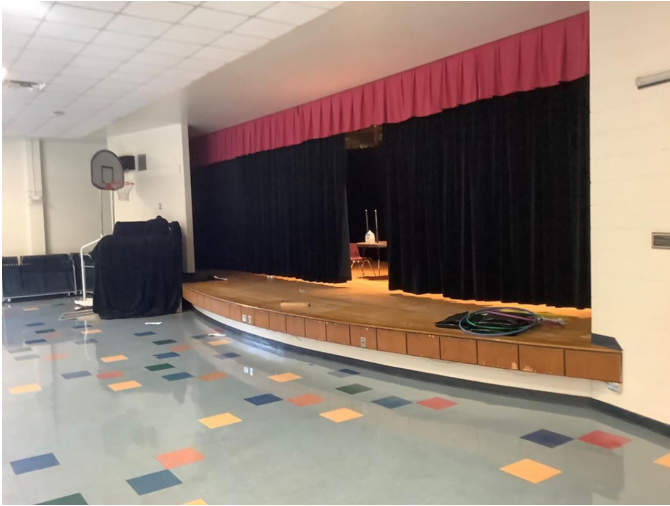
System: C3020999 - Other - Wood

Location: Auditorium
Distress: Beyond Expected Life
Category: Deferred Maintenance
Priority: 3 - Necessary (Years 2-5)
Correction: Renew System
Qty: 1,010.00
Unit of Measure: S.F.
Estimate: \$19,233.00
Assessor Name: Eduardo Lopez
Date Created: 11/26/2019

Notes: Stage is beyond expected life. Signs of wear and age are visible. Replacing or upgrading is recommended

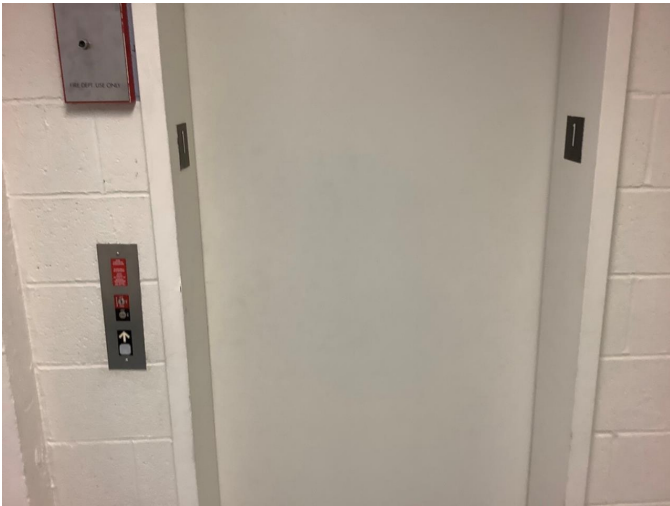
System: D1010 - Elevators and Lifts

Location: 1958_1968 Bldg 2010_2011_2012_2020
Distress: Beyond Expected Life
Category: Deferred Maintenance
Priority: 3 - Necessary (Years 2-5)
Correction: Renew System
Qty: 75,646.00
Unit of Measure: S.F.
Estimate: \$104,013.00
Assessor Name: Eduardo Lopez
Date Created: 10/08/2020

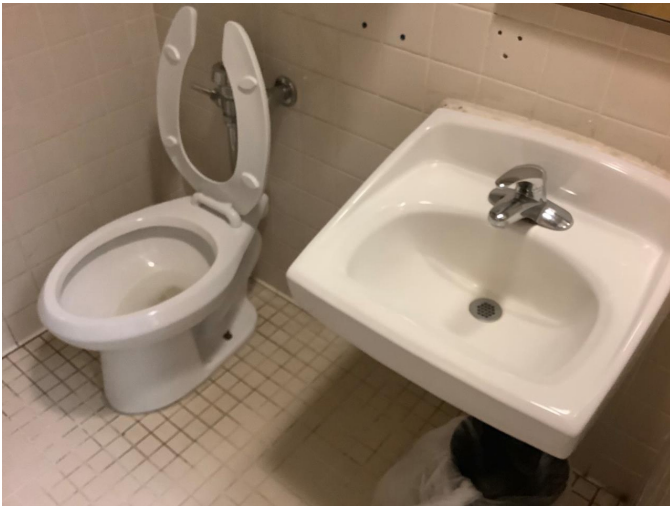
System: D2010 - Plumbing Fixtures

Location: 1958_1968 Bldg 2010_2011_2012_2020
Distress: Beyond Expected Life
Category: Deferred Maintenance
Priority: 3 - Necessary (Years 2-5)
Correction: Renew System
Qty: 75,646.00
Unit of Measure: S.F.
Estimate: \$530,052.00
Assessor Name: Eduardo Lopez
Date Created: 10/08/2020

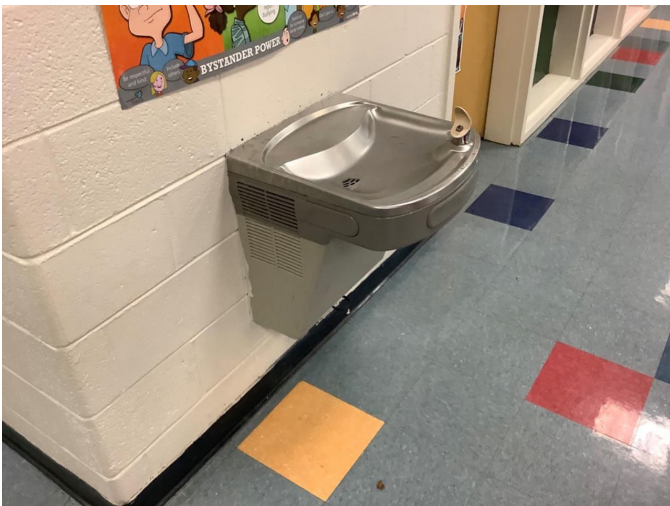
System: D2020 - Domestic Water Distribution

Location: 1958_1968 Bldg 2010_2011_2012_2020
Distress: Beyond Expected Life
Category: Deferred Maintenance
Priority: 3 - Necessary (Years 2-5)
Correction: Renew System
Qty: 75,646.00
Unit of Measure: S.F.
Estimate: \$59,912.00
Assessor Name: Eduardo Lopez
Date Created: 10/08/2020

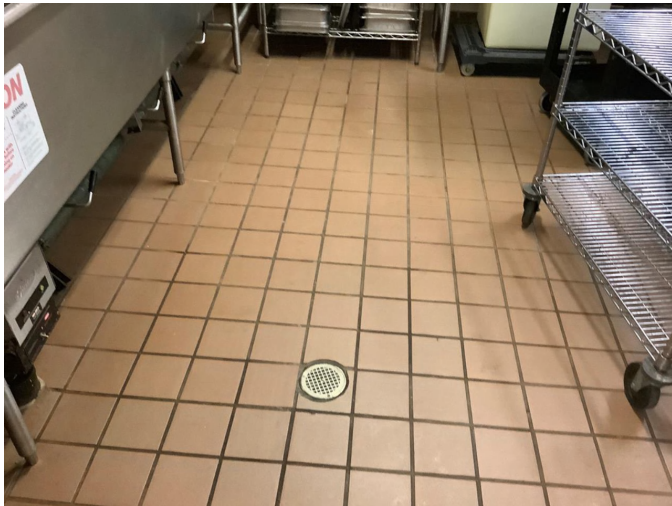
System: D2030 - Sanitary Waste

Location: Kitchen and bathrooms
Distress: Beyond Expected Life
Category: Deferred Maintenance
Priority: 3 - Necessary (Years 2-5)
Correction: Renew System
Qty: 75,646.00
Unit of Measure: S.F.
Estimate: \$140,626.00
Assessor Name: Eduardo Lopez
Date Created: 09/11/2013

Notes: Sanitary waste drains are beyond their life expectancy. Replacing or upgrading is recommended.

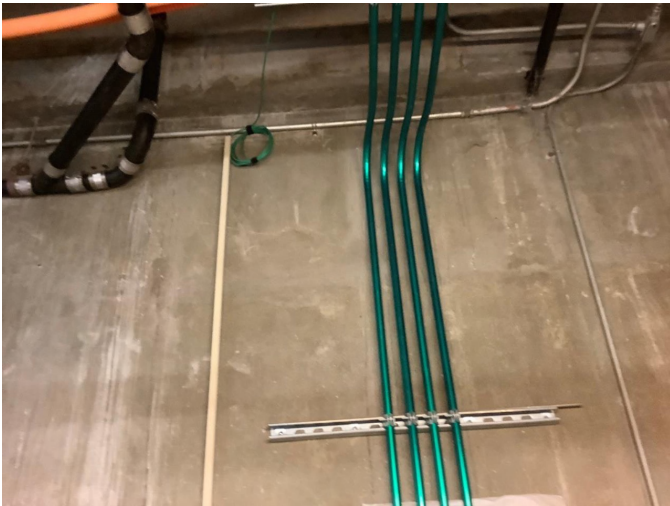
System: D5020 - Branch Wiring

Location: 1958_1968 Bldg 2010_2011_2012_2020
Distress: Beyond Expected Life
Category: Deferred Maintenance
Priority: 3 - Necessary (Years 2-5)
Correction: Renew System
Qty: 75,646.00
Unit of Measure: S.F.
Estimate: \$395,250.00
Assessor Name: Eduardo Lopez
Date Created: 10/08/2020

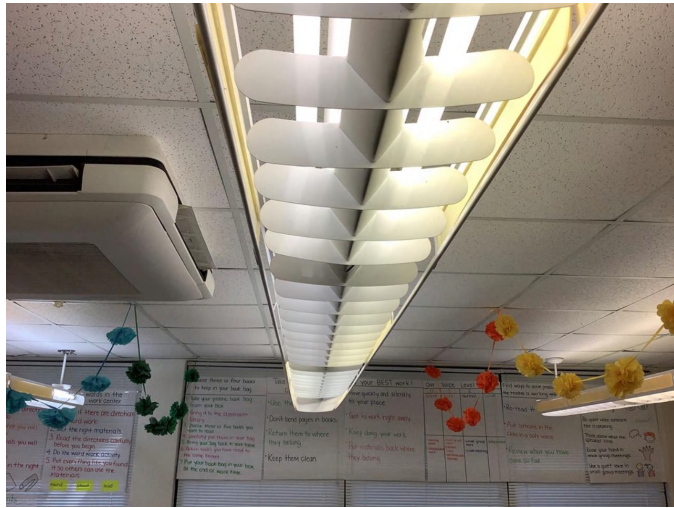
System: D5020 - Lighting

Location: 1958_1968 Bldg 2010_2011_2012_2020

Distress: Beyond Expected Life

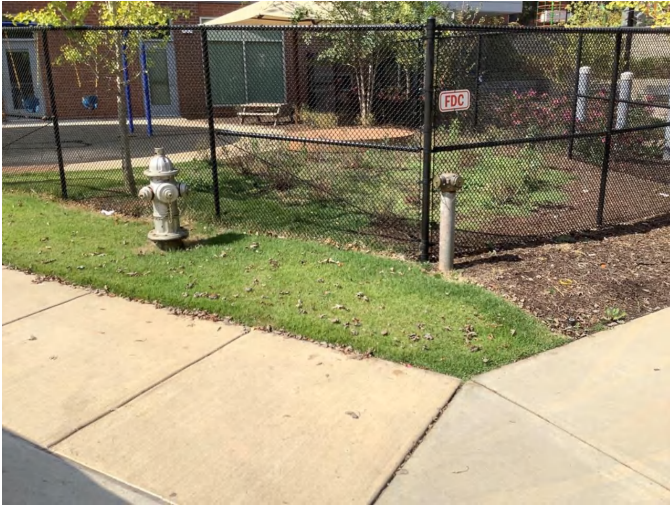
System: G3010 - Water Supply

Location: outside of building
Distress: Beyond Expected Life
Category: Deferred Maintenance
Priority: 3 - Necessary (Years 2-5)
Correction: Renew System
Qty: 75,646.00
Unit of Measure: S.F.
Estimate: \$90,700.00
Assessor Name: Jejuan Hall
Date Created: 09/30/2019

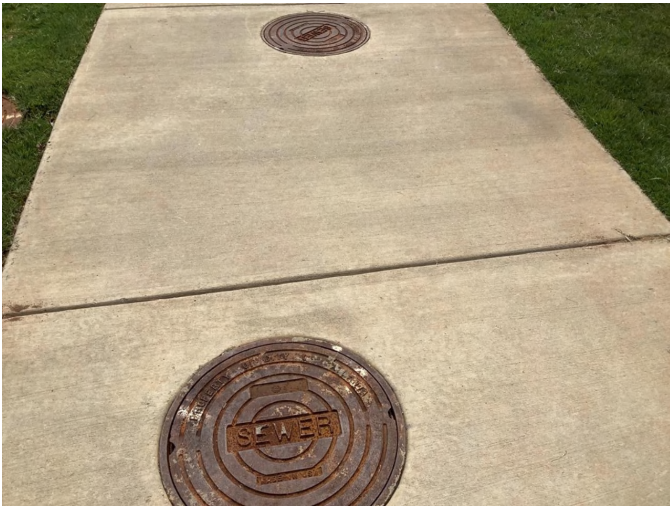
System: G3020 - Sanitary Sewer

Location: Throughout the site outside of building
Distress: Beyond Expected Life
Category: Deferred Maintenance
Priority: 3 - Necessary (Years 2-5)
Correction: Renew System
Qty: 75,646.00
Unit of Measure: S.F.
Estimate: \$183,063.00
Assessor Name: Jejuan Hall
Date Created: 09/30/2019

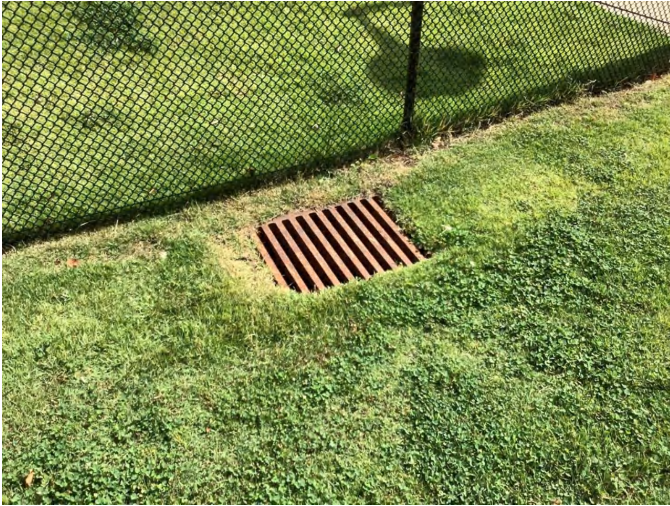
System: G3030 - Storm Sewer

Location: Throughout the site outside of building
Distress: Beyond Expected Life
Category: Deferred Maintenance
Priority: 3 - Necessary (Years 2-5)
Correction: Renew System
Qty: 75,646.00
Unit of Measure: S.F.
Estimate: \$104,013.00
Assessor Name: Jejuan Hall
Date Created: 09/30/2019
