Atlanta Public Schools/ Jackson Cluster

Benteen Elementary School

School Assessment Report

November 10, 2020

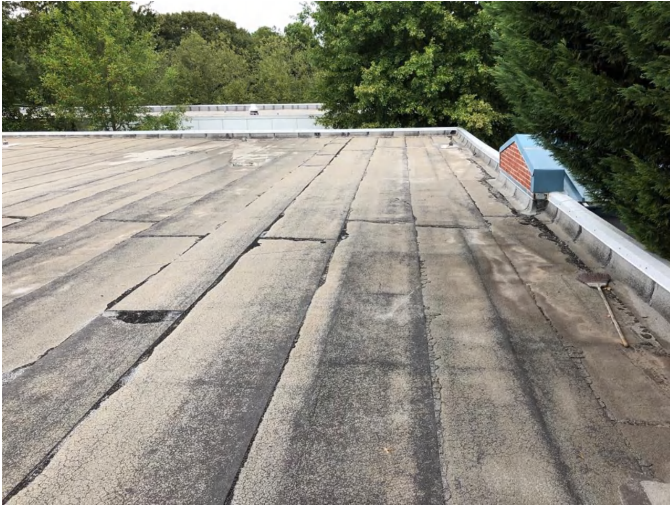
System: B3010105 - Built-Up

Location: Rooftop
Distress: Beyond Expected Life
Category: Deferred Maintenance
Priority: 3 - Necessary (Years 2-5)
Correction: Renew System
Qty: 19,107.00
Unit of Measure: S.F.
Estimate: \$214,486.00
Assessor Name: Jejuan Hall
Date Created: 01/22/2020

Notes: The built up roof covering is beyond its service life and should be scheduled for replacement.

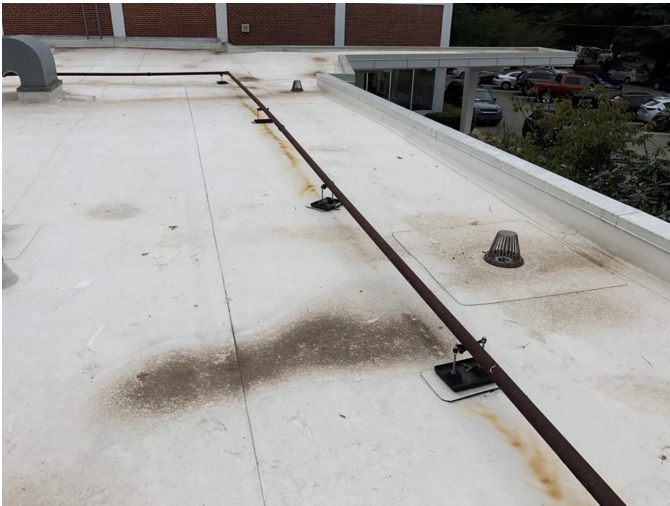
System: B3010120 - Single Ply Membrane

Location: Rooftop
Distress: Beyond Expected Life
Category: Deferred Maintenance
Priority: 3 - Necessary (Years 2-5)
Correction: Renew System
Qty: 6,565.00
Unit of Measure: S.F.
Estimate: \$61,342.00
Assessor Name: Jejuan Hall
Date Created: 01/22/2020

Notes: The single ply membrane roof covering is beyond its service life and should be scheduled for replacement.

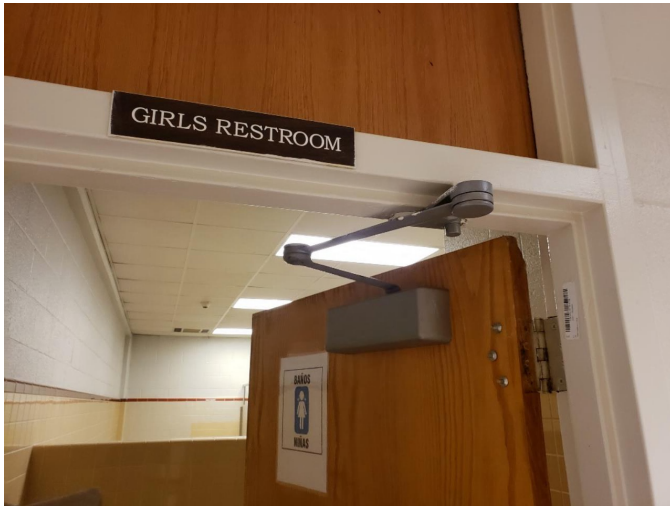
System: C1030 - Fittings

Location: Throughout Building
Distress: Beyond Expected Life
Category: ADA Compliance
Priority: 3 - Necessary (Years 2-5)
Correction: Renew System
Qty: 23,867.00
Unit of Measure: S.F.
Estimate: \$65,897.00
Assessor Name: Jejuan Hall
Date Created: 01/22/2020

Notes: The fittings are aged and beyond their expected service life and should be scheduled for replacement.

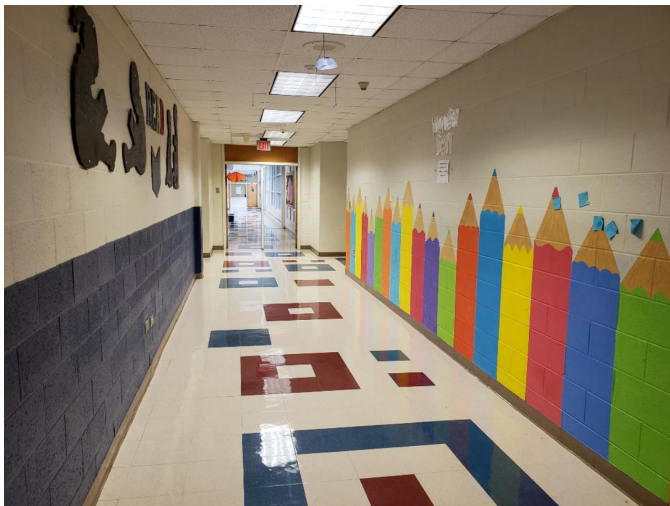
System: C3020903 - VCT

Location: Throughout Building
Distress: Beyond Expected Life
Category: Deferred Maintenance
Priority: 3 - Necessary (Years 2-5)
Correction: Renew System
Qty: 20,160.00
Unit of Measure: S.F.
Estimate: \$108,743.00
Assessor Name: Jejuan Hall
Date Created: 01/22/2020

Notes: The VCT floor finish is beyond its expected service life, worn and damaged, and is recommended for replacement.

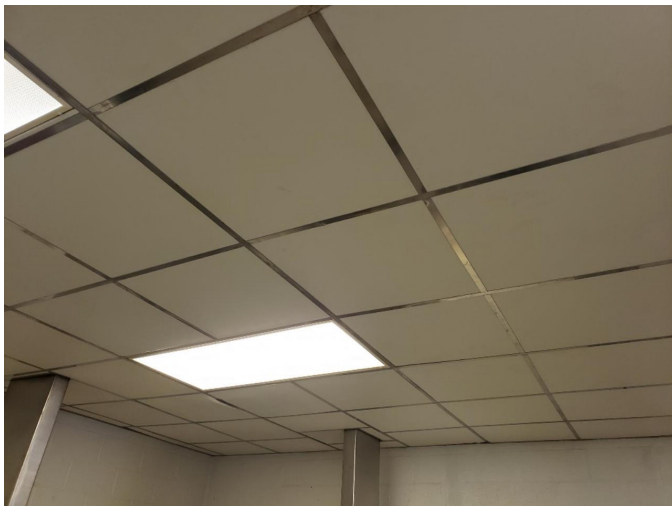
System: C3030 - Ceiling Finishes

Location: Throughout Building
Distress: Beyond Expected Life
Category: Deferred Maintenance
Priority: 3 - Necessary (Years 2-5)
Correction: Renew System
Qty: 23,867.00
Unit of Measure: S.F.
Estimate: \$222,894.00
Assessor Name: Jejuan Hall
Date Created: 01/22/2020

Notes: The ceiling tiles are beyond their expected service life and should be scheduled for replacement.

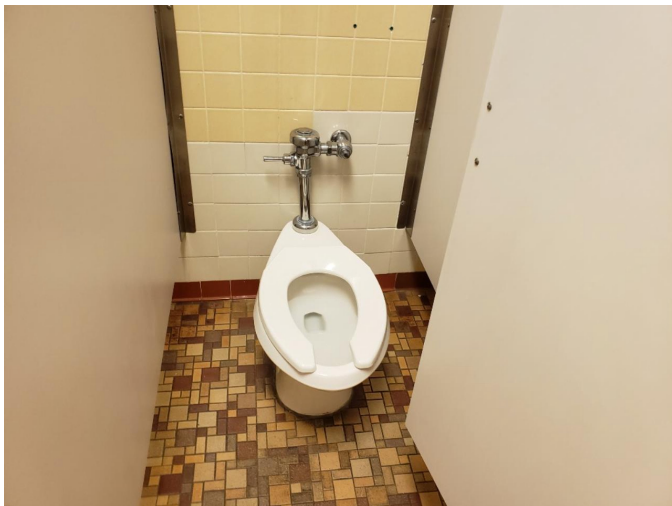
System: D2010 - Plumbing Fixtures

Location: bathrooms
Distress: Beyond Expected Life
Category: ADA Compliance
Priority: 3 - Necessary (Years 2-5)
Correction: Renew System
Qty: 23,867.00
Unit of Measure: S.F.
Estimate: \$163,035.00
Assessor Name: Jejuan Hall
Date Created: 01/22/2020

Notes: The Plumbing fixtures are beyond their expected service life and should be scheduled for replacement.

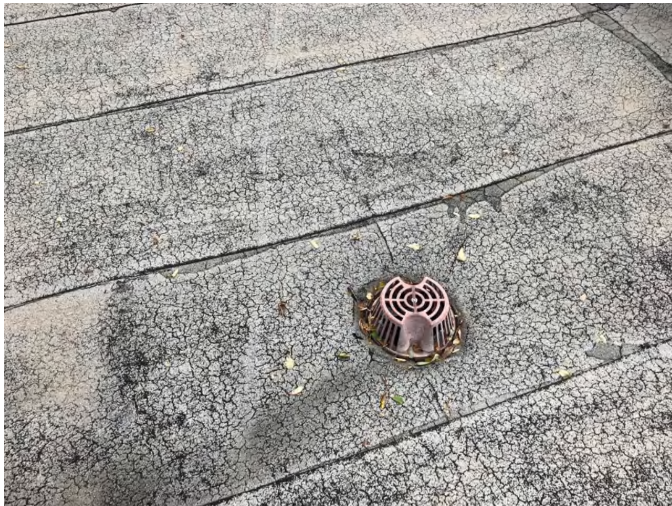
System: D2040 - Rain Water Drainage

Location: Rooftop
Distress: Beyond Expected Life
Category: Deferred Maintenance
Priority: 3 - Necessary (Years 2-5)
Correction: Renew System
Qty: 23,867.00
Unit of Measure: S.F.
Estimate: \$10,501.00
Assessor Name: Jejuan Hall
Date Created: 01/22/2020

Notes: The rainwater drainage system is beyond its expected service life and should be scheduled for replacement.

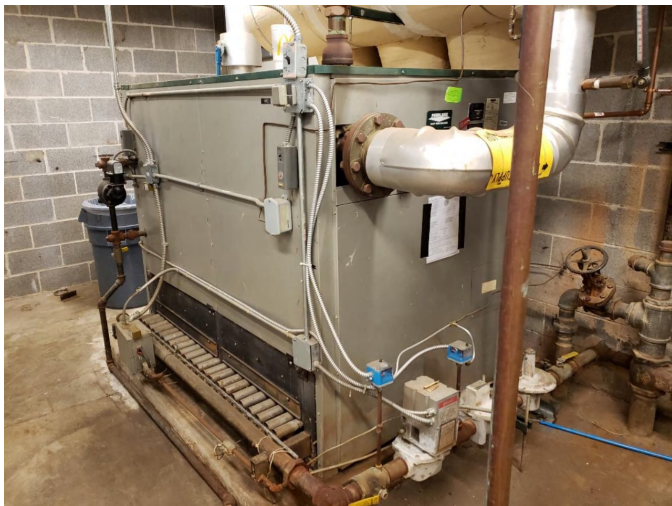
System: D3020 - Heat Generating Systems

Location: Mechanical room
Distress: Beyond Expected Life
Category: Deferred Maintenance
Priority: 3 - Necessary (Years 2-5)
Correction: Renew System
Qty: 23,867.00
Unit of Measure: S.F.
Estimate: \$92,150.00
Assessor Name: Jejuan Hall
Date Created: 08/13/2014

Notes: The boiler is beyond its service life and should be scheduled for replacement.

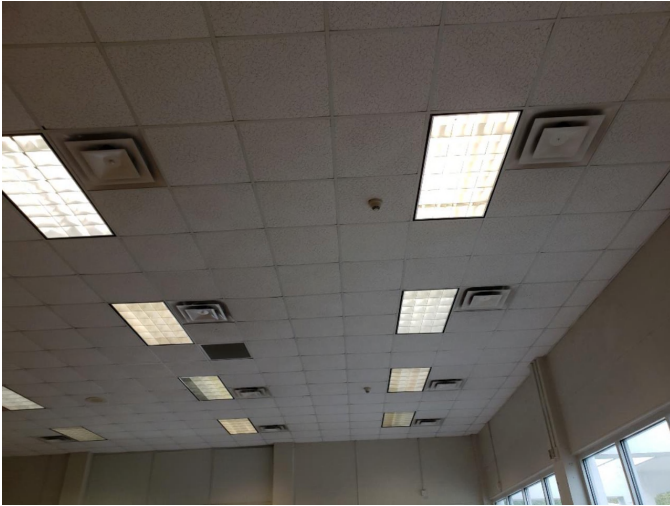
System: D3040 - Distribution Systems

Location: Throughout Building
Distress: Beyond Expected Life
Category: Deferred Maintenance
Priority: 3 - Necessary (Years 2-5)
Correction: Renew System
Qty: 23,867.00
Unit of Measure: S.F.
Estimate: \$272,513.00
Assessor Name: Jejuan Hall
Date Created: 01/22/2020

Notes: The HVAC distribution system is beyond its expected service life and should be scheduled for replacement.

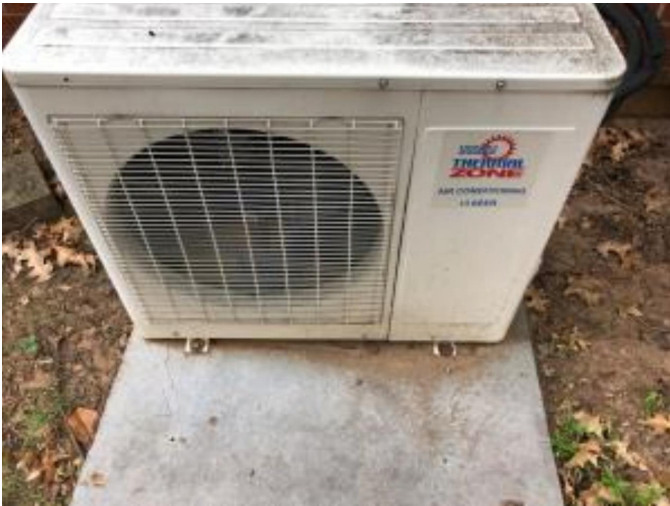
System: D3050 - Terminal & Package Units

Location: Rooftop and around building
Distress: Beyond Expected Life
Category: Deferred Maintenance
Priority: 3 - Necessary (Years 2-5)
Correction: Renew System
Qty: 23,867.00
Unit of Measure: S.F.
Estimate: \$557,366.00
Assessor Name: Jejuan Hall
Date Created: 07/29/2013

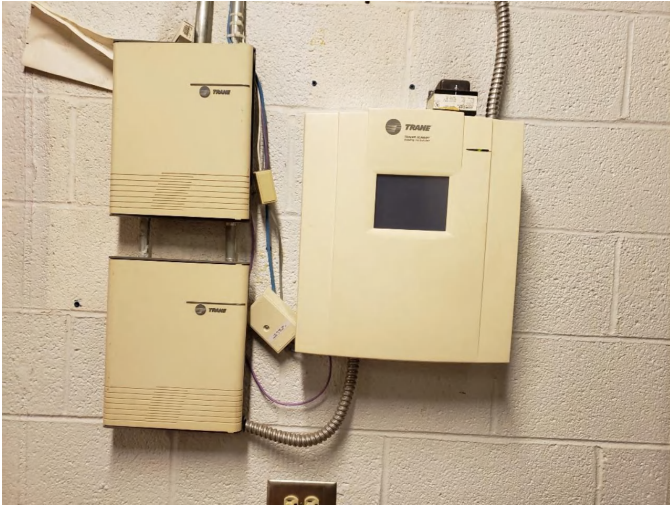
System: D3060 - Controls & Instrumentation

Location: Throughout Building
Distress: Beyond Expected Life
Category: Deferred Maintenance
Priority: 3 - Necessary (Years 2-5)
Correction: Renew System
Qty: 23,867.00
Unit of Measure: S.F.
Estimate: \$56,708.00
Assessor Name: Jejuan Hall
Date Created: 07/29/2013

Notes: The heating and cooling systems, exhaust and ventilation systems, energy monitoring and controls as well as the building automation systems are beyond their expected service life. Upgrades or replacing the system is recommended.

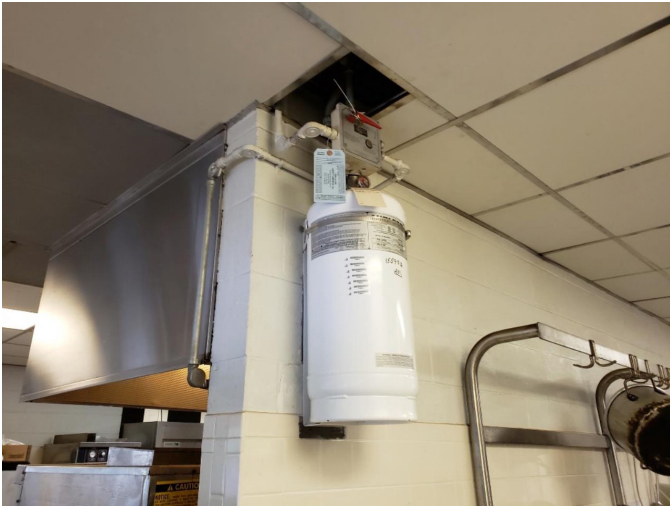
Location: Kitchen
Distress: Beyond Expected Life
Category: Deferred Maintenance
Priority: 3 - Necessary (Years 2-5)
Correction: Renew System
Qty: 23,867.00
Unit of Measure: S.F.
Estimate: \$15,752.00
Assessor Name: Jejuan Hall
Date Created: 07/29/2013

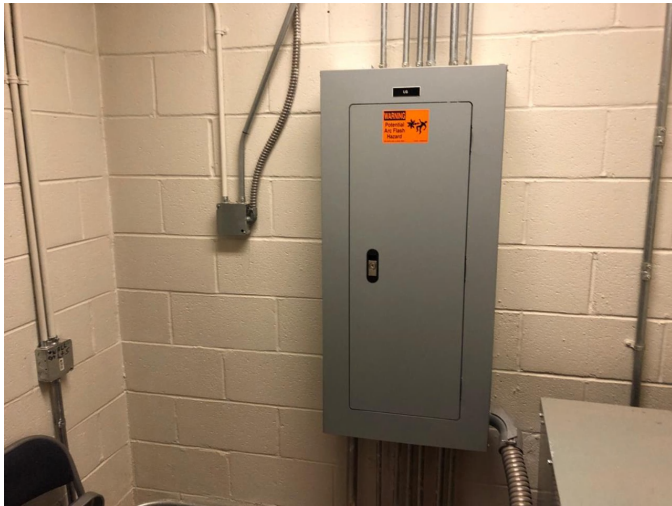
Location: Throughout Building
Distress: Beyond Expected Life
Category: Deferred Maintenance
Priority: 3 - Necessary (Years 2-5)
Correction: Renew System
Qty: 23,867.00
Unit of Measure: S.F.
Estimate: \$57,496.00
Assessor Name: Jejuan Hall
Date Created: 07/29/2013

Notes: The electrical service/distribution system is beyond its expected service life and should be scheduled for replacement.

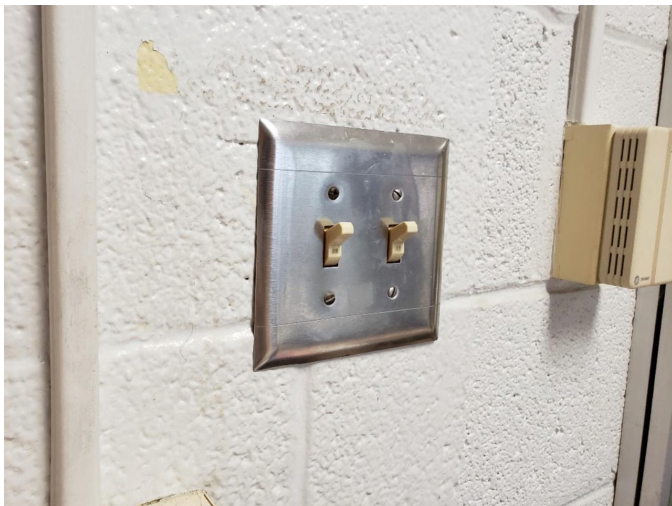
Location: Throughout Building
Distress: Beyond Expected Life
Category: Deferred Maintenance
Priority: 3 - Necessary (Years 2-5)
Correction: Renew System
Qty: 23,867.00
Unit of Measure: S.F.
Estimate: \$118,667.00
Assessor Name: Jejuan Hall
Date Created: 01/22/2020

Notes: The branch wiring system is operational but is aged and should be replaced with an energy efficient system.

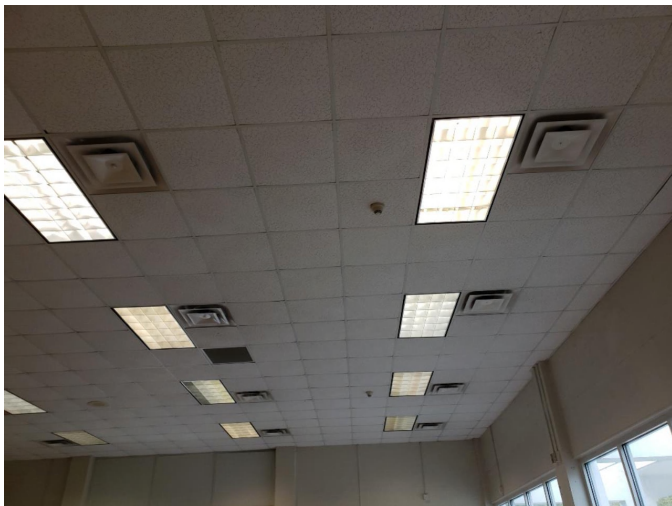
Location: Throughout Building
Distress: Beyond Expected Life
Category: Deferred Maintenance
Priority: 3 - Necessary (Years 2-5)
Correction: Renew System
Qty: 23,867.00
Unit of Measure: S.F.
Estimate: \$178,000.00
Assessor Name: Jejuan Hall
Date Created: 01/22/2020

The lighting system is beyond its expected life and universal upgrades are recommended.

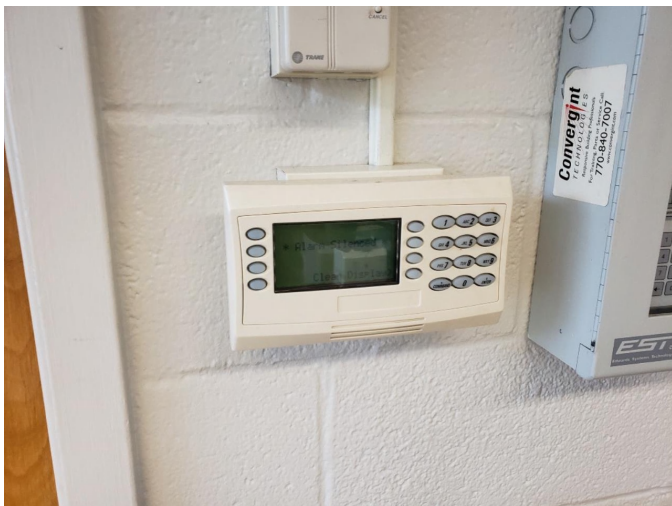
Location: Throughout Building
Distress: Beyond Expected Life
Category: Deferred Maintenance
Priority: 3 - Necessary (Years 2-5)
Correction: Renew System
Qty: 23,867.00
Unit of Measure: S.F.
Estimate: \$39,643.00
Assessor Name: Jejuan Hall
Date Created: 01/22/2020

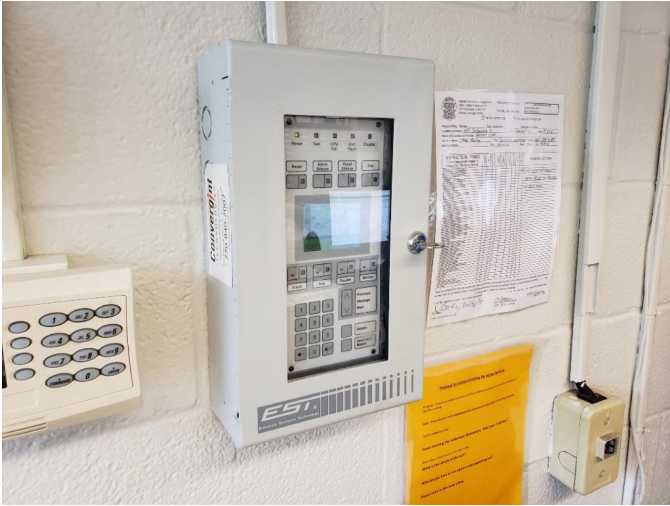
Location: Throughout Building
Distress: Beyond Expected Life
Category: Deferred Maintenance
Priority: 3 - Necessary (Years 2-5)
Correction: Renew System
Qty: 23,867.00
Unit of Measure: S.F.
Estimate: \$71,935.00
Assessor Name: Jejuan Hall
Date Created: 01/22/2020

Notes: The Fire Alarm system is beyond its expected service life and should be scheduled for replacement.

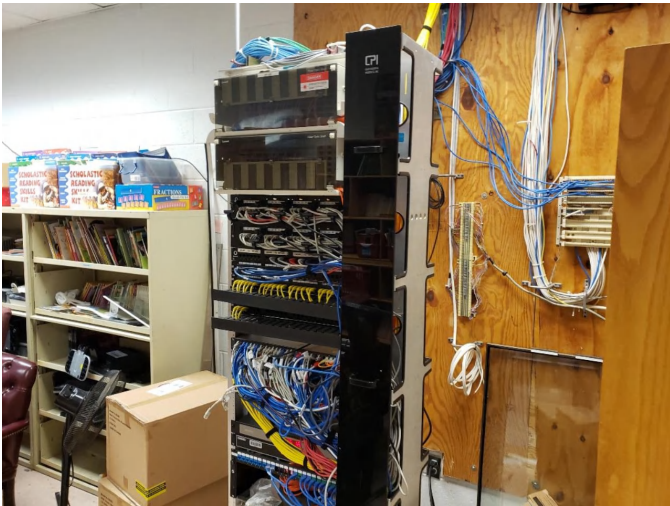
Location: IDF and MDF
Distress: Beyond Expected Life
Category: Deferred Maintenance
Priority: 3 - Necessary (Years 2-5)
Correction: Renew System
Qty: 23,867.00
Unit of Measure: S.F.
Estimate: \$93,463.00
Assessor Name: Jejuan Hall
Date Created: 01/22/2020

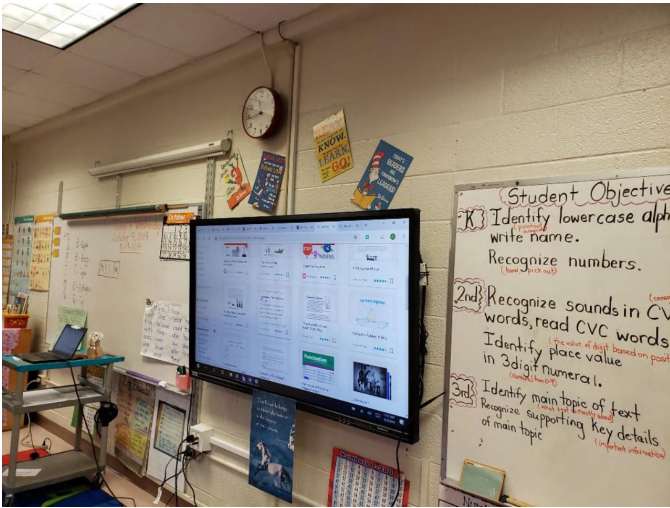
Location: Throughout Building
Distress: Beyond Expected Life
Category: Deferred Maintenance
Priority: 3 - Necessary (Years 2-5)
Correction: Renew System
Qty: 23,867.00
Unit of Measure: S.F.
Estimate: \$2,625.00
Assessor Name: Jejuan Hall
Date Created: 01/22/2020

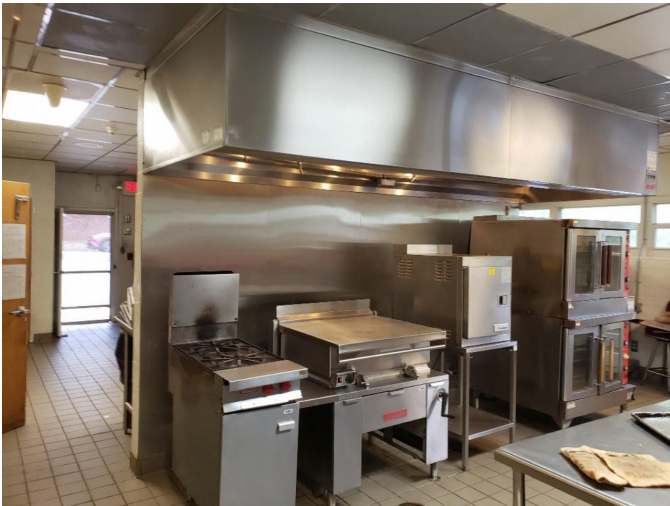
Location: Kitchen
Distress: Beyond Expected Life
Category: Deferred Maintenance
Priority: 3 - Necessary (Years 2-5)
Correction: Renew System
Qty: 23,867.00
Unit of Measure: S.F.
Estimate: \$22,053.00
Assessor Name: Jejuan Hall
Date Created: 01/22/2020

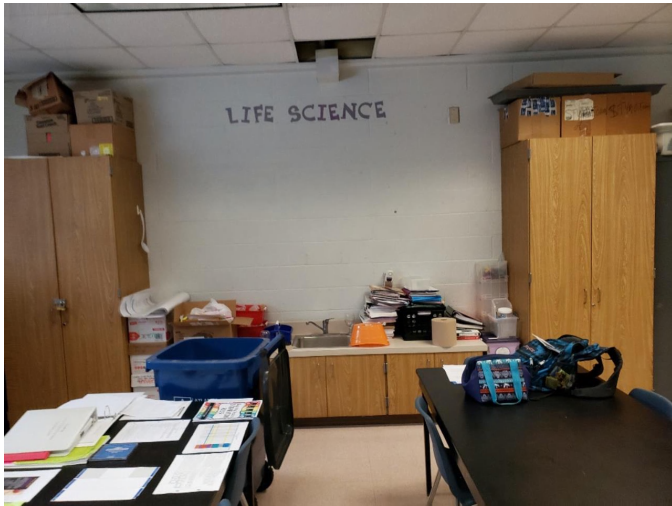
Location: Throughout Building
Distress: Beyond Expected Life
Category: Deferred Maintenance
Priority: 3 - Necessary (Years 2-5)
Correction: Renew System
Qty: 23,867.00
Unit of Measure: S.F.
Estimate: \$55,658.00
Assessor Name: Jejuan Hall
Date Created: 07/29/2013

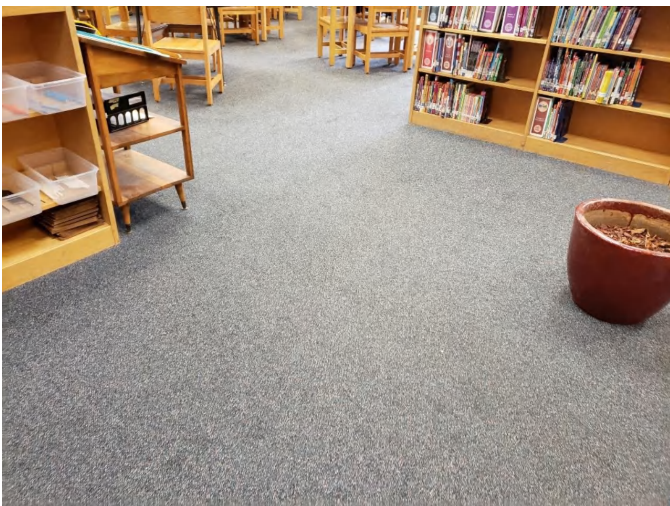
Location: Media Center and Main office
Distress: Beyond Expected Life
Category: Deferred Maintenance
Priority: 3 - Necessary (Years 2-5)
Correction: Renew System
Qty: 2,439.00
Unit of Measure: S.F.
Estimate: \$20,122.00
Assessor Name: Jejuan Hall
Date Created: 01/22/2020

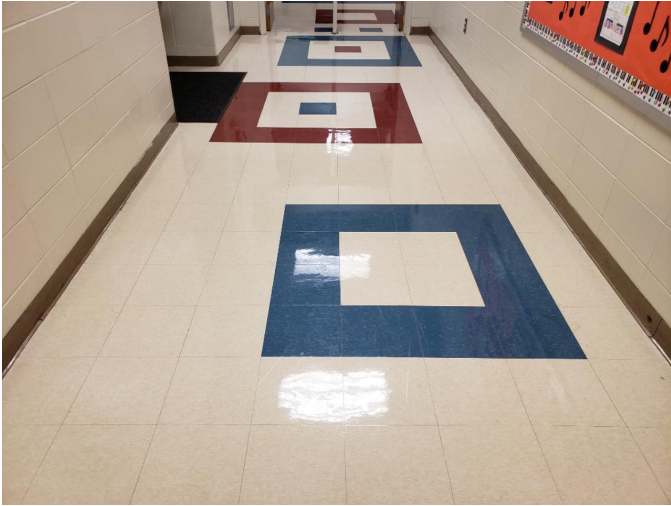
Location: Throughout Building
Distress: Beyond Expected Life
Category: Deferred Maintenance
Priority: 3 - Necessary (Years 2-5)
Correction: Renew System
Qty: 10,229.00
Unit of Measure: S.F.
Estimate: \$55,175.00
Assessor Name: Jejuan Hall
Date Created: 01/22/2020

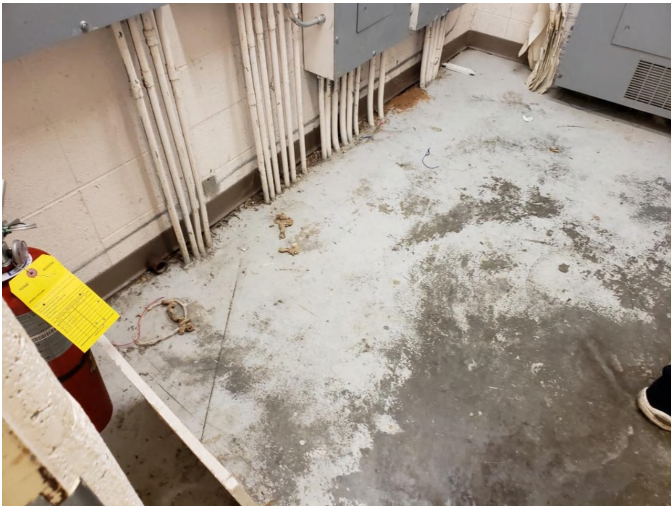
Location: Mechanical room and electrical rooms
Distress: Beyond Expected Life
Category: Deferred Maintenance
Priority: 3 - Necessary (Years 2-5)
Correction: Renew System
Qty: 51.00
Unit of Measure: S.F.
Estimate: \$385.00
Assessor Name: Jejuan Hall
Date Created: 01/22/2020

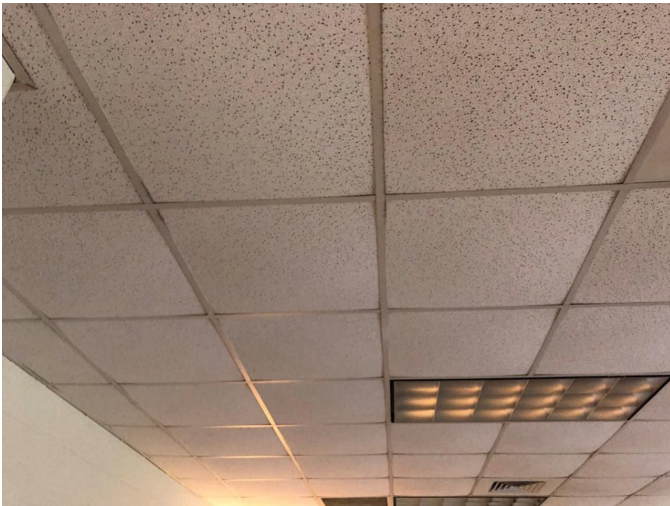
Location: Throughout Building
Distress: Beyond Expected Life
Category: Deferred Maintenance
Priority: 3 - Necessary (Years 2-5)
Correction: Renew System
Qty: 13,199.00
Unit of Measure: S.F.
Estimate: \$123,265.00
Assessor Name: Jejuan Hall
Date Created: 07/29/2013

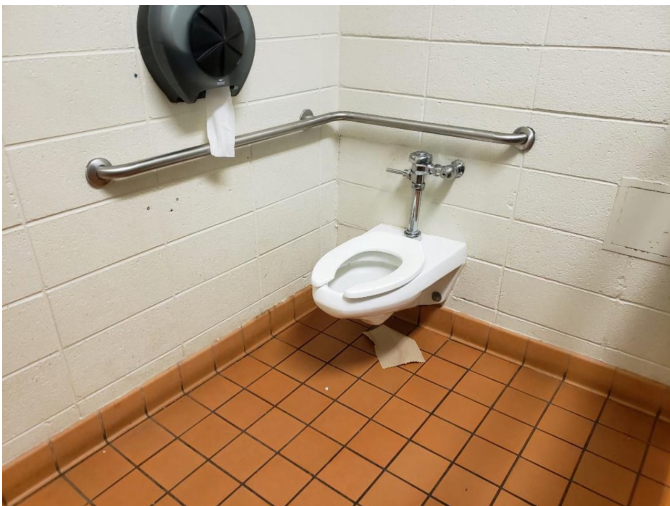
Location: bathrooms
Distress: Beyond Expected Life
Category: ADA Compliance
Priority: 3 - Necessary (Years 2-5)
Correction: Renew System
Qty: 13,199.00
Unit of Measure: S.F.
Estimate: \$90,162.00
Assessor Name: Jejuan Hall
Date Created: 08/13/2014

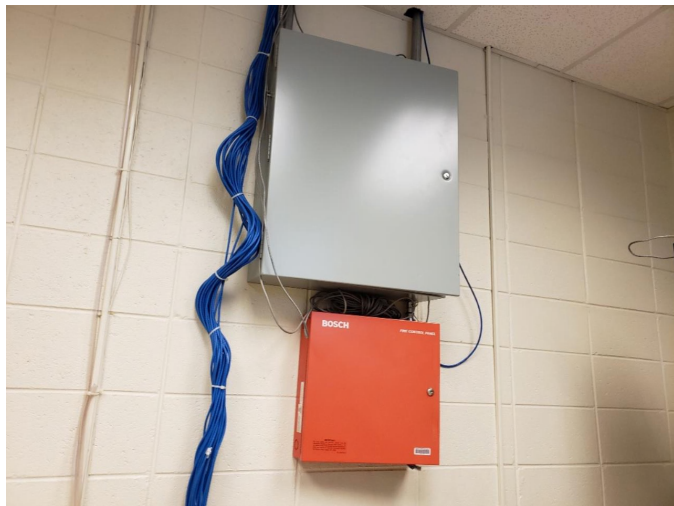
Location: Throughout Building
Distress: Beyond Expected Life
Category: Deferred Maintenance
Priority: 3 - Necessary (Years 2-5)
Correction: Renew System
Qty: 13,199.00
Unit of Measure: S.F.
Estimate: \$39,782.00
Assessor Name: Jejuan Hall
Date Created: 01/22/2020

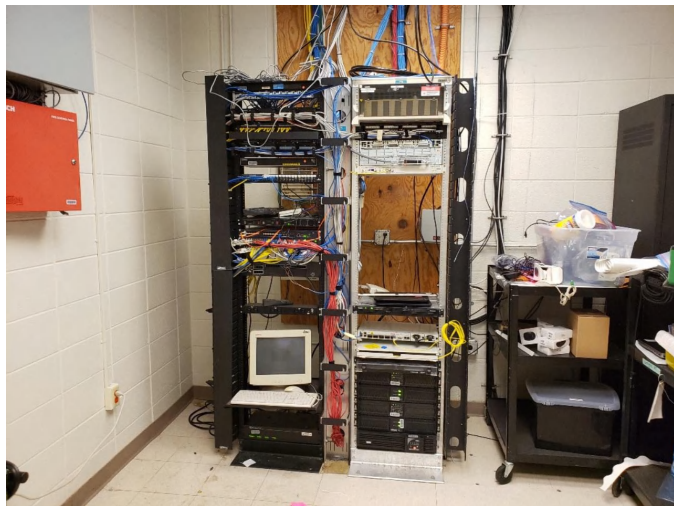
Location: IDF and MDF
Distress: Beyond Expected Life
Category: Deferred Maintenance
Priority: 3 - Necessary (Years 2-5)
Correction: Renew System
Qty: 13,199.00
Unit of Measure: S.F.
Estimate: \$51,687.00
Assessor Name: Jejuan Hall
Date Created: 01/22/2020

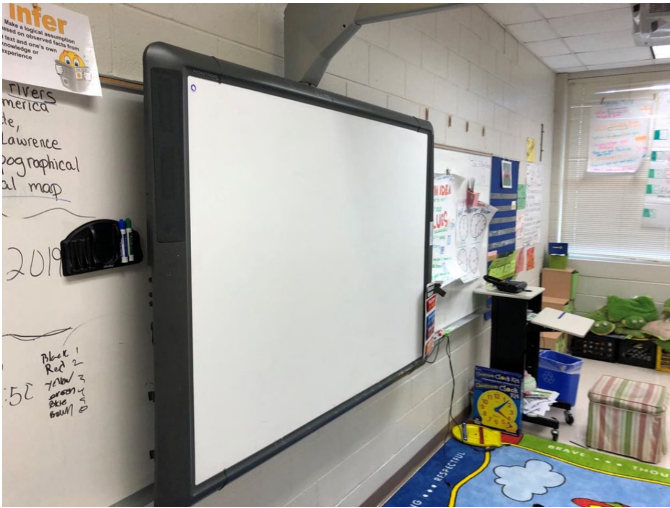
Location: Throughout Building
Distress: Beyond Expected Life
Category: Deferred Maintenance
Priority: 3 - Necessary (Years 2-5)
Correction: Renew System
Qty: 13,199.00
Unit of Measure: S.F.
Estimate: \$1,452.00
Assessor Name: Jejuan Hall
Date Created: 07/29/2013

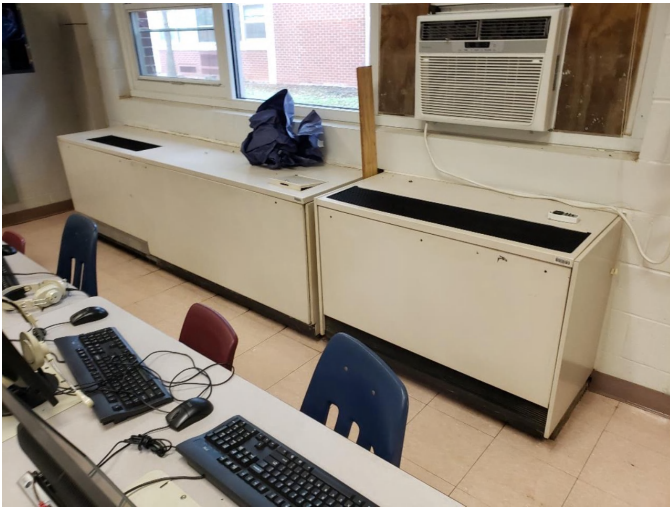
Location: Throughout Building
Distress: Beyond Expected Life
Category: Deferred Maintenance
Priority: 3 - Necessary (Years 2-5)
Correction: Renew System
Qty: 10,777.00
Unit of Measure: S.F.
Estimate: \$159,683.00
Assessor Name: Eduardo Lopez
Date Created: 01/22/2020

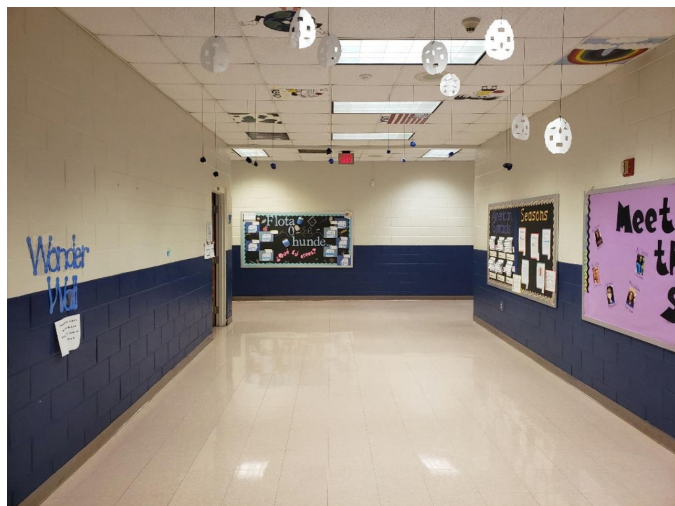
Location: Throughout Building
Distress: Beyond Expected Life
Category: Deferred Maintenance
Priority: 3 - Necessary (Years 2-5)
Correction: Renew System
Qty: 10,777.00
Unit of Measure: S.F.
Estimate: \$3,675.00
Assessor Name: Eduardo Lopez
Date Created: 01/22/2020
