Atlanta Public Schools/Relocation Sites

Bethune ES (Barack and Michelle Obama Academy relocation site)

School Assessment Report

November 10, 2020

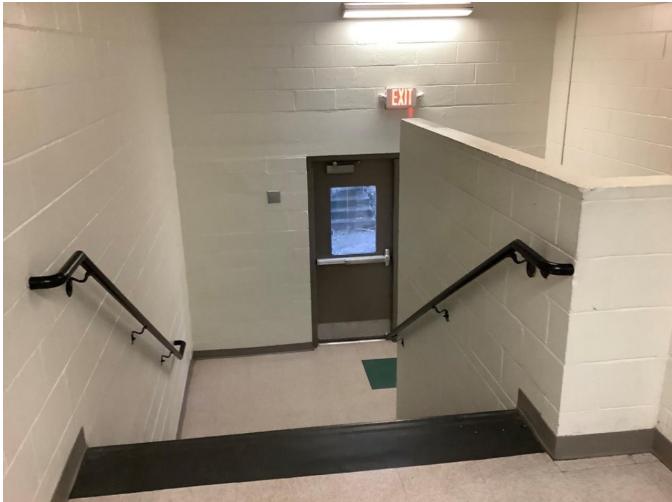
System: C1030 - Fittings

Location:	Throughout Building
Distress:	Beyond Expected Life
Category:	ADA Compliance
Priority:	3 - Necessary (Years 2-5)
Correction:	Renew System
Qty:	50,698.00
Unit of Measure:	S.F.
Estimate:	\$147,785.00
Assessor Name:	Eduardo Lopez
Date Created:	10/01/2019

Notes: The fititngs are aged and stained and should be scheduled for replacement.

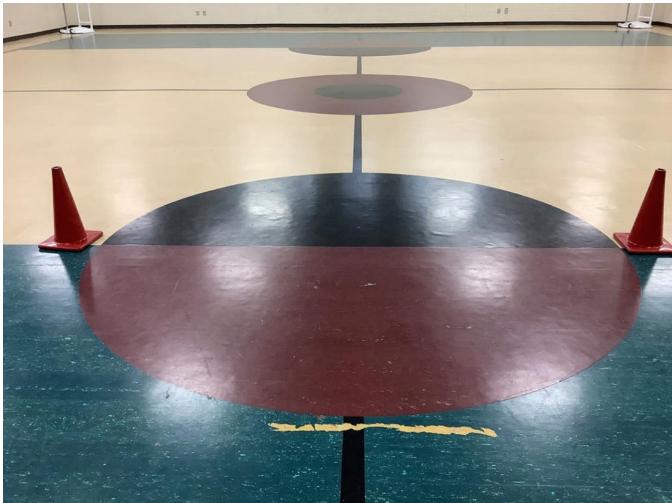
System: C3020405 - Epoxy

Location:	Gym
Distress:	Beyond Expected Life
Category:	Deferred Maintenance
Priority:	3 - Necessary (Years 2-5)
Correction:	Renew System
Qty:	5,000.00
Unit of Measure:	S.F.
Estimate:	\$102,070.00
Assessor Name:	Eduardo Lopez
Date Created:	12/12/2019

Notes: The Epoxy is beyond its expected service life and should be replaced in conjunction with other recommended renovations.

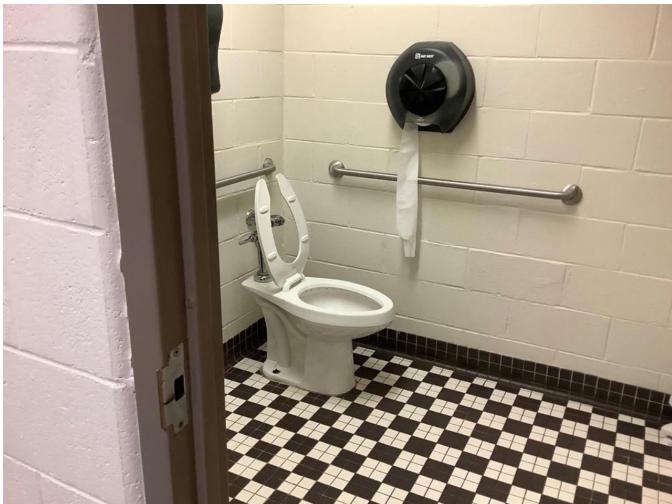
System: C3020420 - Ceramic Tile

Location: Restrooms
Distress: Beyond Expected Life
Category: Deferred Maintenance
Priority: 3 - Necessary (Years 2-5)
Correction: Renew System
Qty: 5,000.00
Unit of Measure: S.F.
Estimate: \$125,550.00
Assessor Name: Eduardo Lopez
Date Created: 12/12/2019

Notes: The ceramic tile floor finish is beyond its expected service life and should be replaced in conjunction with other recommended renovations.

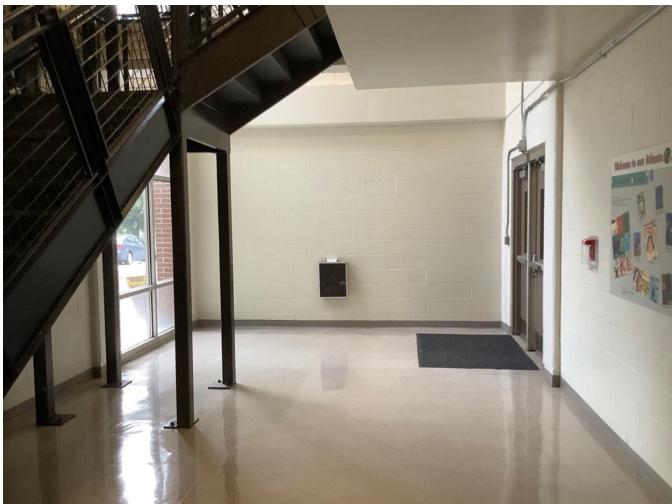
System: C3020903 - VCT

Location: Throughout Building
Distress: Beyond Expected Life
Category: Deferred Maintenance
Priority: 3 - Necessary (Years 2-5)
Correction: Renew System
Qty: 40,698.00
Unit of Measure: S.F.
Estimate: \$219,525.00
Assessor Name: Eduardo Lopez
Date Created: 12/12/2019

Notes: The VCT floor finish is beyond its expected service life, worn and damaged, and is recommended for replacement.

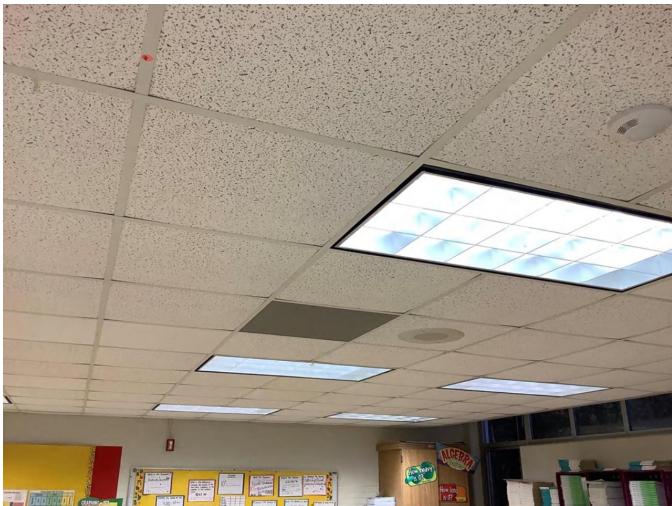
System: C3030 - Ceiling Finishes

Location: Throughout Building
Distress: Beyond Expected Life
Category: Deferred Maintenance
Priority: 3 - Necessary (Years 2-5)
Correction: Renew System
Qty: 50,698.00
Unit of Measure: S.F.
Estimate: \$501,910.00
Assessor Name: Eduardo Lopez
Date Created: 10/01/2019

Notes: The acoustic ceilings are aged and stained and should be scheduled for replacement.

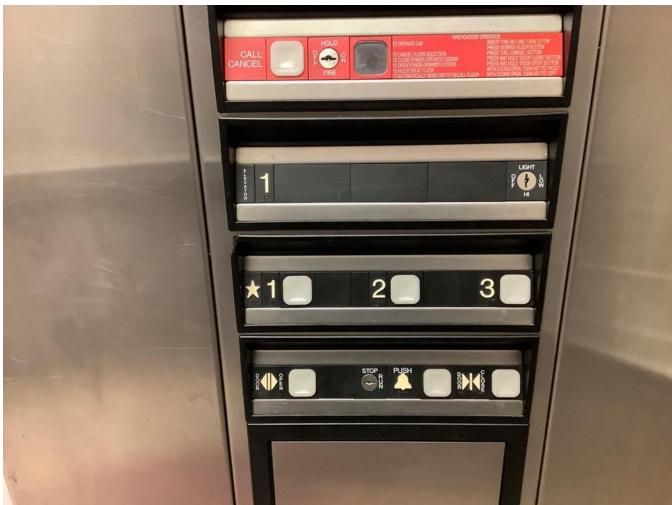
System: D1010 - Elevators and Lifts

Location: Throughout Building
Distress: Beyond Expected Life
Category: Deferred Maintenance
Priority: 3 - Necessary (Years 2-5)
Correction: Renew System
Qty: 78,561.00
Unit of Measure: S.F.
Estimate: \$108,021.00
Assessor Name: Eduardo Lopez
Date Created: 10/01/2019

Notes: The elevator system has exceeded its life cycle and recommended for upgrade. All aspects of the current ADA standards are expected to be included in the new installation.

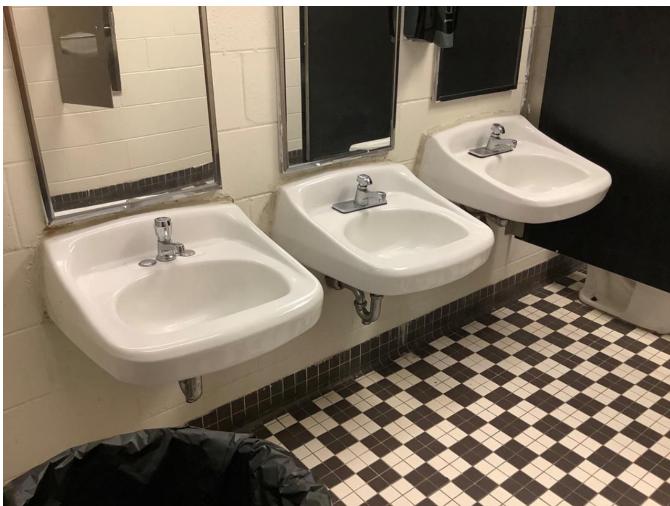
System: D2010 - Plumbing Fixtures

Location: Restrooms
Distress: Beyond Expected Life
Category: ADA Compliance
Priority: 3 - Necessary (Years 2-5)
Correction: Renew System
Qty: 50,698.00
Unit of Measure: S.F.
Estimate: \$355,241.00
Assessor Name: Eduardo Lopez
Date Created: 10/01/2019

Notes: Plumbing fixtures are beyond their expected service life and should be replaced and upgraded for ADA compliance.

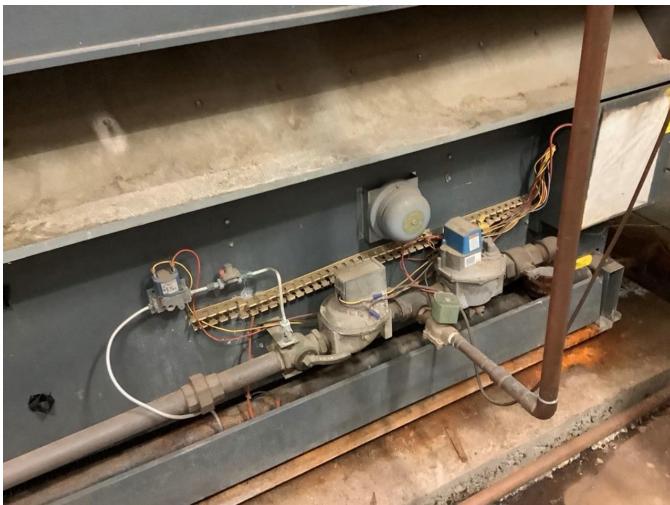
System: D3020 - Heat Generating Systems

Location: Mechanical Room
Distress: Beyond Expected Life
Category: Deferred Maintenance
Priority: 3 - Necessary (Years 2-5)
Correction: Renew System
Qty: 50,698.00
Unit of Measure: S.F.
Estimate: \$200,764.00
Assessor Name: Eduardo Lopez
Date Created: 10/01/2019

Notes: The heating generation systems, exhaust and ventilation systems, energy monitoring and controls as well as the building automation systems are either out of service or not functioning to standard. Several issues will develop as a result of the school no longer being maintained. Although isolated upgrades have taken place to support the systems prior to the school being taken out of service the systems are recommended for upgrade. This deficiency is expected to be completed with other HVAC upgrades.

The heat generation for this school is nearing the end of its useful life. The piping, fitting or auxiliary equipment as well as the main boiler system is recommended for upgrade. This deficiency provides a budgetary consideration for upgrades to support the heat generation system.

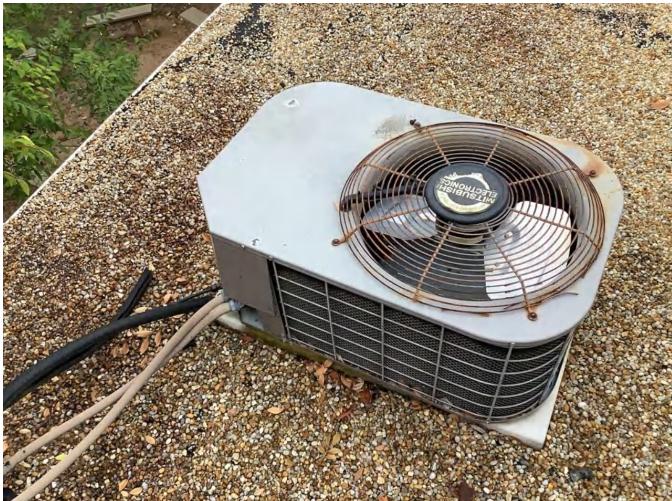
System: D3050 - Terminal & Package Units

Location: Throughout Building
Distress: Beyond Expected Life
Category: Deferred Maintenance
Priority: 3 - Necessary (Years 2-5)
Correction: Renew System
Qty: 50,698.00
Unit of Measure: S.F.
Estimate: \$563,255.00
Assessor Name: Eduardo Lopez
Date Created: 10/06/2020

Notes: The terminal and package units are beyond expected service life and should be scheduled for replacement.

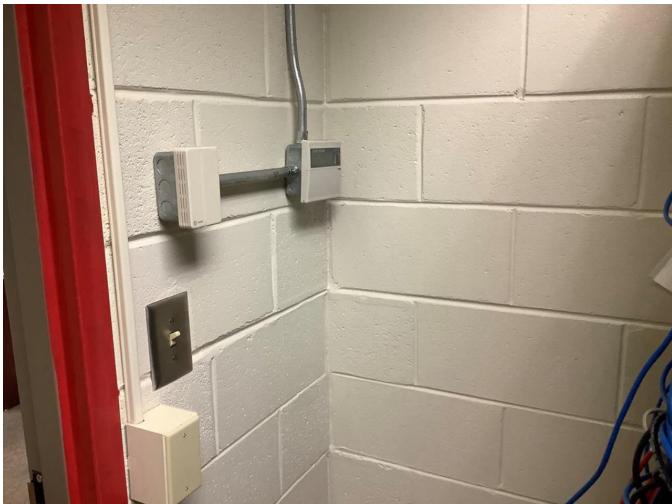
System: D3060 - Controls & Instrumentation

Location: Throughout Building
Distress: Beyond Expected Life
Category: Deferred Maintenance
Priority: 3 - Necessary (Years 2-5)
Correction: Renew System
Qty: 50,698.00
Unit of Measure: S.F.
Estimate: \$122,689.00
Assessor Name: Eduardo Lopez
Date Created: 09/17/2015

Notes: The Controls Instrumentation are aged and stained and should be scheduled for replacement.

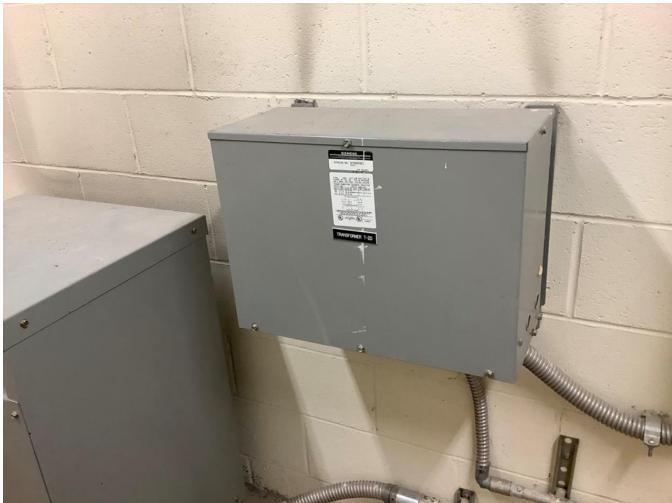
System: D5010 - Electrical Service/Distribution

Location: Electrical Room
Distress: Beyond Expected Life
Category: Deferred Maintenance
Priority: 3 - Necessary (Years 2-5)
Correction: Renew System
Qty: 50,698.00
Unit of Measure: S.F.
Estimate: \$128,266.00
Assessor Name: Eduardo Lopez
Date Created: 10/01/2019

Notes: The electrical service/distribution system is beyond its expected service life and should be scheduled for replacement.

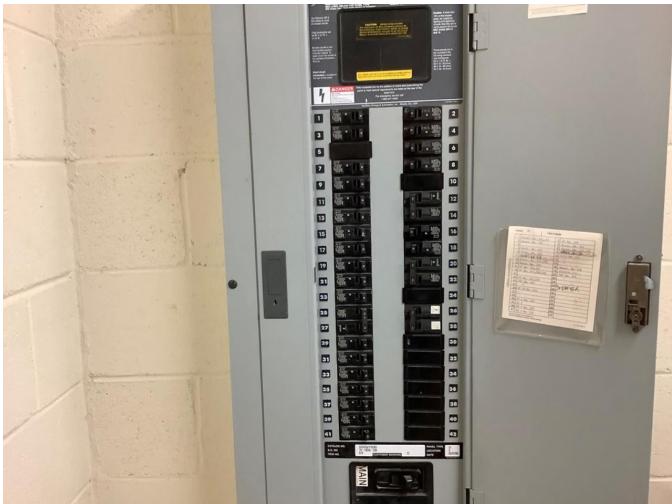
System: D5020 - Branch Wiring

Location: Throughout building
Distress: Beyond Expected Life
Category: Deferred Maintenance
Priority: 3 - Necessary (Years 2-5)
Correction: Renew System
Qty: 50,698.00
Unit of Measure: S.F.
Estimate: \$249,840.00
Assessor Name: Eduardo Lopez
Date Created: 10/01/2019

Notes: Most of the branch wire system appears to be from the original construction. The age and environmental conditions warrants upgrades. Upgrades are recommended.

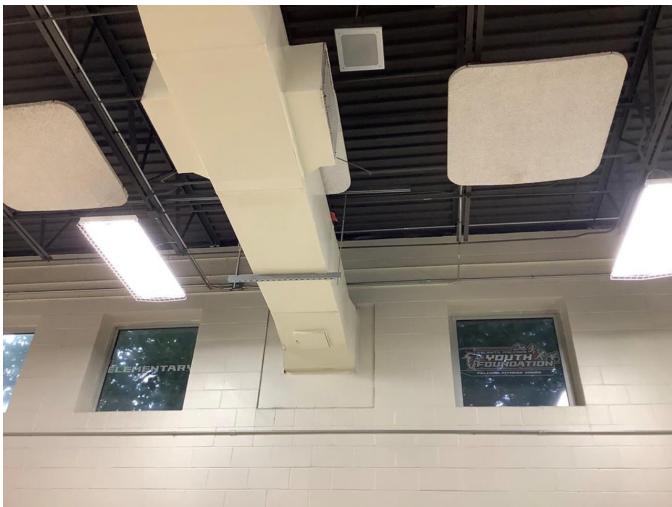
System: D5020 - Lighting

Location: Throughout Building
Distress: Beyond Expected Life
Category: Deferred Maintenance
Priority: 3 - Necessary (Years 2-5)
Correction: Renew System
Qty: 50,698.00
Unit of Measure: S.F.
Estimate: \$374,202.00
Assessor Name: Eduardo Lopez
Date Created: 12/11/2019

Notes: Most of the lighting system appears to be from the original construction. The age and environmental conditions warrants upgrades. Universal upgrades are recommended.

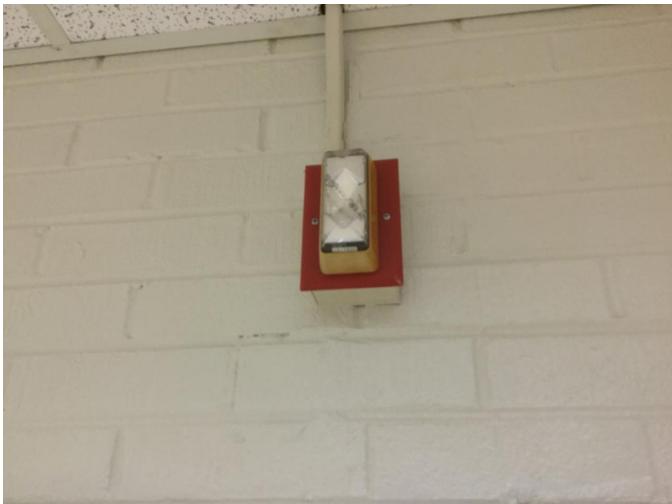
System: D5030910 - Fire Alarm Systems

Location: Throughout Building

Distress: Inadequate

Notes: The Silent Knight fire alarm system appears to be from original construction. There are components such as push stations, lights and alarm bells installed to support the fire life safety for this building. This system is nearing the end of its expected life and upgrades are warranted. This deficiency provides a budgetary consideration for universal upgrades to the fire alarm system.

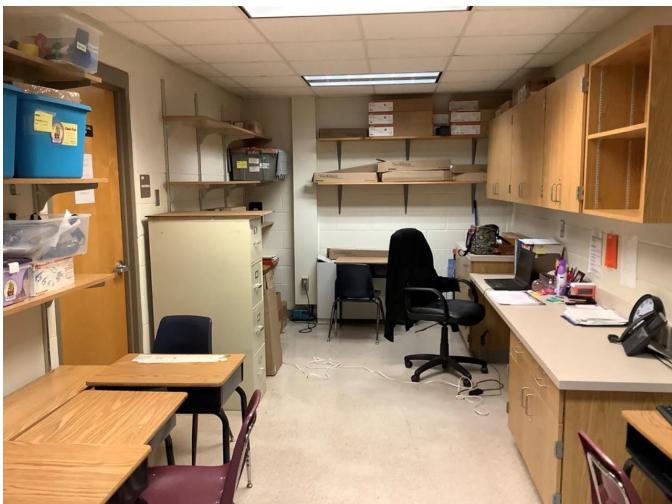
System: E2010 - Fixed Furnishings

Location: Throughout building

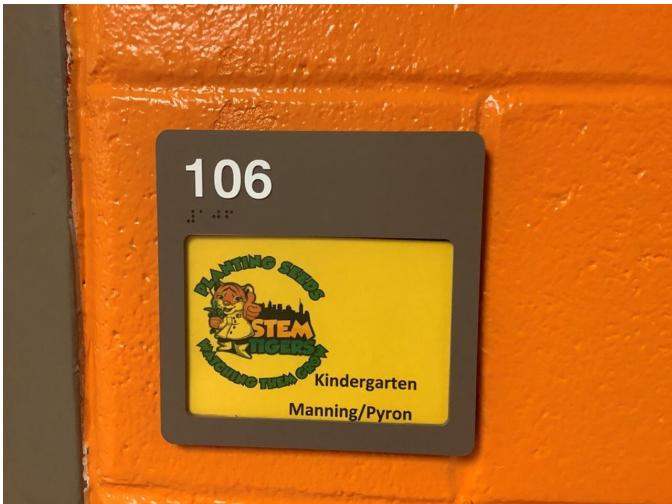
System: C1030 - Fittings

Location:	Throughout Building
Distress:	Beyond Expected Life
Category:	ADA Compliance
Priority:	3 - Necessary (Years 2-5)
Correction:	Renew System
Qty:	27,863.00
Unit of Measure:	S.F.
Estimate:	\$81,221.00
Assessor Name:	Eduardo Lopez
Date Created:	10/01/2019

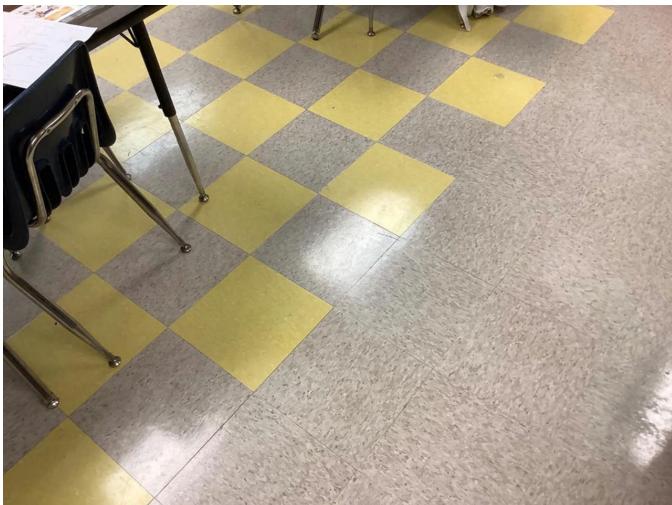
System: C3020903 - VCT

Location:	Throughout building
Distress:	Beyond Expected Life
Category:	Deferred Maintenance
Priority:	3 - Necessary (Years 2-5)
Correction:	Renew System
Qty:	20,000.00
Unit of Measure:	S.F.
Estimate:	\$107,880.00
Assessor Name:	Eduardo Lopez
Date Created:	01/31/2020

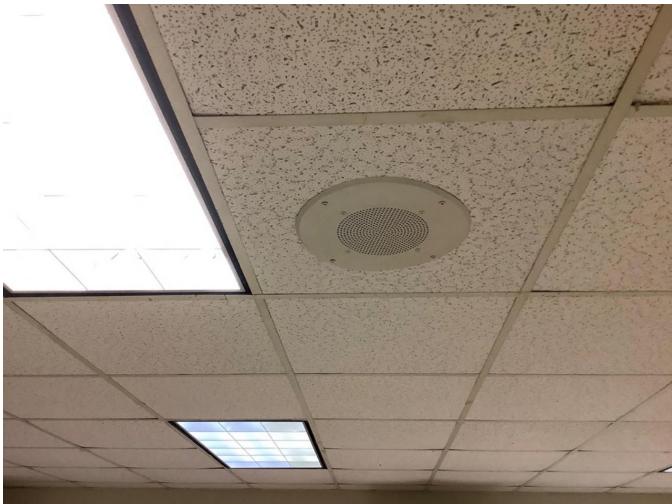
System: C3030 - Ceiling Finishes

Location: Throughout Building
Distress: Beyond Expected Life
Category: Deferred Maintenance
Priority: 3 - Necessary (Years 2-5)
Correction: Renew System
Qty: 27,863.00
Unit of Measure: S.F.
Estimate: \$275,844.00
Assessor Name: Eduardo Lopez
Date Created: 10/01/2019

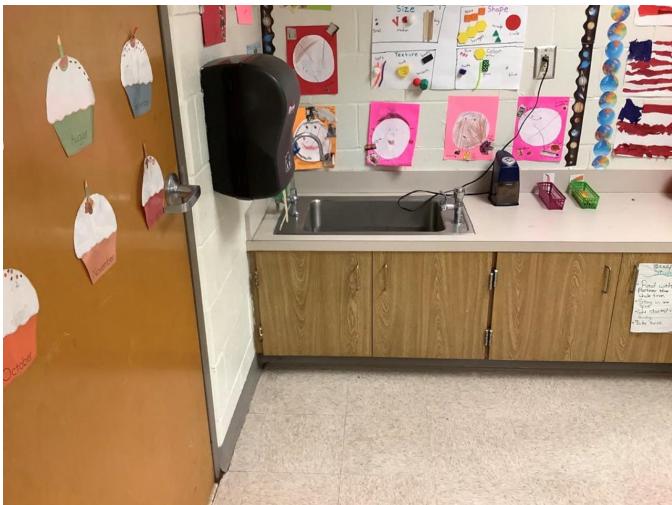
System: D2010 - Plumbing Fixtures

Location: Restrooms
Distress: Beyond Expected Life
Category: ADA Compliance
Priority: 3 - Necessary (Years 2-5)
Correction: Renew System
Qty: 27,863.00
Unit of Measure: S.F.
Estimate: \$195,236.00
Assessor Name: Eduardo Lopez
Date Created: 10/01/2019

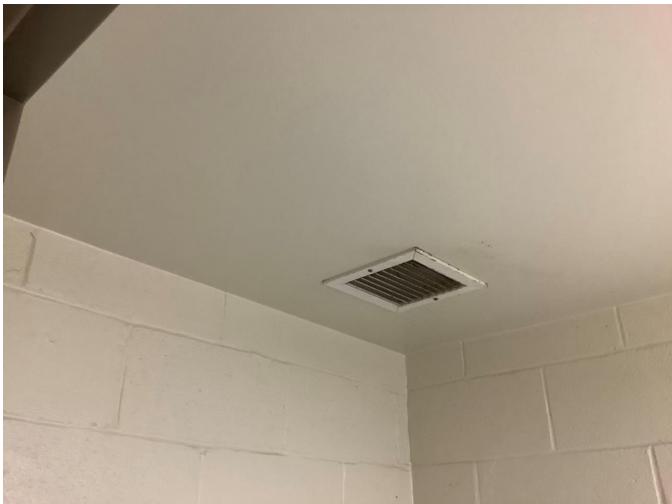
System: D3040 - Distribution Systems

Location: Throughout Building
Distress: Beyond Expected Life
Category: Deferred Maintenance
Priority: 3 - Necessary (Years 2-5)
Correction: Renew System
Qty: 27,863.00
Unit of Measure: S.F.
Estimate: \$486,404.00
Assessor Name: Eduardo Lopez
Date Created: 10/01/2019

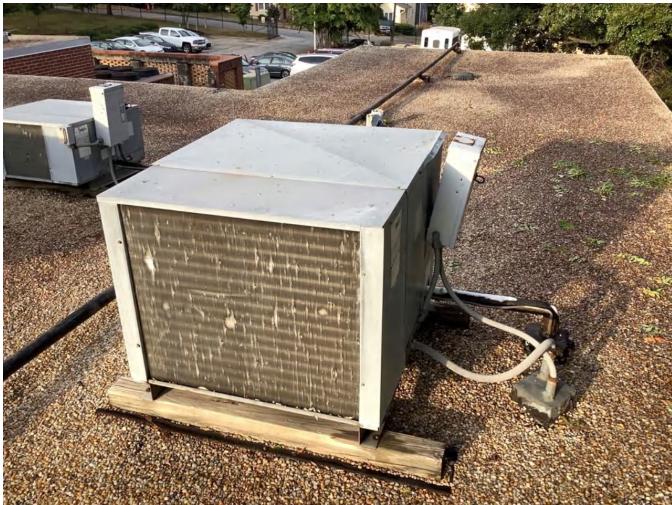
System: D3050 - Terminal & Package Units

Location: Throughout Building
Distress: Beyond Expected Life
Category: Deferred Maintenance
Priority: 3 - Necessary (Years 2-5)
Correction: Renew System
Qty: 27,863.00
Unit of Measure: S.F.
Estimate: \$536,669.00
Assessor Name: Eduardo Lopez
Date Created: 10/06/2020

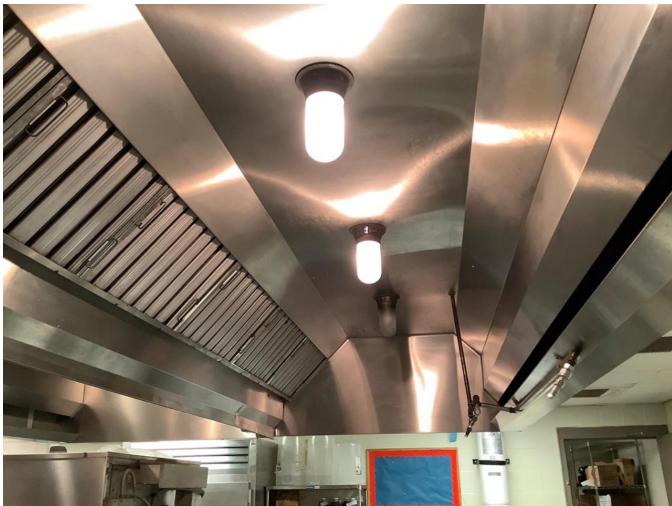
System: D4090 - Other Fire Protection Systems

Location: Kitchen
Distress: Beyond Expected Life
Category: Deferred Maintenance
Priority: 3 - Necessary (Years 2-5)
Correction: Renew System
Qty: 27,863.00
Unit of Measure: S.F.
Estimate: \$18,390.00
Assessor Name: Eduardo Lopez
Date Created: 09/17/2015

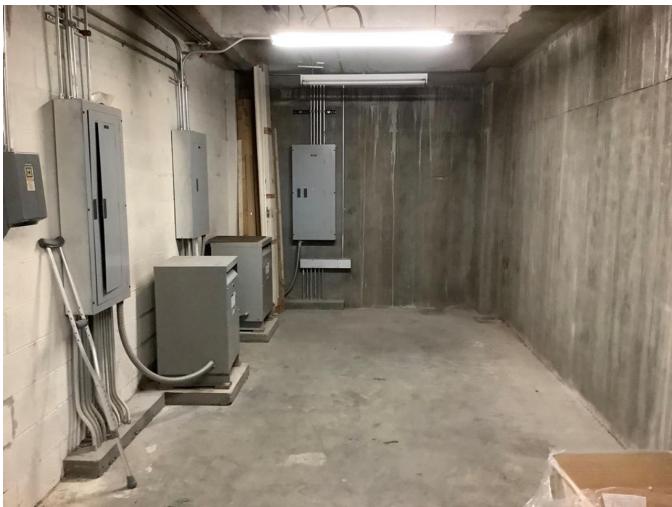
System: D5010 - Electrical Service/Distribution

Location: Electrical Room
Distress: Beyond Expected Life
Category: Deferred Maintenance
Priority: 3 - Necessary (Years 2-5)
Correction: Renew System
Qty: 27,863.00
Unit of Measure: S.F.
Estimate: \$70,493.00
Assessor Name: Eduardo Lopez
Date Created: 10/01/2019

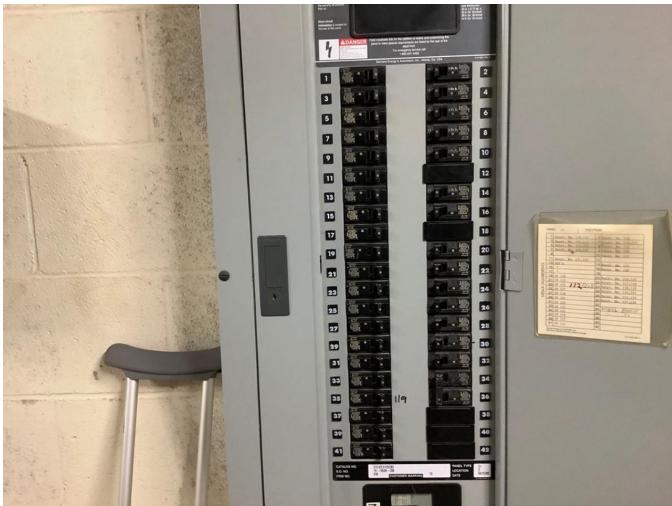
System: D5020 - Branch Wiring

Location: Throughout Building
Distress: Beyond Expected Life
Category: Deferred Maintenance
Priority: 3 - Necessary (Years 2-5)
Correction: Renew System
Qty: 27,863.00
Unit of Measure: S.F.
Estimate: \$137,309.00
Assessor Name: Eduardo Lopez
Date Created: 10/01/2019

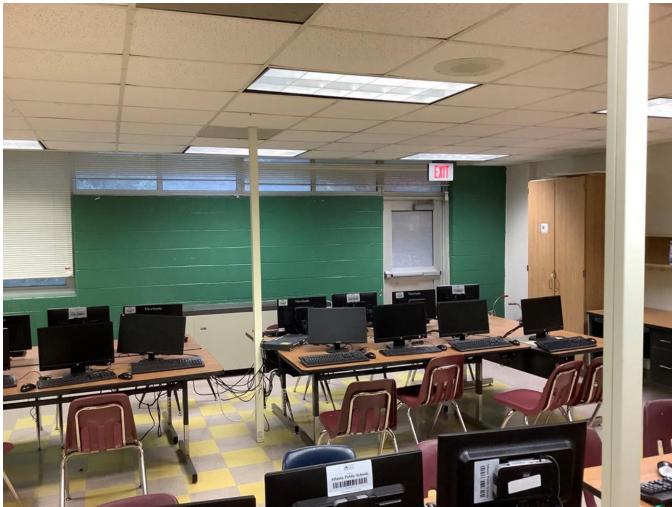
Location: Throughout Building
Distress: Beyond Expected Life
Category: Deferred Maintenance
Priority: 3 - Necessary (Years 2-5)
Correction: Renew System
Qty: 27,863.00
Unit of Measure: S.F.
Estimate: \$205,657.00
Assessor Name: Eduardo Lopez
Date Created: 12/11/2019

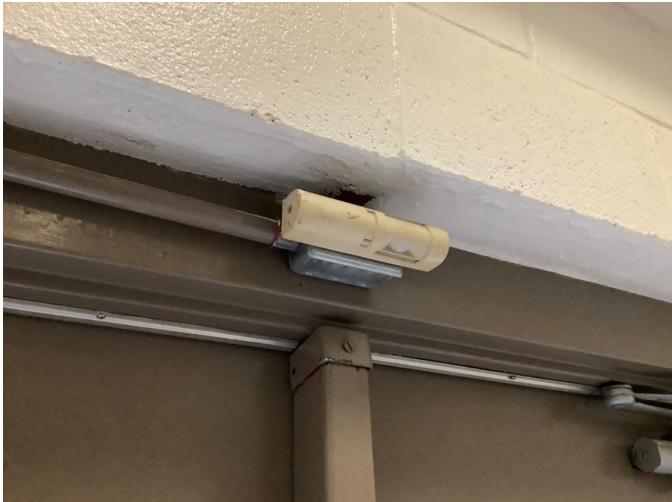
Location: Throughout Building
Distress: Beyond Expected Life
Category: Deferred Maintenance
Priority: 3 - Necessary (Years 2-5)
Correction: Renew System
Qty: 27,863.00
Unit of Measure: S.F.
Estimate: \$46,280.00
Assessor Name: Eduardo Lopez
Date Created: 12/11/2019

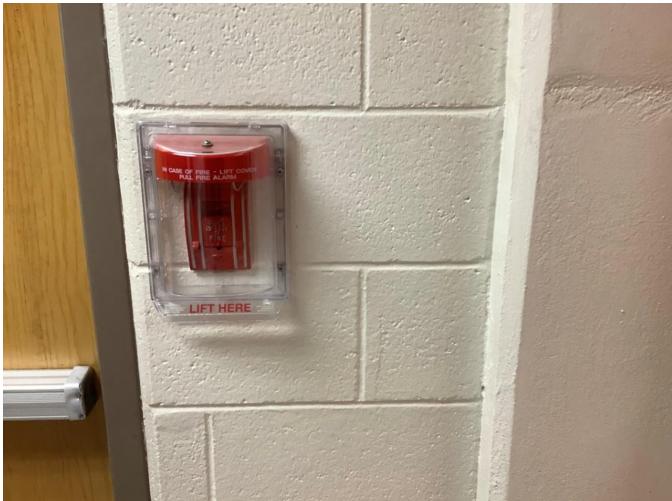
Location: Throughout Building
Distress: Beyond Expected Life
Category: Deferred Maintenance
Priority: 3 - Necessary (Years 2-5)
Correction: Renew System
Qty: 27,863.00
Unit of Measure: S.F.
Estimate: \$83,979.00
Assessor Name: Eduardo Lopez
Date Created: 12/12/2019

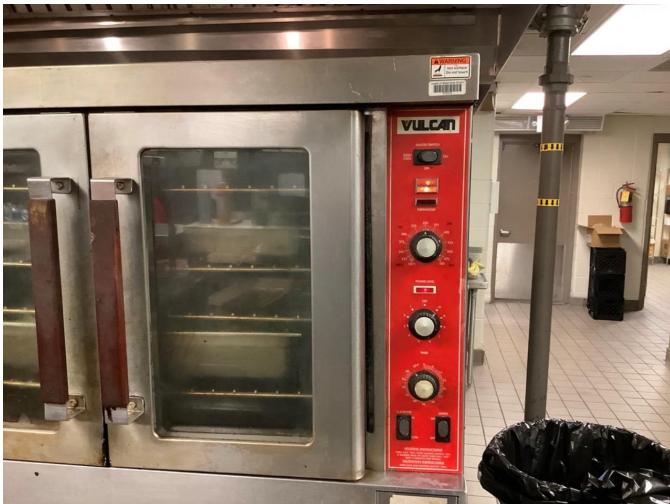
Location: Kitchen

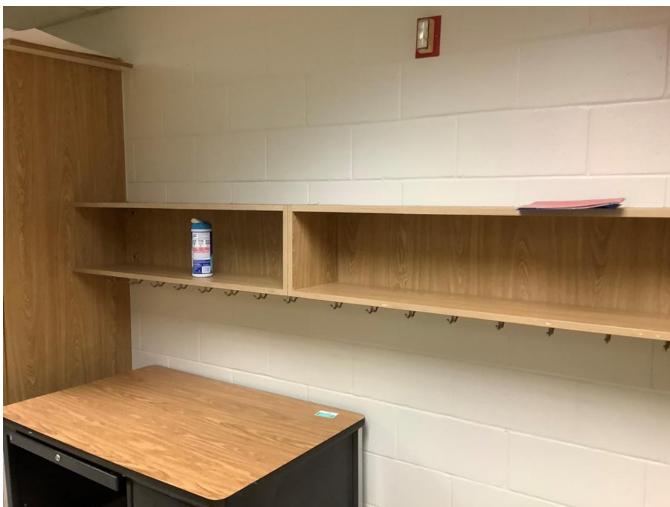
Location: Throughout Building
