Atlanta Public Schools/ Douglass Cluster

Boyd Elementary School

School Assessment Report

November 10, 2020

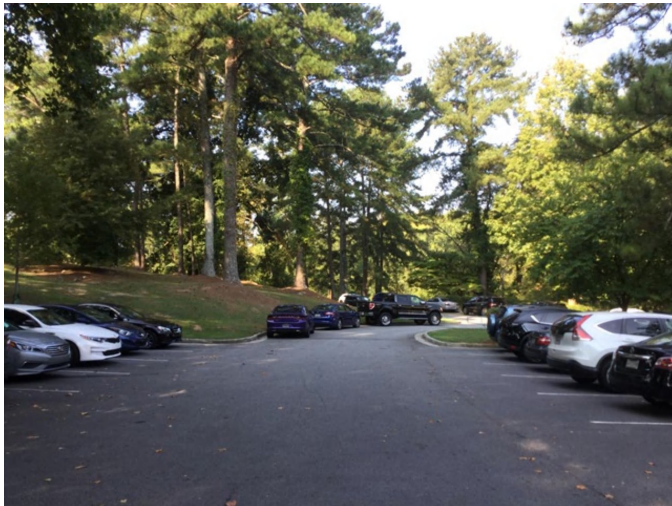
System: G2010 - Roadways

Location: Site
Distress: Beyond Expected Life
Category: Deferred Maintenance
Priority: 3 - Necessary (Years 2-5)
Correction: Renew System
Qty: 74,705.00
Unit of Measure: S.F.
Estimate: \$203,795.00
Assessor Name: Hayden Collins
Date Created: 07/19/2013

Notes: Rear parking and roadways need repair and/or replacement.

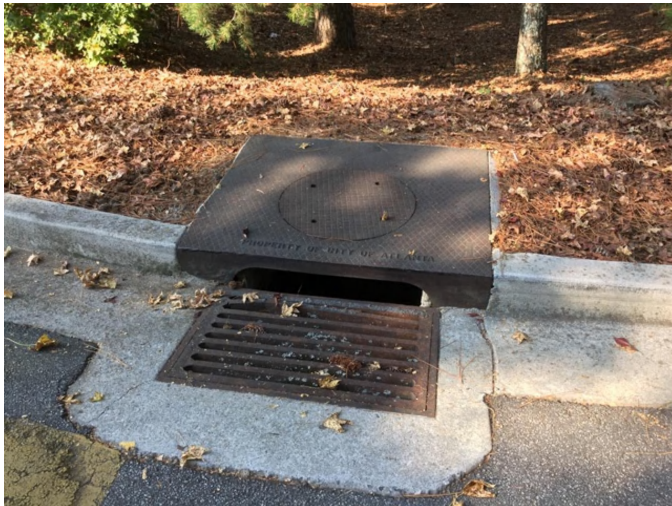
System: G3030 - Storm Sewer

Location: Site
Distress: Beyond Expected Life
Category: Deferred Maintenance
Priority: 3 - Necessary (Years 2-5)
Correction: Renew System
Qty: 74,705.00
Unit of Measure: S.F.
Estimate: \$107,650.00
Assessor Name: Hayden Collins
Date Created: 07/19/2013

Notes: The site storm drains that support the water runoff are functional however, have exceeded the expected life cycle. This project provides a budgetary consideration for a new rainwater drainage system.
