Atlanta Public Schools/ N. Atlanta Cluster

Brandon Elementary School

School Assessment Report

November 10, 2020

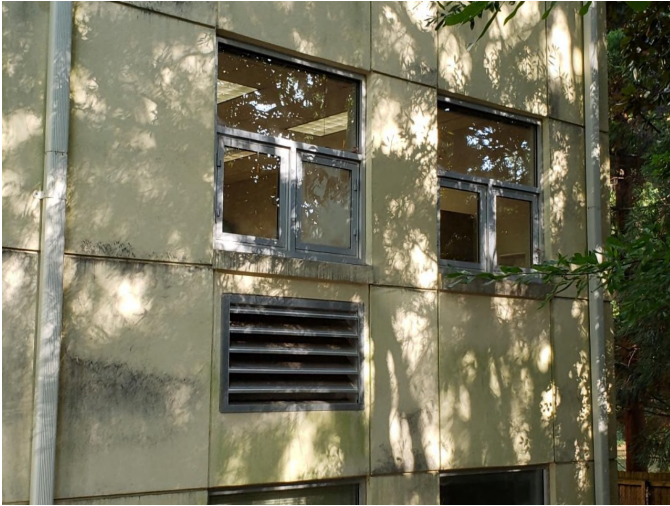
System: B2020 - Exterior Windows

Location: Throughout Building
Distress: Beyond Expected Life
Category: Deferred Maintenance
Priority: 3 - Necessary (Years 2-5)
Correction: Renew System
Qty: 40,017.00
Unit of Measure: S.F.
Estimate: \$383,843.00
Assessor Name: Jejuan Hall
Date Created: 08/16/2013

Notes: The exterior windows are original to the construction of this building. The system has exceeded the expected life cycle and is recommended for replacement.

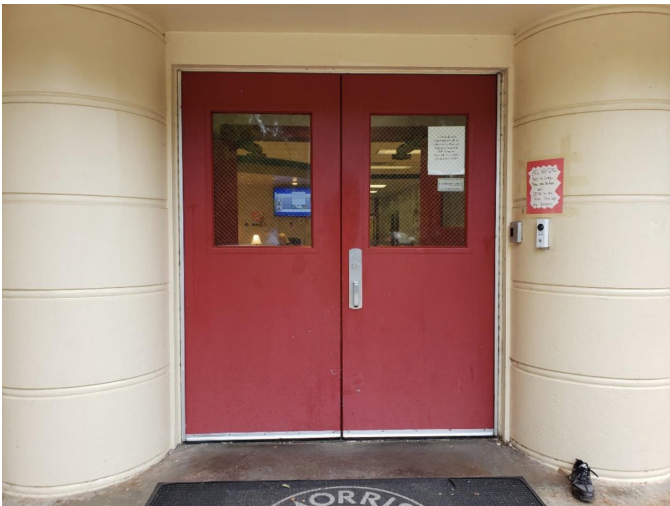
System: B2030 - Exterior Doors

Location: Throughout Building
Distress: Beyond Expected Life
Category: ADA Compliance
Priority: 3 - Necessary (Years 2-5)
Correction: Renew System
Qty: 40,017.00
Unit of Measure: S.F.
Estimate: \$38,296.00
Assessor Name: Hayden Collins
Date Created: 08/16/2013

Notes: The glazed metal exterior doors are original to the building's construction with few exceptions. The door system is beyond its expected life cycle, worn and damaged, and should be replaced and upgraded.

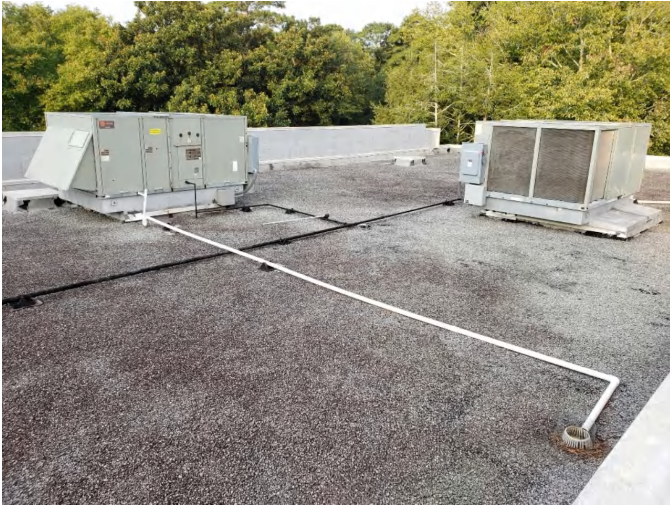
System: B3010105 - Built-Up

Location: Roof
Distress: Beyond Expected Life
Category: Deferred Maintenance
Priority: 3 - Necessary (Years 2-5)
Correction: Renew System
Qty: 40,017.00
Unit of Measure: S.F.
Estimate: \$449,211.00
Assessor Name: Jejuan Hall
Date Created: 01/25/2020

Notes: The roofing system is a built up system that was reported to be original to the buildings construction. This system has exceeded its expected life cycle and is recommended for replacement.

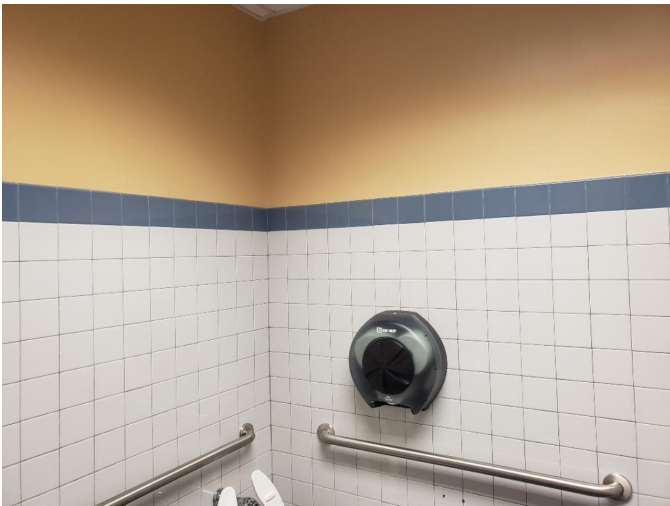
System: C3010220 - Tile

Location: Restrooms
Distress: Beyond Expected Life
Category: Deferred Maintenance
Priority: 3 - Necessary (Years 2-5)
Correction: Renew System
Qty: 2,000.00
Unit of Measure: S.F.
Estimate: \$27,750.00
Assessor Name: Jejuan Hall
Date Created: 01/25/2020

Notes: The Tile finish is beyond its expected service life, worn and damaged, and is recommended for replacement.

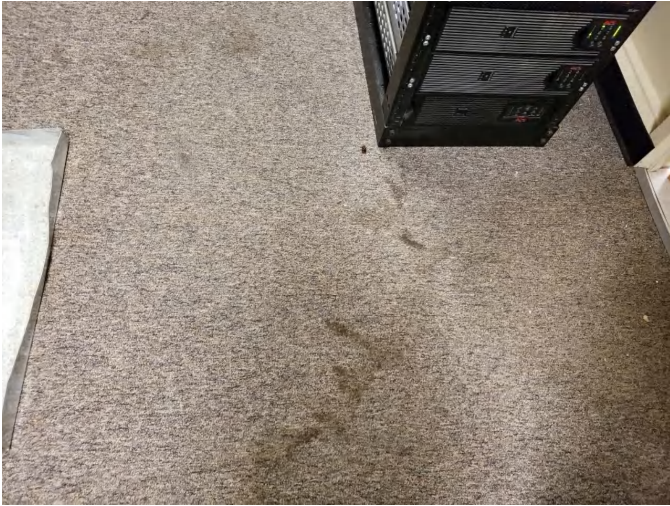
System: C3020901 - Carpet

Location: Throughout Building
Distress: Beyond Expected Life
Category: Deferred Maintenance
Priority: 3 - Necessary (Years 2-5)
Correction: Renew System
Qty: 2,000.00
Unit of Measure: S.F.
Estimate: \$16,500.00
Assessor Name: Jejuan Hall
Date Created: 01/25/2020

Notes: The carpet floor finish is beyond its expected service life, worn and damaged, and is recommended for replacement.

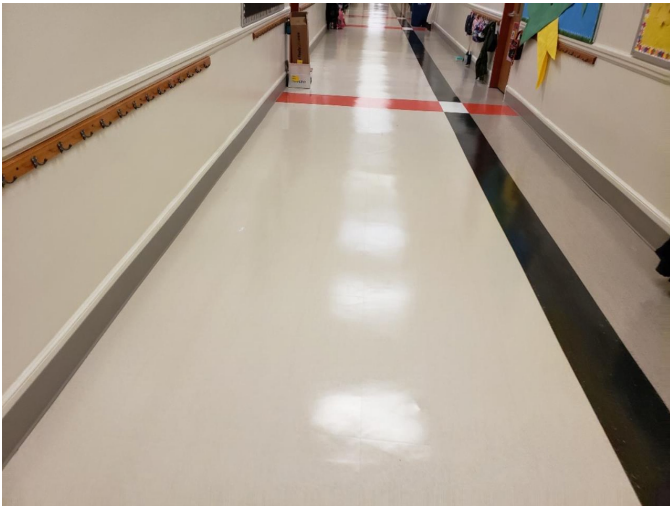
System: C3020903 - VCT

Location: Throughout Building
Distress: Beyond Expected Life
Category: Deferred Maintenance
Priority: 3 - Necessary (Years 2-5)
Correction: Renew System
Qty: 35,017.00
Unit of Measure: S.F.
Estimate: \$188,882.00
Assessor Name: Jejuan Hall
Date Created: 01/25/2020

Notes: The VCT floor finish is beyond its expected service life, worn and damaged, and is recommended for replacement.

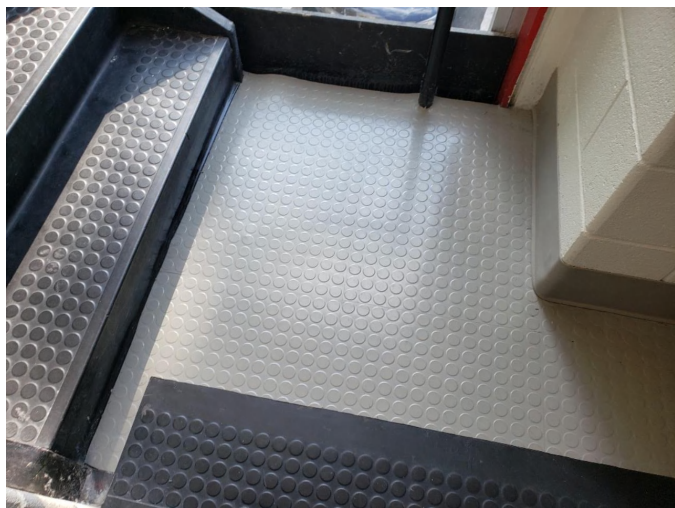
System: C3020999 - Other - Rubber or Neoprene

Location: Stairs
Distress: Beyond Expected Life
Category: Deferred Maintenance
Priority: 3 - Necessary (Years 2-5)
Correction: Renew System
Qty: 1,000.00
Unit of Measure: S.F.
Estimate: \$29,337.00
Assessor Name: Jejuan Hall
Date Created: 01/25/2020

Notes: The rubber or neoprene floor finish is beyond its expected service life, worn and damaged, and is recommended for replacement.

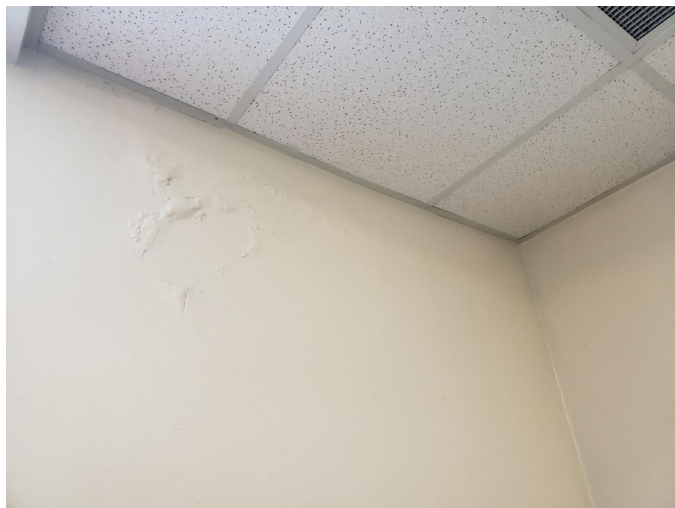
System: C3030 - Ceiling Finishes

Location: Throughout Building
Distress: Beyond Expected Life
Category: Deferred Maintenance
Priority: 3 - Necessary (Years 2-5)
Correction: Renew System
Qty: 40,017.00
Unit of Measure: S.F.
Estimate: \$399,690.00
Assessor Name: Jejuan Hall
Date Created: 08/16/2013

Notes: The acoustic ceilings are aged and stained and should be scheduled for replacement.

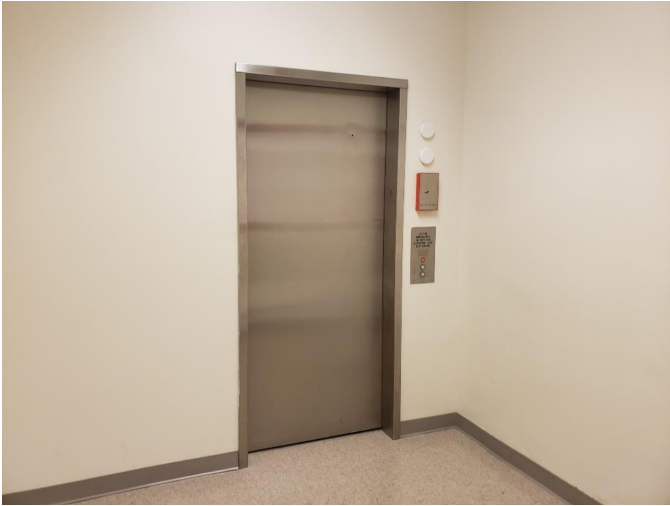
System: D1010 - Elevators and Lifts

Location: Throughout Building
Distress: Beyond Expected Life
Category: Deferred Maintenance
Priority: 3 - Necessary (Years 2-5)
Correction: Renew System
Qty: 53,296.00
Unit of Measure: S.F.
Estimate: \$74,455.00
Assessor Name: Jejuan Hall
Date Created: 09/17/2015

Notes: The elevator system has exceeded its life cycle and recommended for upgrade. All aspects of the current ADA standards are expected to be included in the new installation.

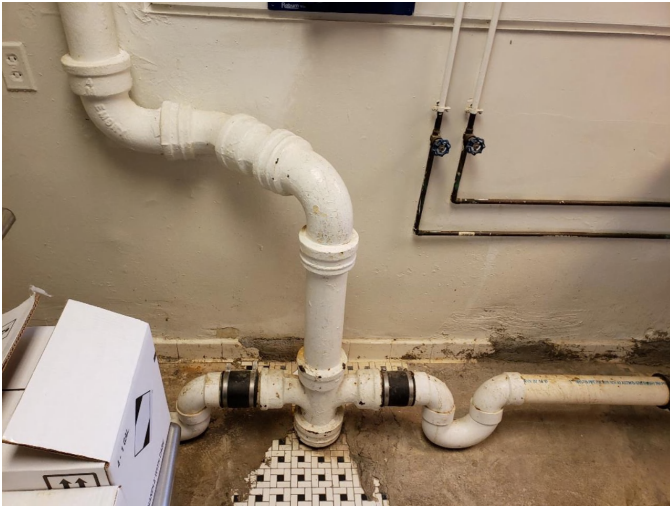
System: D2030 - Sanitary Waste

Location: Throughout Building
Distress: Beyond Expected Life
Category: Deferred Maintenance
Priority: 3 - Necessary (Years 2-5)
Correction: Renew System
Qty: 40,017.00
Unit of Measure: S.F.
Estimate: \$77,033.00
Assessor Name: Jejuan Hall
Date Created: 02/22/2020

Notes: Sanitary waste system is beyond its expected life and needs to be upgraded or replaced.

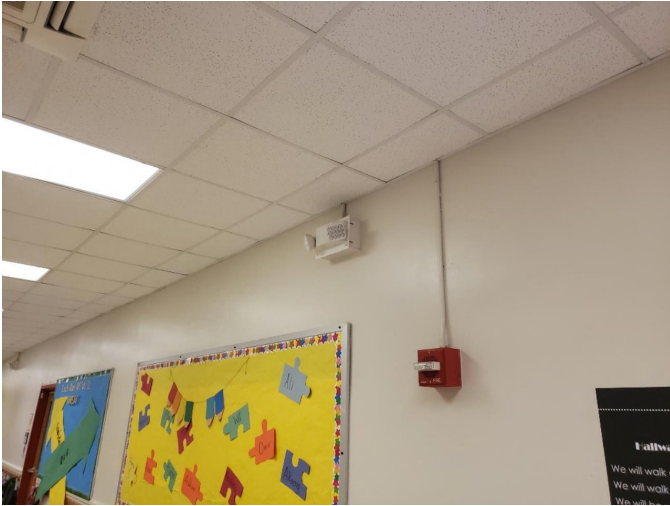
System: D5030910 - Fire Alarm Systems

Location: Throughout Building
Distress: Beyond Expected Life
Category: Deferred Maintenance
Priority: 3 - Necessary (Years 2-5)
Correction: Renew System
Qty: 40,017.00
Unit of Measure: S.F.
Estimate: \$120,611.00
Assessor Name: Jejuan Hall
Date Created: 01/25/2020

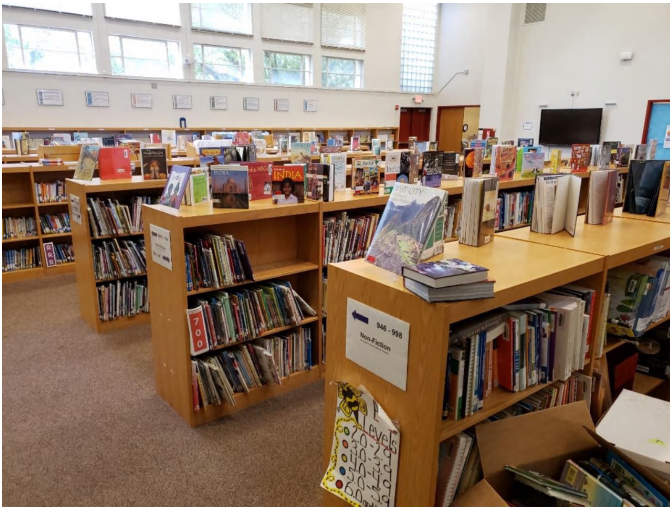
System: E1020 - Institutional Equipment

Location: Throughout Building
Distress: Beyond Expected Life
Category: Deferred Maintenance
Priority: 4 - Recommended (Years 6-10)
Correction: Renew System
Qty: 40,017.00
Unit of Measure: S.F.
Estimate: \$3,962.00
Assessor Name: Jejuan Hall
Date Created: 08/16/2013

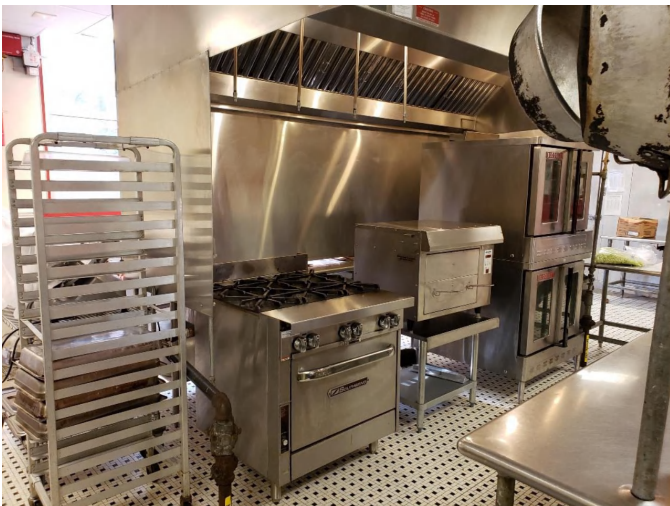
System: E1090 - Other Equipment

Location: Kitchen
Distress: Beyond Expected Life
Category: Deferred Maintenance
Priority: 4 - Recommended (Years 6-10)
Correction: Renew System
Qty: 40,017.00
Unit of Measure: S.F.
Estimate: \$34,775.00
Assessor Name: Jejuan Hall
Date Created: 08/16/2013

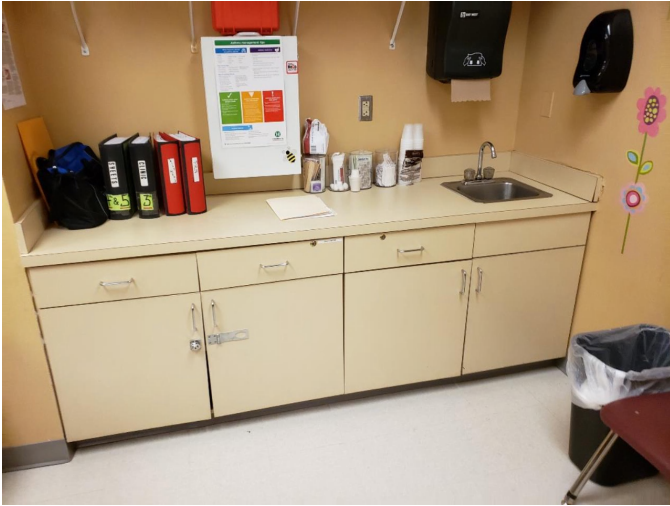
System: E2010 - Fixed Furnishings

Location: Throughout Building
Distress: Beyond Expected Life
Category: Deferred Maintenance
Priority: 4 - Recommended (Years 6-10)
Correction: Renew System
Qty: 40,017.00
Unit of Measure: S.F.
Estimate: \$84,956.00
Assessor Name: Jejuan Hall
Date Created: 08/16/2013

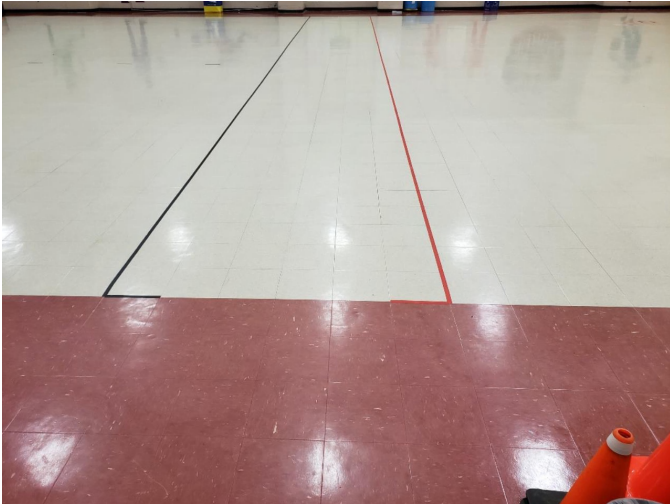
System: C3020903 - VCT

Location: gym
Distress: Beyond Expected Life
Category: Deferred Maintenance
Priority: 3 - Necessary (Years 2-5)
Correction: Renew System
Qty: 23,376.00
Unit of Measure: S.F.
Estimate: \$126,090.00
Assessor Name: Jejuan Hall
Date Created: 01/25/2020

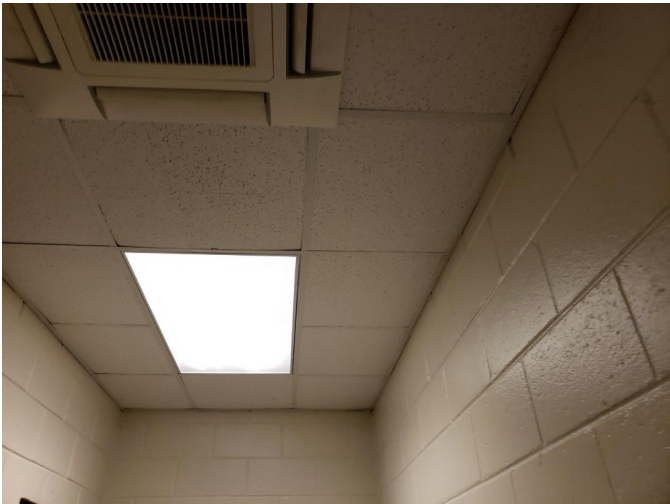
System: C3030 - Ceiling Finishes

Location: Throughout Building
Distress: Beyond Expected Life
Category: Deferred Maintenance
Priority: 3 - Necessary (Years 2-5)
Correction: Renew System
Qty: 23,376.00
Unit of Measure: S.F.
Estimate: \$236,565.00
Assessor Name: Jejuan Hall
Date Created: 02/22/2020

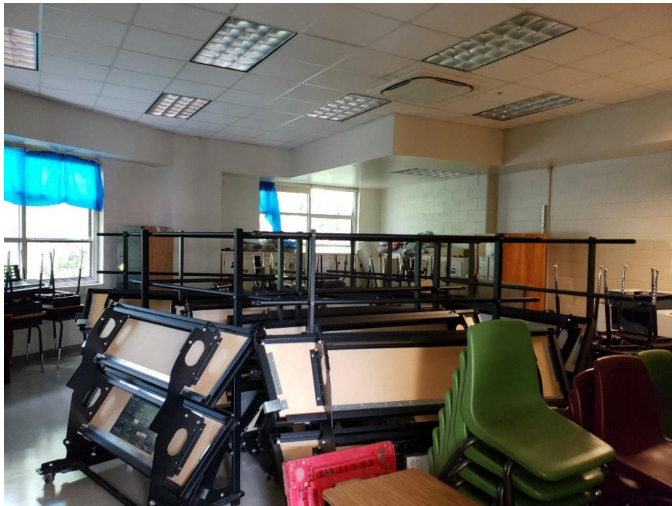
System: E1020 - Institutional Equipment

Location: Throughout Building
Distress: Beyond Expected Life
Category: Deferred Maintenance
Priority: 3 - Necessary (Years 2-5)
Correction: Renew System
Qty: 23,376.00
Unit of Measure: S.F.
Estimate: \$2,314.00
Assessor Name: Jejuan Hall
Date Created: 01/25/2020

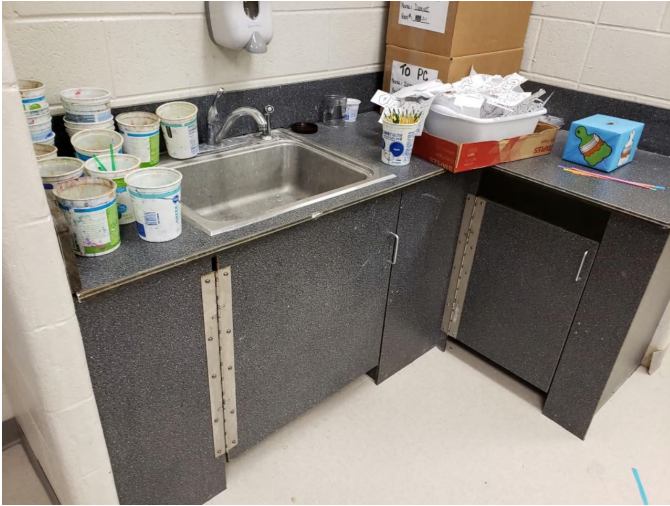
System: E2010 - Fixed Furnishings

Location: Throughout Building
Distress: Beyond Expected Life
Category: Deferred Maintenance
Priority: 3 - Necessary (Years 2-5)
Correction: Renew System
Qty: 23,376.00
Unit of Measure: S.F.
Estimate: \$49,884.00
Assessor Name: Jejuan Hall
Date Created: 02/22/2020

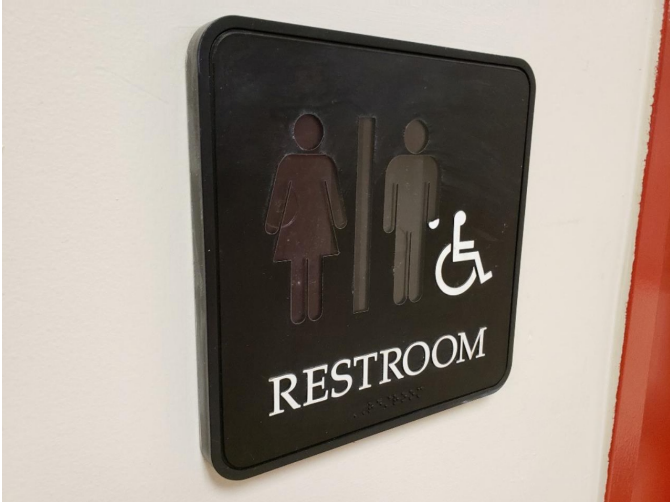
System: C1030 - Fittings

Location: Throughout Building
Distress: Beyond Expected Life
Category: ADA Compliance
Priority: 4 - Recommended (Years 6-10)
Correction: Renew System
Qty: 23,376.00
Unit of Measure: S.F.
Estimate: \$69,941.00
Assessor Name: Jejuan Hall
Date Created: 08/16/2013

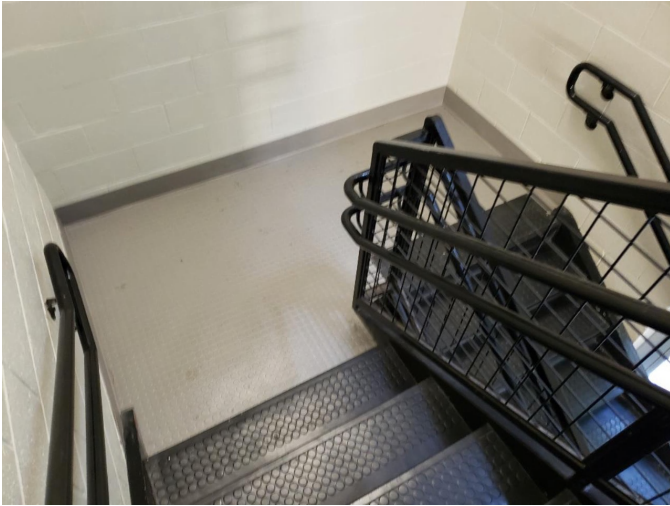
System: C3020999 - Other - Rubber or Neoprene

Location: Stairs
Distress: Beyond Expected Life
Category: Deferred Maintenance
Priority: 3 - Necessary (Years 2-5)
Correction: Renew System
Qty: 500.00
Unit of Measure: S.F.
Estimate: \$14,669.00
Assessor Name: Eduardo Lopez
Date Created: 01/27/2020
