Atlanta Public Schools/ Washington Cluster

# Brown Middle School

## School Assessment Report

November 10, 2020

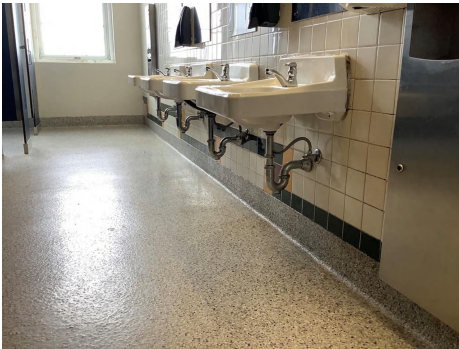
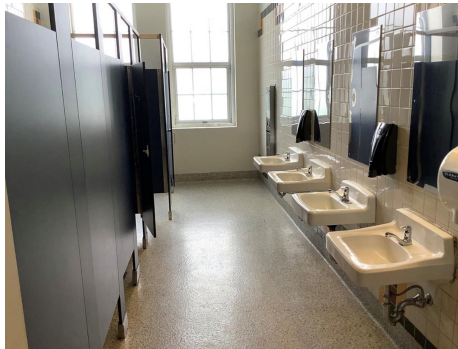
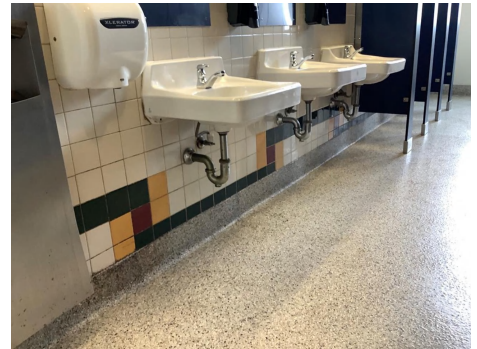
### System: D2010 - Plumbing Fixtures

**Note:** Slightly more than half (approx. 52%) of the plumbing fixtures were replaced in 2015. As of 2019 the remaining plumbing fixtures have been replaced.

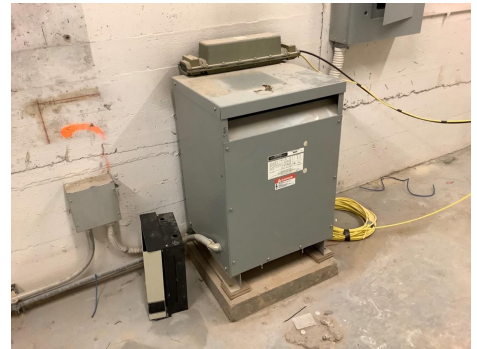
**System:** D5010 - Electrical Service/Distribution

**Note:** Electrical panels in Building 502.3 are expired (original to building 1949).

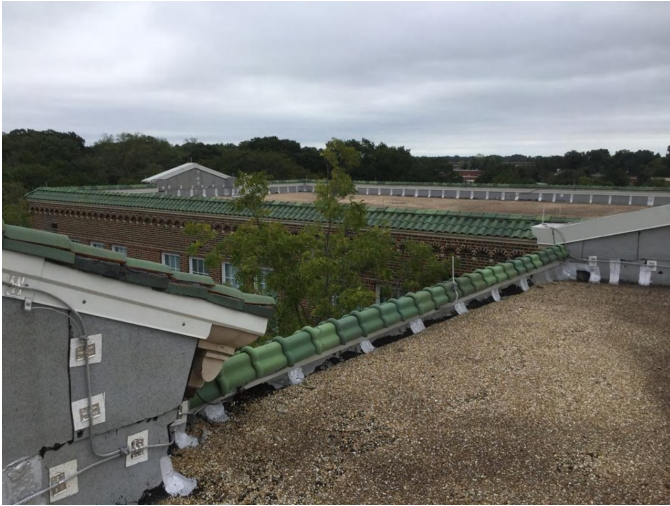
#### System: B3010105 - Built-Up

**Location:** Roof  
**Distress:** Beyond Expected Life  
**Category:** Deferred Maintenance  
**Priority:** 3 - Necessary (Years 2-5)  
**Correction:** Renew System  
**Qty:** 32,534.00  
**Unit of Measure:** S.F.  
**Estimate:** \$365,210.00  
**Assessor Name:** Eduardo Lopez  
**Date Created:** 10/06/2020

**Notes:** The built-up roof is in poor conditions, beyond service life and should be replaced.

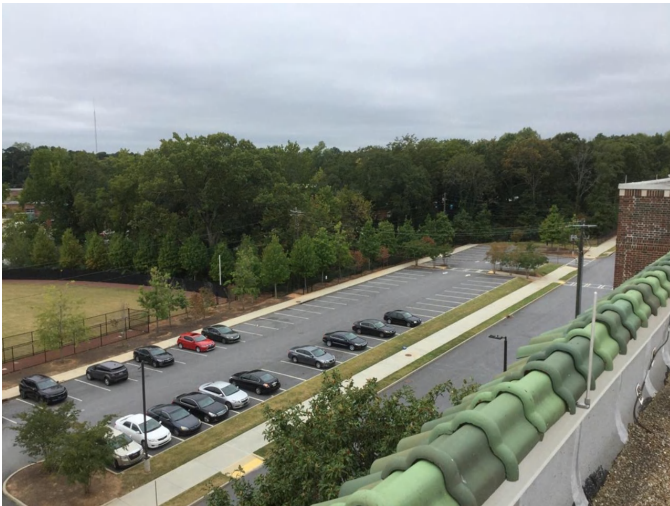
#### System: B3010140 - Shingle & Tile

**Location:** Roof  
**Distress:** Beyond Expected Life  
**Category:** Deferred Maintenance  
**Priority:** 3 - Necessary (Years 2-5)  
**Correction:** Renew System  
**Qty:** 307.00  
**Unit of Measure:** S.F.  
**Estimate:** \$1,202.00  
**Assessor Name:** Eduardo Lopez  
**Date Created:** 12/17/2019

**Notes:** The roofing system is not expected to outlast the purview of this analysis. Future budgetary consideration should include provision for the renewal of the clay tile roofing system.

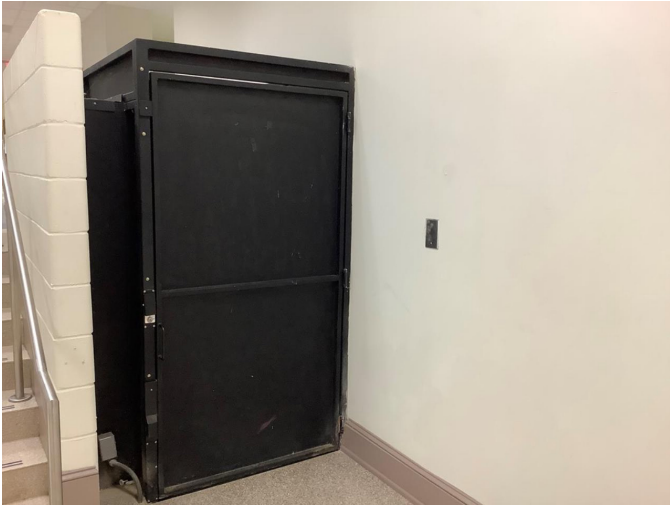
**System: D1010 - Elevators and Lifts**

**Location:** Auditorium  
**Distress:** Beyond Expected Life  
**Category:** Deferred Maintenance  
**Priority:** 3 - Necessary (Years 2-5)  
**Correction:** Renew System  
**Qty:** 135,706.00  
**Unit of Measure:** S.F.  
**Estimate:** \$197,045.00  
**Assessor Name:** Eduardo Lopez  
**Date Created:** 12/17/2019

**Notes:** The ADA lift elevator system is nearing the end of its useful life and recommended for upgrade. All aspects of the current ADA standards are expected to be included in the new installation.

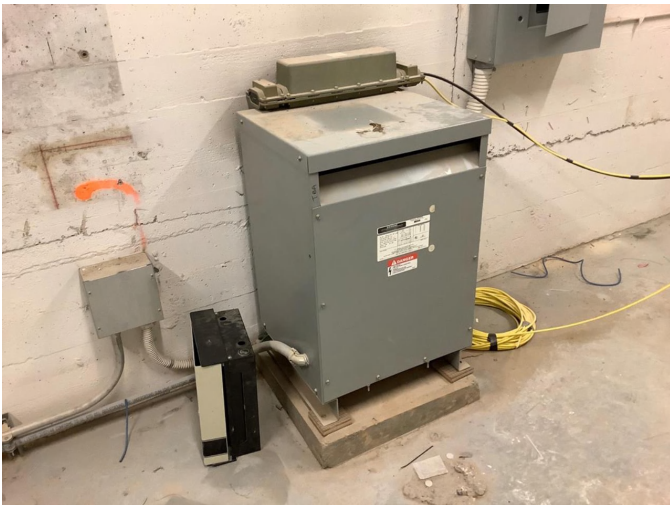
**System: D5010 - Electrical Service/Distribution**

**Location:** Electrical Room  
**Distress:** Beyond Expected Life  
**Category:** Deferred Maintenance  
**Priority:** 3 - Necessary (Years 2-5)  
**Correction:** Renew System  
**Qty:** 135,706.00  
**Unit of Measure:** S.F.  
**Estimate:** \$359,757.00  
**Assessor Name:** Eduardo Lopez  
**Date Created:** 12/17/2019

**Notes:** Electrical panels in Building 502.3 are expired (original to building 1949).
