Atlanta Public Schools/Relocation Sites

Campbell Building

School Assessment Report

November 10, 2020

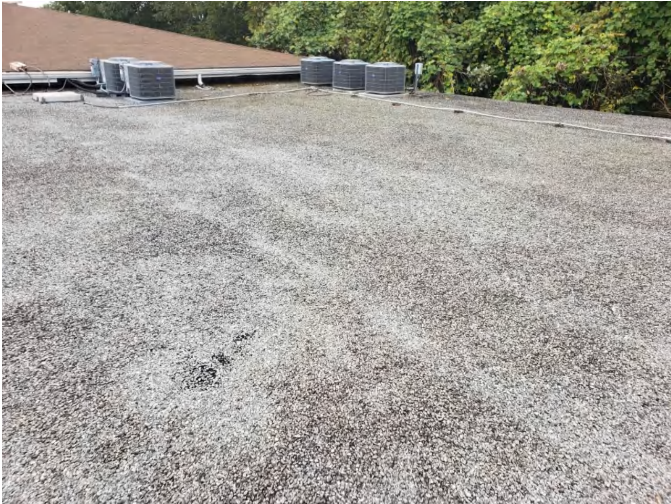
System: B3010105 - Built-Up

Location: Roof
Distress: Beyond Expected Life
Category: Deferred Maintenance
Priority: 3 - Necessary (Years 2-5)
Correction: Renew System
Qty: 18,445.00
Unit of Measure: S.F.
Estimate: \$207,054.00
Assessor Name: Eduardo Lopez
Date Created: 01/29/2020

Notes: Built-up roof covering is in deteriorating conditions with signs of cracks, bubbling, patches and reported water leaks through parapets and other areas.

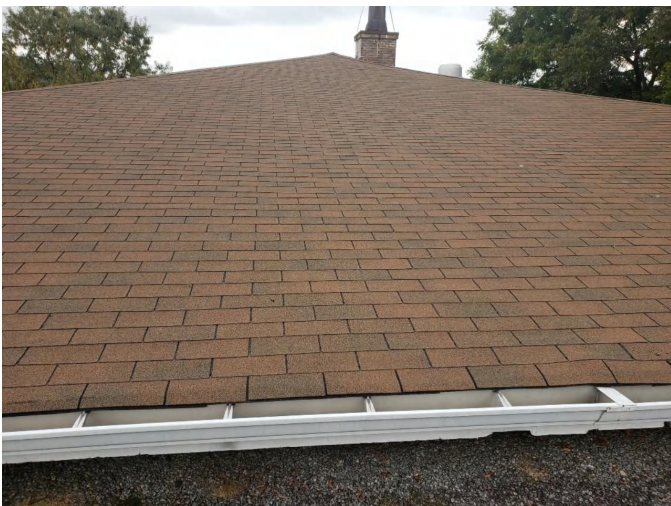
System: B3010140 - Shingle & Tile

Location: Roof
Distress: Beyond Expected Life
Category: Deferred Maintenance
Priority: 3 - Necessary (Years 2-5)
Correction: Renew System
Qty: 6,279.00
Unit of Measure: S.F.
Estimate: \$35,318.00
Assessor Name: Eduardo Lopez
Date Created: 01/29/2020

Notes: The asphalt shingles covering is in deteriorating conditions with signs of cracks, bubbling, patches and reported water leaks through parapets and other areas.

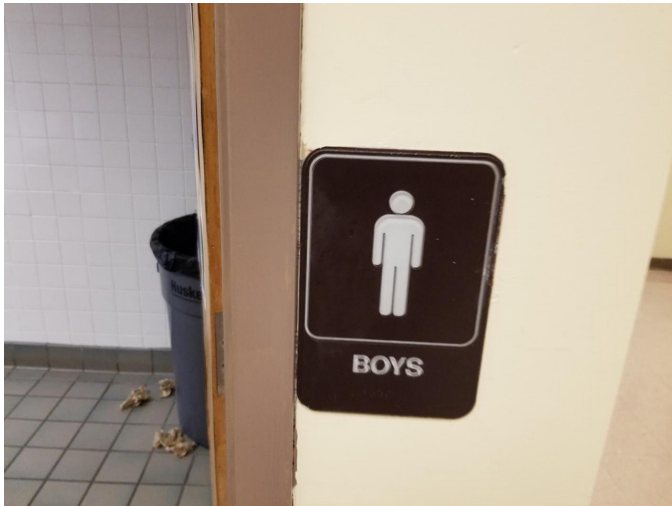
System: C1030 - Fittings

Location: Throughout Building
Distress: Beyond Expected Life
Category: ADA Compliance
Priority: 3 - Necessary (Years 2-5)
Correction: Renew System
Qty: 45,360.00
Unit of Measure: S.F.
Estimate: \$132,224.00
Assessor Name: Eduardo Lopez
Date Created: 09/17/2015

Notes: The fittings throughout the building are aged, in marginal condition, handrails and room signage are not ADA compliance and system should be replaced. Include missing handrails in corridor ramp and elevator jamb floor signage.

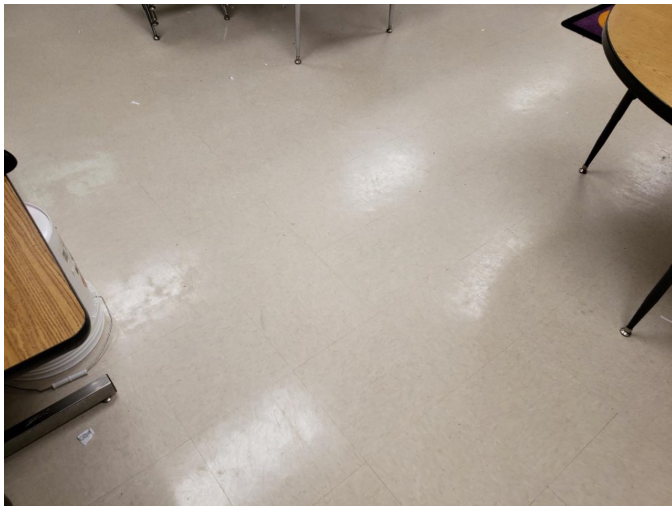
System: C3020903 - VCT

Location: Throughout Building
Distress: Beyond Expected Life
Category: Deferred Maintenance
Priority: 3 - Necessary (Years 2-5)
Correction: Renew System
Qty: 34,569.00
Unit of Measure: S.F.
Estimate: \$186,465.00
Assessor Name: Eduardo Lopez
Date Created: 01/29/2020

Notes: The VCT flooring is in poor conditions, with different areas separating from the substrate, and should be replaced.

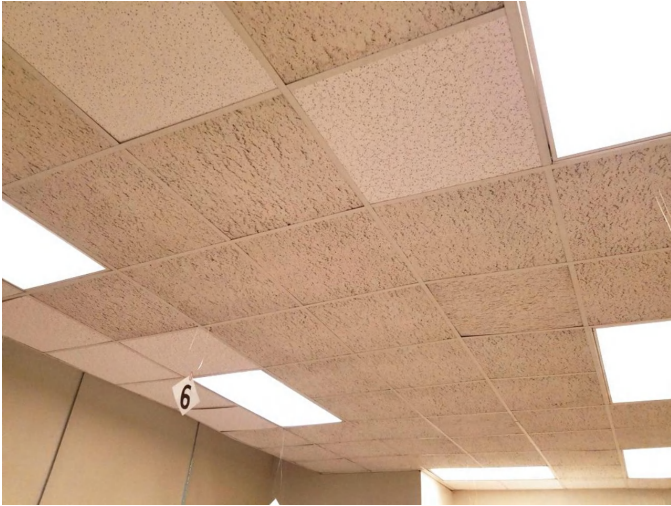
System: C3030 - Ceiling Finishes

Location: Throughout Building
Distress: Beyond Expected Life
Category: Deferred Maintenance
Priority: 3 - Necessary (Years 2-5)
Correction: Renew System
Qty: 45,360.00
Unit of Measure: S.F.
Estimate: \$449,064.00
Assessor Name: Eduardo Lopez
Date Created: 09/17/2015

Notes: The original ceiling finishes are aged, failing and should be replaced.

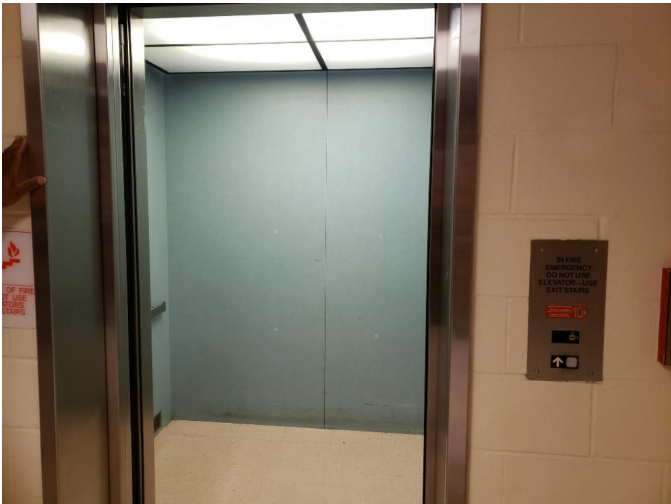
System: D1010 - Elevators and Lifts

Location: Throughout Building
Distress: Beyond Expected Life
Category: Deferred Maintenance
Priority: 3 - Necessary (Years 2-5)
Correction: Renew System
Qty: 45,360.00
Unit of Measure: S.F.
Estimate: \$62,370.00
Assessor Name: Eduardo Lopez
Date Created: 09/17/2015

Notes: The system is beyond its expected service life and should be scheduled for replacement.

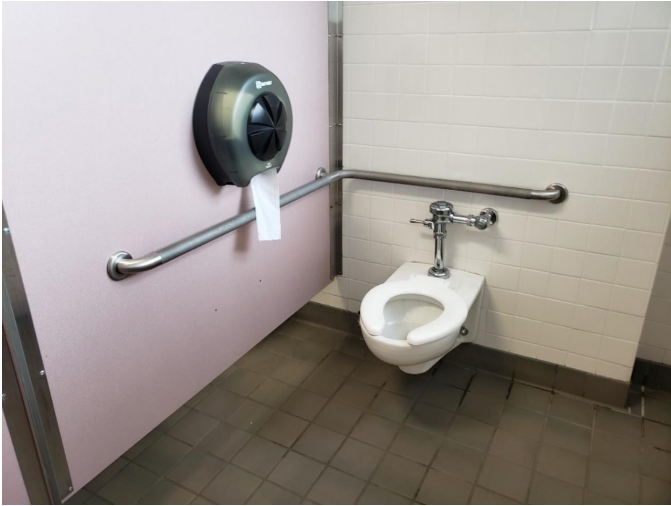
System: D2010 - Plumbing Fixtures

Location: Throughout Building
Distress: Beyond Expected Life
Category: ADA Compliance
Priority: 3 - Necessary (Years 2-5)
Correction: Renew System
Qty: 45,360.00
Unit of Measure: S.F.
Estimate: \$317,838.00
Assessor Name: Eduardo Lopez
Date Created: 02/05/2020

Notes: Plumbing fixtures are in operational conditions. However, they are aged, beyond its expected service life and should be replaced with a low-flow water fixture.

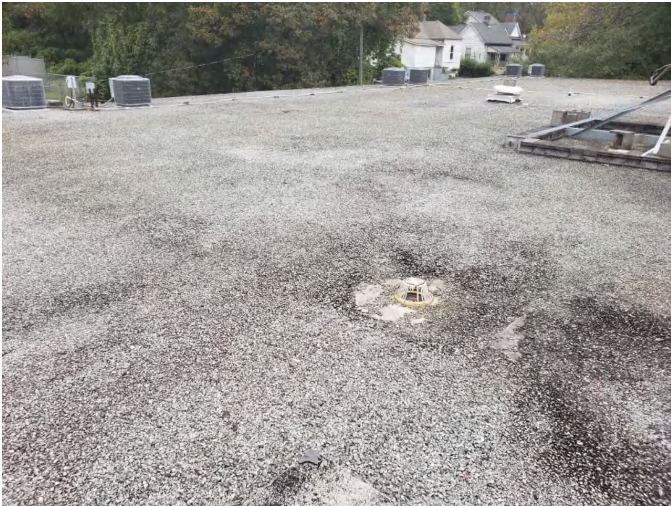
System: D2040 - Rain Water Drainage

Location: Roof
Distress: Beyond Expected Life
Category: Deferred Maintenance
Priority: 3 - Necessary (Years 2-5)
Correction: Renew System
Qty: 45,360.00
Unit of Measure: S.F.
Estimate: \$17,464.00
Assessor Name: Eduardo Lopez
Date Created: 02/02/2020

Notes: The rainwater drainage system is aged, in marginal condition, and should be replaced.

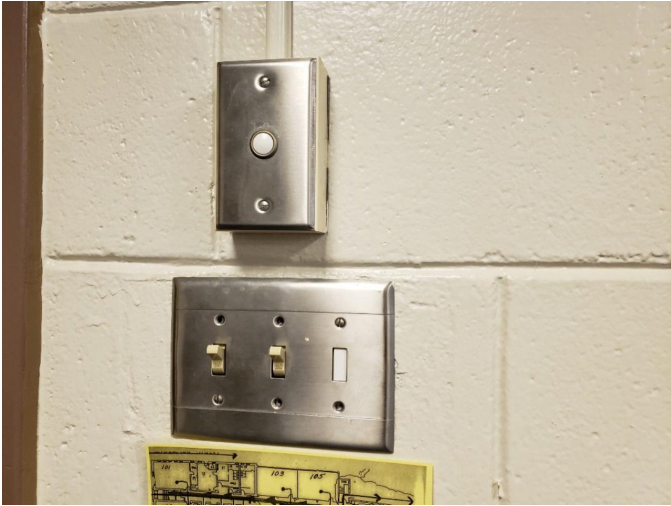
System: D5020 - Branch Wiring

Location: Throughout Building
Distress: Beyond Expected Life
Category: Deferred Maintenance
Priority: 3 - Necessary (Years 2-5)
Correction: Renew System
Qty: 45,360.00
Unit of Measure: S.F.
Estimate: \$237,006.00
Assessor Name: Eduardo Lopez
Date Created: 01/29/2020

Notes: The branch wiring system is operating, but is aged, in poor condition, and should be replaced.

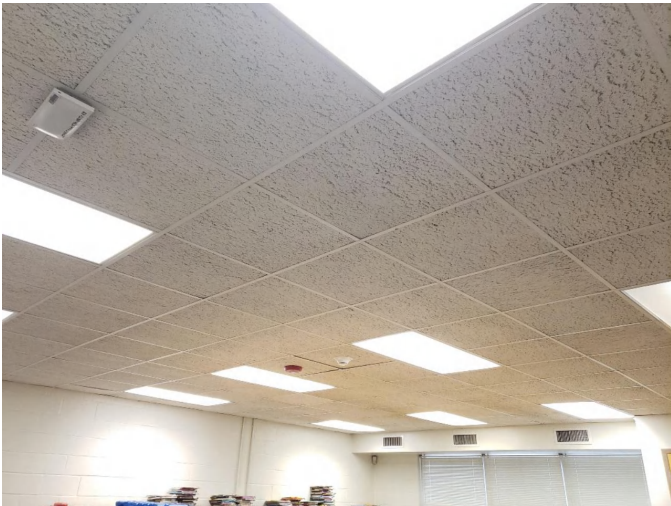
System: D5020 - Lighting

Location: Throughout Building
Distress: Beyond Expected Life
Category: Deferred Maintenance
Priority: 3 - Necessary (Years 2-5)
Correction: Renew System
Qty: 45,360.00
Unit of Measure: S.F.
Estimate: \$355,260.00
Assessor Name: Eduardo Lopez
Date Created: 08/05/2013

Notes: The lighting system is operating, but is aged, in poor condition, and should be replaced.

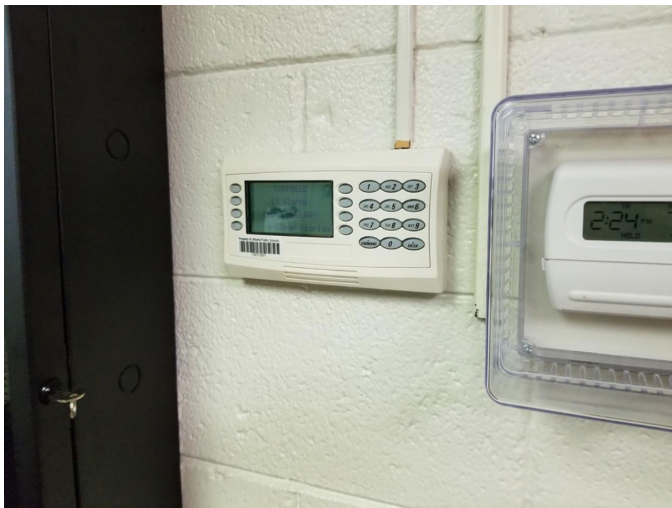
System: D5030810 - Security & Detection Systems

Location: Throughout Building
Distress: Beyond Expected Life
Category: Deferred Maintenance
Priority: 3 - Necessary (Years 2-5)
Correction: Renew System
Qty: 45,360.00
Unit of Measure: S.F.
Estimate: \$75,343.00
Assessor Name: Eduardo Lopez
Date Created: 01/29/2020

Notes: The security system is beyond its expected service life and should be scheduled for replacement.

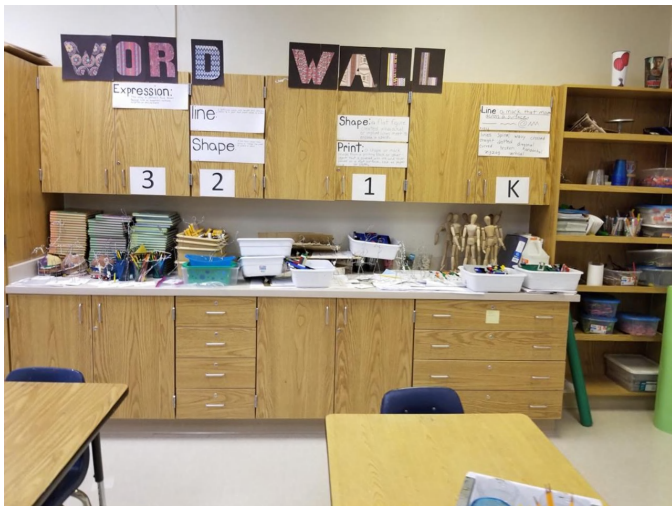
System: E2010 - Fixed Furnishings

Location: Throughout Building
Distress: Beyond Expected Life
Category: Deferred Maintenance
Priority: 3 - Necessary (Years 2-5)
Correction: Renew System
Qty: 45,360.00
Unit of Measure: S.F.
Estimate: \$95,301.00
Assessor Name: Eduardo Lopez
Date Created: 09/17/2015

Notes: The fixed furnishings are aged, and should be replaced.

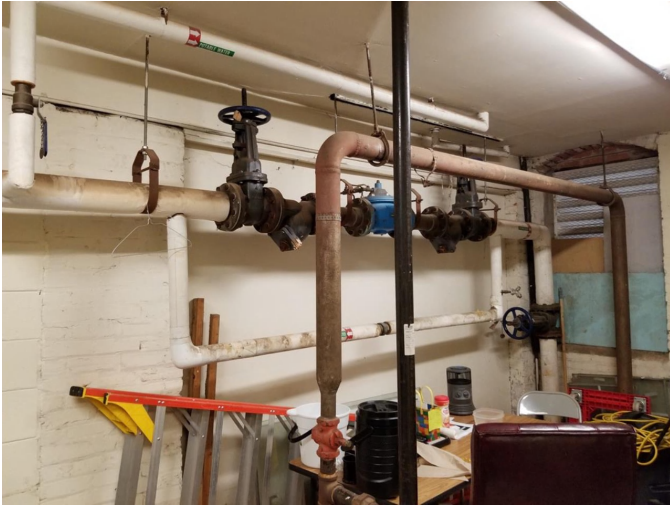
System: D2020 - Domestic Water Distribution

Location: Throughout Building
Distress: Beyond Expected Life
Category: Deferred Maintenance
Priority: 4 - Recommended (Years 6-10)
Correction: Renew System
Qty: 45,360.00
Unit of Measure: S.F.
Estimate: \$35,925.00
Assessor Name: Eduardo Lopez
Date Created: 08/05/2013

Notes: The domestic water distribution system is aged and should be replaced

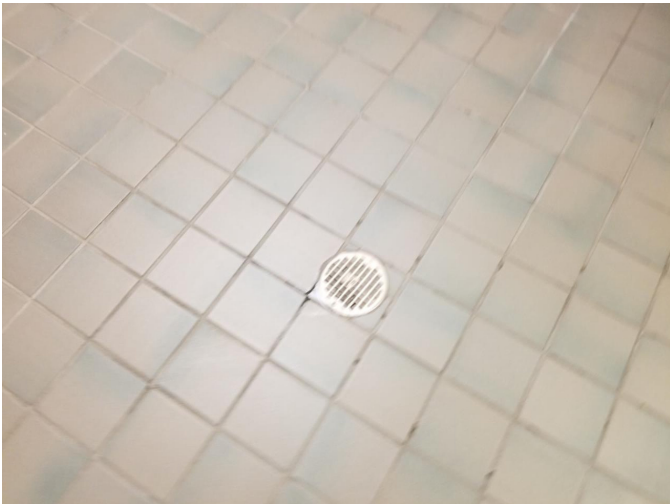
System: D2030 - Sanitary Waste

Location: Throughout Building
Distress: Beyond Expected Life
Category: Deferred Maintenance
Priority: 4 - Recommended (Years 6-10)
Correction: Renew System
Qty: 45,360.00
Unit of Measure: S.F.
Estimate: \$84,324.00
Assessor Name: Eduardo Lopez
Date Created: 08/05/2013

Notes: The sanitary waste system is aged, has reported periodic failures, and should be replaced.

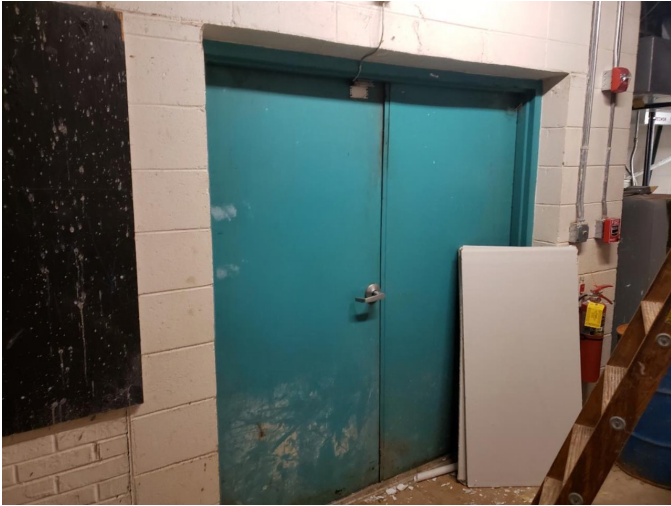
System: B2030 - Exterior Doors

Location: Electrical Room
Distress: Missing
Category: ADA Compliance
Priority: 1 - Critical Immediate Need
Correction: Replace door panic device
Qty: 1.00
Unit of Measure: Ea.
Estimate: \$1,885.26
Assessor Name: Eduardo Lopez
Date Created: 02/07/2020

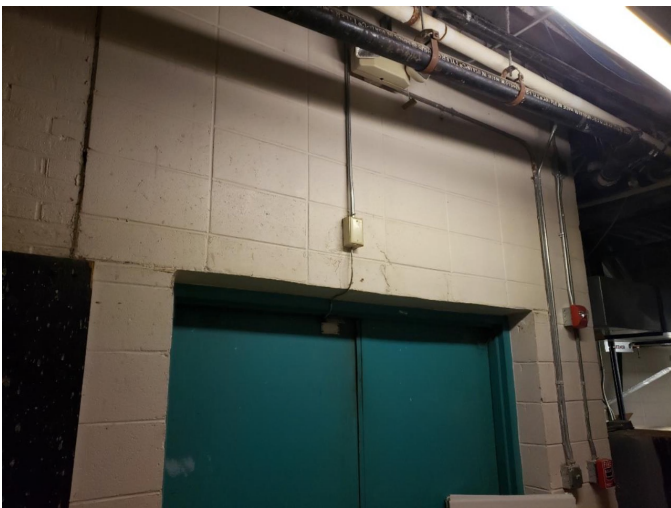
System: D5020 - Branch Wiring

Location: Electrical Room
Distress: Missing
Category: Code Compliance
Priority: 1 - Critical Immediate Need
Correction: Replace and/or add Exit Light fixtures w/wiring
Qty: 1.00
Unit of Measure: Ea.
Estimate: \$740.70
Assessor Name: Eduardo Lopez
Date Created: 02/07/2020

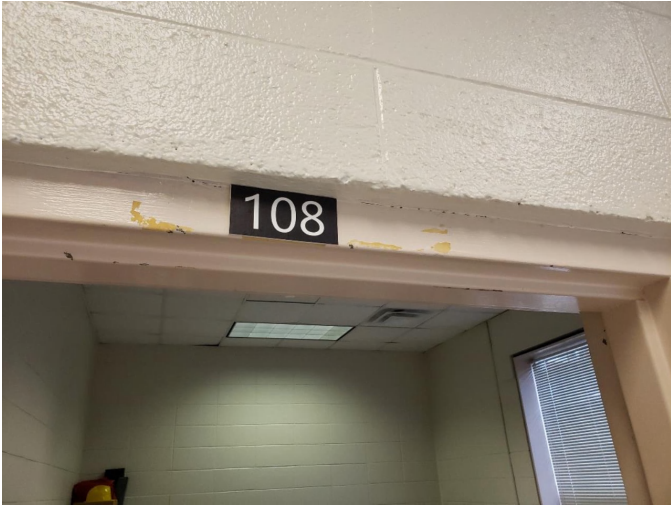
System: C1030 - Fittings

Location: Throughout Building
Distress: Beyond Expected Life
Category: ADA Compliance
Priority: 3 - Necessary (Years 2-5)
Correction: Renew System
Qty: 5,532.00
Unit of Measure: S.F.
Estimate: \$18,134.00
Assessor Name: Eduardo Lopez
Date Created: 02/05/2020

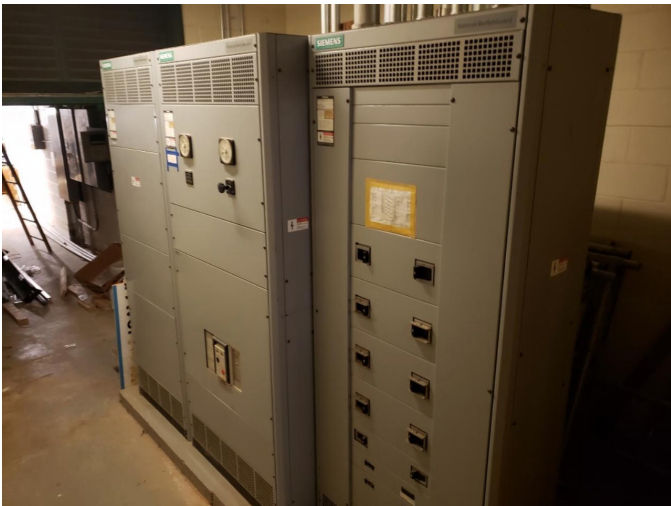
System: D5010 - Electrical Service/Distribution

Location: Electrical Room
Distress: Beyond Expected Life
Category: Deferred Maintenance
Priority: 3 - Necessary (Years 2-5)
Correction: Renew System
Qty: 5,532.00
Unit of Measure: S.F.
Estimate: \$30,852.00
Assessor Name: Eduardo Lopez
Date Created: 02/05/2020

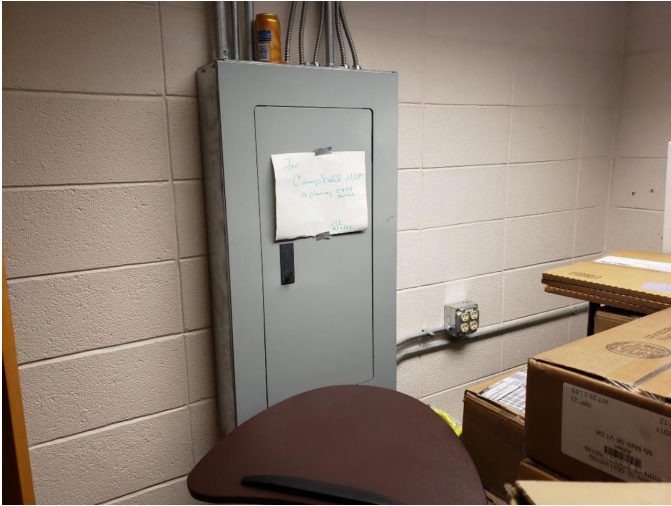
System: D5020 - Branch Wiring

Location: Throughout Building
Distress: Beyond Expected Life
Category: Deferred Maintenance
Priority: 3 - Necessary (Years 2-5)
Correction: Renew System
Qty: 5,532.00
Unit of Measure: S.F.
Estimate: \$26,349.00
Assessor Name: Eduardo Lopez
Date Created: 02/05/2020

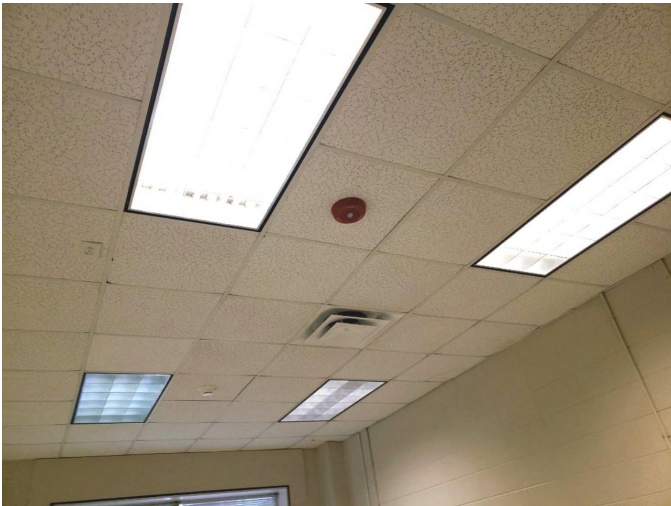
System: D5020 - Lighting

Location: Throughout Building
Distress: Beyond Expected Life
Category: Deferred Maintenance
Priority: 3 - Necessary (Years 2-5)
Correction: Renew System
Qty: 5,532.00
Unit of Measure: S.F.
Estimate: \$34,016.00
Assessor Name: Eduardo Lopez
Date Created: 02/05/2020

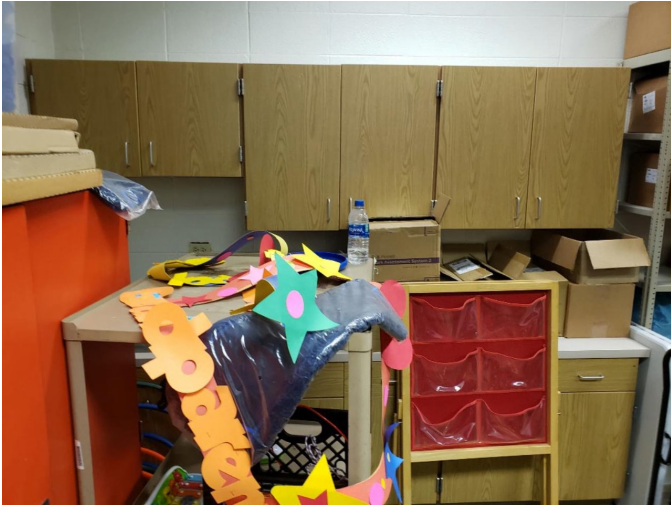
Location: Throughout Building
Distress: Beyond Expected Life
Category: Deferred Maintenance
Priority: 3 - Necessary (Years 2-5)
Correction: Renew System
Qty: 5,532.00
Unit of Measure: S.F.
Estimate: \$13,083.00
Assessor Name: Eduardo Lopez
Date Created: 02/05/2020

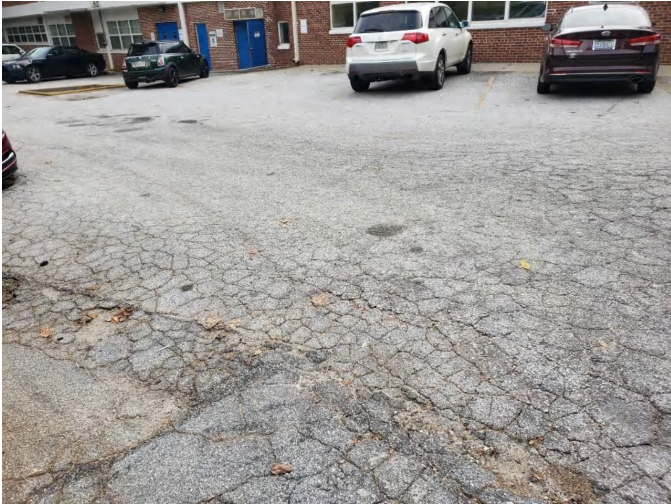
Location: Roadways
Distress: Damaged
Category: Deferred Maintenance
Priority: 2 - Trending Critical (Year 1)
Correction: Renew System
Qty: 50,892.00
Unit of Measure: S.F.
Estimate: \$132,675.00
Assessor Name: Eduardo Lopez
Date Created: 08/12/2013

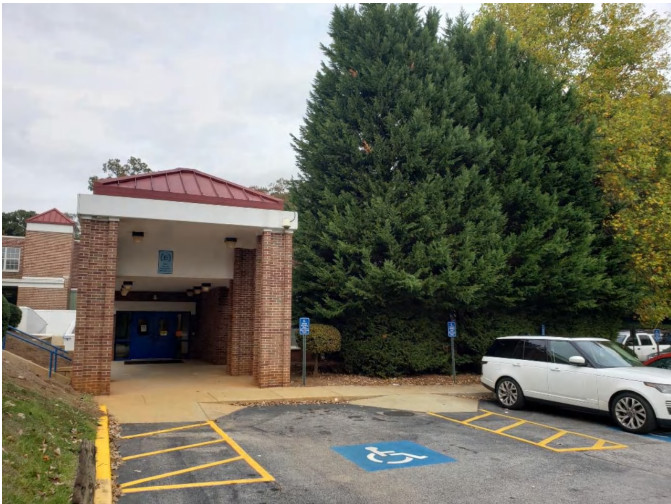
Location: ADA Parking
Distress: Missing
Category: ADA Compliance
Priority: 2 - Trending Critical (Year 1)
Correction: Add handicap parking space, incl. pavement markings, sign and post
Qty: 1.00
Unit of Measure: Ea.
Estimate: \$518.63
Assessor Name: Eduardo Lopez
Date Created: 02/07/2020

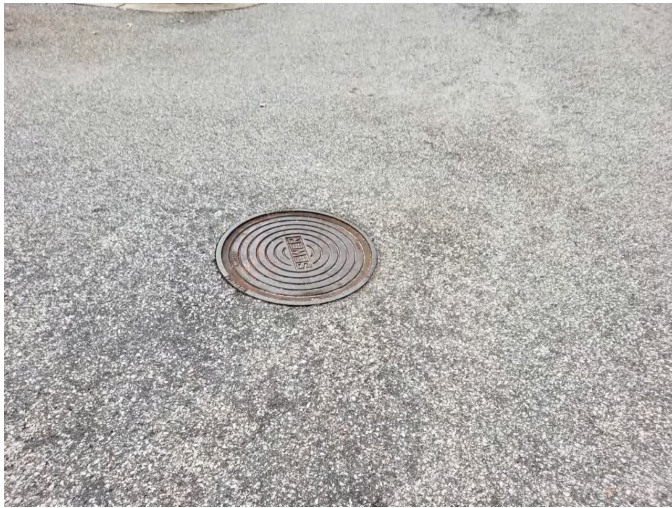
Location: Site
Distress: Beyond Expected Life
Category: Deferred Maintenance
Priority: 3 - Necessary (Years 2-5)
Correction: Renew System
Qty: 50,892.00
Unit of Measure: S.F.
Estimate: \$123,159.00
Assessor Name: Eduardo Lopez
Date Created: 02/05/2020

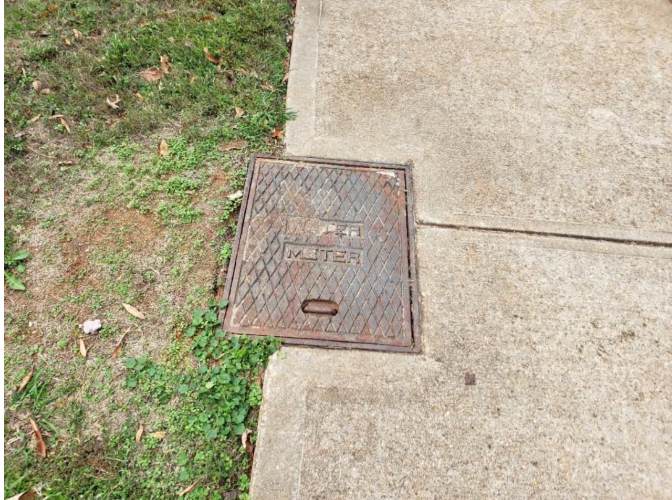
Location: Site
Distress: Beyond Expected Life
Category: Deferred Maintenance
Priority: 4 - Recommended (Years 6-10)
Correction: Renew System
Qty: 50,892.00
Unit of Measure: S.F.
Estimate: \$61,020.00
Assessor Name: Eduardo Lopez
Date Created: 08/05/2013

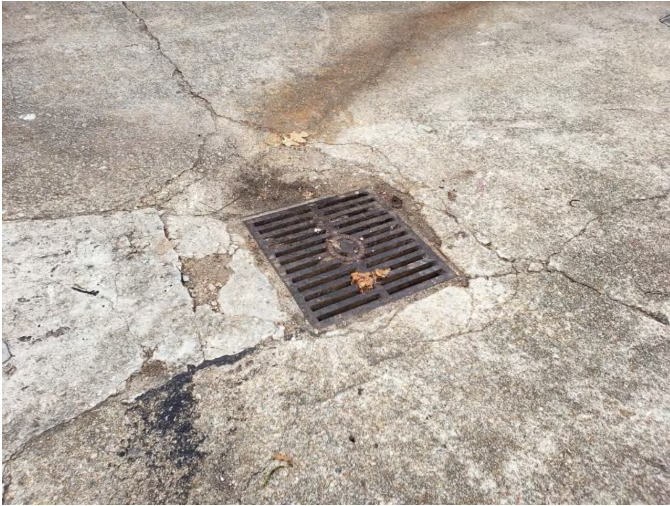
Location: Site
Distress: Beyond Expected Life
Category: Deferred Maintenance
Priority: 4 - Recommended (Years 6-10)
Correction: Renew System
Qty: 50,892.00
Unit of Measure: S.F.
Estimate: \$69,976.00
Assessor Name: Eduardo Lopez
Date Created: 08/05/2013

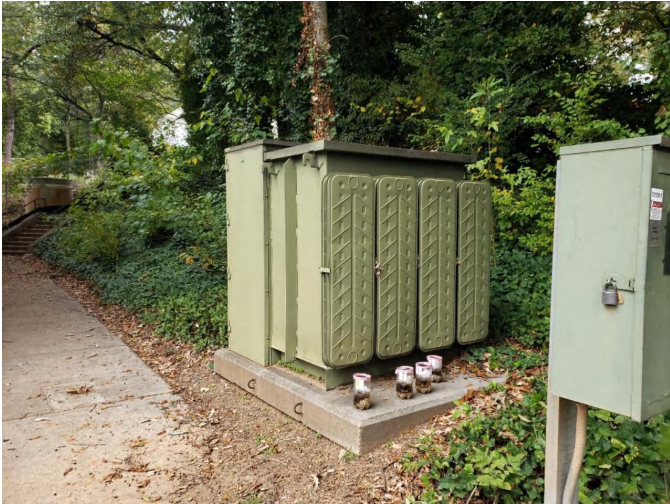
Location: Site
Distress: Beyond Expected Life
Category: Deferred Maintenance
Priority: 4 - Recommended (Years 6-10)
Correction: Renew System
Qty: 50,892.00
Unit of Measure: S.F.
Estimate: \$142,752.00
Assessor Name: Eduardo Lopez
Date Created: 08/05/2013
