Atlanta Public Schools/Relocation Sites

# Capitol View Elementary School

## School Assessment Report

November 10, 2020

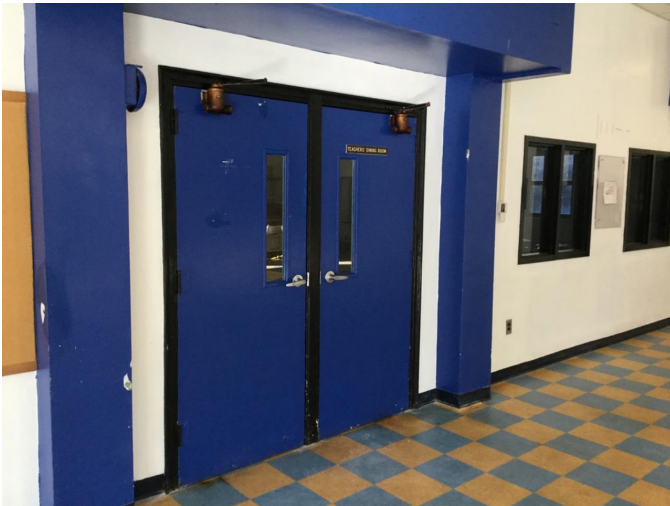
#### System: C1030 - Fittings

**Location:** Throughout building  
**Distress:** Beyond Expected Life  
**Category:** ADA Compliance  
**Priority:** 1 - Critical Immediate Need  
**Correction:** Renew System  
**Qty:** 49,075.00  
**Unit of Measure:** S.F.  
**Estimate:** \$143,054.00  
**Assessor Name:** Jejuan Hall  
**Date Created:** 09/17/2015

**Notes:** The fittings system should be scheduled for replacement. This school is abandoned and most systems are recommended for replacement. This deficiency is expected to be completed as part of an overall effort to renew the interior finishes.

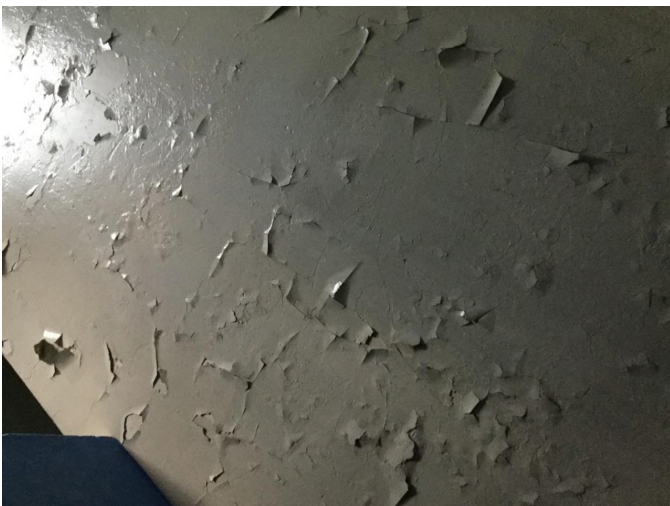
#### System: C3010230 - Paint & Covering

**Location:** Throughout building  
**Distress:** Beyond Expected Life  
**Category:** Deferred Maintenance  
**Priority:** 1 - Critical Immediate Need  
**Correction:** Renew System  
**Qty:** 49,075.00  
**Unit of Measure:** S.F.  
**Estimate:** \$79,354.00  
**Assessor Name:** Hayden Collins  
**Date Created:** 01/26/2020

**Notes:** The applied finish should be scheduled for replacement. This school is abandoned and most systems are recommended for replacement. This deficiency is expected to be completed as part of an overall effort to renew the interior finishes.

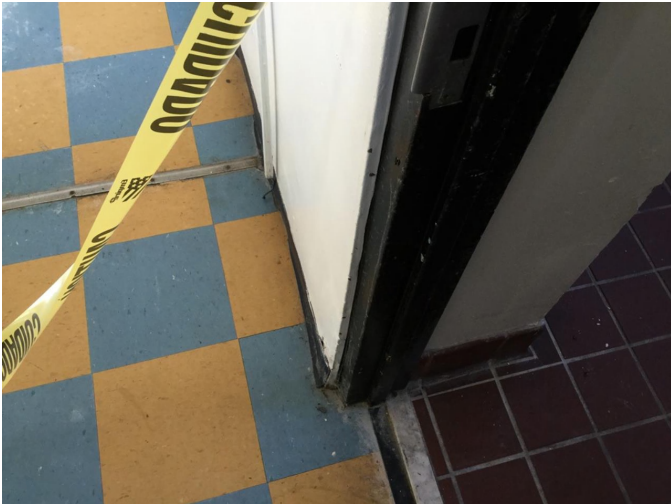
**System: C3020903 - VCT**

**Location:** Throughout building  
**Distress:** Beyond Expected Life  
**Category:** Deferred Maintenance  
**Priority:** 1 - Critical Immediate Need  
**Correction:** Renew System  
**Qty:** 39,075.00  
**Unit of Measure:** S.F.  
**Estimate:** \$210,771.00  
**Assessor Name:** Hayden Collins  
**Date Created:** 01/26/2020

**Notes:** The VCT floor finish is aged and stained and should be scheduled for replacement. This school is abandoned, and the systems are recommended for replacement. This deficiency is expected to be completed as part of an overall effort to renew the interior finishes.

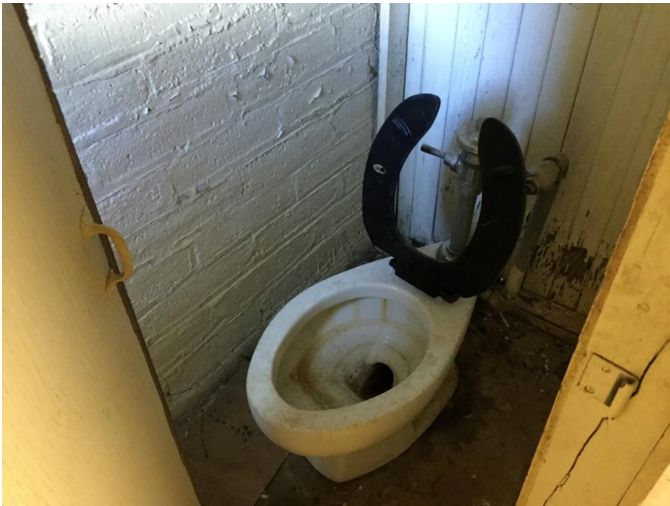
**Location:** Restrooms  
**Distress:** Beyond Expected Life  
**Category:** ADA Compliance  
**Priority:** 1 - Critical Immediate Need  
**Correction:** Renew System  
**Qty:** 49,075.00  
**Unit of Measure:** S.F.  
**Estimate:** \$343,869.00  
**Assessor Name:** Jejuan Hall  
**Date Created:** 09/17/2015

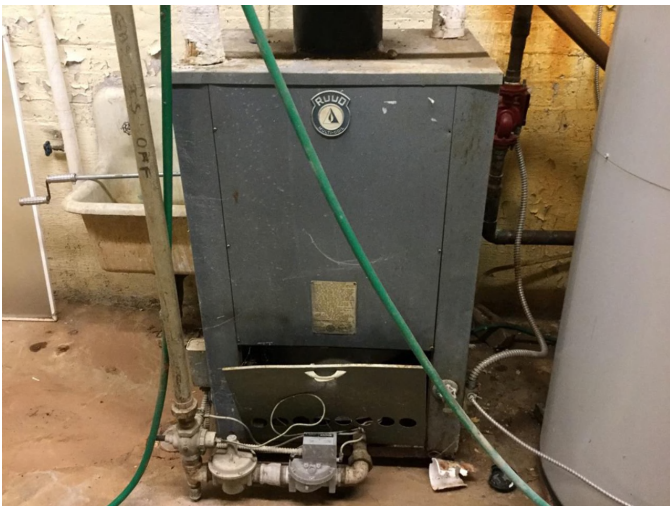
**Location:** Mechanical Room  
**Distress:** Beyond Expected Life  
**Category:** Deferred Maintenance  
**Priority:** 1 - Critical Immediate Need  
**Correction:** Renew System  
**Qty:** 49,075.00  
**Unit of Measure:** S.F.  
**Estimate:** \$194,337.00  
**Assessor Name:** Hayden Collins  
**Date Created:** 02/11/2020

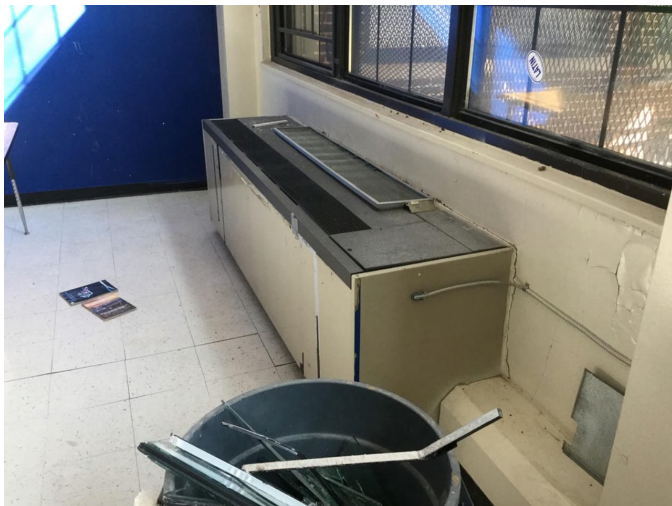
**Location:** Throughout building  
**Distress:** Beyond Expected Life  
**Category:** Deferred Maintenance  
**Priority:** 1 - Critical Immediate Need  
**Correction:** Renew System  
**Qty:** 49,075.00  
**Unit of Measure:** S.F.  
**Estimate:** \$573,294.00  
**Assessor Name:** Hayden Collins  
**Date Created:** 02/11/2020

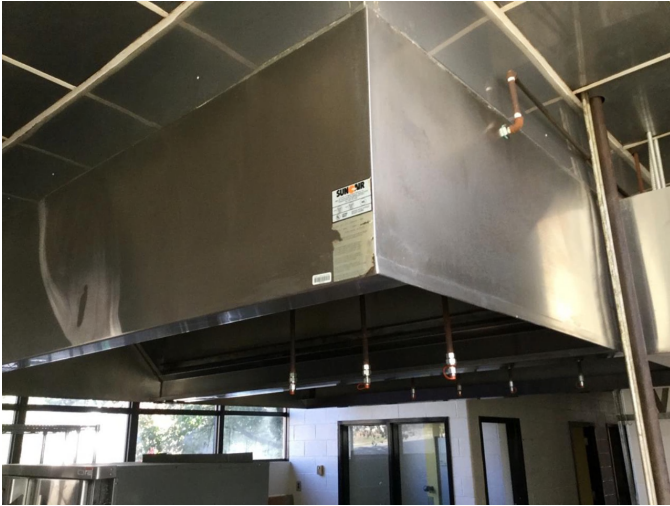
**Location:** Throughout building  
**Distress:** Beyond Expected Life  
**Category:** Deferred Maintenance  
**Priority:** 1 - Critical Immediate Need  
**Correction:** Renew System  
**Qty:** 49,075.00  
**Unit of Measure:** S.F.  
**Estimate:** \$4,858.00  
**Assessor Name:** Hayden Collins  
**Date Created:** 09/17/2015

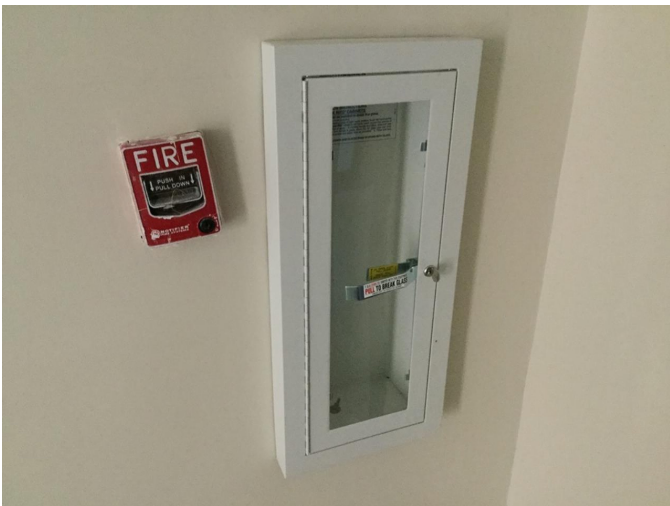
**Location:** Throughout building  
**Distress:** Beyond Expected Life  
**Category:** Deferred Maintenance  
**Priority:** 1 - Critical Immediate Need  
**Correction:** Renew System  
**Qty:** 49,075.00  
**Unit of Measure:** S.F.  
**Estimate:** \$32,390.00  
**Assessor Name:** Hayden Collins  
**Date Created:** 09/17/2015

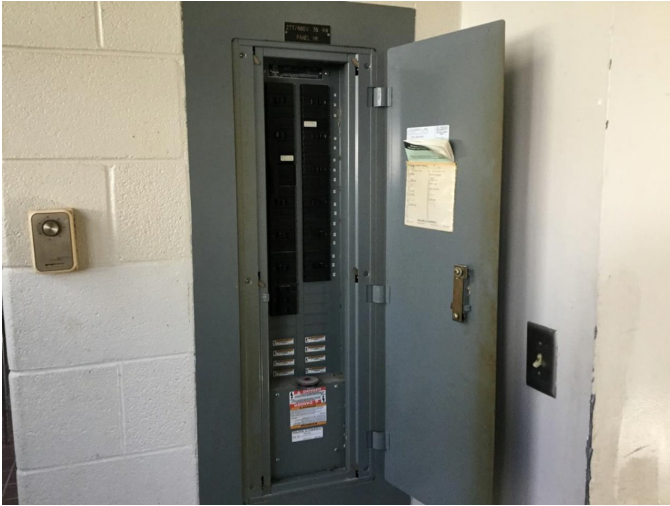
**Location:** Throughout building  
**Distress:** Beyond Expected Life  
**Category:** Deferred Maintenance  
**Priority:** 1 - Critical Immediate Need  
**Correction:** Renew System  
**Qty:** 49,075.00  
**Unit of Measure:** S.F.  
**Estimate:** \$124,160.00  
**Assessor Name:** Hayden Collins  
**Date Created:** 09/17/2015

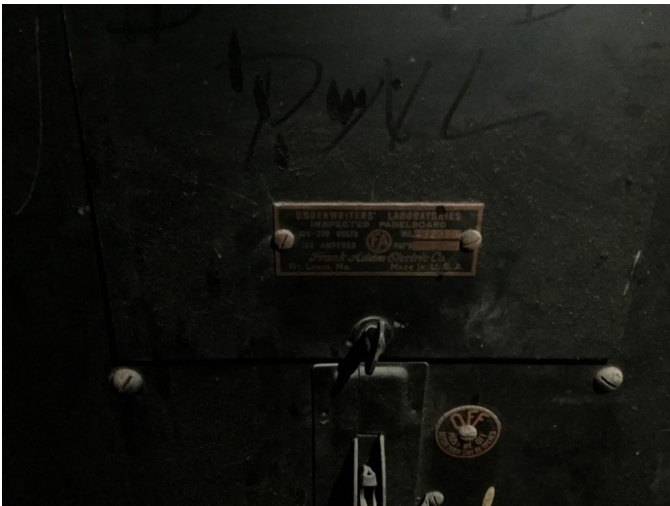
**Location:** Throughout building  
**Distress:** Beyond Expected Life  
**Category:** Deferred Maintenance  
**Priority:** 1 - Critical Immediate Need  
**Correction:** Renew System  
**Qty:** 49,075.00  
**Unit of Measure:** S.F.  
**Estimate:** \$287,727.00  
**Assessor Name:** Hayden Collins  
**Date Created:** 01/26/2020

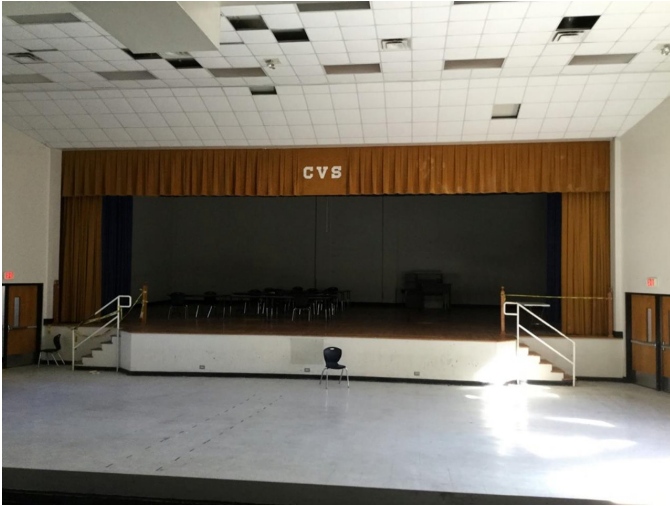
**Location:** Throughout building  
**Distress:** Beyond Expected Life  
**Category:** Deferred Maintenance  
**Priority:** 1 - Critical Immediate Need  
**Correction:** Renew System  
**Qty:** 49,075.00  
**Unit of Measure:** S.F.  
**Estimate:** \$4,858.00  
**Assessor Name:** Hayden Collins  
**Date Created:** 02/11/2020

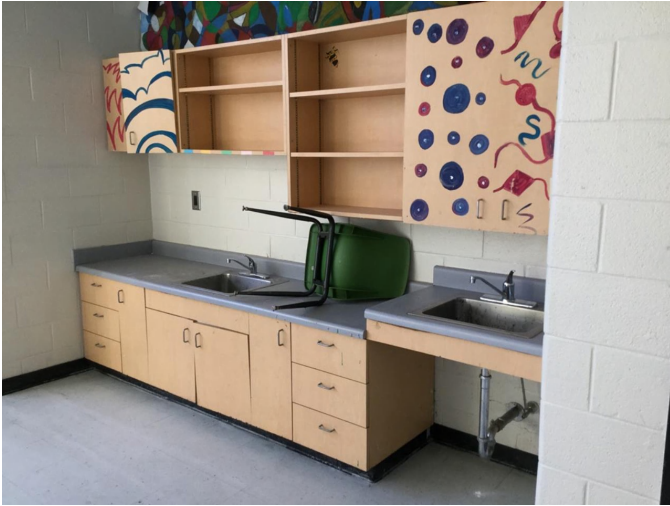
**Location:** Throughout building  
**Distress:** Beyond Expected Life  
**Category:** Deferred Maintenance  
**Priority:** 1 - Critical Immediate Need  
**Correction:** Renew System  
**Qty:** 49,075.00  
**Unit of Measure:** S.F.  
**Estimate:** \$103,107.00  
**Assessor Name:** Hayden Collins  
**Date Created:** 09/17/2015

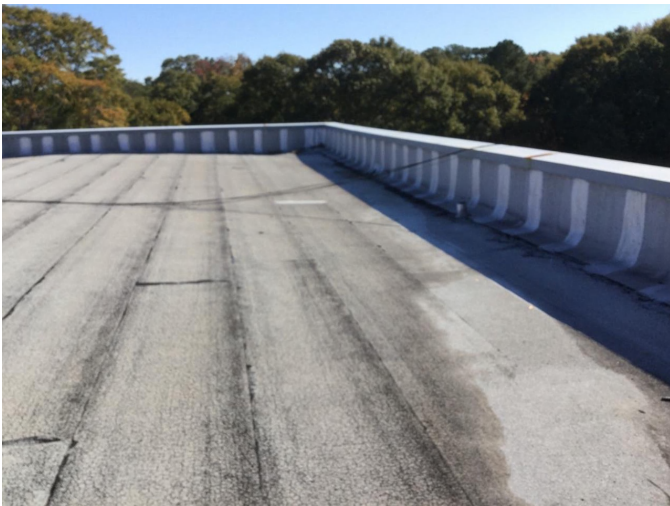
**Location:** Roof  
**Distress:** Beyond Expected Life  
**Category:** Deferred Maintenance  
**Priority:** 2 - Trending Critical (Year 1)  
**Correction:** Renew System  
**Qty:** 16,373.00  
**Unit of Measure:** S.F.  
**Estimate:** \$183,795.00  
**Assessor Name:** Hayden Collins  
**Date Created:** 01/26/2020

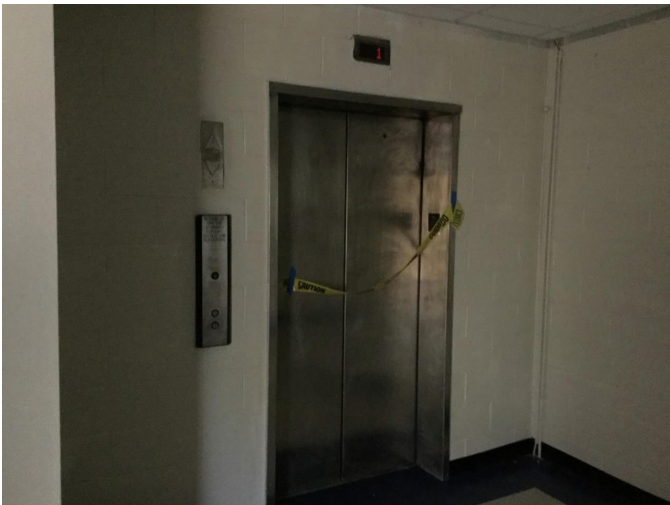
**Location:** Throughout building  
**Distress:** Beyond Expected Life  
**Category:** Deferred Maintenance  
**Priority:** 3 - Necessary (Years 2-5)  
**Correction:** Renew System  
**Qty:** 49,075.00  
**Unit of Measure:** S.F.  
**Estimate:** \$67,478.00  
**Assessor Name:** Hayden Collins  
**Date Created:** 09/17/2015

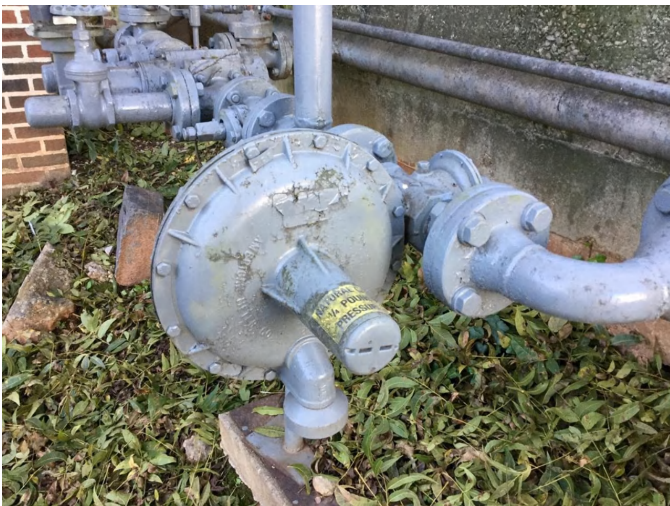
**Location:** Throughout building  
**Distress:** Beyond Expected Life  
**Category:** Deferred Maintenance  
**Priority:** 3 - Necessary (Years 2-5)  
**Correction:** Renew System  
**Qty:** 49,075.00  
**Unit of Measure:** S.F.  
**Estimate:** \$32,929.00  
**Assessor Name:** Hayden Collins  
**Date Created:** 02/11/2020

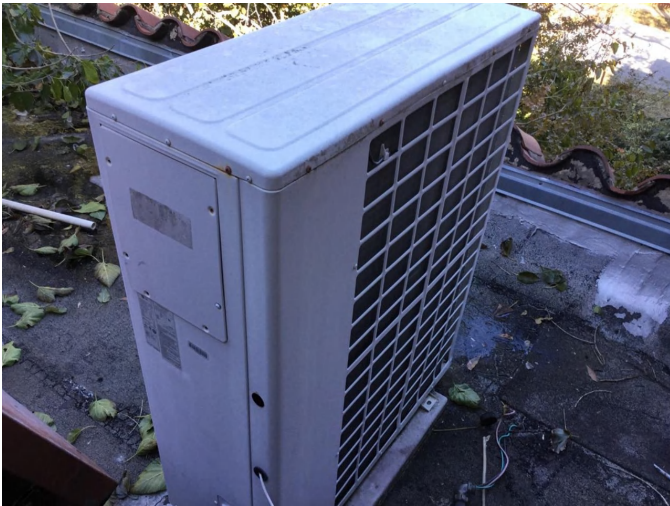
**Location:** Throughout building  
**Distress:** Beyond Expected Life  
**Category:** Deferred Maintenance  
**Priority:** 3 - Necessary (Years 2-5)  
**Correction:** Renew System  
**Qty:** 49,075.00  
**Unit of Measure:** S.F.  
**Estimate:** \$712,569.00  
**Assessor Name:** Hayden Collins  
**Date Created:** 02/21/2020

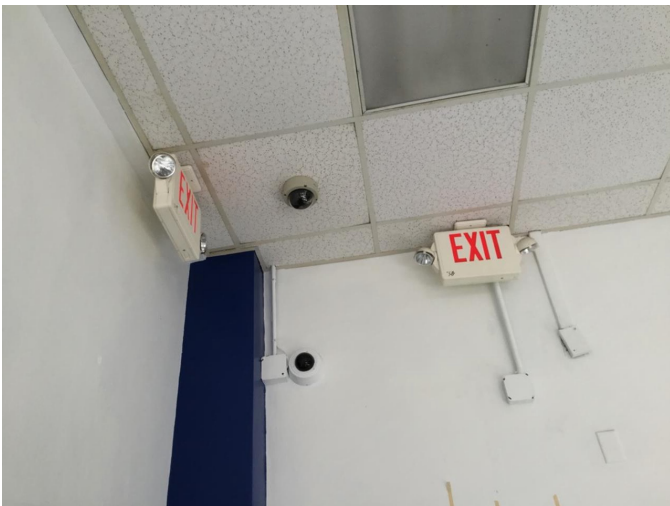
**Location:** Throughout building  
**Distress:** Beyond Expected Life  
**Category:** Deferred Maintenance  
**Priority:** 3 - Necessary (Years 2-5)  
**Correction:** Renew System  
**Qty:** 49,075.00  
**Unit of Measure:** S.F.  
**Estimate:** \$353,585.00  
**Assessor Name:** Hayden Collins  
**Date Created:** 02/21/2020

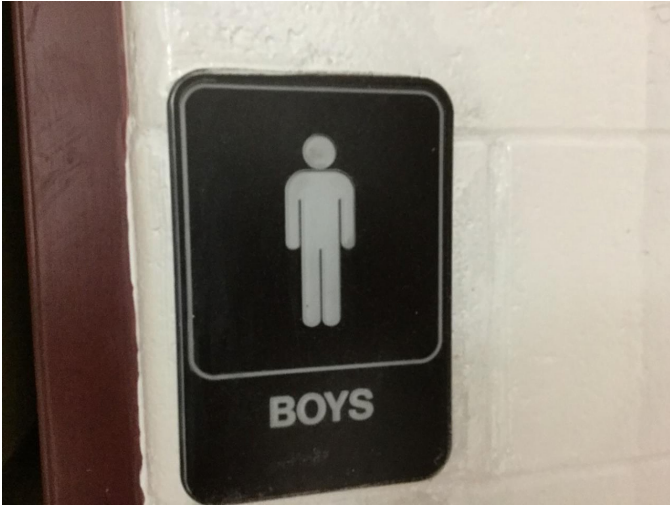
**Location:** Throughout building  
**Distress:** Beyond Expected Life  
**Category:** ADA Compliance  
**Priority:** 3 - Necessary (Years 2-5)  
**Correction:** Renew System  
**Qty:** 11,434.00  
**Unit of Measure:** S.F.  
**Estimate:** \$37,481.00  
**Assessor Name:** Jejuan Hall  
**Date Created:** 09/17/2015

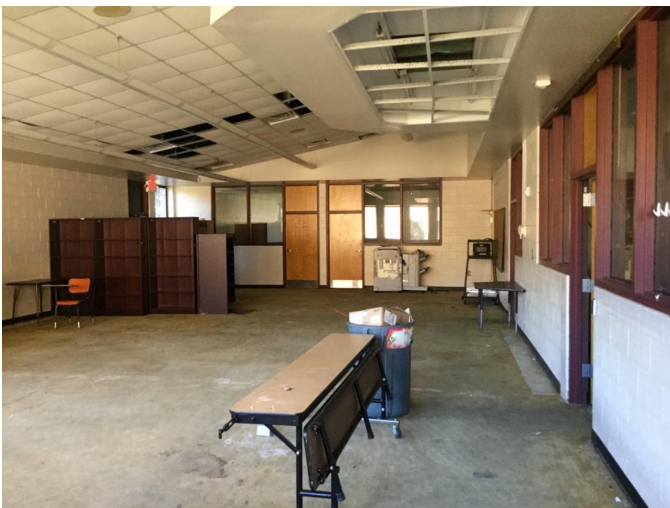
**Location:** Throughout building  
**Distress:** Beyond Expected Life  
**Category:** Deferred Maintenance  
**Priority:** 3 - Necessary (Years 2-5)  
**Correction:** Renew System  
**Qty:** 11,434.00  
**Unit of Measure:** S.F.  
**Estimate:** \$18,489.00  
**Assessor Name:** Hayden Collins  
**Date Created:** 02/19/2020

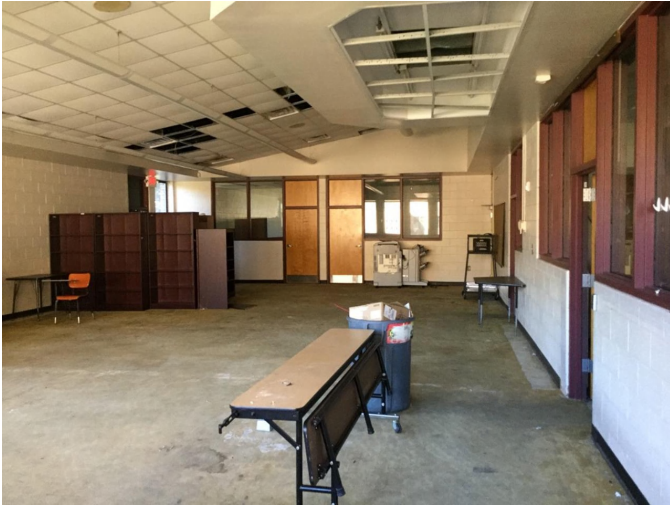
**Location:** Throughout building  
**Distress:** Beyond Expected Life  
**Category:** Deferred Maintenance  
**Priority:** 3 - Necessary (Years 2-5)  
**Correction:** Renew System  
**Qty:** 11,434.00  
**Unit of Measure:** S.F.  
**Estimate:** \$125,774.00  
**Assessor Name:** Hayden Collins  
**Date Created:** 09/17/2015

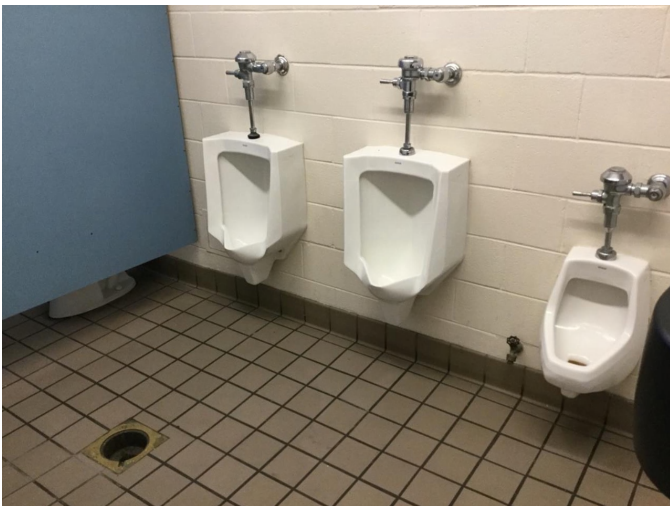
**Location:** Restrooms  
**Distress:** Beyond Expected Life  
**Category:** ADA Compliance  
**Priority:** 3 - Necessary (Years 2-5)  
**Correction:** Renew System  
**Qty:** 11,434.00  
**Unit of Measure:** S.F.  
**Estimate:** \$88,796.00  
**Assessor Name:** Jejuan Hall  
**Date Created:** 09/17/2015

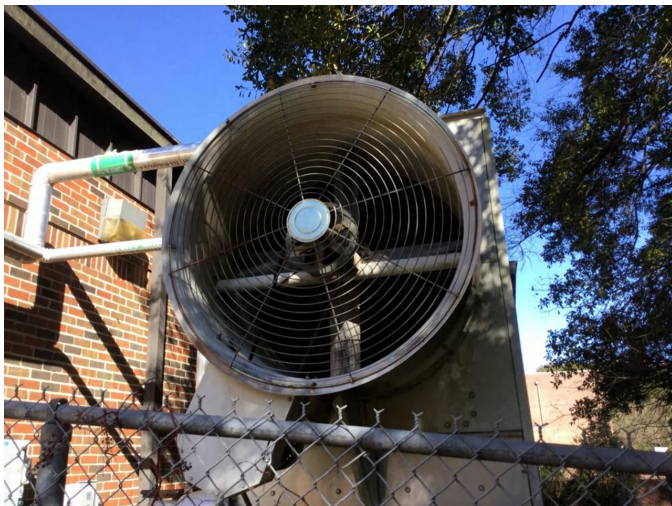
**Location:** Throughout building  
**Distress:** Beyond Expected Life  
**Category:** Deferred Maintenance  
**Priority:** 3 - Necessary (Years 2-5)  
**Correction:** Renew System  
**Qty:** 11,434.00  
**Unit of Measure:** S.F.  
**Estimate:** \$85,275.00  
**Assessor Name:** Hayden Collins  
**Date Created:** 09/17/2015

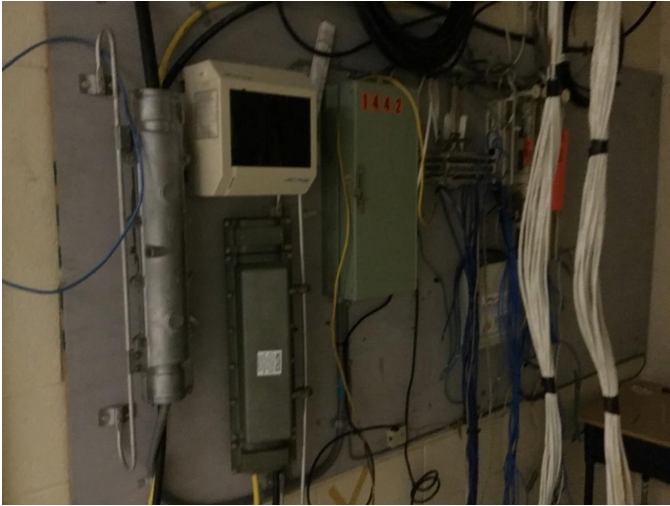
**Location:** Throughout building  
**Distress:** Beyond Expected Life  
**Category:** Deferred Maintenance  
**Priority:** 3 - Necessary (Years 2-5)  
**Correction:** Renew System  
**Qty:** 11,434.00  
**Unit of Measure:** S.F.  
**Estimate:** \$148,539.00  
**Assessor Name:** Hayden Collins  
**Date Created:** 09/17/2015

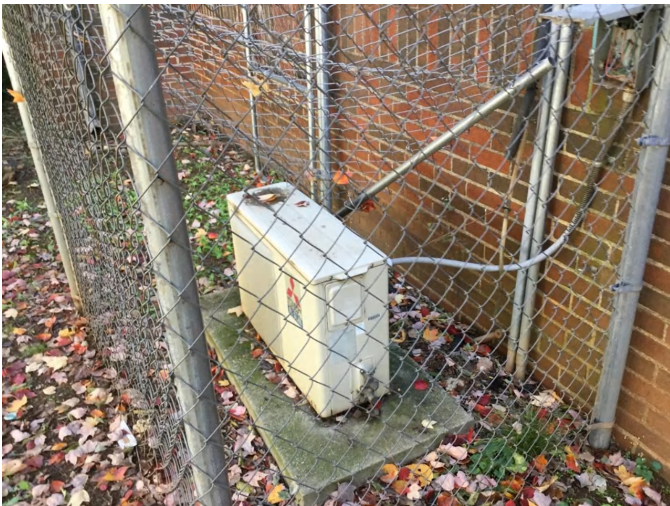
**Location:** Throughout building  
**Distress:** Beyond Expected Life  
**Category:** Deferred Maintenance  
**Priority:** 3 - Necessary (Years 2-5)  
**Correction:** Renew System  
**Qty:** 11,434.00  
**Unit of Measure:** S.F.  
**Estimate:** \$88,419.00  
**Assessor Name:** Hayden Collins  
**Date Created:** 02/21/2020

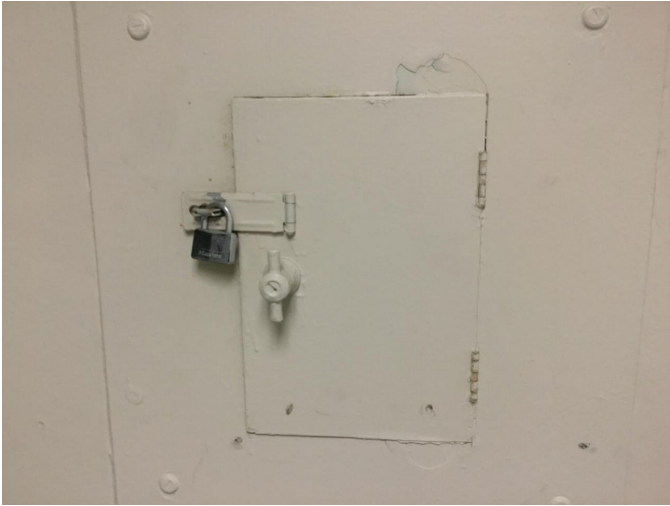
**Location:** Throughout building  
**Distress:** Beyond Expected Life  
**Category:** Deferred Maintenance  
**Priority:** 3 - Necessary (Years 2-5)  
**Correction:** Renew System  
**Qty:** 11,434.00  
**Unit of Measure:** S.F.  
**Estimate:** \$32,072.00  
**Assessor Name:** Hayden Collins  
**Date Created:** 09/17/2015

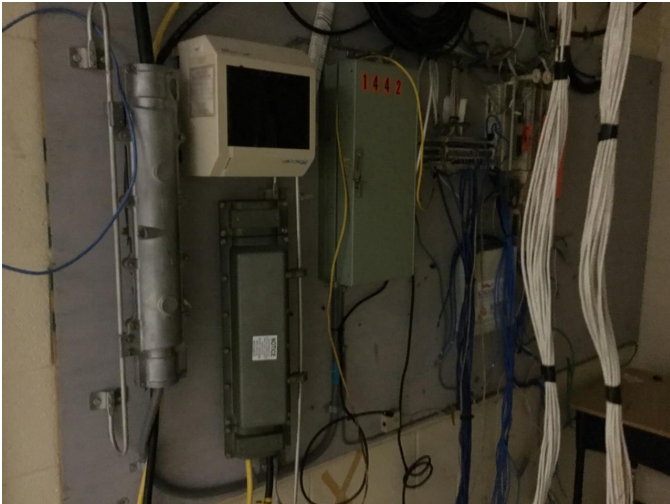
**Location:** Throughout building  
**Distress:** Beyond Expected Life  
**Category:** Deferred Maintenance  
**Priority:** 3 - Necessary (Years 2-5)  
**Correction:** Renew System  
**Qty:** 11,434.00  
**Unit of Measure:** S.F.  
**Estimate:** \$75,464.00  
**Assessor Name:** Hayden Collins  
**Date Created:** 01/28/2020

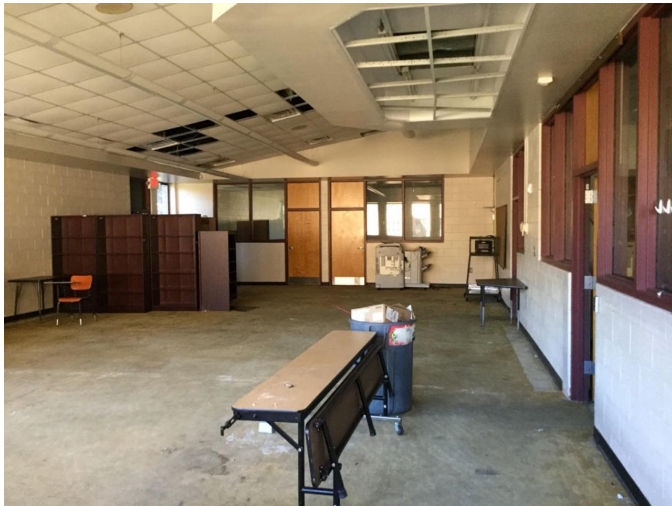
**Location:** Throughout building  
**Distress:** Beyond Expected Life  
**Category:** Deferred Maintenance  
**Priority:** 3 - Necessary (Years 2-5)  
**Correction:** Renew System  
**Qty:** 11,434.00  
**Unit of Measure:** S.F.  
**Estimate:** \$99,110.00  
**Assessor Name:** Hayden Collins  
**Date Created:** 09/17/2015

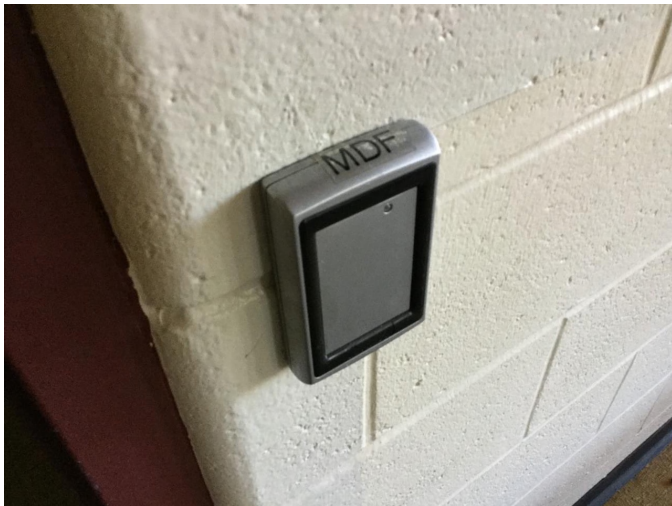
**Location:** Throughout building  
**Distress:** Beyond Expected Life  
**Category:** Deferred Maintenance  
**Priority:** 3 - Necessary (Years 2-5)  
**Correction:** Renew System  
**Qty:** 11,434.00  
**Unit of Measure:** S.F.  
**Estimate:** \$18,992.00  
**Assessor Name:** Hayden Collins  
**Date Created:** 01/28/2020

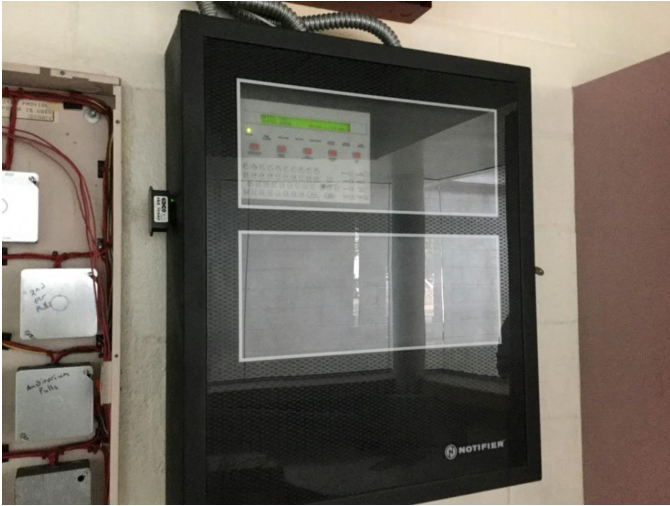
**Location:** Throughout building  
**Distress:** Beyond Expected Life  
**Category:** Deferred Maintenance  
**Priority:** 3 - Necessary (Years 2-5)  
**Correction:** Renew System  
**Qty:** 11,434.00  
**Unit of Measure:** S.F.  
**Estimate:** \$35,594.00  
**Assessor Name:** Hayden Collins  
**Date Created:** 01/28/2020

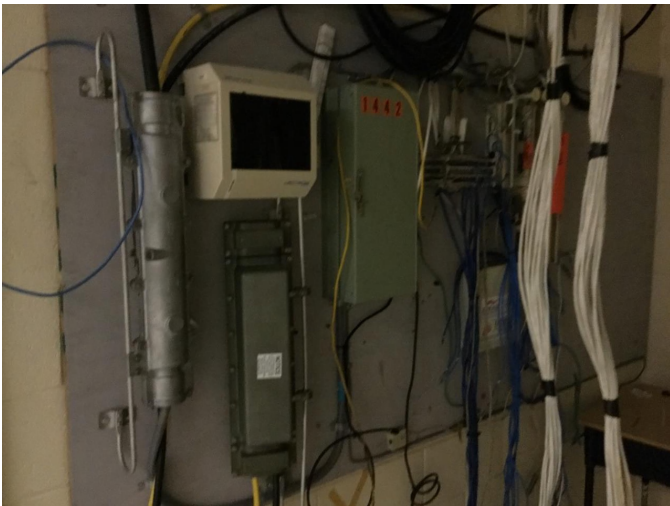
**Location:** Throughout building  
**Distress:** Beyond Expected Life  
**Category:** Deferred Maintenance  
**Priority:** 3 - Necessary (Years 2-5)  
**Correction:** Renew System  
**Qty:** 11,434.00  
**Unit of Measure:** S.F.  
**Estimate:** \$44,776.00  
**Assessor Name:** Hayden Collins  
**Date Created:** 01/28/2020

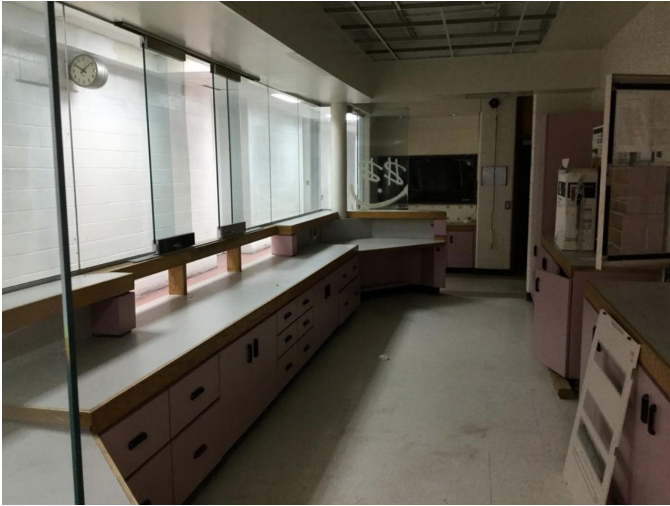
**Location:** Throughout building  
**Distress:** Beyond Expected Life  
**Category:** Deferred Maintenance  
**Priority:** 3 - Necessary (Years 2-5)  
**Correction:** Renew System  
**Qty:** 11,434.00  
**Unit of Measure:** S.F.  
**Estimate:** \$1,258.00  
**Assessor Name:** Hayden Collins  
**Date Created:** 02/11/2020

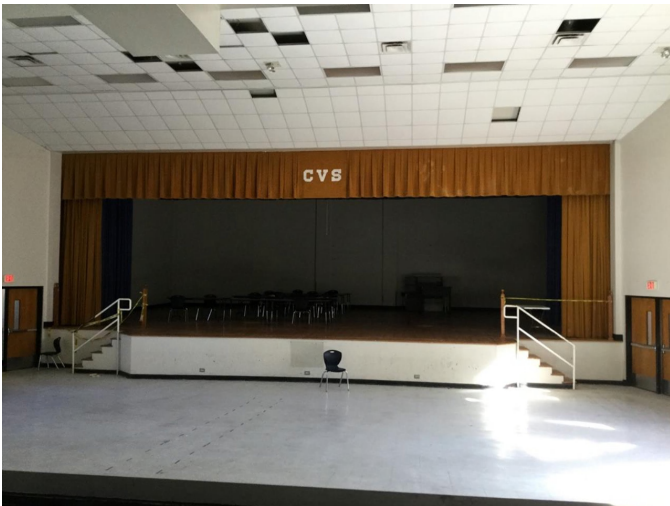
**Location:** Missing Assumed Stolen  
**Distress:** Beyond Expected Life  
**Category:** Deferred Maintenance  
**Priority:** 3 - Necessary (Years 2-5)  
**Correction:** Renew System  
**Qty:** 11,434.00  
**Unit of Measure:** S.F.  
**Estimate:** \$10,942.00  
**Assessor Name:** Hayden Collins  
**Date Created:** 02/11/2020

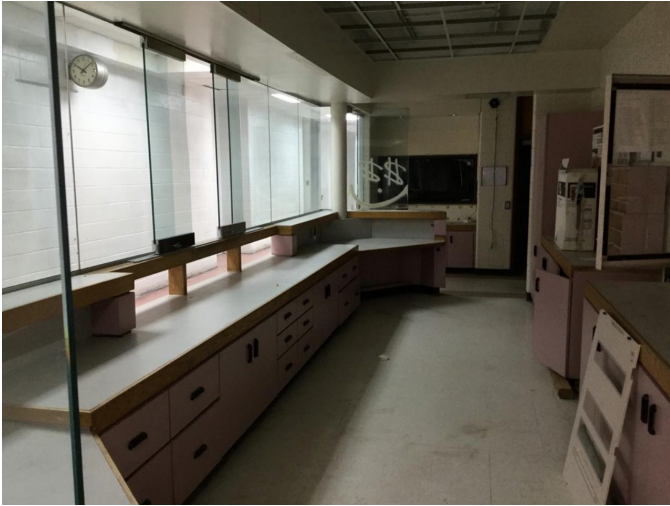
**Location:** Throughout building  
**Distress:** Beyond Expected Life  
**Category:** Deferred Maintenance  
**Priority:** 3 - Necessary (Years 2-5)  
**Correction:** Renew System  
**Qty:** 11,434.00  
**Unit of Measure:** S.F.  
**Estimate:** \$27,041.00  
**Assessor Name:** Hayden Collins  
**Date Created:** 09/17/2015

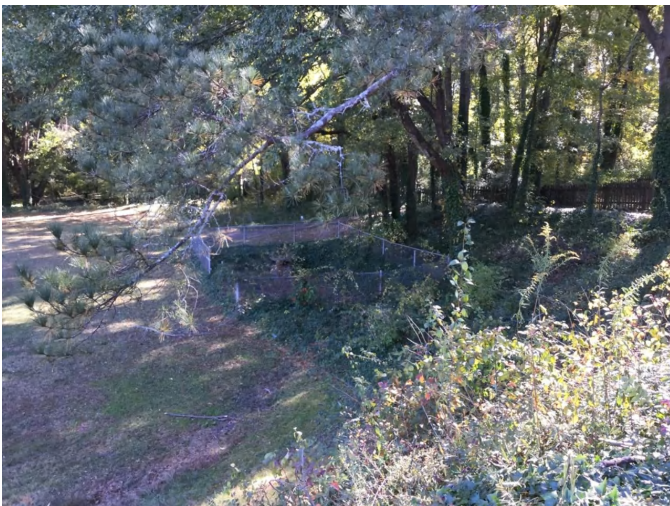
**Location:** Site  
**Distress:** Beyond Expected Life  
**Category:** Deferred Maintenance  
**Priority:** 3 - Necessary (Years 2-5)  
**Correction:** Renew System  
**Qty:** 60,509.00  
**Unit of Measure:** S.F.  
**Estimate:** \$78,541.00  
**Assessor Name:** Hayden Collins  
**Date Created:** 02/21/2020
