Atlanta Public Schools/ Mays Cluster

Cascade Elementary School

School Assessment Report

November 10, 2020

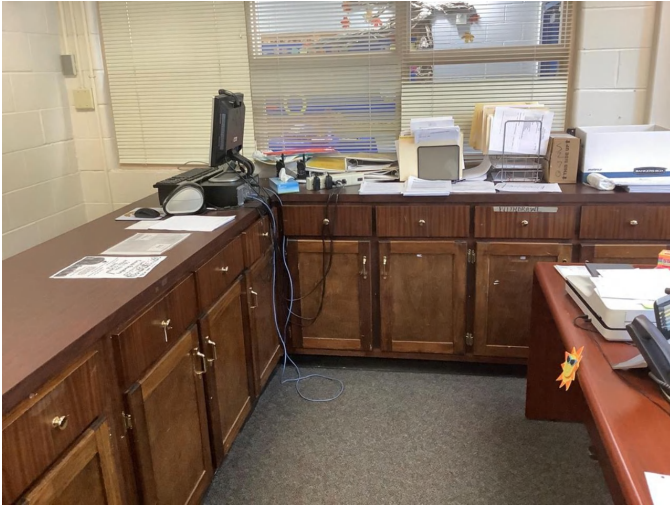
System: C3020901 - Carpet

Location: Media Center and Administration Areas
Distress: Beyond Expected Life
Category: Deferred Maintenance
Priority: 3 - Necessary (Years 2-5)
Correction: Renew System
Qty: 3,000.00
Unit of Measure: S.F.
Estimate: \$24,750.00
Assessor Name: Eduardo Lopez
Date Created: 10/18/2019

Notes: The carpet is aged, worn and stained, and should be replaced.

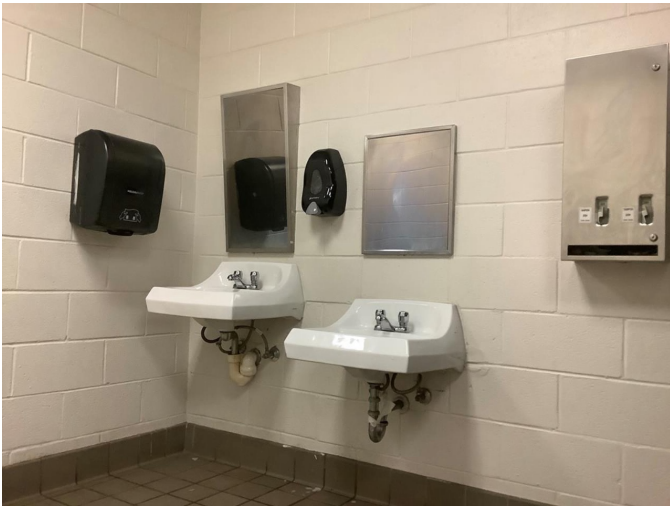
System: D2010 - Plumbing Fixtures

Location: Throughout building
Distress: Beyond Expected Life
Category: ADA Compliance
Priority: 3 - Necessary (Years 2-5)
Correction: Renew System
Qty: 70,101.00
Unit of Measure: S.F.
Estimate: \$544,404.00
Assessor Name: Eduardo Lopez
Date Created: 09/17/2015

Notes: The restroom fixtures are from the 1994 original construction. The systems are beyond the expected life cycle and upgrades are warranted. The new restroom fixtures should include all aspects of the current ADA standards.

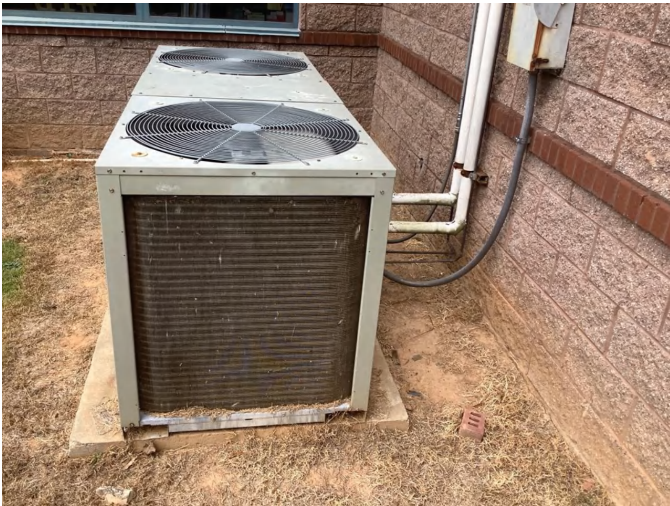
System: D3050 - Terminal & Package Units

Location: Throughout Building
Distress: Beyond Expected Life
Category: Deferred Maintenance
Priority: 3 - Necessary (Years 2-5)
Correction: Renew System
Qty: 70,101.00
Unit of Measure: S.F.
Estimate: \$569,851.00
Assessor Name: Eduardo Lopez
Date Created: 10/06/2020

Notes: The terminal and package units are beyond expected service life and should be scheduled for replacement.

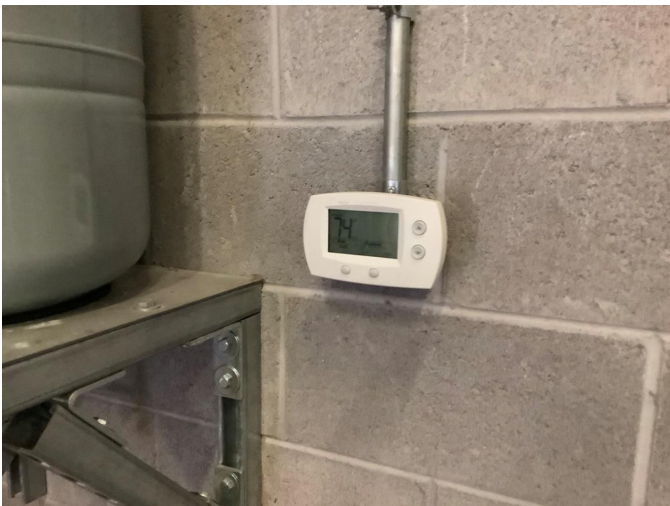
System: D3060 - Controls & Instrumentation

Location: Throughout Building
Distress: Beyond Expected Life
Category: Deferred Maintenance
Priority: 3 - Necessary (Years 2-5)
Correction: Renew System
Qty: 70,101.00
Unit of Measure: S.F.
Estimate: \$189,693.00
Assessor Name: Eduardo Lopez
Date Created: 10/06/2020

Notes: The controls and instrumentation system is beyond service life and should be scheduled for replacement.

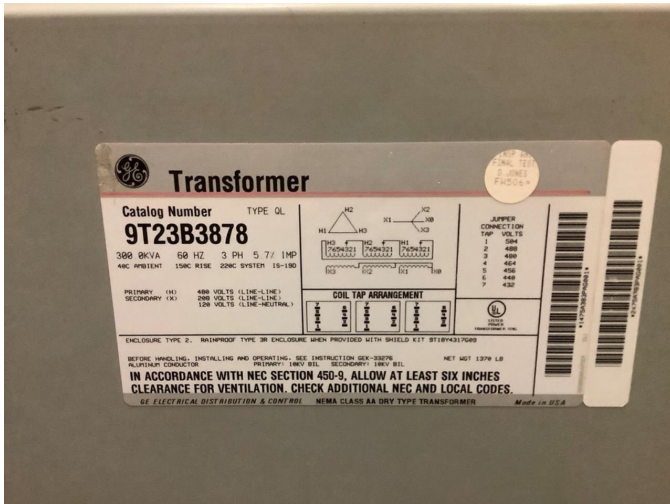
System: D5010 - Electrical Service/Distribution

Location: Throughout Building
Distress: Beyond Expected Life
Category: Deferred Maintenance
Priority: 3 - Necessary (Years 2-5)
Correction: Renew System
Qty: 70,101.00
Unit of Measure: S.F.
Estimate: \$196,633.00
Assessor Name: Eduardo Lopez
Date Created: 09/17/2015

Notes: The electrical services and distribution system consist of dry step down pad mounted transformer located in the main electrical room. This system has expired and will require upgrades.

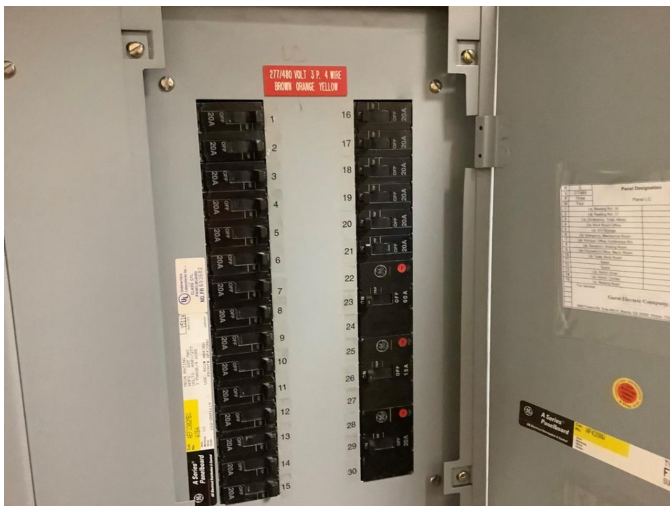
System: D5020 - Branch Wiring

Location: Throughout Building
Distress: Beyond Expected Life
Category: Deferred Maintenance
Priority: 3 - Necessary (Years 2-5)
Correction: Renew System
Qty: 70,101.00
Unit of Measure: S.F.
Estimate: \$390,182.00
Assessor Name: Eduardo Lopez
Date Created: 09/17/2015

Notes: The original 1994 branch wiring system is operational but is aged and should be replaced with an energy efficient system.

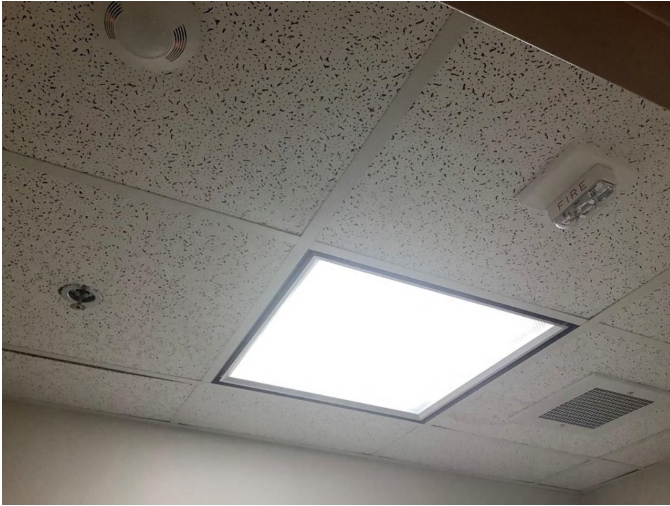
System: D5020 - Lighting

Location: Throughout building
Distress: Beyond Expected Life
Category: Deferred Maintenance
Priority: 3 - Necessary (Years 2-5)
Correction: Renew System
Qty: 70,101.00
Unit of Measure: S.F.
Estimate: \$584,502.00
Assessor Name: Eduardo Lopez
Date Created: 10/17/2019

Notes: This buildings lighting system consists of a T12 hanging four rack two and four foot florescent system. The upgrades have no records to indicate the date of the installation. With this in mind this system is recommended for universal upgrades based on condition and estimated age.

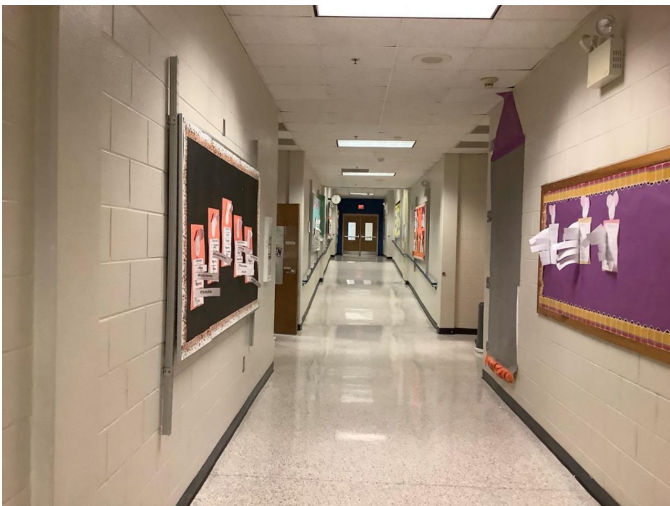
System: E2010 - Fixed Furnishings

Location: Throughout building
Distress: Beyond Expected Life
Category: Deferred Maintenance
Priority: 3 - Necessary (Years 2-5)
Correction: Renew System
Qty: 70,101.00
Unit of Measure: S.F.
Estimate: \$165,789.00
Assessor Name: Eduardo Lopez
Date Created: 09/17/2015

Notes: Fittings, such as toilet partitions, lockers, signage and railing, are beyond their expected service life, outdated and missing in areas, and should be replaced and upgraded.

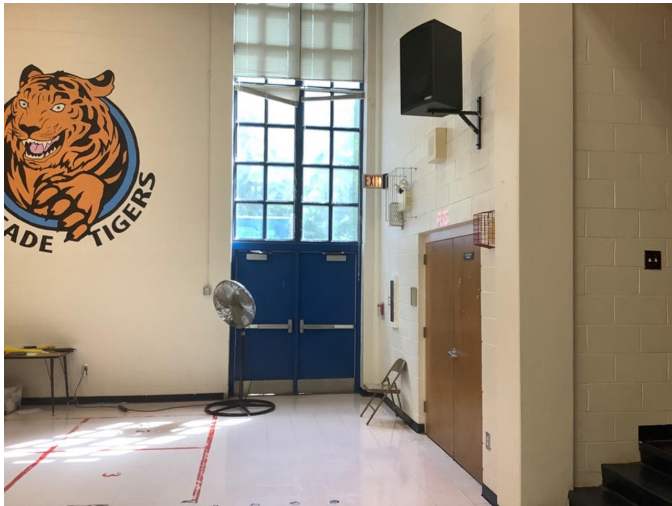
System: C3020903 - VCT

Location: Gym and Classrooms
Distress: Beyond Expected Life
Category: Deferred Maintenance
Priority: 4 - Recommended (Years 6-10)
Correction: Renew System
Qty: 27,101.00
Unit of Measure: S.F.
Estimate: \$146,183.00
Assessor Name: Eduardo Lopez
Date Created: 10/18/2019

Notes: The vinyl tile finish was installed in 1994 and is nearing the end of its useful life. This finish is recommended for upgrade based on life cycle.
