Atlanta Public Schools/Relocation Sites

Coan Middle School

School Assessment Report

November 10, 2020

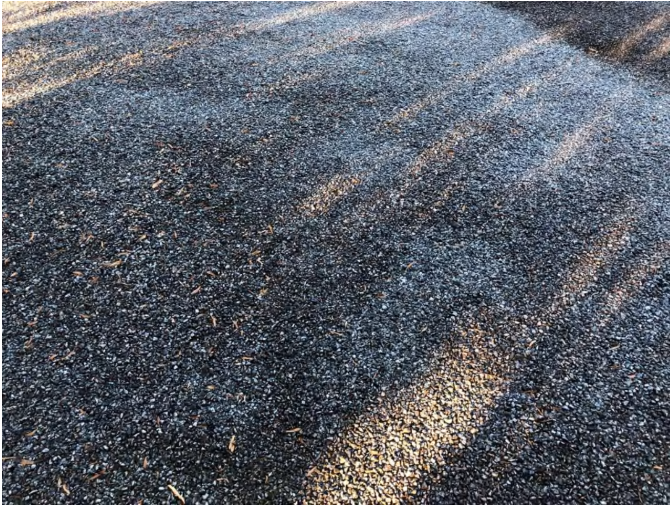
System: B3010105 - Built-Up

Location: Roof
Distress: Beyond Expected Life
Category: Deferred Maintenance
Priority: 3 - Necessary (Years 2-5)
Correction: Renew System
Qty: 167,169.00
Unit of Measure: S.F.
Estimate: \$1,876,556.00
Assessor Name: Eduardo Lopez
Date Created: 01/31/2020

Notes: The roof is original and beyond its service life and should be scheduled for replacement.

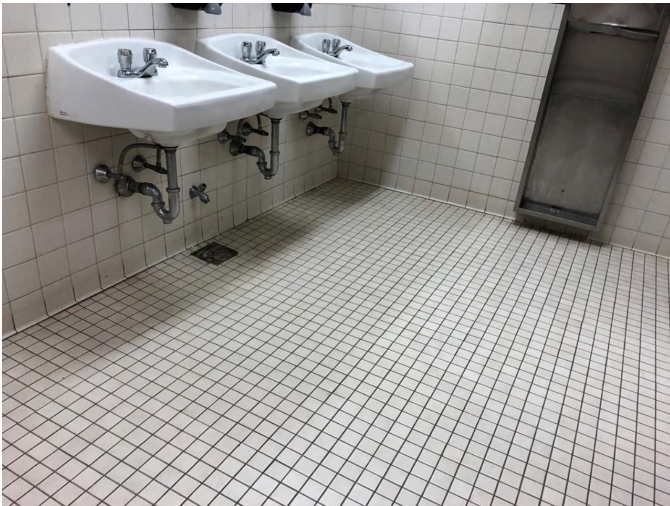
System: C3010220 - Tile

Location: Restroom
Distress: Beyond Expected Life
Category: Deferred Maintenance
Priority: 3 - Necessary (Years 2-5)
Correction: Renew System
Qty: 5,000.00
Unit of Measure: S.F.
Estimate: \$69,375.00
Assessor Name: Eduardo Lopez
Date Created: 01/25/2020

Notes: The ceramic tile floor finish is beyond its expected service life and should be replaced in conjunction with other recommended renovations.

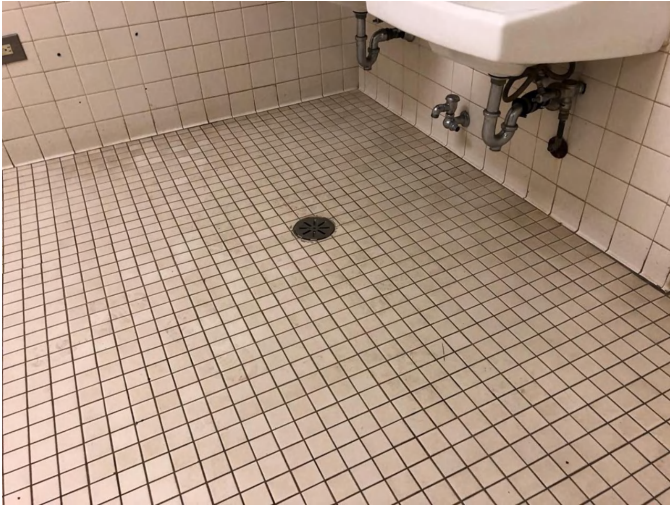
System: C3020420 - Ceramic Tile

Location: Restroom
Distress: Beyond Expected Life
Category: Deferred Maintenance
Priority: 3 - Necessary (Years 2-5)
Correction: Renew System
Qty: 10,000.00
Unit of Measure: S.F.
Estimate: \$251,100.00
Assessor Name: Eduardo Lopez
Date Created: 01/25/2020

Notes: The ceramic tile wall finish is beyond its expected service life, damaged and missing in areas, and should be replaced.

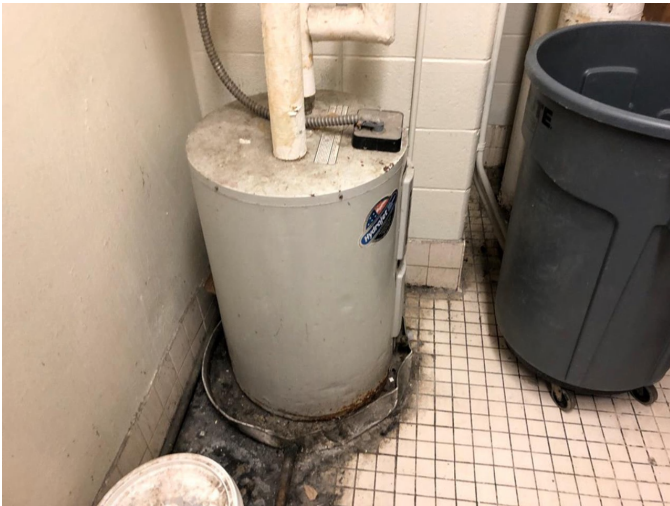
System: D2020 - Domestic Water Distribution

Location: Throughout building
Distress: Beyond Expected Life
Category: Deferred Maintenance
Priority: 3 - Necessary (Years 2-5)
Correction: Renew System
Qty: 167,169.00
Unit of Measure: S.F.
Estimate: \$132,398.00
Assessor Name: Eduardo Lopez
Date Created: 01/25/2020

Notes: The domestic water distribution system consists of galvanized and copper pipes, valves and domestic water supply. The system is beyond its expected life cycle and upgrades are recommended.

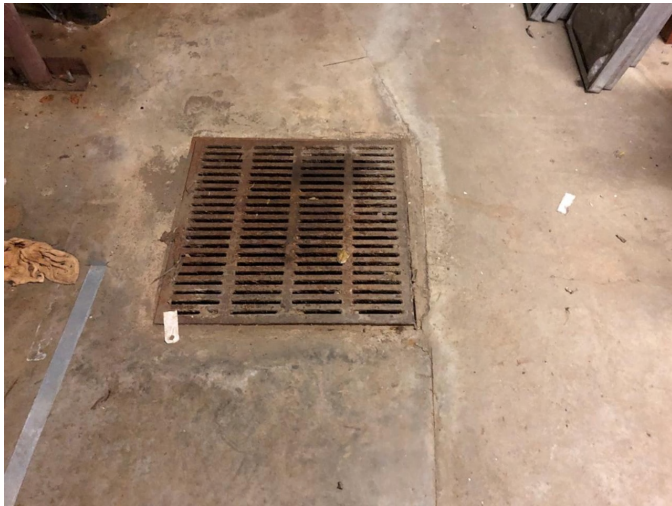
System: D2030 - Sanitary Waste

Location: Throughout building
Distress: Beyond Expected Life
Category: Deferred Maintenance
Priority: 3 - Necessary (Years 2-5)
Correction: Renew System
Qty: 167,169.00
Unit of Measure: S.F.
Estimate: \$316,284.00
Assessor Name: Eduardo Lopez
Date Created: 01/25/2020

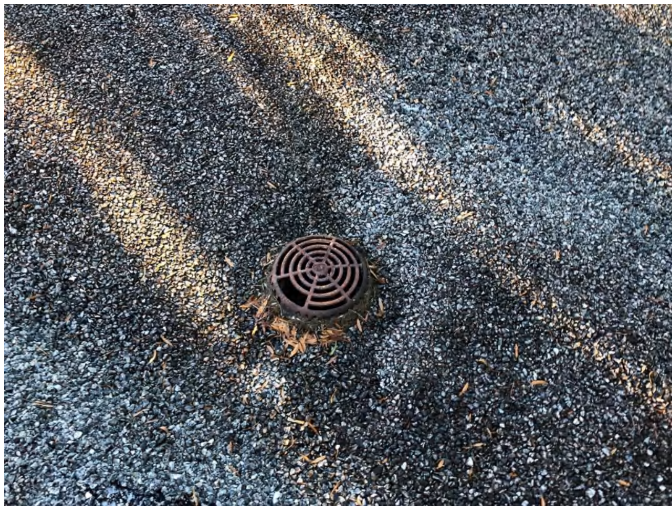
System: D2040 - Rain Water Drainage

Location: Roof
Distress: Beyond Expected Life
Category: Deferred Maintenance
Priority: 3 - Necessary (Years 2-5)
Correction: Renew System
Qty: 167,169.00
Unit of Measure: S.F.
Estimate: \$75,393.00
Assessor Name: Eduardo Lopez
Date Created: 01/25/2020

Notes: The roof drains, insulation and fittings that support the water run off from this roof are original. The insulation is damaged from leaks and the drains have developed leaks. This deficiency provides a budgetary consideration for a new rainwater drainage system. This is expected to be completed as part of an overall effort to upgrade the roof

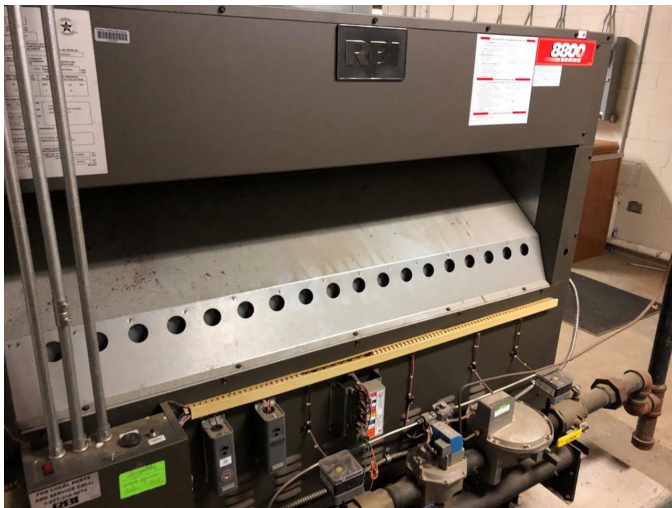
System: D3020 - Heat Generating Systems

Location: Throughout Building
Distress: Beyond Expected Life
Category: Deferred Maintenance
Priority: 3 - Necessary (Years 2-5)
Correction: Renew System
Qty: 167,169.00
Unit of Measure: S.F.
Estimate: \$665,667.00
Assessor Name: Eduardo Lopez
Date Created: 10/06/2020

Notes: The heating generating system is beyond expected service life and should be scheduled for replacement.

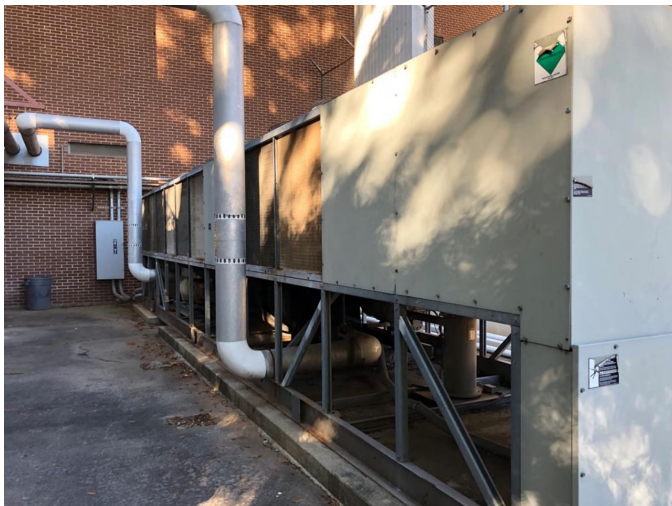
System: D3030 - Cooling Generating Systems

Location: Site
Distress: Beyond Expected Life
Category: Deferred Maintenance
Priority: 3 - Necessary (Years 2-5)
Correction: Renew System
Qty: 167,169.00
Unit of Measure: S.F.
Estimate: \$1,123,543.00
Assessor Name: Eduardo Lopez
Date Created: 10/06/2020

Notes: The cooling generating system is beyond expected service life and should be scheduled for replacement.

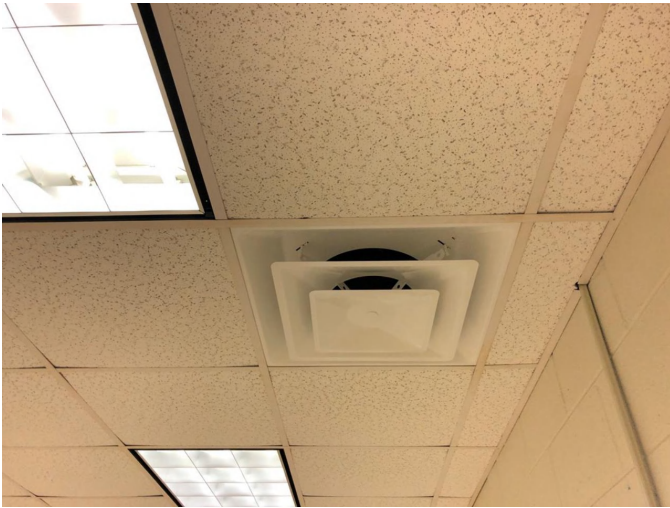
System: D3040 - Distribution Systems

Location: Throughout Building
Distress: Beyond Expected Life
Category: Deferred Maintenance
Priority: 3 - Necessary (Years 2-5)
Correction: Renew System
Qty: 167,169.00
Unit of Measure: S.F.
Estimate: \$2,929,302.00
Assessor Name: Eduardo Lopez
Date Created: 10/06/2020

Notes: The distribution system is beyond expected service life and should be scheduled for replacement.

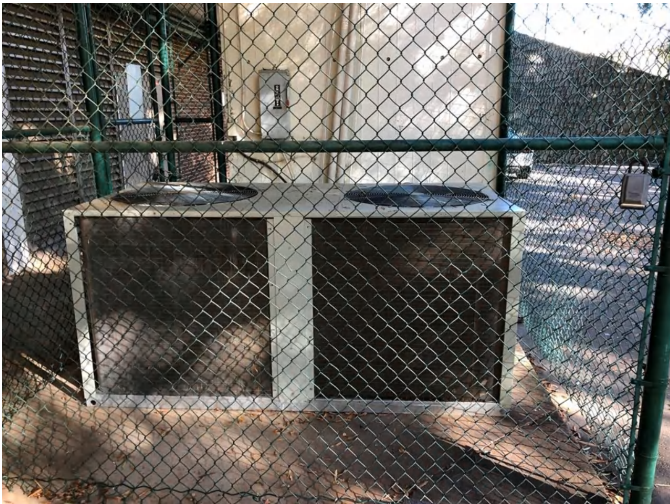
System: D3050 - Terminal & Package Units

Location: Throughout building
Distress: Beyond Expected Life
Category: Deferred Maintenance
Priority: 3 - Necessary (Years 2-5)
Correction: Renew System
Qty: 167,169.00
Unit of Measure: S.F.
Estimate: \$2,394,194.00
Assessor Name: Eduardo Lopez
Date Created: 09/28/2019

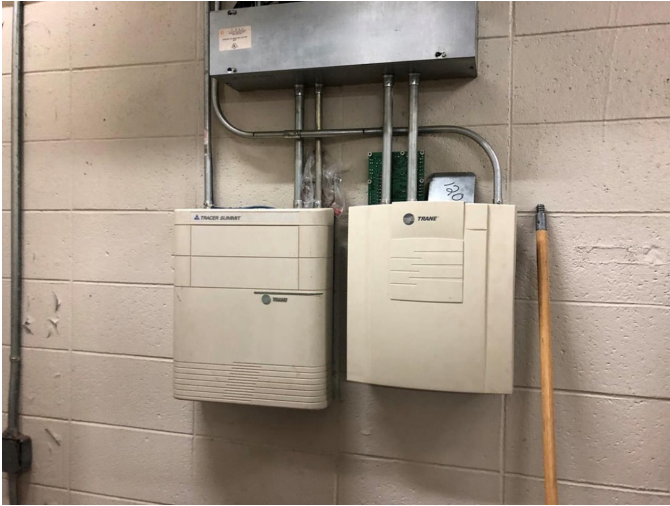
System: D3060 - Controls & Instrumentation

Location: Throughout building
Distress: Beyond Expected Life
Category: Deferred Maintenance
Priority: 3 - Necessary (Years 2-5)
Correction: Renew System
Qty: 167,169.00
Unit of Measure: S.F.
Estimate: \$406,388.00
Assessor Name: Eduardo Lopez
Date Created: 09/28/2019

Notes: The heating generation systems, exhaust and ventilation systems, energy monitoring and controls as well as the building automation systems are original. Several issues have surfaced over recent years and isolated upgrades have taken place to support the systems. This deficiency provides a budgetary consideration for a universal upgrade.

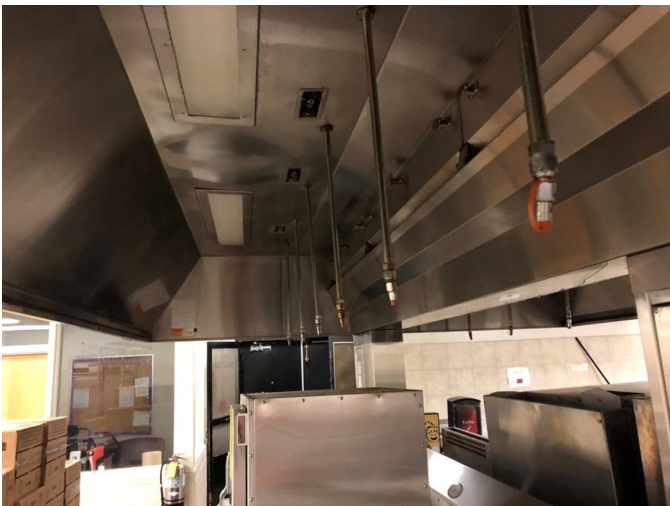
System: D4090 - Other Fire Protection Systems

Location: Kitchen
Distress: Beyond Expected Life
Category: Deferred Maintenance
Priority: 3 - Necessary (Years 2-5)
Correction: Renew System
Qty: 167,169.00
Unit of Measure: S.F.
Estimate: \$112,170.00
Assessor Name: Eduardo Lopez
Date Created: 09/28/2019

Notes: The exhaust hood system is original. This building high traffic use warrants upgrades to this system based on usage and age. This deficiency provides a budgetary consideration for universal upgrades to the system.

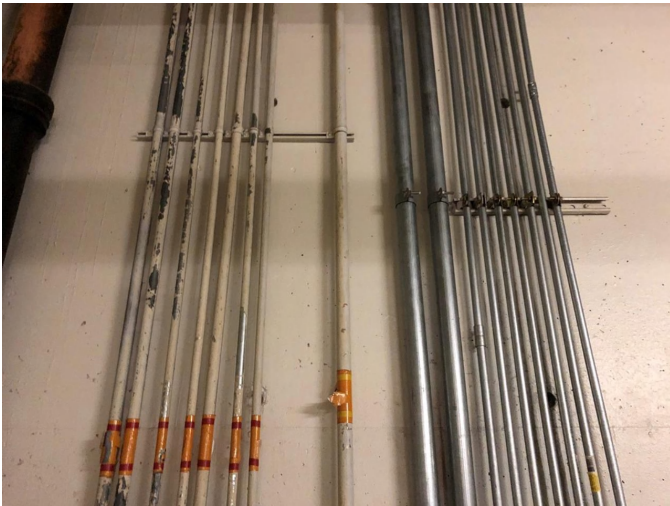
System: D5020 - Branch Wiring

Location: Throughout building
Distress: Beyond Expected Life
Category: Deferred Maintenance
Priority: 3 - Necessary (Years 2-5)
Correction: Renew System
Qty: 167,169.00
Unit of Measure: S.F.
Estimate: \$875,297.00
Assessor Name: Eduardo Lopez
Date Created: 09/17/2015

Notes: The branch wiring system is operational but is aged and should be replaced with an energy efficient system.

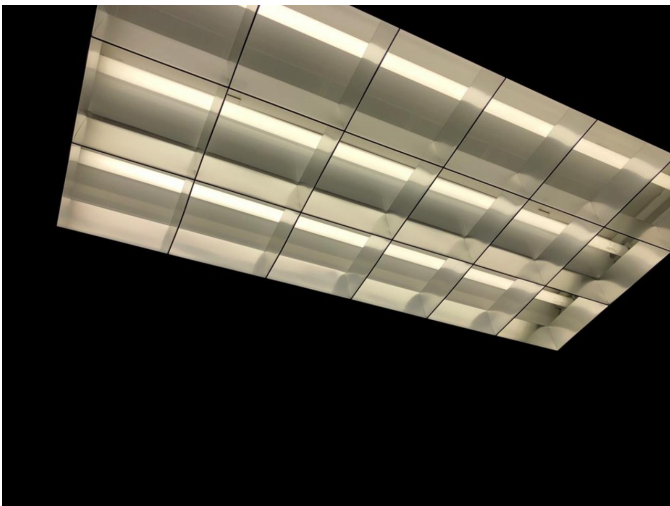
System: D5020 - Lighting

Location: Throughout building
Distress: Beyond Expected Life
Category: Deferred Maintenance
Priority: 3 - Necessary (Years 2-5)
Correction: Renew System
Qty: 167,169.00
Unit of Measure: S.F.
Estimate: \$1,314,784.00
Assessor Name: Eduardo Lopez
Date Created: 12/16/2019

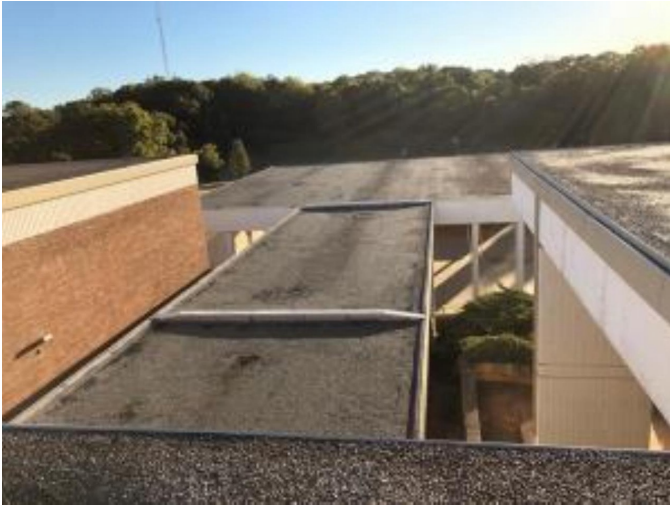
System: B3010105 - Built-Up

Location: Roof
Distress: Beyond Expected Life
Category: Deferred Maintenance
Priority: 3 - Necessary (Years 2-5)
Correction: Renew System
Qty: 15,500.00
Unit of Measure: S.F.
Estimate: \$173,995.00
Assessor Name: Homero Guerrero
Date Created: 01/25/2020

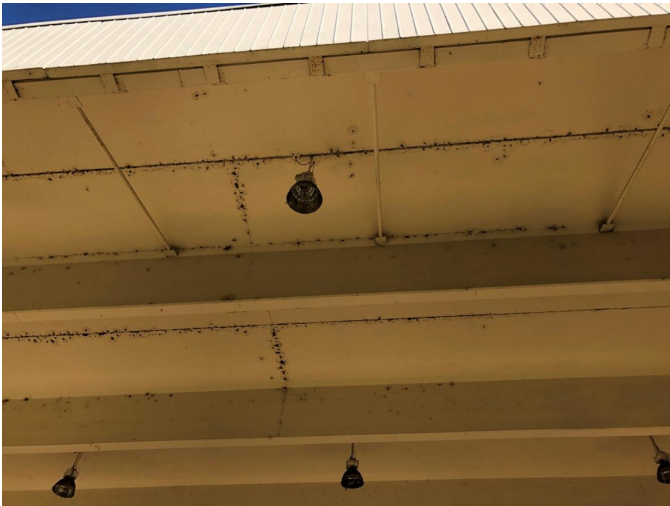
System: C3030 - Ceiling Finishes

Location: Throughout building
Distress: Beyond Expected Life
Category: Deferred Maintenance
Priority: 3 - Necessary (Years 2-5)
Correction: Renew System
Qty: 15,500.00
Unit of Measure: S.F.
Estimate: \$26,939.00
Assessor Name: Homero Guerrero
Date Created: 01/25/2020

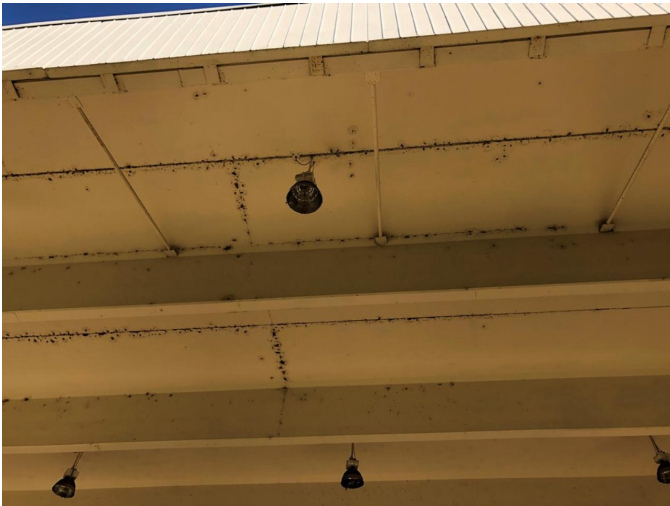
System: D5020 - Lighting

Location: Throughout building
Distress: Beyond Expected Life
Category: Deferred Maintenance
Priority: 3 - Necessary (Years 2-5)
Correction: Renew System
Qty: 15,500.00
Unit of Measure: S.F.
Estimate: \$59,846.00
Assessor Name: Homero Guerrero
Date Created: 01/25/2020

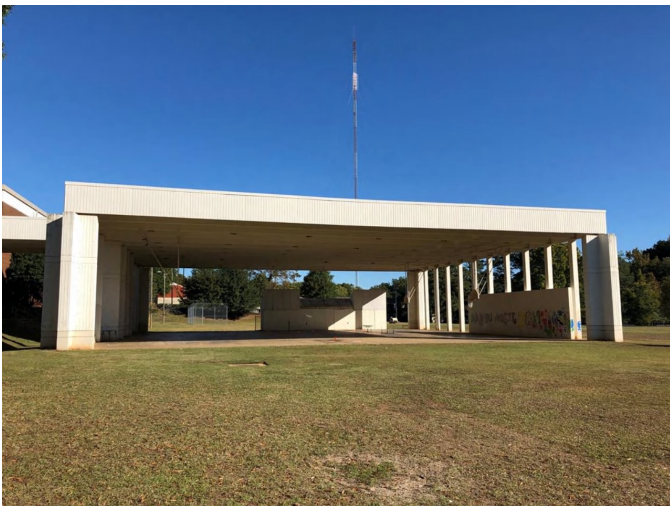
System: E1090 - Other Equipment

Location: Throughout building
Distress: Beyond Expected Life
Category: Deferred Maintenance
Priority: 3 - Necessary (Years 2-5)
Correction: Renew System
Qty: 15,500.00
Unit of Measure: S.F.
Estimate: \$4,433.00
Assessor Name: Homero Guerrero
Date Created: 01/25/2020

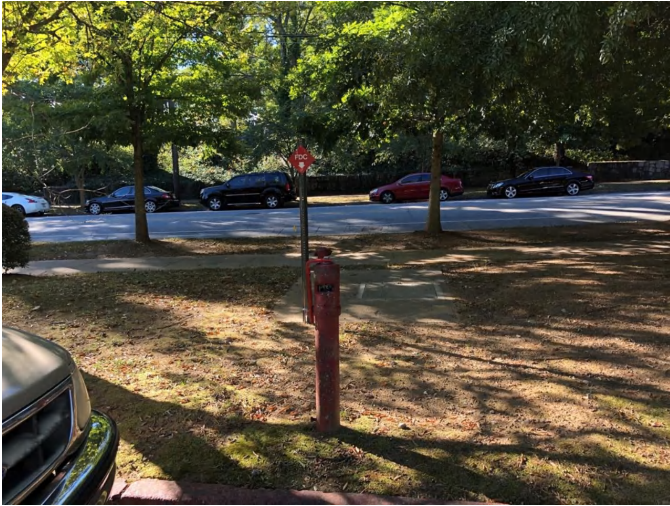
System: G3010 - Water Supply

Location: Site
Distress: Beyond Expected Life
Category: Deferred Maintenance
Priority: 3 - Necessary (Years 2-5)
Correction: Renew System
Qty: 182,669.00
Unit of Measure: S.F.
Estimate: \$219,020.00
Assessor Name: Hayden Collins
Date Created: 01/25/2020

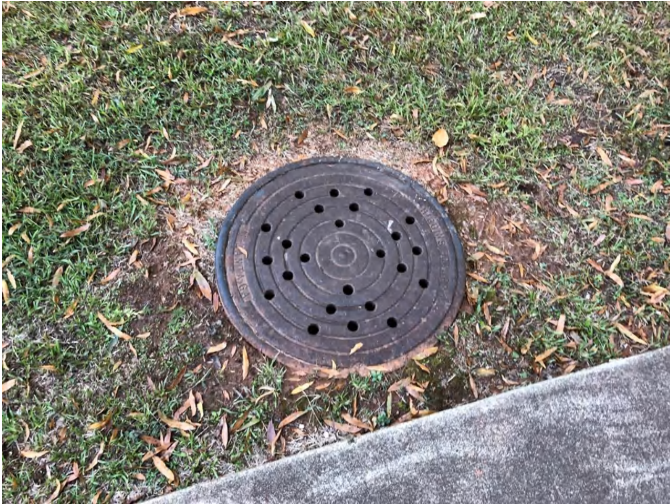
System: G3020 - Sanitary Sewer

Location: Site
Distress: Beyond Expected Life
Category: Deferred Maintenance
Priority: 3 - Necessary (Years 2-5)
Correction: Renew System
Qty: 182,669.00
Unit of Measure: S.F.
Estimate: \$442,059.00
Assessor Name: Hayden Collins
Date Created: 01/25/2020

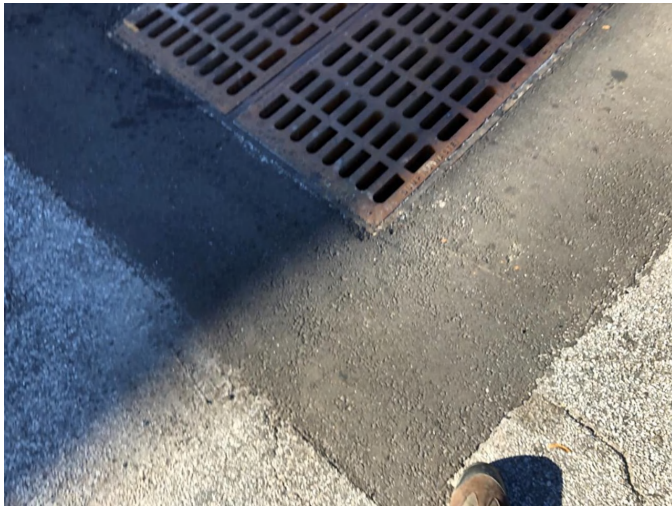
System: G3030 - Storm Sewer

Location: Site
Distress: Beyond Expected Life
Category: Deferred Maintenance
Priority: 3 - Necessary (Years 2-5)
Correction: Renew System
Qty: 182,669.00
Unit of Measure: S.F.
Estimate: \$251,170.00
Assessor Name: Hayden Collins
Date Created: 01/25/2020
