Atlanta Public Schools/ Therrell Cluster

Continental Colony Elementary School

School Assessment Report

November 10, 2020

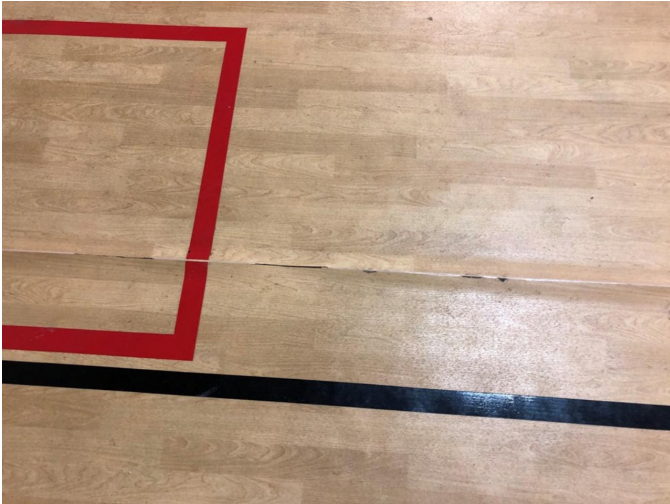
System: C3020999 - Other - Rubber or Neoprene

Location: Gym
Distress: Beyond Expected Life
Category: Deferred Maintenance
Priority: 1 - Critical Immediate Need
Correction: Renew System
Qty: 5,691.00
Unit of Measure: S.F.
Estimate: \$166,957.00
Assessor Name: Jejuan Hall
Date Created: 02/07/2020

Notes: The Neoprene/Rubber floor finish is beyond its expected service life, worn and damaged, and is recommended for replacement.
