# School Assessment Report

School: Cook ES (Wesley International Academy)

Report: Nov 17, 2015

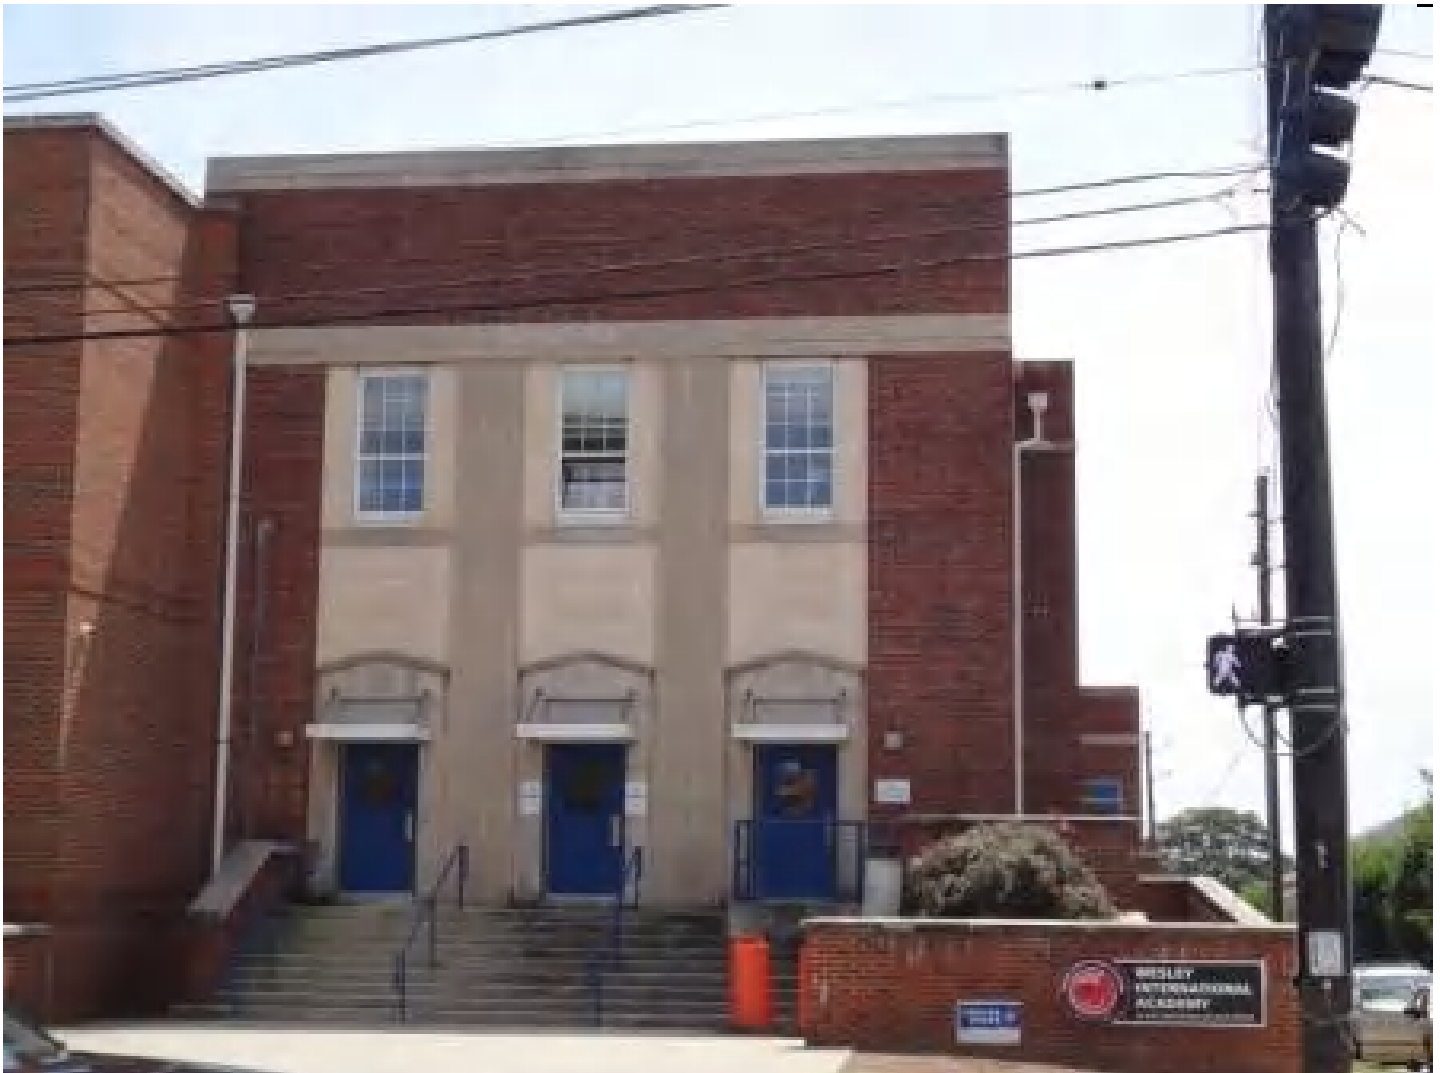
The superstructure is concrete frame. Floor construction is slab on-grade. Roof construction is a concrete pan joist system. The exterior enclosure is comprised of brick veneer over CMU. Exterior windows are aluminum frame with fixed and operable panes. Exterior doors are painted hollow metal mostly with glazing. Roofing is comprised of low slope with built-up coverings. The roof is in mostly good condition, but is aging in place.

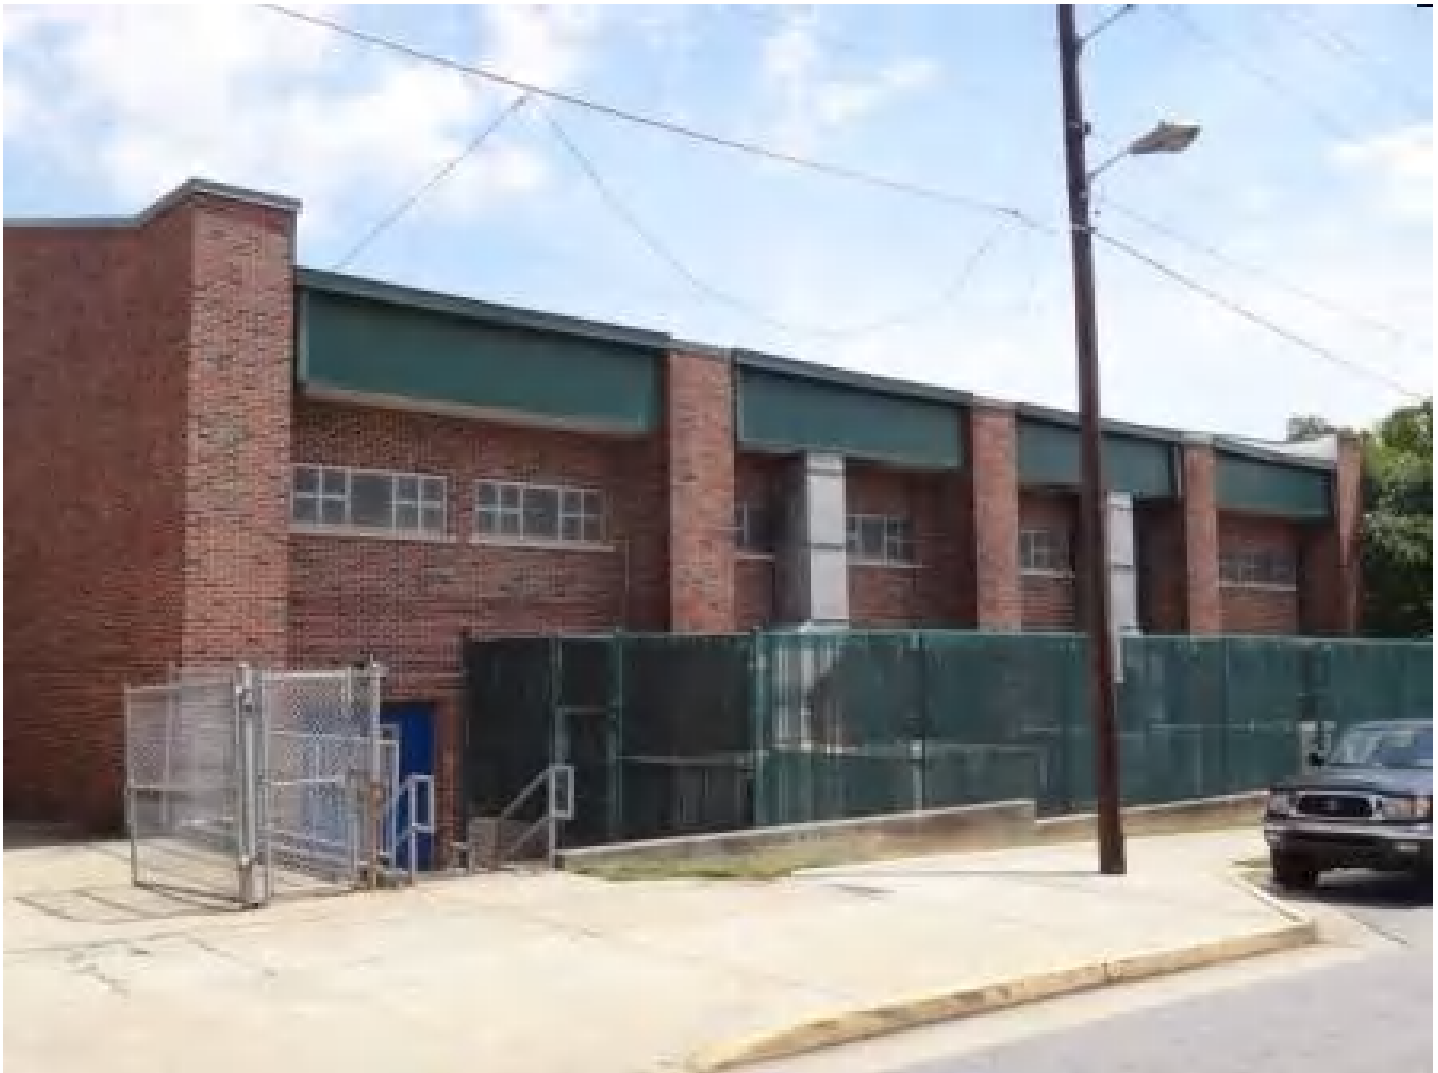
The superstructure is steel frame with load bearing CMU. Floor construction is slab on-grade. Roof construction is steel. The exterior enclosure is comprised of walls with brick veneer over CMU. Exterior windows are aluminum frame with fixed and operable panes. Exterior doors are both painted hollow metal and aluminum framed with glazing. Roofing is sloped with metal roof coverings. The roof is in good condition with no reported leaks.

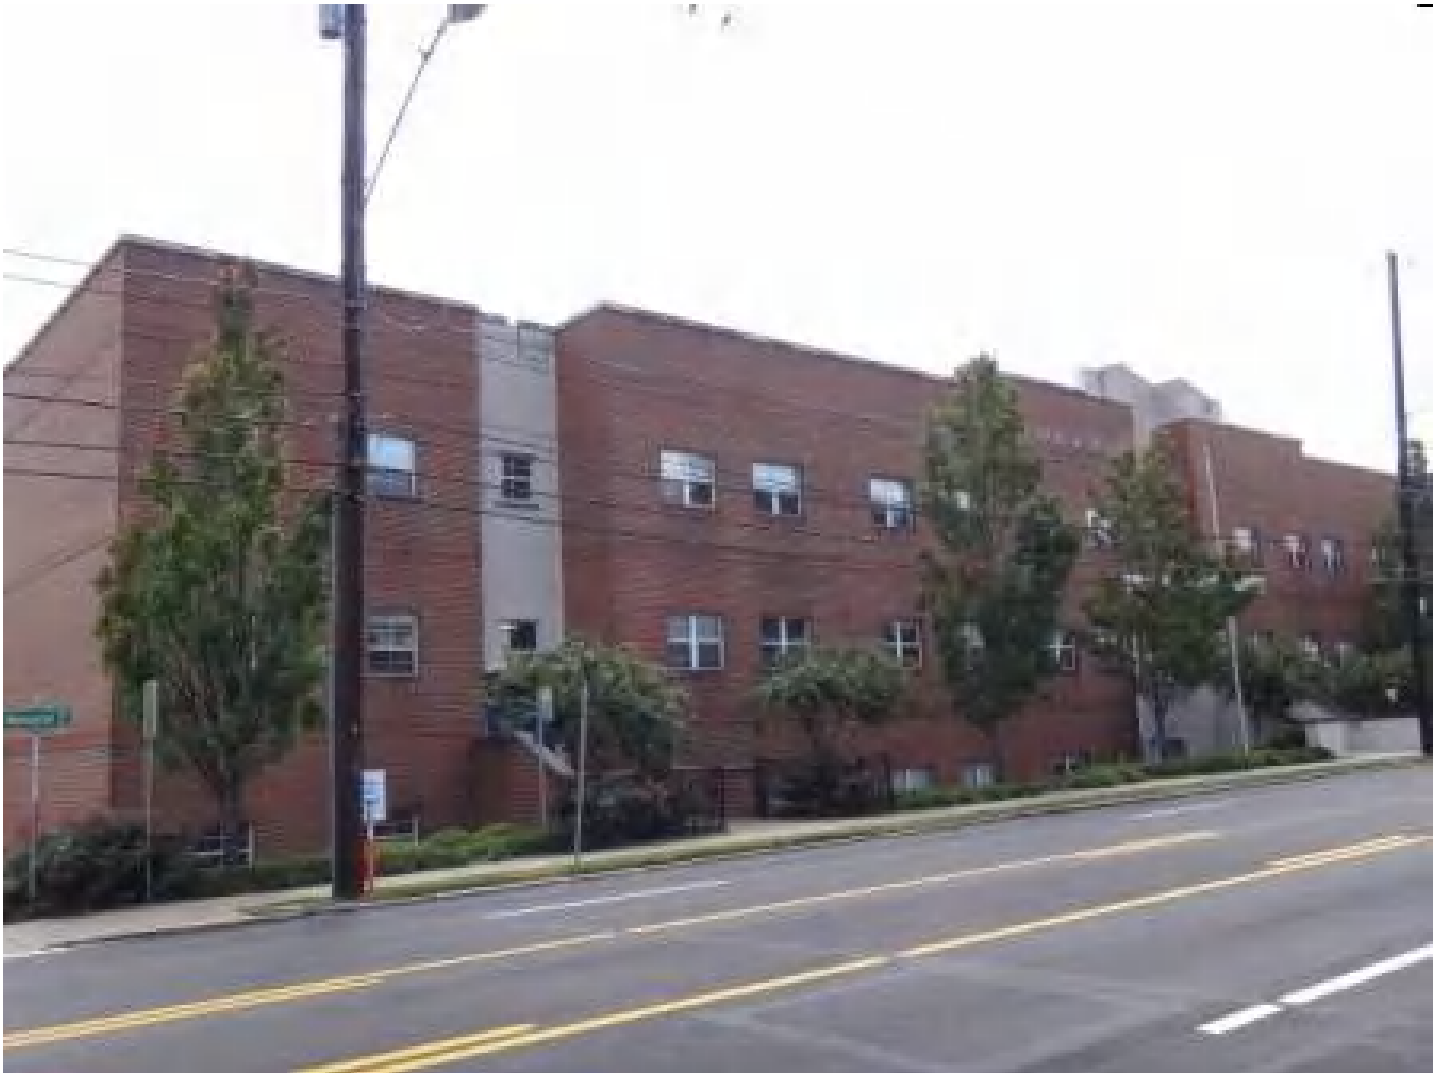
The superstructure is steel frame with load bearing CMU. Floor construction is slab on-grade. Roof construction is steel. The exterior enclosure is comprised of walls with brick veneer over CMU. Exterior windows are aluminum frame with fixed and operable panes. Exterior doors are both painted hollow metal and aluminum framed with glazing. Roofing is comprised of low slope with built-up coverings. The roof is in mostly good condition with no reported leaks.

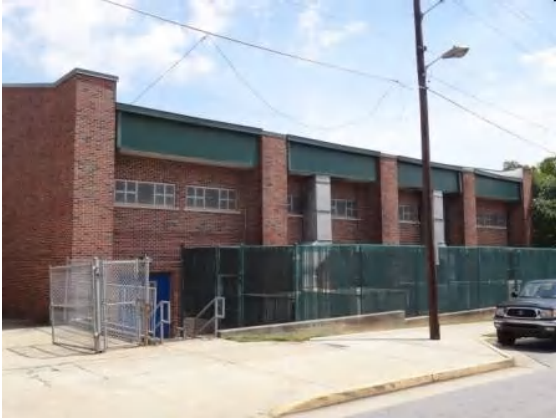
**Analysis:** The system is in use and functioning with an estimated remaining service life as indicated in the report section "Condition/Replacement Budget Detail". The system was installed in 1994. It has a 50-year service life. However, in the assessment, it was found to be currently deficient.

Location: Site

**Recomm.:** The system should be replaced.
