Atlanta Public Schools/ Jackson Cluster

Crim HS -Phoenix Academy

School Assessment Report

November 10, 2020

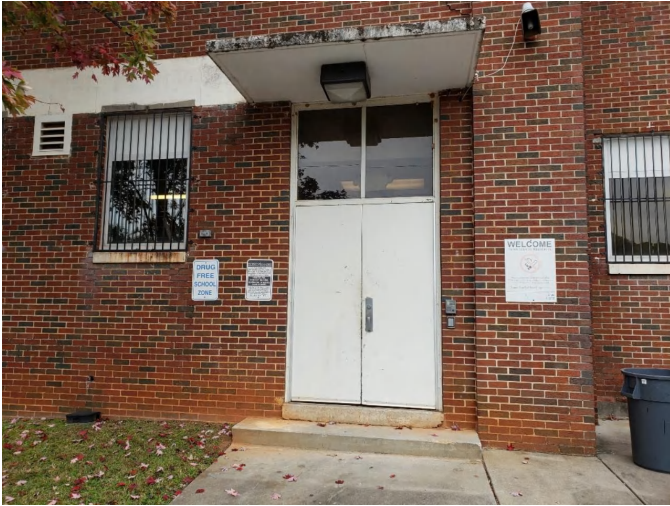
System: B2030 - Exterior Doors

Location: Exterior Walls
Distress: Beyond Expected Life
Category: ADA Compliance
Priority: 3 - Necessary (Years 2-5)
Correction: Renew System
Qty: 149,792.00
Unit of Measure: S.F.
Estimate: \$135,112.00
Assessor Name: Hayden Collins
Date Created: 02/17/2020

Notes: The exterior doors are a combination of wooden and metal applications with metal or wood frames. The exterior door system for this facility is a very high traffic secure system. The doors are aging at a faster rate than expected based on traffic and condition. The exterior door system and service doors are recommended for upgrade.

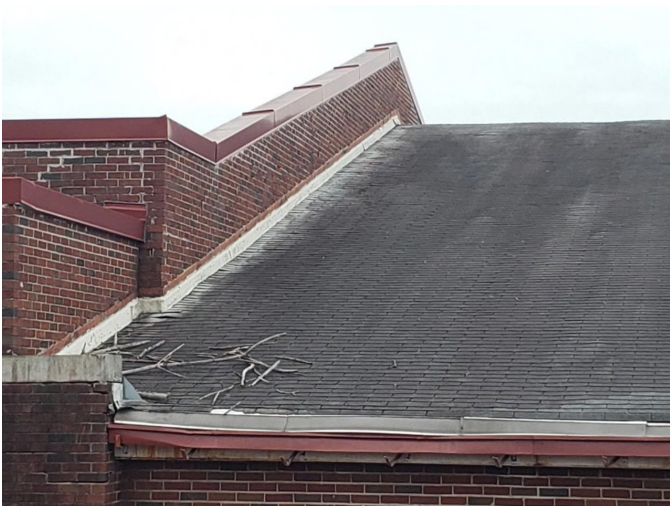
System: B3010120 - Single Ply Membrane

Location: Roof
Distress: Beyond Expected Life
Category: Deferred Maintenance
Priority: 3 - Necessary (Years 2-5)
Correction: Renew System
Qty: 12,272.00
Unit of Measure: S.F.
Estimate: \$114,667.00
Assessor Name: Jejuan Hall
Date Created: 02/05/2020

Notes: The roofing system with asphalt shingles was reported to be original to the buildings construction. This system has exceeded its expected life cycle and is recommended for replacement.

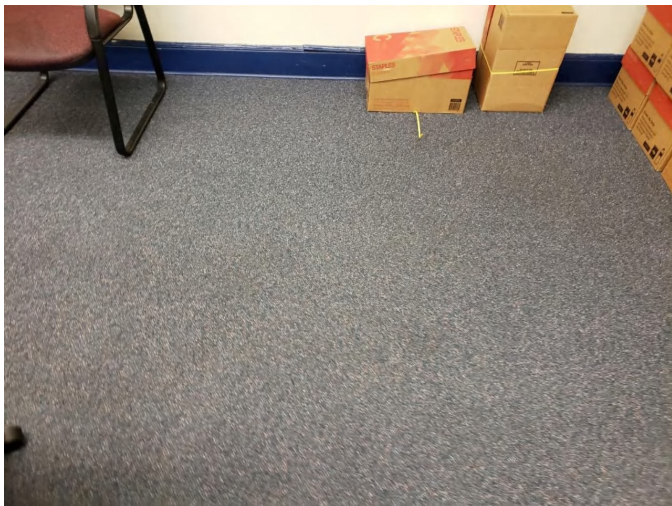
System: C3020901 - Carpet

Location: Throughout Building
Distress: Beyond Expected Life
Category: Deferred Maintenance
Priority: 3 - Necessary (Years 2-5)
Correction: Renew System
Qty: 6,520.00
Unit of Measure: S.F.
Estimate: \$53,790.00
Assessor Name: Jejuan Hall
Date Created: 02/17/2020

Notes: Some office areas has been replaced. However, other areas are still beyond service life and should be replaced,

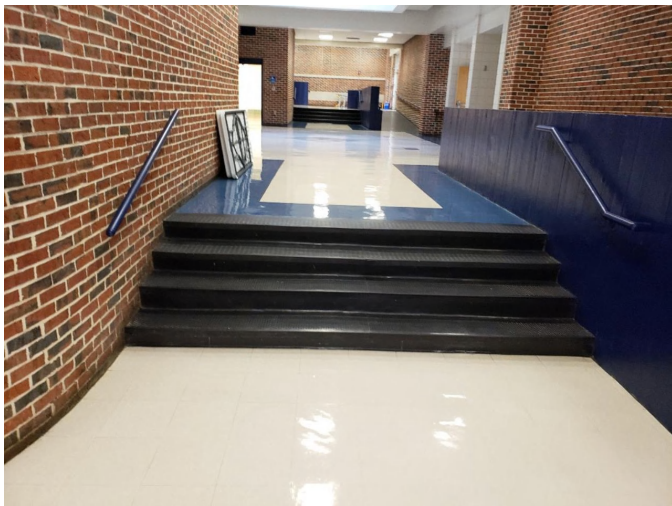
System: C3020999 - Other - Rubber or Neoprene

Location: Stairs
Distress: Beyond Expected Life
Category: Deferred Maintenance
Priority: 3 - Necessary (Years 2-5)
Correction: Renew System
Qty: 1,245.00
Unit of Measure: S.F.
Estimate: \$36,525.00
Assessor Name: Jejuan Hall
Date Created: 02/05/2020

Notes: The Rubber or Neoprene floor finish is beyond its expected service life, worn and damaged, and is recommended for replacement.

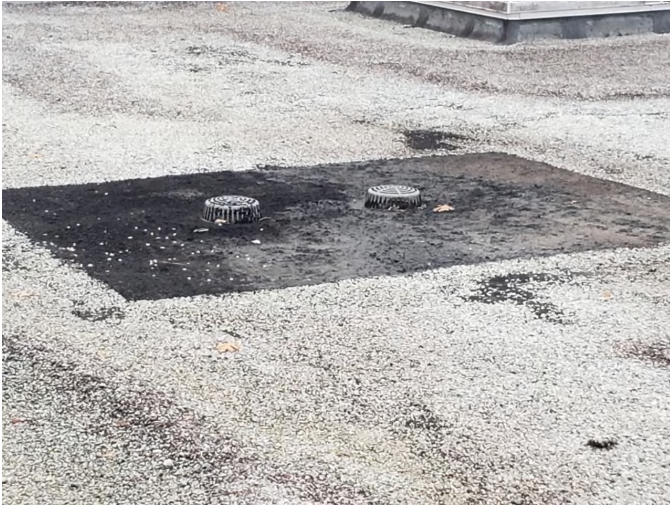
System: D2040 - Rain Water Drainage

Location: Roof
Distress: Beyond Expected Life
Category: Deferred Maintenance
Priority: 3 - Necessary (Years 2-5)
Correction: Renew System
Qty: 149,792.00
Unit of Measure: S.F.
Estimate: \$74,147.00
Assessor Name: Jejuan Hall
Date Created: 08/13/2014

Notes: The roof drains, insulation and fittings that support the water run off from this roof are in poor condition. The insulation is damaged from leaks and the drains have developed leaks. This deficiency provides a budgetary consideration for a new rainwater drainage system.

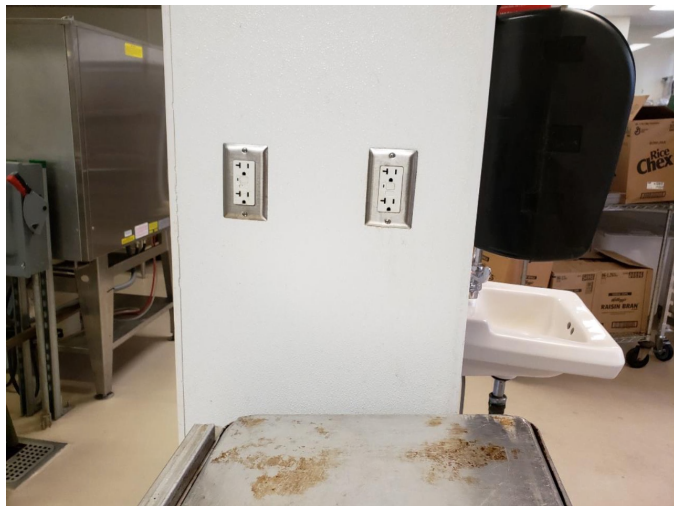
System: D5020 - Branch Wiring

Location: Electrical Room
Distress: Beyond Expected Life
Category: Deferred Maintenance
Priority: 3 - Necessary (Years 2-5)
Correction: Renew System
Qty: 149,792.00
Unit of Measure: S.F.
Estimate: \$782,663.00
Assessor Name: Jejuan Hall
Date Created: 01/30/2020

Notes: Most of the branch wire system appears to be from the original construction. The age conditions warrant upgrades.

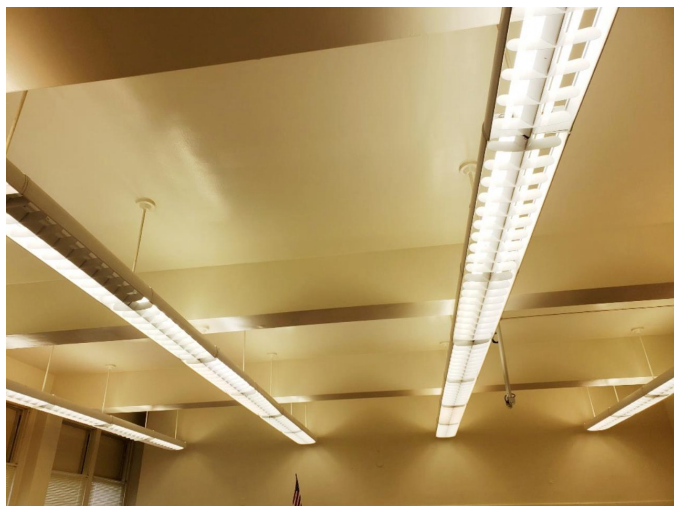
System: D5020 - Lighting

Location: Throughout Building
Distress: Beyond Expected Life
Category: Deferred Maintenance
Priority: 3 - Necessary (Years 2-5)
Correction: Renew System
Qty: 149,792.00
Unit of Measure: S.F.
Estimate: \$1,174,819.00
Assessor Name: Jejuan Hall
Date Created: 02/17/2020

Notes: Most of the lighting system appears to be beyond expected service life. The age conditions warrant upgrades.

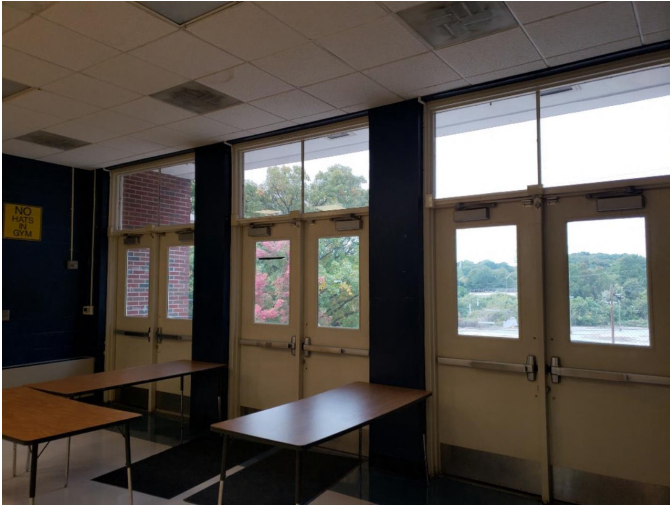
System: D5020 - Lighting

Location: Exit Doors
Distress: Missing
Category: Code Compliance
Priority: 3 - Necessary (Years 2-5)
Correction: Replace and/or add Exit Light fixtures w/wiring
Qty: 6.00
Unit of Measure: Ea.
Estimate: \$4,444.20
Assessor Name: Jejuan Hall
Date Created: 02/17/2020

Notes: Emergency exit lights are missing in Exit doors and should be provided.

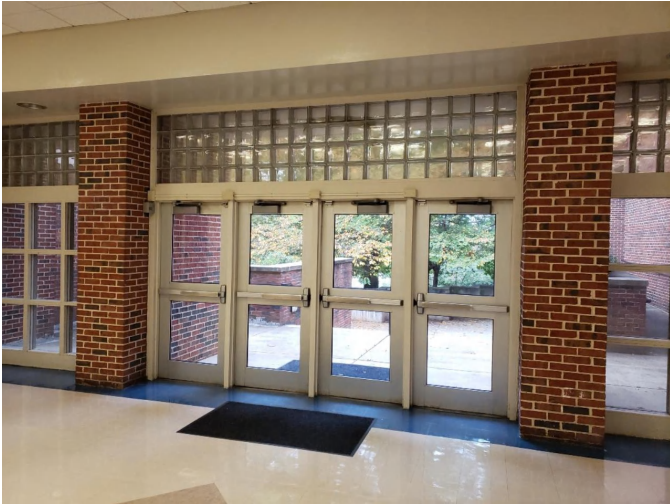
System: D5020 - Lighting

Location: Exit Doors
Distress: Missing
Category: Code Compliance
Priority: 1 - Critical Immediate Need
Correction: Replace and/or add Exit Light fixtures w/wiring
Qty: 6.00
Unit of Measure: Ea.
Estimate: \$4,444.20
Assessor Name: Eduardo Lopez
Date Created: 02/17/2020

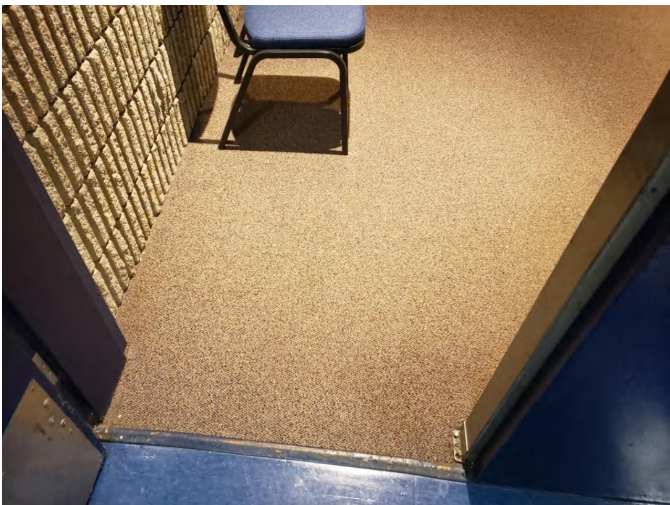
System: C3020901 - Carpet

Location: Throughout Building
Distress: Beyond Expected Life
Category: Deferred Maintenance
Priority: 3 - Necessary (Years 2-5)
Correction: Renew System
Qty: 27,910.00
Unit of Measure: S.F.
Estimate: \$230,258.00
Assessor Name: Eduardo Lopez
Date Created: 02/17/2020

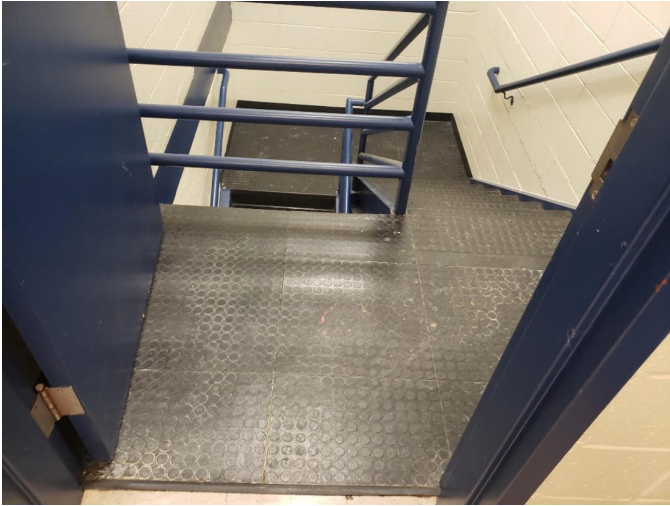
System: C3020999 - Other - Rubber or Neoprene

Location: Stairs
Distress: Beyond Expected Life
Category: Deferred Maintenance
Priority: 3 - Necessary (Years 2-5)
Correction: Renew System
Qty: 610.00
Unit of Measure: S.F.
Estimate: \$17,896.00
Assessor Name: Eduardo Lopez
Date Created: 01/31/2020

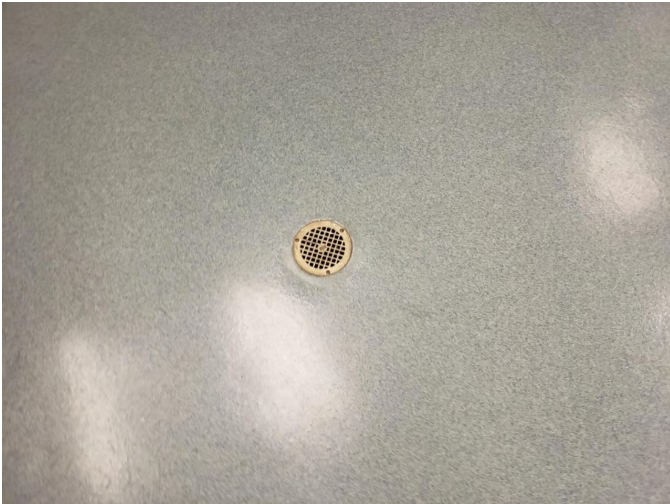
System: D2030 - Sanitary Waste

Location: Throughout Building
Distress: Beyond Expected Life
Category: Deferred Maintenance
Priority: 3 - Necessary (Years 2-5)
Correction: Renew System
Qty: 54,150.00
Unit of Measure: S.F.
Estimate: \$111,982.00
Assessor Name: Eduardo Lopez
Date Created: 10/01/2019

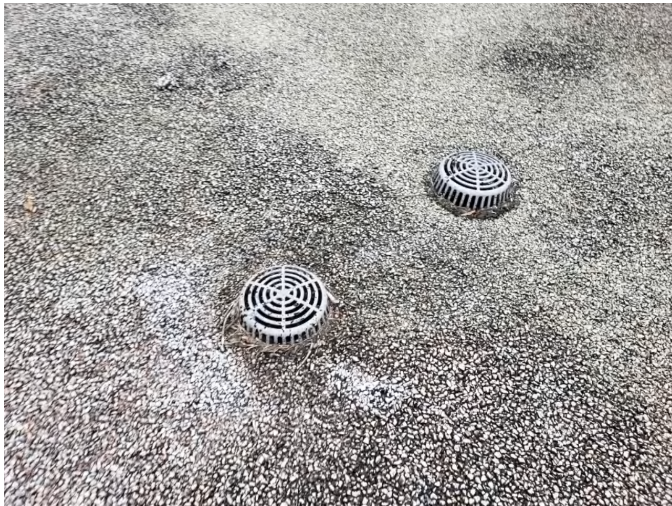
System: D2040 - Rain Water Drainage

Location: Roof
Distress: Beyond Expected Life
Category: Deferred Maintenance
Priority: 3 - Necessary (Years 2-5)
Correction: Renew System
Qty: 54,150.00
Unit of Measure: S.F.
Estimate: \$29,783.00
Assessor Name: Eduardo Lopez
Date Created: 08/13/2014

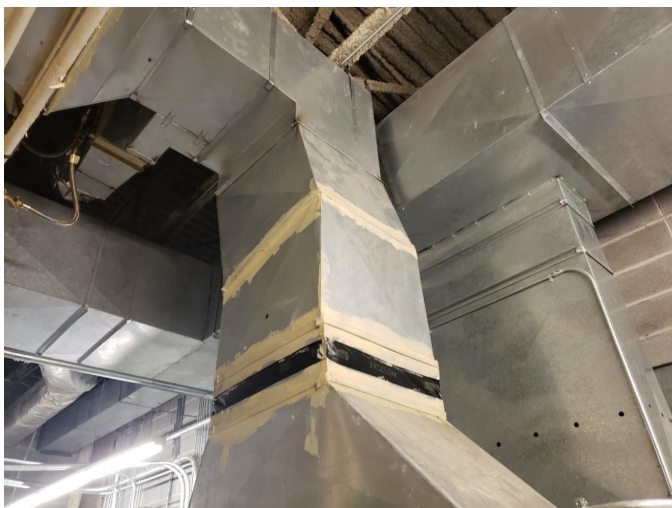
System: D3040 - Distribution Systems

Location: Throughout Building
Distress: Beyond Expected Life
Category: Deferred Maintenance
Priority: 3 - Necessary (Years 2-5)
Correction: Renew System
Qty: 54,150.00
Unit of Measure: S.F.
Estimate: \$695,719.00
Assessor Name: Eduardo Lopez
Date Created: 08/13/2014

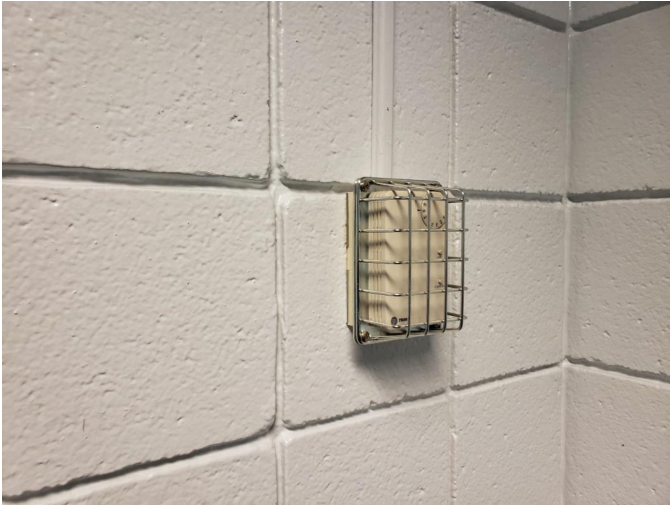
System: D3060 - Controls & Instrumentation

Location: Throughout Building
Distress: Beyond Expected Life
Category: Deferred Maintenance
Priority: 3 - Necessary (Years 2-5)
Correction: Renew System
Qty: 54,150.00
Unit of Measure: S.F.
Estimate: \$144,147.00
Assessor Name: Eduardo Lopez
Date Created: 08/05/2013

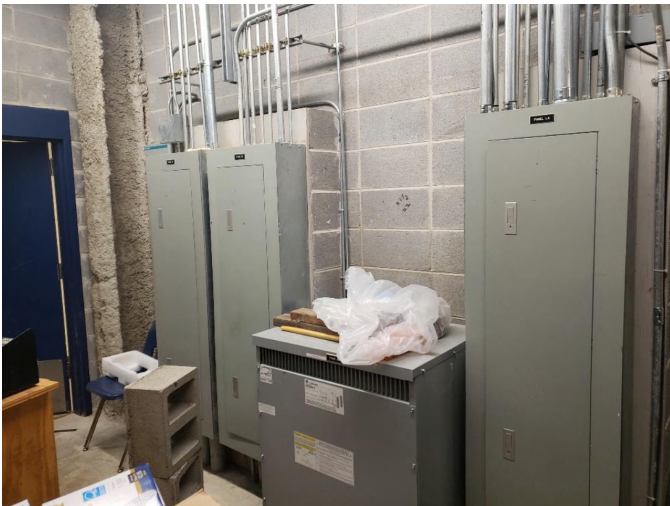
System: D5020 - Branch Wiring

Location: Electrical Room
Distress: Beyond Expected Life
Category: Deferred Maintenance
Priority: 3 - Necessary (Years 2-5)
Correction: Renew System
Qty: 54,150.00
Unit of Measure: S.F.
Estimate: \$309,738.00
Assessor Name: Eduardo Lopez
Date Created: 08/13/2014

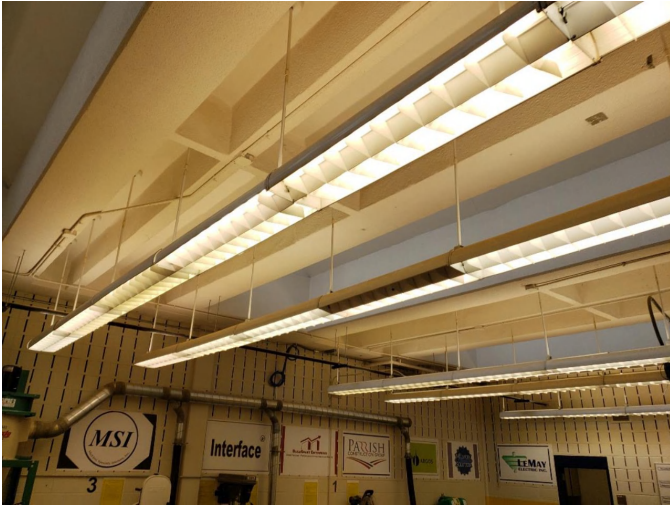
System: D5020 - Lighting

Location: Throughout Building
Distress: Beyond Expected Life
Category: Deferred Maintenance
Priority: 3 - Necessary (Years 2-5)
Correction: Renew System
Qty: 54,150.00
Unit of Measure: S.F.
Estimate: \$464,607.00
Assessor Name: Eduardo Lopez
Date Created: 01/30/2020

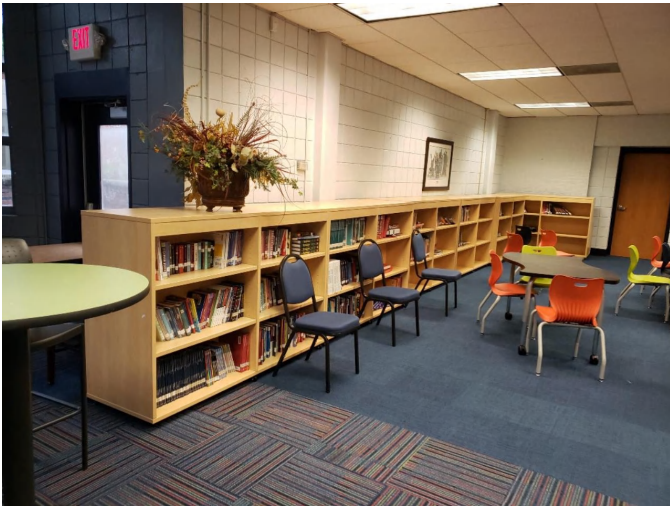
System: E1090 - Other Equipment

Location: Media Center
Distress: Beyond Expected Life
Category: Deferred Maintenance
Priority: 3 - Necessary (Years 2-5)
Correction: Renew System
Qty: 54,150.00
Unit of Measure: S.F.
Estimate: \$64,926.00
Assessor Name: Eduardo Lopez
Date Created: 09/17/2015

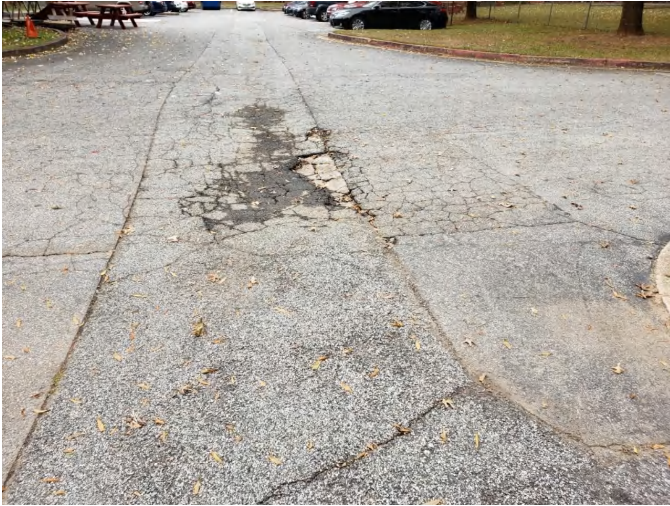
System: G2010 - Roadways

Location: Roadway, Northeast
Distress: Damaged
Category: Deferred Maintenance
Priority: 2 - Trending Critical (Year 1)
Correction: Replace or resurface asphalt paving 20ft wide X 4"
Qty: 500.00
Unit of Measure: L.F.
Estimate: \$92,674.89
Assessor Name: Eduardo Lopez
Date Created: 02/17/2020

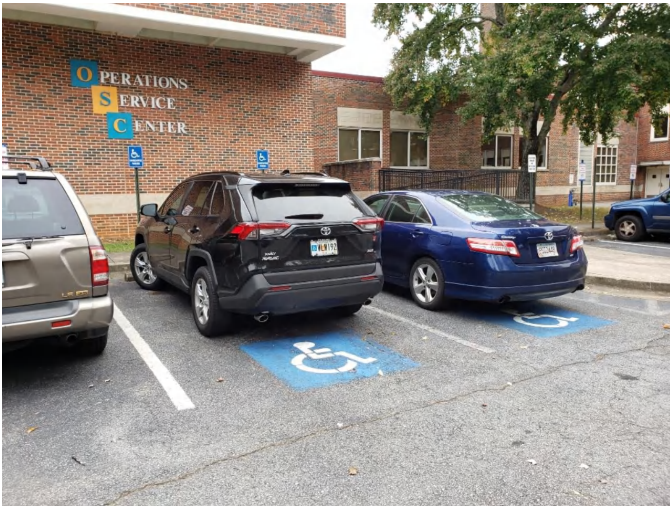
System: G2020 - Parking Lots

Location: ADA Parking
Distress: Missing
Category: ADA Compliance
Priority: 2 - Trending Critical (Year 1)
Correction: Add handicap parking space, incl. pavement markings, sign and post
Qty: 2.00
Unit of Measure: Ea.
Estimate: \$1,037.27
Assessor Name: Hayden Collins
Date Created: 02/17/2020

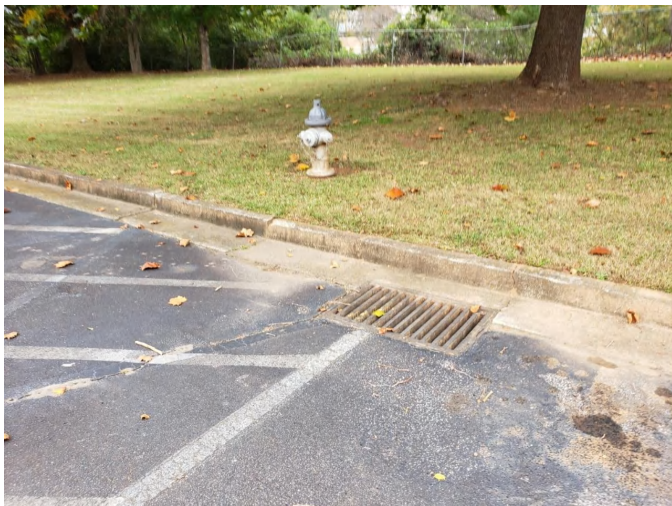
System: G3010 - Water Supply

Location: Site
Distress: Beyond Expected Life
Category: Deferred Maintenance
Priority: 3 - Necessary (Years 2-5)
Correction: Renew System
Qty: 203,942.00
Unit of Measure: S.F.
Estimate: \$244,526.00
Assessor Name: Eduardo Lopez
Date Created: 09/17/2015

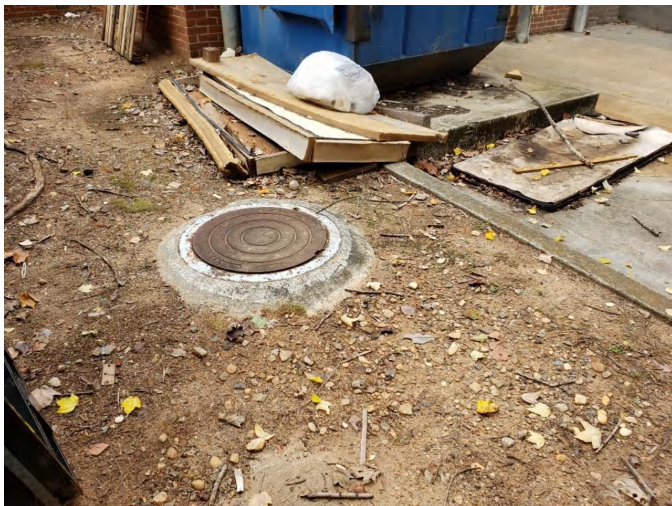
Location: Site
Distress: Beyond Expected Life
Category: Deferred Maintenance
Priority: 3 - Necessary (Years 2-5)
Correction: Renew System
Qty: 203,942.00
Unit of Measure: S.F.
Estimate: \$493,540.00
Assessor Name: Eduardo Lopez
Date Created: 09/17/2015

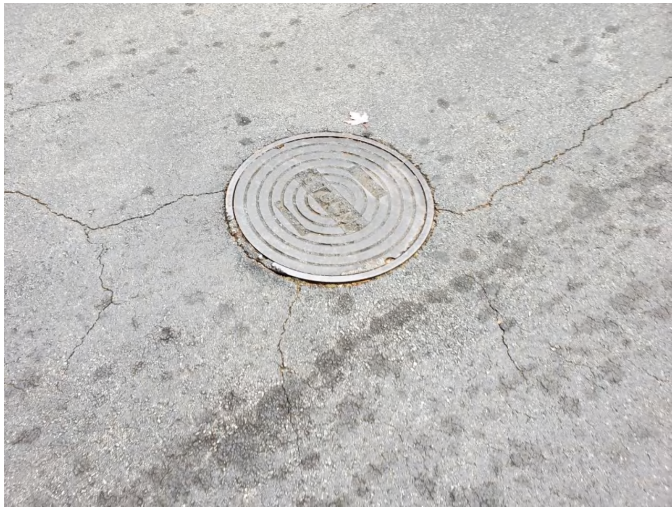
Location: Site
Distress: Beyond Expected Life
Category: Deferred Maintenance
Priority: 3 - Necessary (Years 2-5)
Correction: Renew System
Qty: 203,942.00
Unit of Measure: S.F.
Estimate: \$280,420.00
Assessor Name: Eduardo Lopez
Date Created: 09/17/2015
