Atlanta Public Schools/ Douglass Cluster

Douglass High School

School Assessment Report

November 10, 2020

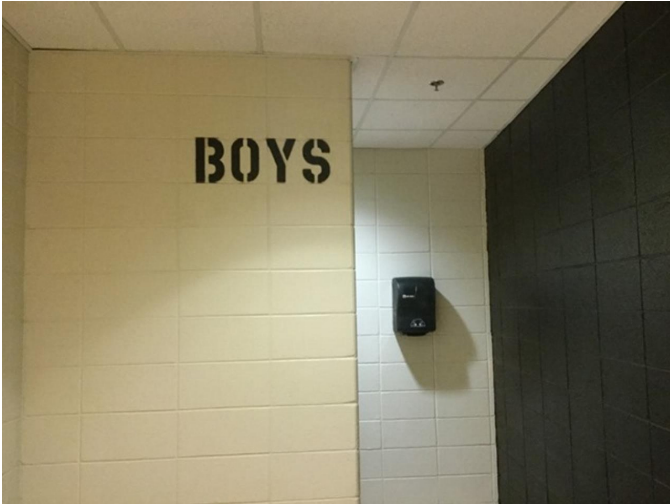
System: C1030 - Fittings

Location: Throughout building
Distress: Inadequate
Category: ADA Compliance
Priority: 3 - Necessary (Years 2-5)
Correction: Replace missing or damaged signage - insert the number of rooms
Qty: 200.00
Unit of Measure: Ea.
Estimate: \$37,183.29
Assessor Name: Eduardo Lopez
Date Created: 10/30/2019

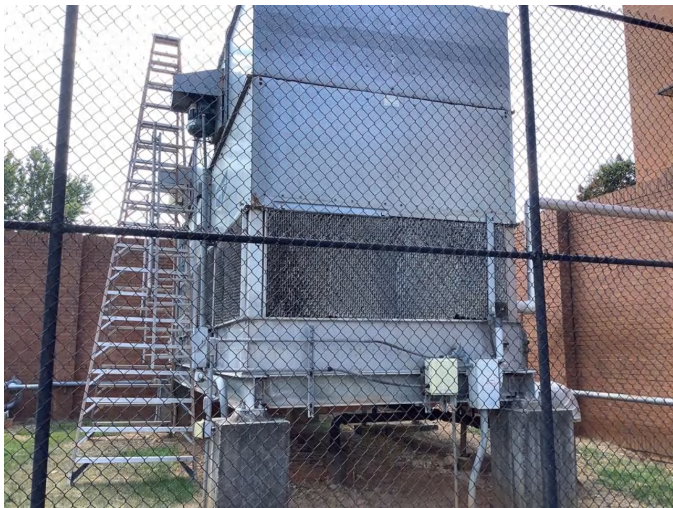
System: D3030 - Cooling Generating Systems

Location: Site
Distress: Beyond Expected Life
Category: Deferred Maintenance
Priority: 3 - Necessary (Years 2-5)
Correction: Renew System
Qty: 202,611.00
Unit of Measure: S.F.
Estimate: \$1,223,568.00
Assessor Name: Eduardo Lopez
Date Created: 10/06/2020

Notes: The cooling generating system is beyond its expected service life and should be scheduled for replacement.

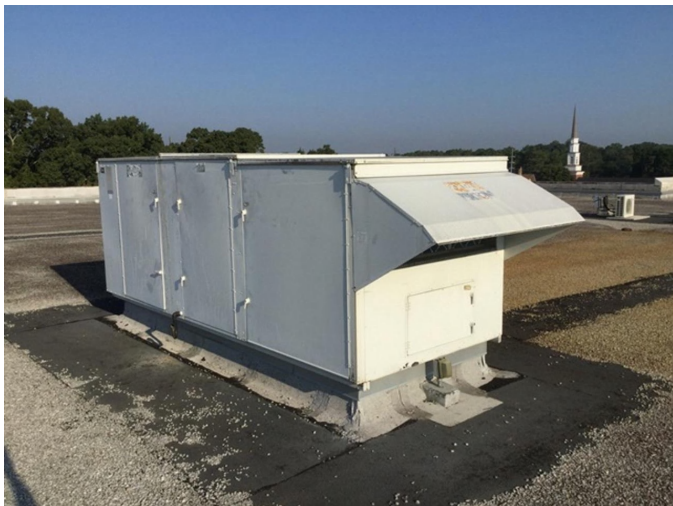
System: D3050 - Terminal & Package Units

Location: Roof
Distress: Beyond Expected Life
Category: Deferred Maintenance
Priority: 3 - Necessary (Years 2-5)
Correction: Renew System
Qty: 202,611.00
Unit of Measure: S.F.
Estimate: \$2,612,061.00
Assessor Name: Eduardo Lopez
Date Created: 10/01/2019

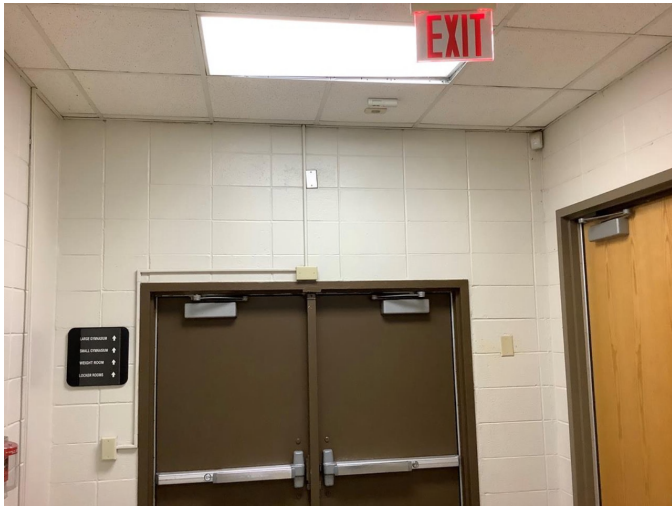
System: D3060 - Controls & Instrumentation

Location: Throughout building
Distress: Beyond Expected Life
Category: Deferred Maintenance
Priority: 3 - Necessary (Years 2-5)
Correction: Renew System
Qty: 202,611.00
Unit of Measure: S.F.
Estimate: \$528,207.00
Assessor Name: Eduardo Lopez
Date Created: 10/01/2019

Notes: The controls as well as the building automation systems were partially upgraded in 2004. Several issues have surfaced over recent years and isolated upgrades have taken place to support the systems. However, this system has exceeded its expected life cycle and upgrades are warranted. This deficiency provides a budgetary consideration for a universal upgrade.

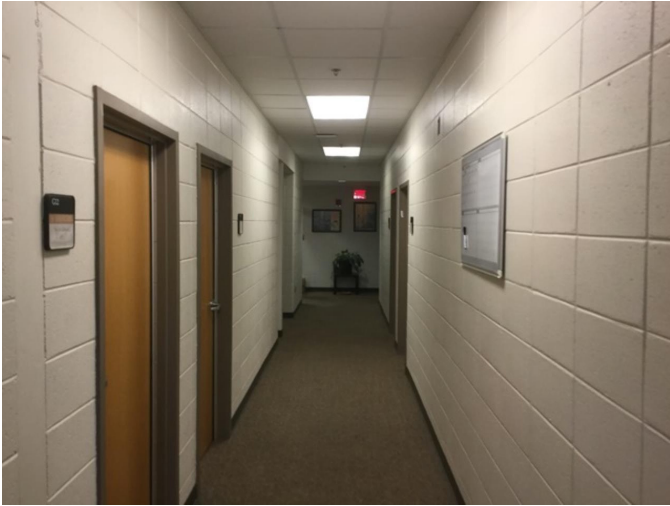
System: C3020901 - Carpet

Location: Throughout building
Distress: Beyond Expected Life
Category: Deferred Maintenance
Priority: 3 - Necessary (Years 2-5)
Correction: Renew System
Qty: 10,000.00
Unit of Measure: S.F.
Estimate: \$82,500.00
Assessor Name: Jejuan Hall
Date Created: 10/29/2019

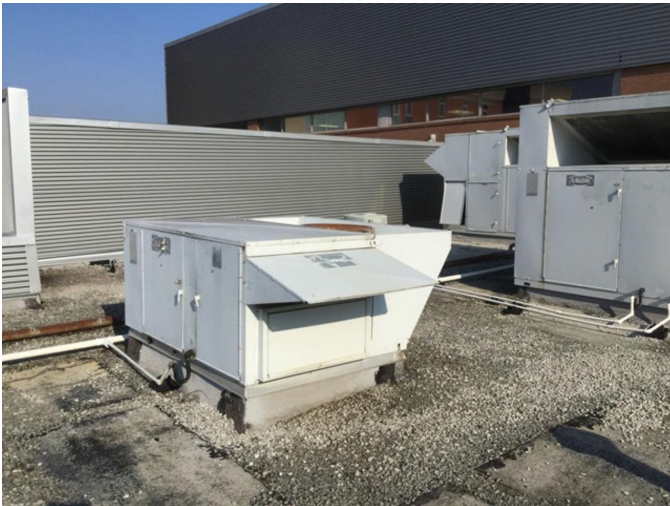
System: D3050 - Terminal & Package Units

Location: Roof
Distress: Beyond Expected Life
Category: Deferred Maintenance
Priority: 3 - Necessary (Years 2-5)
Correction: Renew System
Qty: 27,097.00
Unit of Measure: S.F.
Estimate: \$489,724.00
Assessor Name: Jejuan Hall
Date Created: 10/01/2019

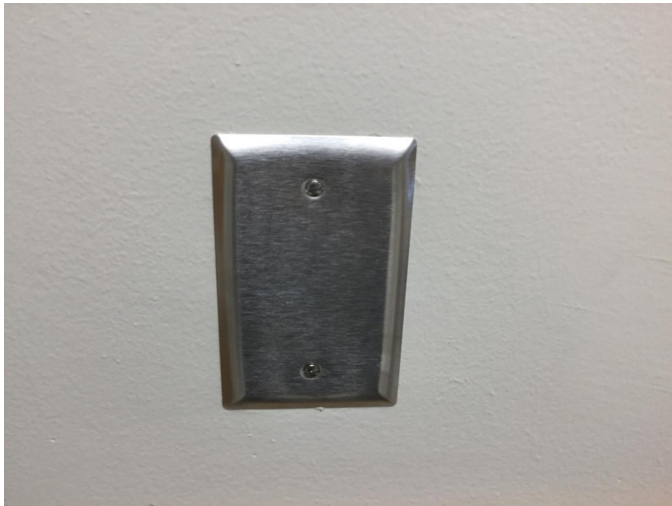
System: D3060 - Controls & Instrumentation

Location: Throughout building
Distress: Beyond Expected Life
Category: Deferred Maintenance
Priority: 3 - Necessary (Years 2-5)
Correction: Renew System
Qty: 27,097.00
Unit of Measure: S.F.
Estimate: \$70,940.00
Assessor Name: Jejuan Hall
Date Created: 10/01/2019

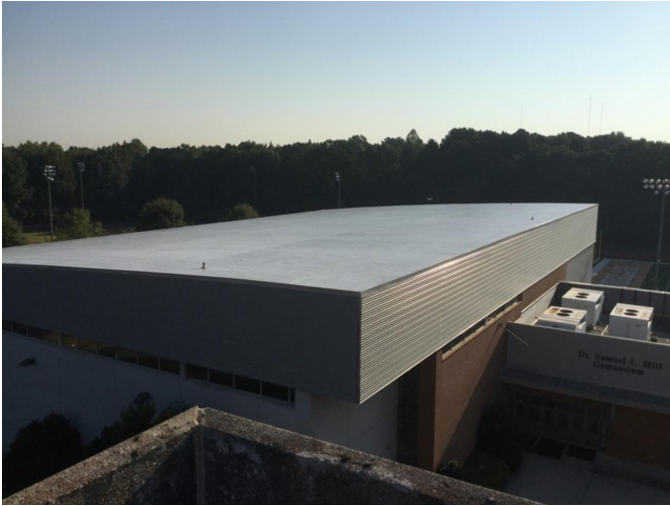
System: B3010120 - Single Ply Membrane

Location: Roof
Distress: Beyond Expected Life
Category: Deferred Maintenance
Priority: 3 - Necessary (Years 2-5)
Correction: Renew System
Qty: 53,495.00
Unit of Measure: S.F.
Estimate: \$499,847.00
Assessor Name: Jejuan Hall
Date Created: 10/29/2019

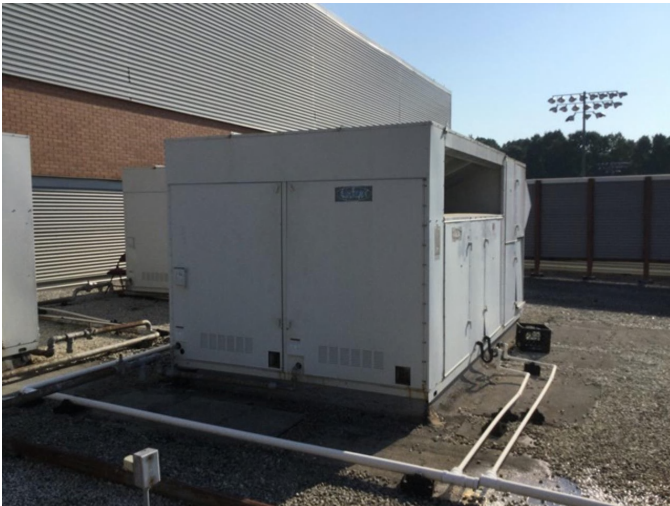
System: D3050 - Terminal & Package Units

Location: Roof
Distress: Beyond Expected Life
Category: Deferred Maintenance
Priority: 3 - Necessary (Years 2-5)
Correction: Renew System
Qty: 53,495.00
Unit of Measure: S.F.
Estimate: \$1,052,140.00
Assessor Name: Jejuan Hall
Date Created: 10/01/2019

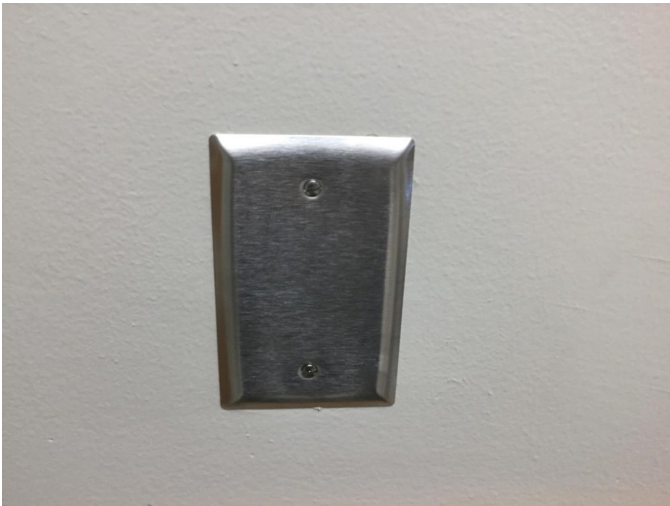
System: D3060 - Controls & Instrumentation

Location: Throughout building
Distress: Beyond Expected Life
Category: Deferred Maintenance
Priority: 3 - Necessary (Years 2-5)
Correction: Renew System
Qty: 53,495.00
Unit of Measure: S.F.
Estimate: \$140,638.00
Assessor Name: Jejuan Hall
Date Created: 10/01/2019

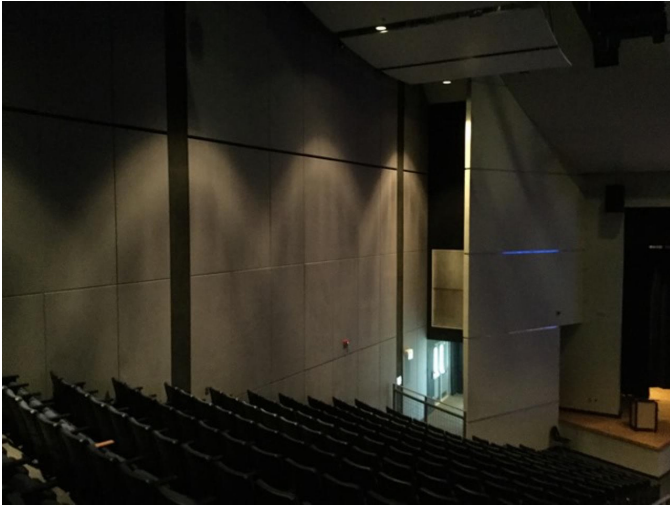
System: C3020901 - Carpet

Location: Auditorium
Distress: Beyond Expected Life
Category: Deferred Maintenance
Priority: 3 - Necessary (Years 2-5)
Correction: Renew System
Qty: 35,000.00
Unit of Measure: S.F.
Estimate: \$288,750.00
Assessor Name: Jejuan Hall
Date Created: 10/30/2019

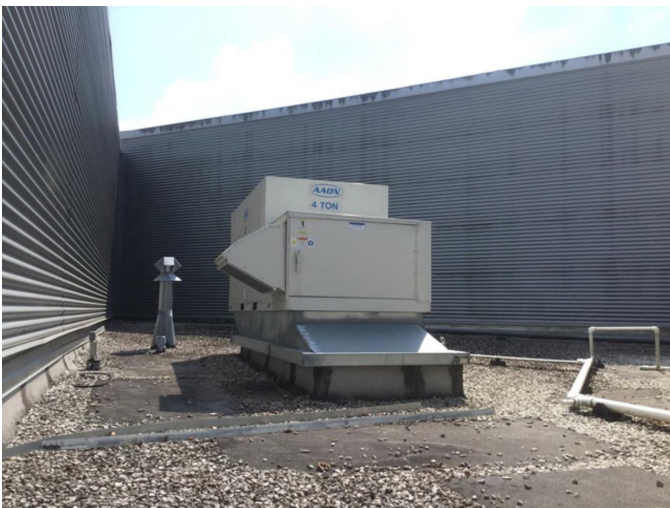
System: D3050 - Terminal & Package Units

Location: Roof
Distress: Beyond Expected Life
Category: Deferred Maintenance
Priority: 3 - Necessary (Years 2-5)
Correction: Renew System
Qty: 52,898.00
Unit of Measure: S.F.
Estimate: \$1,040,398.00
Assessor Name: Jejuan Hall
Date Created: 10/01/2019

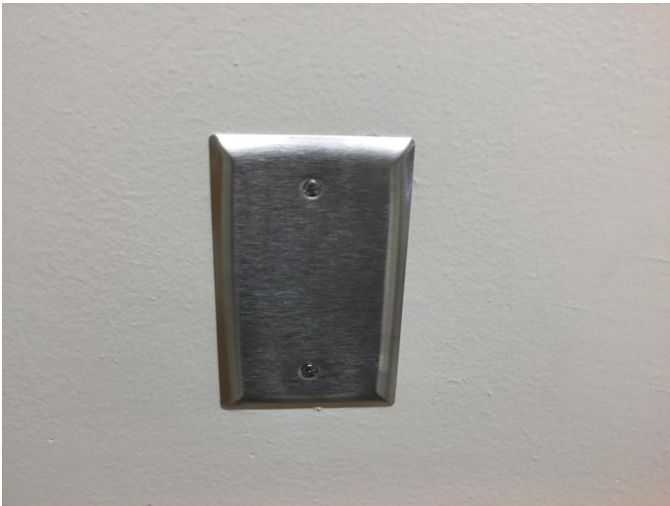
System: D3060 - Controls & Instrumentation

Location: Throughout building
Distress: Beyond Expected Life
Category: Deferred Maintenance
Priority: 3 - Necessary (Years 2-5)
Correction: Renew System
Qty: 52,898.00
Unit of Measure: S.F.
Estimate: \$140,814.00
Assessor Name: Jejuan Hall
Date Created: 10/01/2019

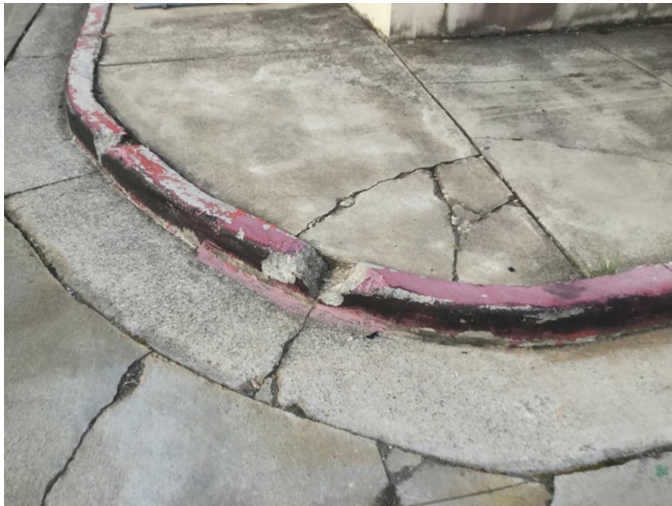
Location: Parking Lot
Distress: Damaged
Category: Deferred Maintenance
Priority: 1 - Critical Immediate Need
Correction: Remove and replace concrete curb or berm
Qty: 200.00
Unit of Measure: L.F.
Estimate: \$10,472.02
Assessor Name: Hayden Collins
Date Created: 10/29/2019

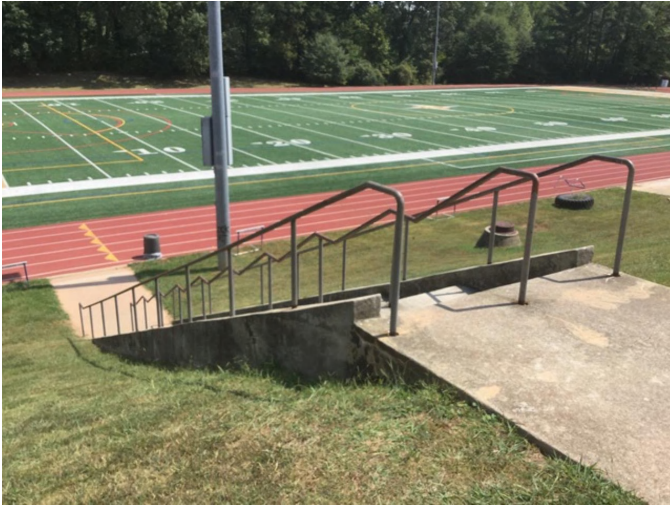
Location: Sports Access Sidewalks and Stairs
Distress: Inadequate
Category: ADA Compliance
Priority: 2 - Trending Critical (Year 1)
Correction: Add handicap ramp with railings
Qty: 100.00
Unit of Measure: L.F.
Estimate: \$50,460.79
Assessor Name: Hayden Collins
Date Created: 10/29/2019

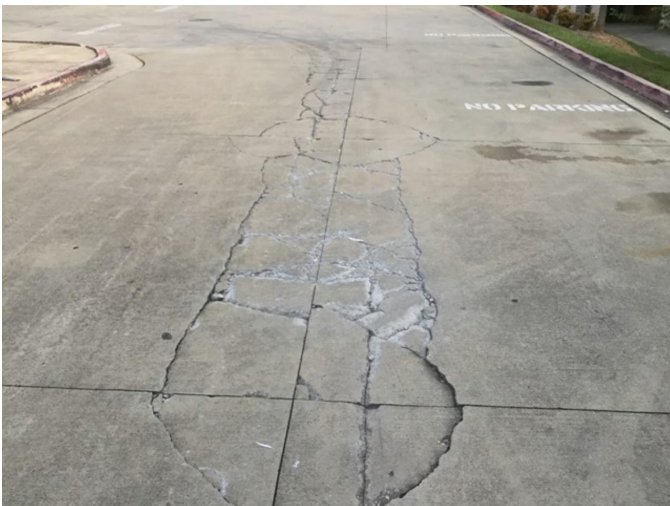
Location: Loading dock
Distress: Damaged
Category: Deferred Maintenance
Priority: 2 - Trending Critical (Year 1)
Correction: Repair damaged concrete surfaces
Qty: 30.00
Unit of Measure: S.Y.
Estimate: \$11,996.11
Assessor Name: Hayden Collins
Date Created: 10/29/2019

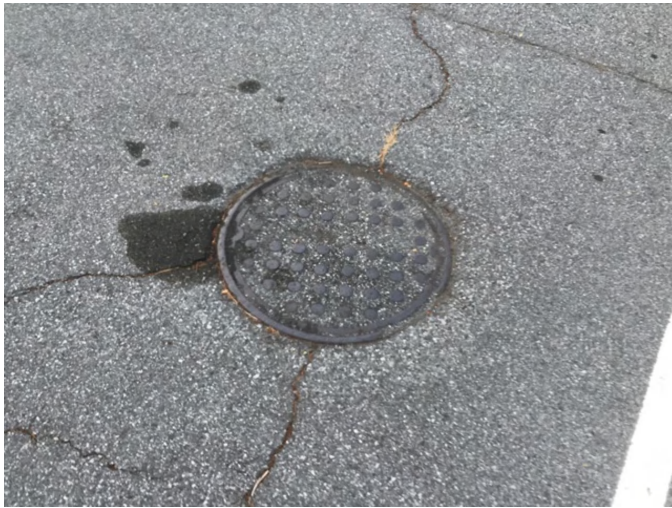
Location: Parking lot
Distress: Failing
Category: Deferred Maintenance
Priority: 4 - Recommended (Years 6-10)
Correction: Parking lot repair and resurface
Qty: 1.00
Unit of Measure: S.Y.
Estimate: \$69,048.81
Assessor Name: Hayden Collins
Date Created: 10/29/2019
