Atlanta Public Schools/ Jackson Cluster

Dunbar Elementary School

School Assessment Report

November 10, 2020

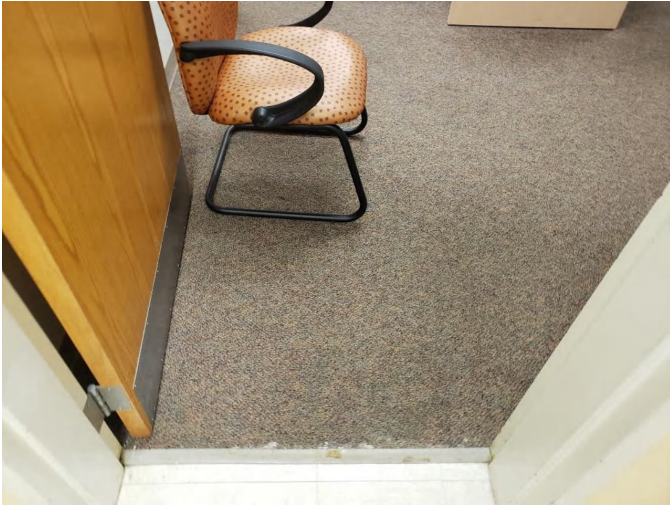
System: C3020901 - Carpet

Location: Media Center and Main office
Distress: Beyond Expected Life
Category: Deferred Maintenance
Priority: 3 - Necessary (Years 2-5)
Correction: Renew System
Qty: 4,060.00
Unit of Measure: S.F.
Estimate: \$33,495.00
Assessor Name: Eduardo Lopez
Date Created: 10/21/2019

Notes: Carpet is beyond expected life. The carpet is aged, worn and stained, and should be replaced.

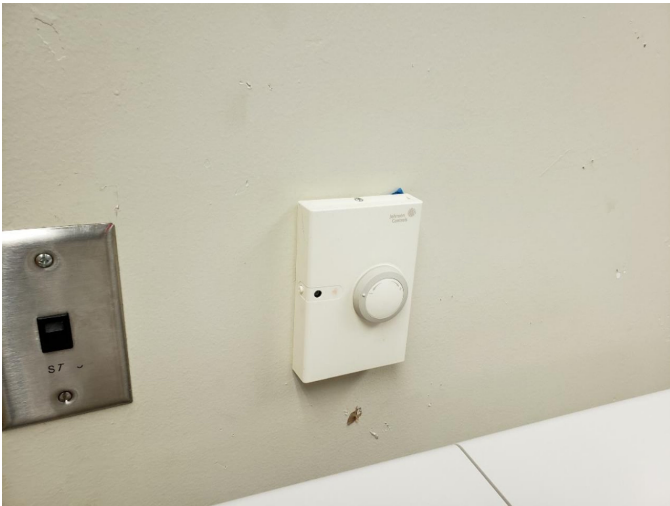
System: D3060 - Controls & Instrumentation

Location: Throughout Building
Distress: Beyond Expected Life
Category: Deferred Maintenance
Priority: 3 - Necessary (Years 2-5)
Correction: Renew System
Qty: 81,687.00
Unit of Measure: S.F.
Estimate: \$197,683.00
Assessor Name: Eduardo Lopez
Date Created: 10/06/2020

Notes: The controls and instrumentation system is beyond its expected service life and should be scheduled for replacement.

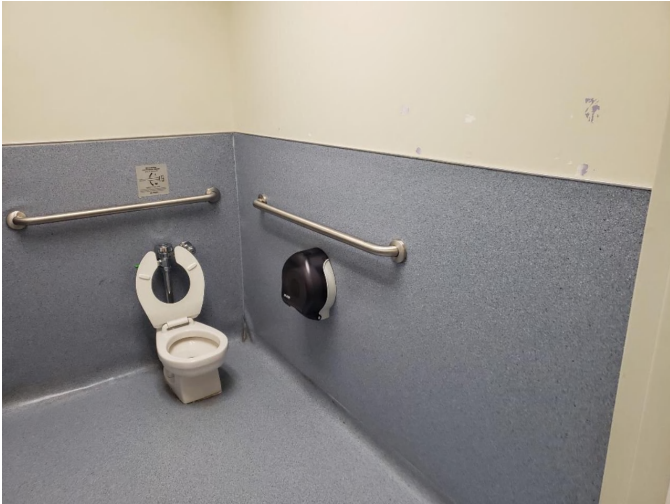
System: C3010903 - Vinyl Wall Covering

Location: bathrooms in in building 2012
Distress: Beyond Expected Life
Category: Deferred Maintenance
Priority: 3 - Necessary (Years 2-5)
Correction: Renew System
Qty: 810.00
Unit of Measure: S.F.
Estimate: \$4,406.00
Assessor Name: Eduardo Lopez
Date Created: 12/18/2019

Notes: The applied interior wall covering is beyond its service life and should be scheduled for replacement.

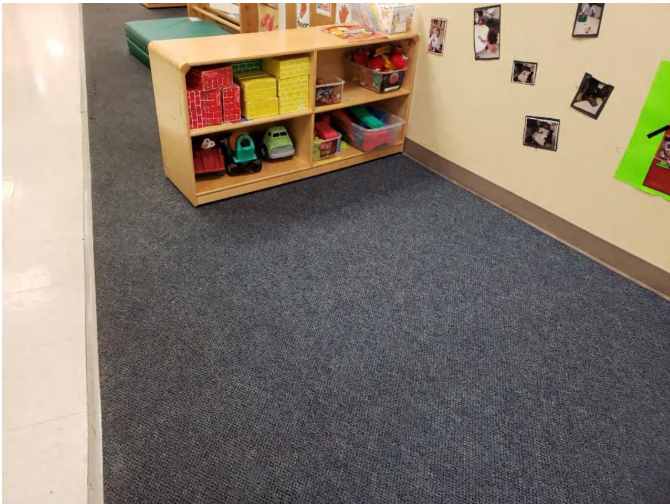
System: C3020901 - Carpet

Location: Throughout Building 2011 and 2012
Distress: Beyond Expected Life
Category: Deferred Maintenance
Priority: 3 - Necessary (Years 2-5)
Correction: Renew System
Qty: 1,730.00
Unit of Measure: S.F.
Estimate: \$14,273.00
Assessor Name: Eduardo Lopez
Date Created: 10/21/2019

Notes: Carpet is beyond expected life. The carpet is aged, worn and stained, and should be replaced.

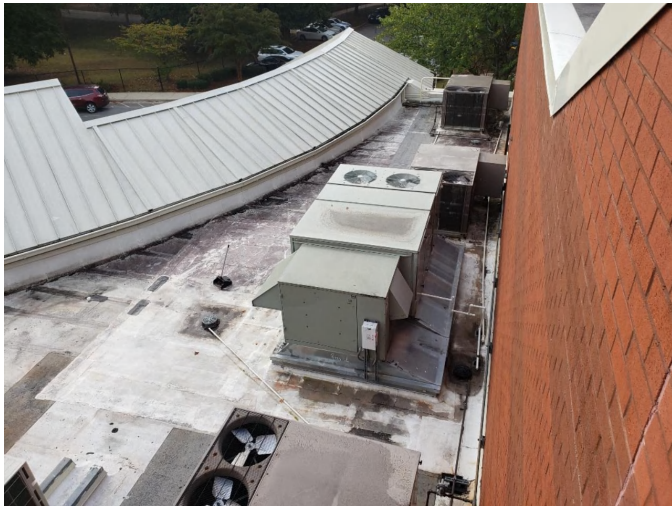
System: D3050 - Terminal & Package Units

Location: Throughout Building
Distress: Beyond Expected Life
Category: Deferred Maintenance
Priority: 3 - Necessary (Years 2-5)
Correction: Renew System
Qty: 17,319.00
Unit of Measure: S.F.
Estimate: \$311,292.00
Assessor Name: Eduardo Lopez
Date Created: 10/06/2020

Notes: The terminal and package units are beyond its expected service life and should be scheduled for replacement.

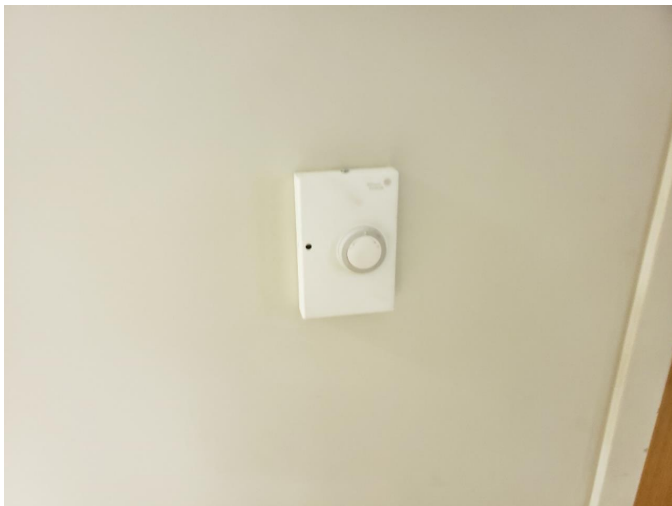
System: D3060 - Controls & Instrumentation

Location: Throughout Building
Distress: Beyond Expected Life
Category: Deferred Maintenance
Priority: 3 - Necessary (Years 2-5)
Correction: Renew System
Qty: 17,319.00
Unit of Measure: S.F.
Estimate: \$41,912.00
Assessor Name: Eduardo Lopez
Date Created: 10/06/2020

Notes: The controls and instrumentation system is beyond its expected service life and should be scheduled for replacement.

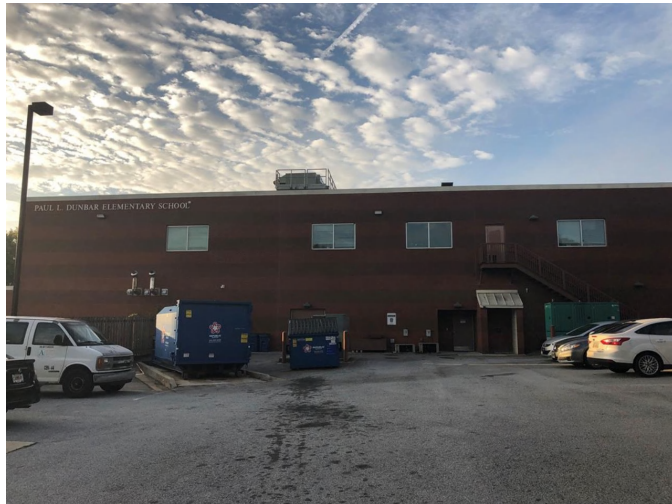
System: G2040 - Site Development

HEALTH: The trash dumpster is in the parking lot open to the public. The exterior services are not protected. Upgrades to landscaping and hardscape to protect the exterior services and trash area are recommended.

Location: Loading dock
Distress: Inadequate
Category: Code Compliance
Priority: 3 - Necessary (Years 2-5)
Correction: Build secure trash dumpster enclosure
Qty: 1.00
Unit of Measure: Ea.
Estimate: \$10,670.41
Assessor Name: Jejuan Hall
Date Created: 12/18/2019
