Atlanta Public Schools/Other Facilities

Facilities Service Center

Support Campus Assessment Report

November 10, 2020

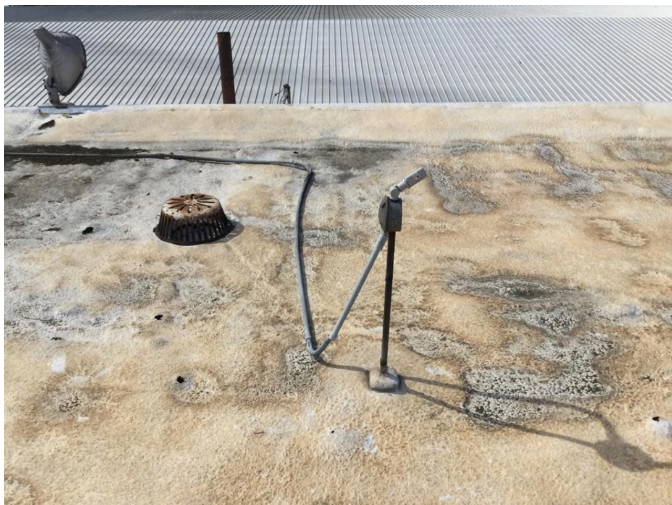
System: B3010120 - Single Ply Membrane

Location: Roof
Distress: Beyond Expected Life
Category: Deferred Maintenance
Priority: 3 - Necessary (Years 2-5)
Correction: Renew System
Qty: 96,205.00
Unit of Measure: S.F.
Estimate: \$898,920.00
Assessor Name: Eduardo Lopez
Date Created: 01/09/2020

Notes: The roofing system is a foam and coat applied over a single ply system that was reported to be original to the buildings construction. This system has exceeded its expected life cycle and is recommended for replacement.

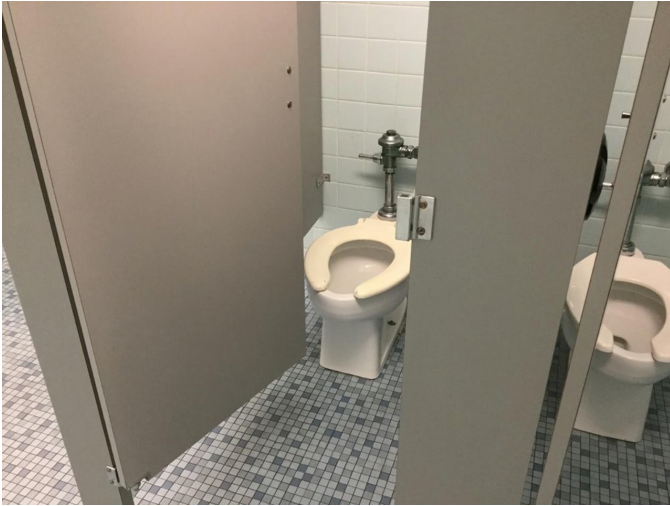
System: C1030 - Fittings

Location: Throughout building
Distress: Beyond Expected Life
Category: ADA Compliance
Priority: 3 - Necessary (Years 2-5)
Correction: Renew System
Qty: 40,950.00
Unit of Measure: S.F.
Estimate: \$200,450.00
Assessor Name: Eduardo Lopez
Date Created: 02/21/2020

Fittings, such as toilet partitions, lockers, signage and railing, are beyond their expected service life, worn and damaged in areas, and should be replaced and upgraded for compliance with ADA standards.

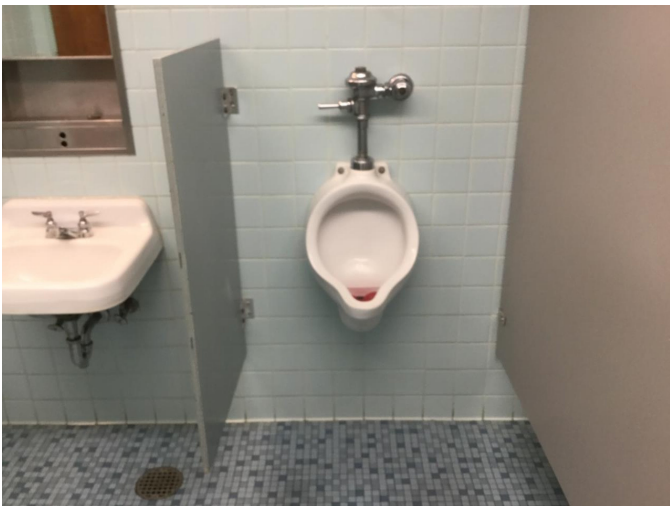
System: C3010220 - Tile

Location: Throughout building
Distress: Beyond Expected Life
Category: Deferred Maintenance
Priority: 3 - Necessary (Years 2-5)
Correction: Renew System
Qty: 2,000.00
Unit of Measure: S.F.
Estimate: \$27,750.00
Assessor Name: Eduardo Lopez
Date Created: 01/09/2020

Notes: The ceramic tile wall finish is beyond its expected service life, damaged and missing in areas, and should be replaced.

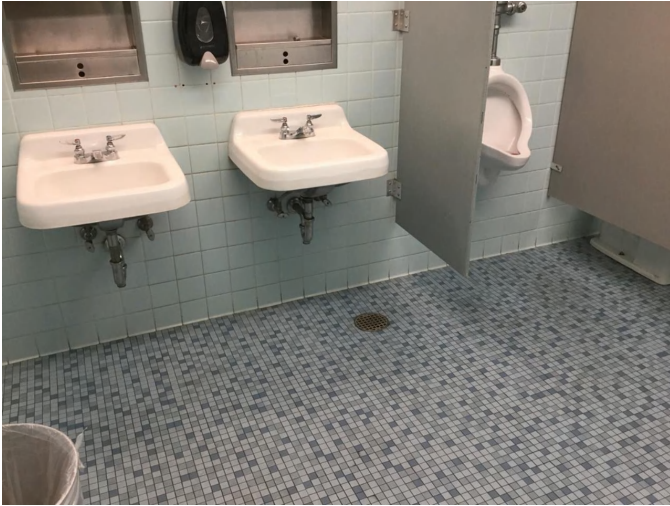
System: C3020420 - Ceramic Tile

Location: Restroom / Locker Room
Distress: Beyond Expected Life
Category: Deferred Maintenance
Priority: 3 - Necessary (Years 2-5)
Correction: Renew System
Qty: 5,000.00
Unit of Measure: S.F.
Estimate: \$125,550.00
Assessor Name: Eduardo Lopez
Date Created: 01/09/2020

Notes: The ceramic tile floor finish is beyond its expected service life and should be replaced.

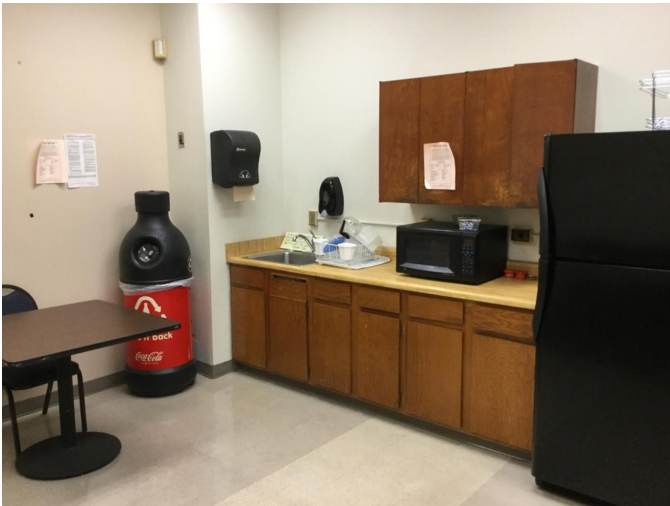
System: C3020903 - VCT

Location: Throughout building
Distress: Beyond Expected Life
Category: Deferred Maintenance
Priority: 3 - Necessary (Years 2-5)
Correction: Renew System
Qty: 32,950.00
Unit of Measure: S.F.
Estimate: \$177,732.00
Assessor Name: Eduardo Lopez
Date Created: 01/09/2020

Notes: The VCT floor finish is beyond its expected service life, worn and damaged, and is recommended for replacement.

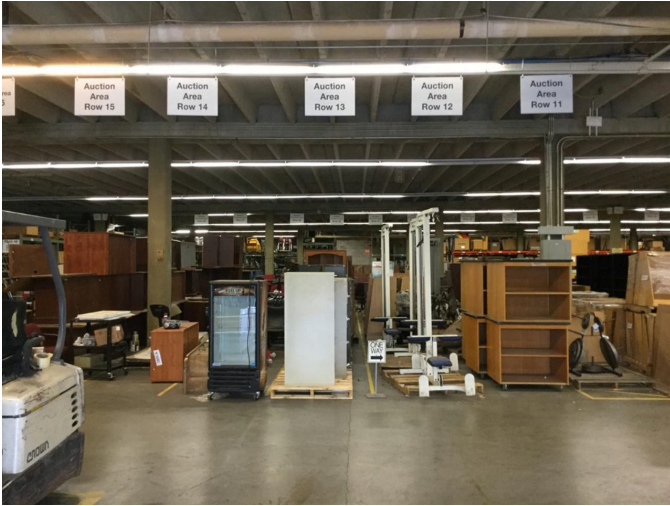
System: C3020999 - Other - Concrete Finish w/Sealer

Location: Throughout building
Distress: Beyond Expected Life
Category: Deferred Maintenance
Priority: 3 - Necessary (Years 2-5)
Correction: Renew System
Qty: 122,850.00
Unit of Measure: S.F.
Estimate: \$928,377.00
Assessor Name: Eduardo Lopez
Date Created: 01/09/2020

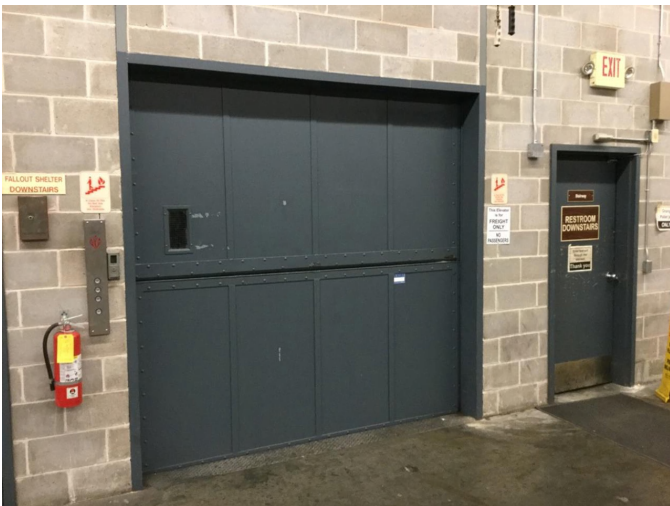
System: D1010 - Elevators and Lifts

Location: elevator
Distress: Beyond Expected Life
Category: Deferred Maintenance
Priority: 3 - Necessary (Years 2-5)
Correction: Renew System
Qty: 163,800.00
Unit of Measure: S.F.
Estimate: \$172,809.00
Assessor Name: Eduardo Lopez
Date Created: 02/21/2020

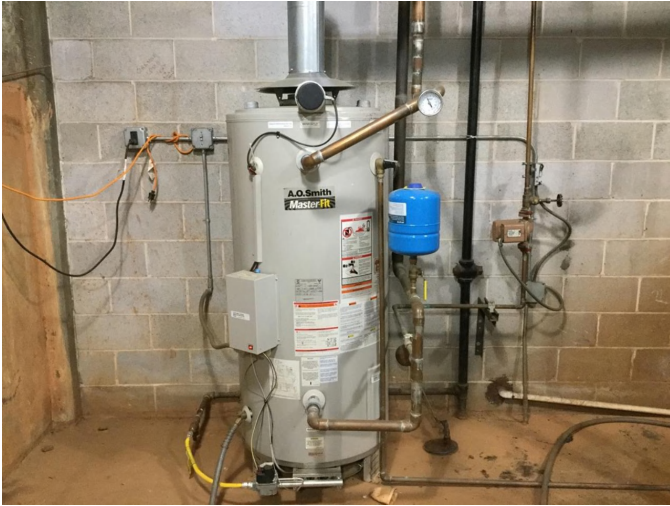
System: D2020 - Domestic Water Distribution

Location: Throughout building
Distress: Beyond Expected Life
Category: Deferred Maintenance
Priority: 3 - Necessary (Years 2-5)
Correction: Renew System
Qty: 40,950.00
Unit of Measure: S.F.
Estimate: \$55,405.00
Assessor Name: Eduardo Lopez
Date Created: 09/03/2013

Notes: Although minor upgrades to the domestic water system are noted the building wide system is beyond its expected life and upgrades are warranted.

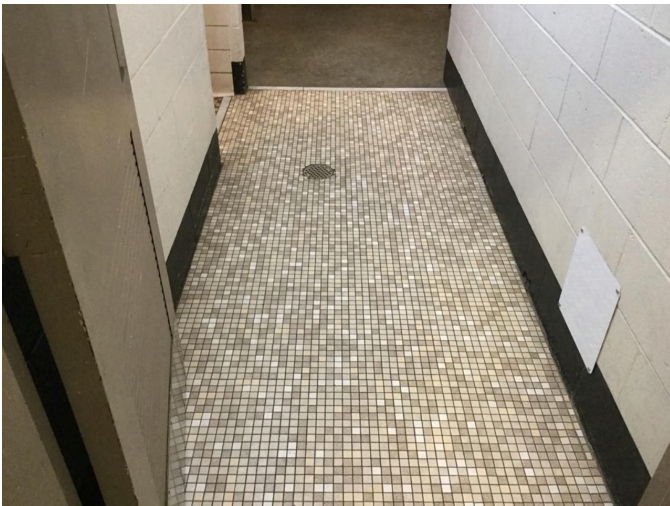
System: D2030 - Sanitary Waste

Location: Throughout building
Distress: Beyond Expected Life
Category: Deferred Maintenance
Priority: 3 - Necessary (Years 2-5)
Correction: Renew System
Qty: 40,950.00
Unit of Measure: S.F.
Estimate: \$128,829.00
Assessor Name: Eduardo Lopez
Date Created: 09/03/2013

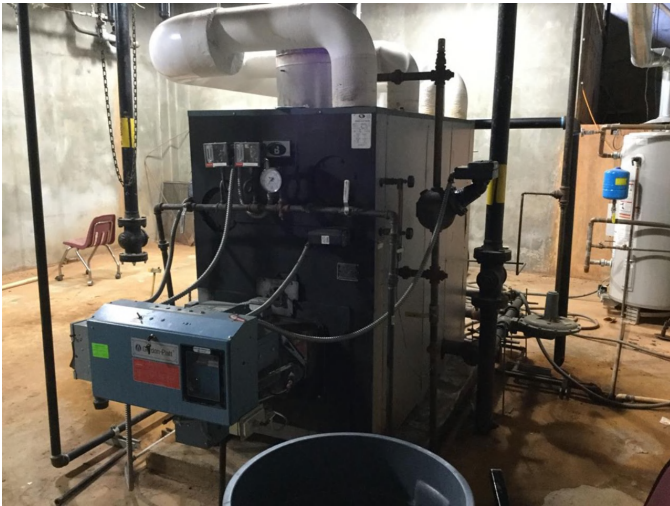
System: D3020 - Heat Generating Systems

Location: Throughout Building
Distress: Beyond Expected Life
Category: Deferred Maintenance
Priority: 3 - Necessary (Years 2-5)
Correction: Renew System
Qty: 40,950.00
Unit of Measure: S.F.
Estimate: \$271,621.00
Assessor Name: Eduardo Lopez
Date Created: 10/06/2020

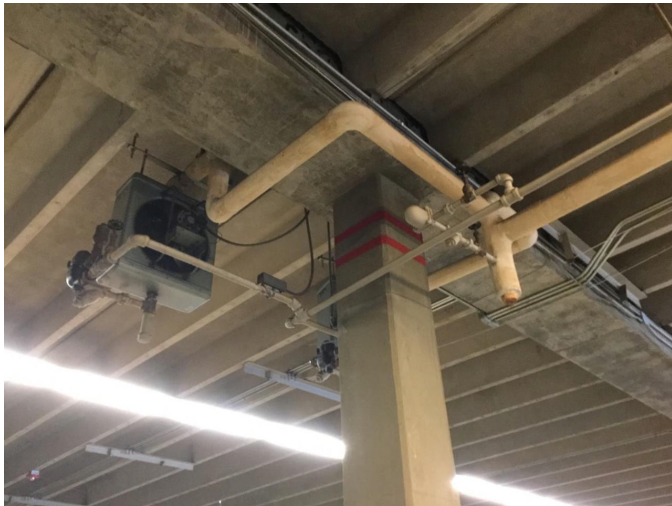
System: D3040 - Distribution Systems

Location: Throughout building
Distress: Beyond Expected Life
Category: Deferred Maintenance
Priority: 3 - Necessary (Years 2-5)
Correction: Renew System
Qty: 40,950.00
Unit of Measure: S.F.
Estimate: \$527,027.00
Assessor Name: Eduardo Lopez
Date Created: 09/03/2013

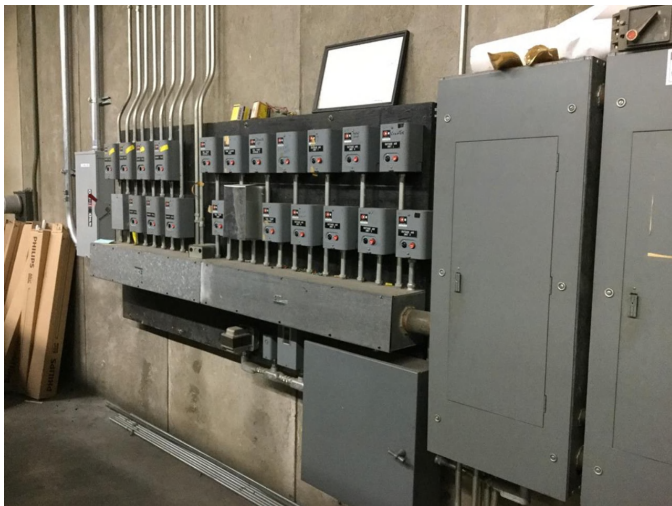
System: D3060 - Controls & Instrumentation

Location: Throughout building
Distress: Beyond Expected Life
Category: Deferred Maintenance
Priority: 3 - Necessary (Years 2-5)
Correction: Renew System
Qty: 40,950.00
Unit of Measure: S.F.
Estimate: \$166,667.00
Assessor Name: Eduardo Lopez
Date Created: 02/21/2020

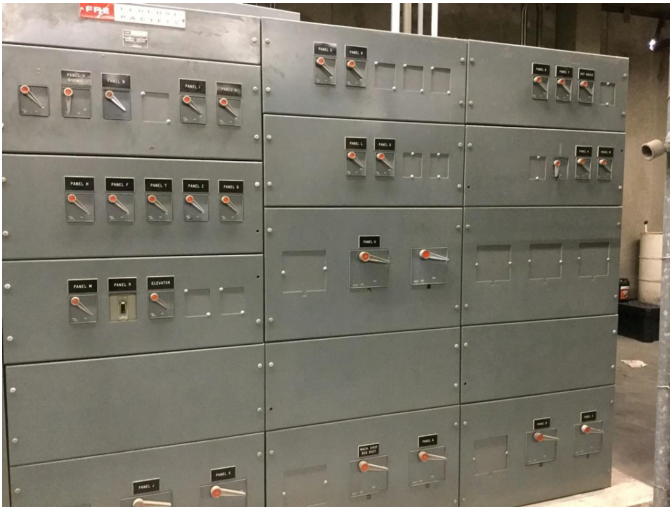
System: D5010 - Electrical Service/Distribution

Location: Throughout building
Distress: Beyond Expected Life
Category: Deferred Maintenance
Priority: 3 - Necessary (Years 2-5)
Correction: Renew System
Qty: 163,800.00
Unit of Measure: S.F.
Estimate: \$695,495.00
Assessor Name: Eduardo Lopez
Date Created: 09/03/2013

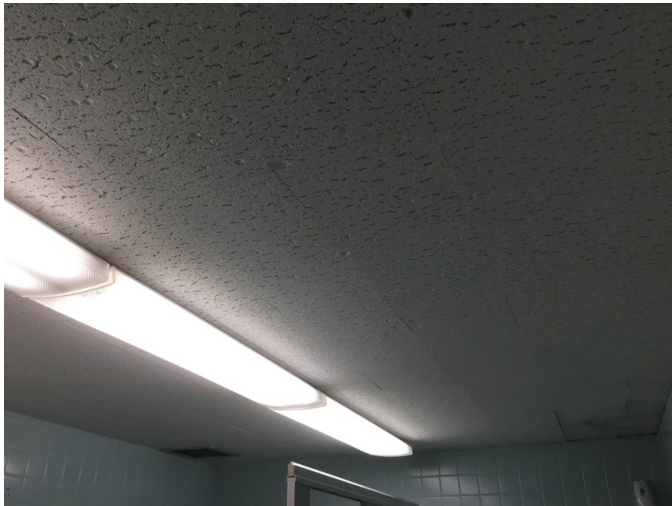
System: D5020 - Lighting

Location: Throughout building
Distress: Beyond Expected Life
Category: Deferred Maintenance
Priority: 3 - Necessary (Years 2-5)
Correction: Renew System
Qty: 163,800.00
Unit of Measure: S.F.
Estimate: \$1,967,566.00
Assessor Name: Eduardo Lopez
Date Created: 08/13/2014

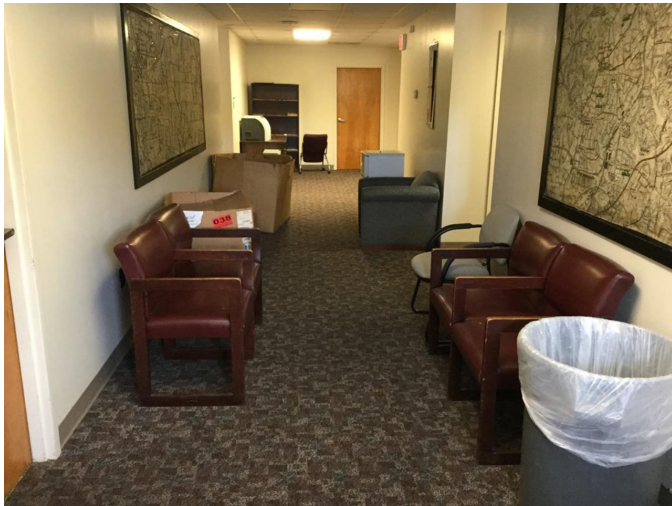
System: C3020901 - Carpet

Location: Throughout building
Distress: Beyond Expected Life
Category: Deferred Maintenance
Priority: 3 - Necessary (Years 2-5)
Correction: Renew System
Qty: 3,000.00
Unit of Measure: S.F.
Estimate: \$24,750.00
Assessor Name: Eduardo Lopez
Date Created: 01/10/2020

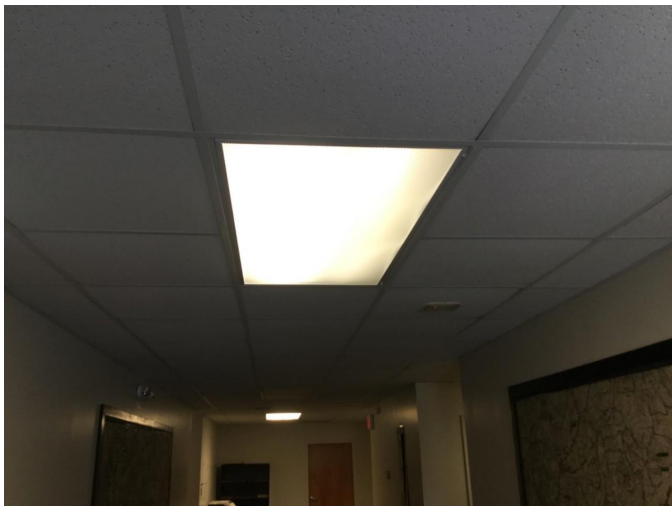
System: C3030 - Ceiling Finishes

Location: Throughout building
Distress: Beyond Expected Life
Category: Deferred Maintenance
Priority: 3 - Necessary (Years 2-5)
Correction: Renew System
Qty: 3,000.00
Unit of Measure: S.F.
Estimate: \$5,346.00
Assessor Name: Eduardo Lopez
Date Created: 10/01/2019

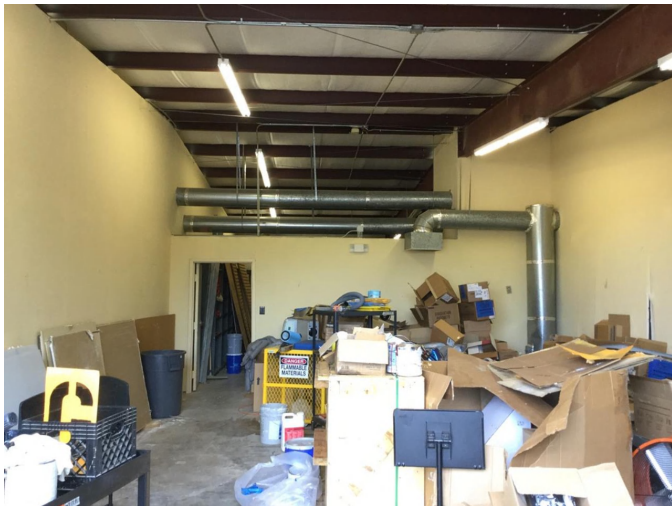
System: D5020 - Branch Wiring

Location: Throughout building
Distress: Beyond Expected Life
Category: Deferred Maintenance
Priority: 3 - Necessary (Years 2-5)
Correction: Renew System
Qty: 9,000.00
Unit of Measure: S.F.
Estimate: \$49,572.00
Assessor Name: Eduardo Lopez
Date Created: 01/10/2020

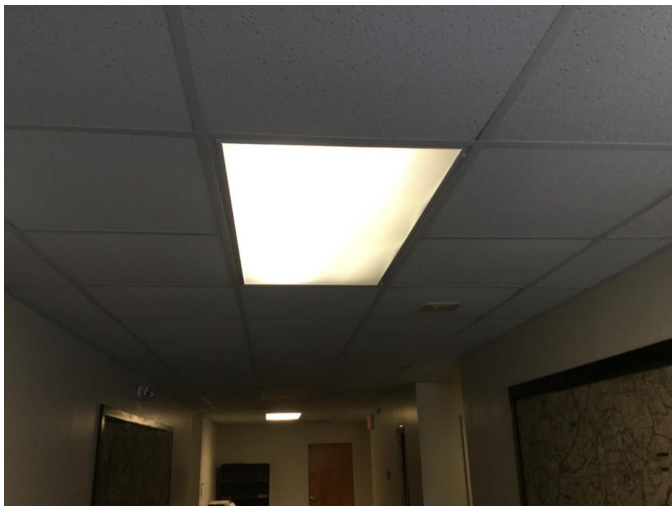
System: D5020 - Lighting

Location: Throughout building
Distress: Beyond Expected Life
Category: Deferred Maintenance
Priority: 3 - Necessary (Years 2-5)
Correction: Renew System
Qty: 9,000.00
Unit of Measure: S.F.
Estimate: \$79,623.00
Assessor Name: Eduardo Lopez
Date Created: 10/01/2019

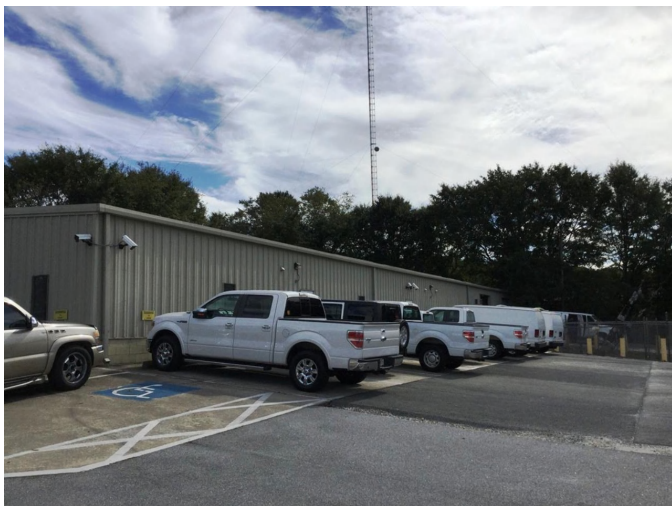
System: D5030810 - Security & Detection Systems

Location: Throughout building
Distress: Beyond Expected Life
Category: Deferred Maintenance
Priority: 3 - Necessary (Years 2-5)
Correction: Renew System
Qty: 9,000.00
Unit of Measure: S.F.
Estimate: \$14,949.00
Assessor Name: Eduardo Lopez
Date Created: 01/10/2020

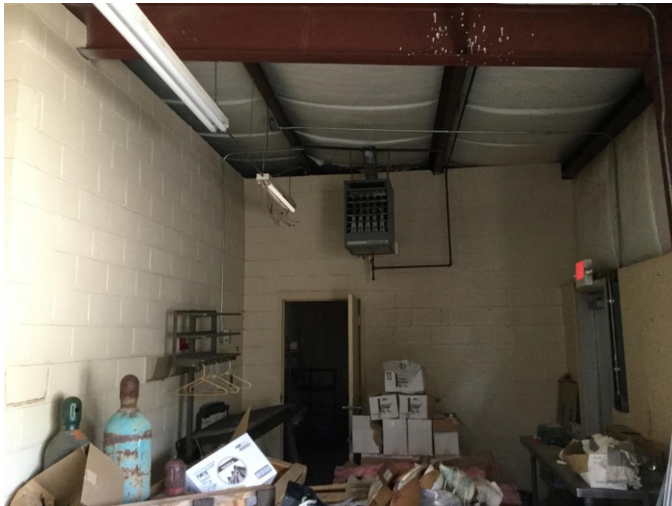
Location: Throughout building
Distress: Beyond Expected Life
Category: Deferred Maintenance
Priority: 3 - Necessary (Years 2-5)
Correction: Renew System
Qty: 5,100.00
Unit of Measure: S.F.
Estimate: \$27,377.00
Assessor Name: Homero Guerrero
Date Created: 01/10/2020

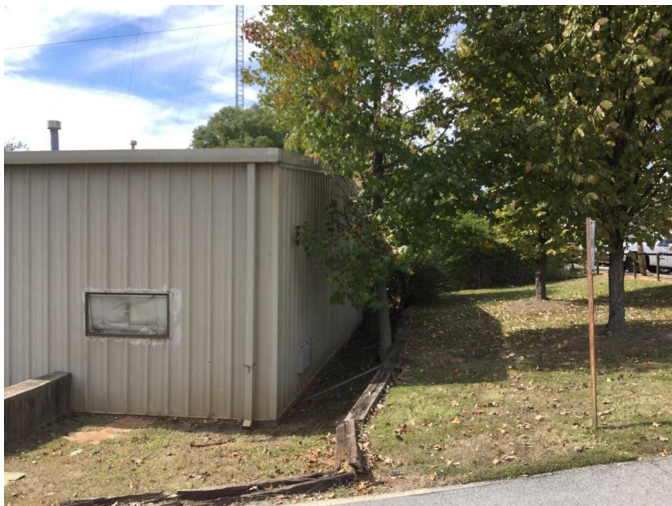
Location: Throughout building
Distress: Beyond Expected Life
Category: Deferred Maintenance
Priority: 3 - Necessary (Years 2-5)
Correction: Renew System
Qty: 5,100.00
Unit of Measure: S.F.
Estimate: \$33,380.00
Assessor Name: Homero Guerrero
Date Created: 01/10/2020

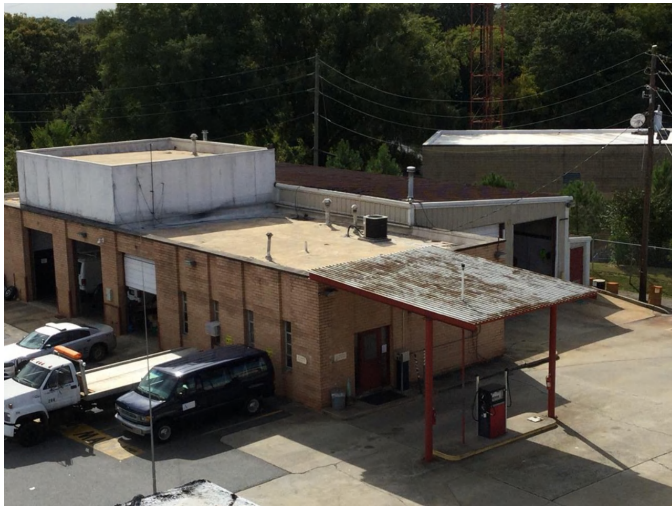
Location: Roof
Distress: Missing
Category: Facility Integrity
Priority: 4 - Recommended (Years 6-10)
Correction: Renew System
Qty: 4,427.00
Unit of Measure: S.F.
Estimate: \$5,113.00
Assessor Name: Eduardo Lopez
Date Created: 09/04/2013

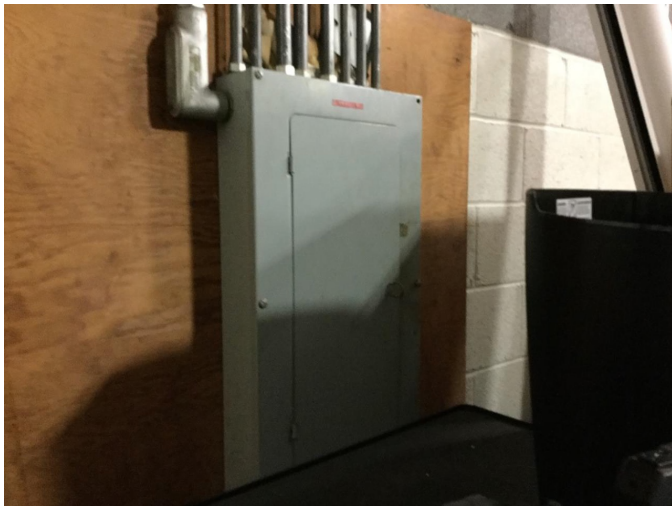
Location: Throughout building
Distress: Beyond Expected Life
Category: Deferred Maintenance
Priority: 3 - Necessary (Years 2-5)
Correction: Renew System
Qty: 43,000.00
Unit of Measure: S.F.
Estimate: \$267,804.00
Assessor Name: Eduardo Lopez
Date Created: 01/13/2020

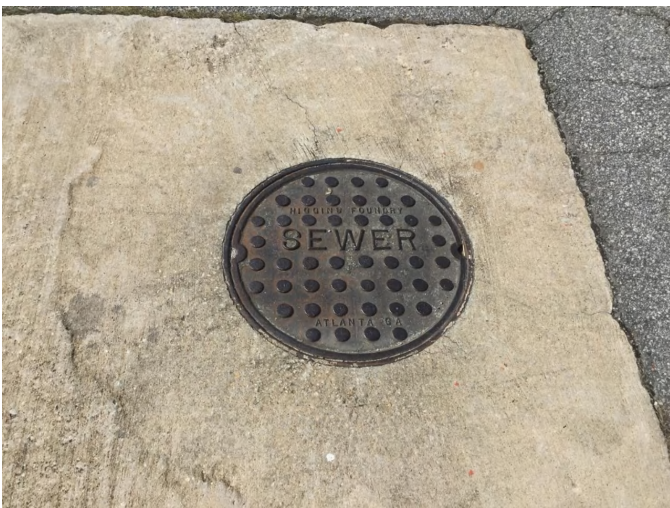
Location: Site
Distress: Beyond Expected Life
Category: Deferred Maintenance
Priority: 3 - Necessary (Years 2-5)
Correction: Renew System
Qty: 225,327.00
Unit of Measure: S.F.
Estimate: \$545,291.00
Assessor Name: Hayden Collins
Date Created: 09/17/2015
