Atlanta Public Schools/Relocation Sites

Fain ES (West Manor relocation site)

School Assessment Report

November 10, 2020

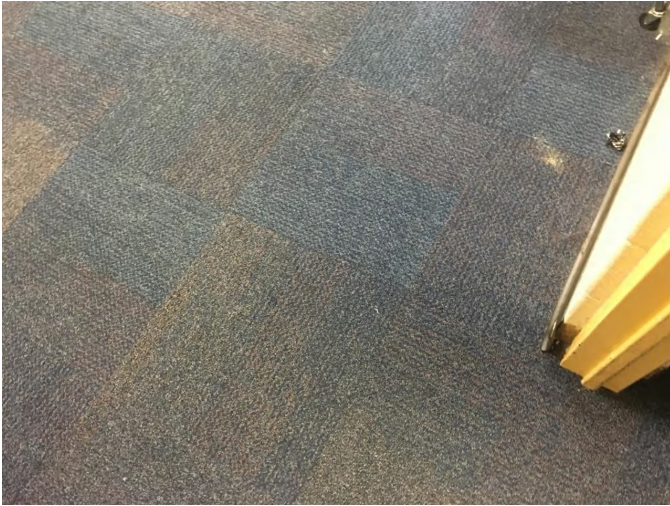
System: C3020901 - Carpet

Location: Throughout Building
Distress: Beyond Expected Life
Category: Deferred Maintenance
Priority: 3 - Necessary (Years 2-5)
Correction: Renew System
Qty: 6,000.00
Unit of Measure: S.F.
Estimate: \$49,500.00
Assessor Name: Eduardo Lopez
Date Created: 10/03/2019

Notes: The carpet finish is beyond its expected service life, worn and damaged, and is recommended for replacement.

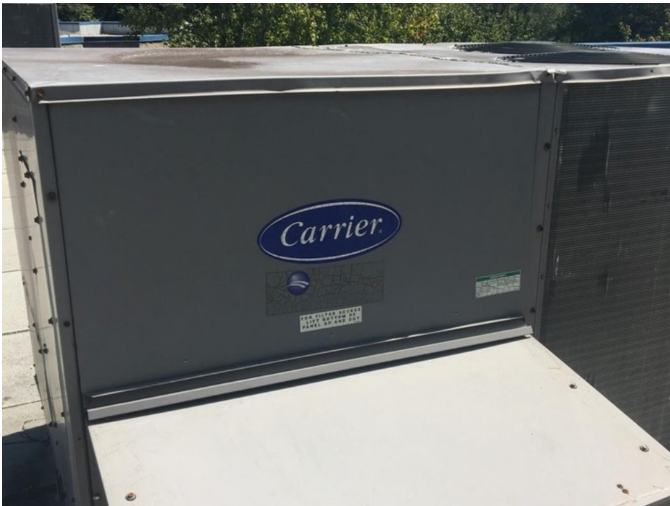
System: D3050 - Terminal & Package Units

Location: Roof
Distress: Beyond Expected Life
Category: Deferred Maintenance
Priority: 3 - Necessary (Years 2-5)
Correction: Renew System
Qty: 83,782.00
Unit of Measure: S.F.
Estimate: \$581,531.00
Assessor Name: Eduardo Lopez
Date Created: 10/06/2020

Notes: The terminal and package units are beyond its expected service life and should be scheduled for replacement.

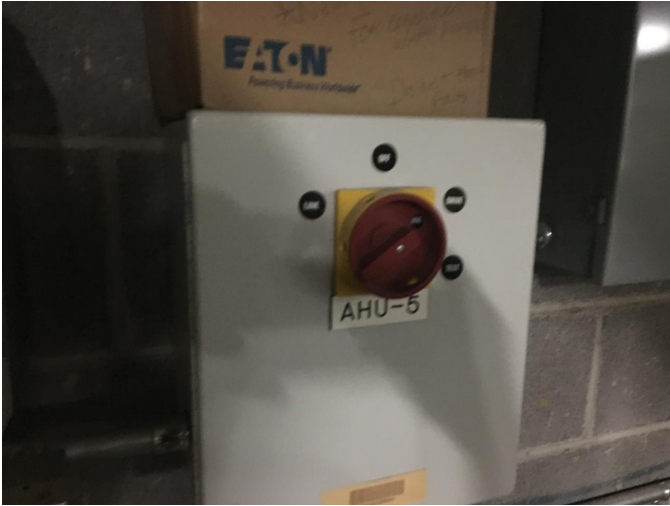
System: D3060 - Controls & Instrumentation

Location: Throughout Building
Distress: Beyond Expected Life
Category: Deferred Maintenance
Priority: 3 - Necessary (Years 2-5)
Correction: Renew System
Qty: 83,782.00
Unit of Measure: S.F.
Estimate: \$202,752.00
Assessor Name: Eduardo Lopez
Date Created: 10/06/2020

Notes: The controls and instrumentation system is beyond its expected service life and should be scheduled for replacement.

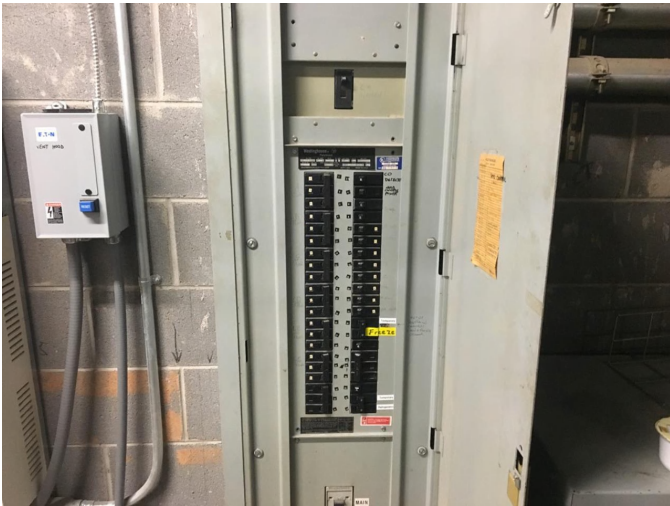
System: D5020 - Branch Wiring

Location: Throughout Building
Distress: Beyond Expected Life
Category: Deferred Maintenance
Priority: 3 - Necessary (Years 2-5)
Correction: Renew System
Qty: 83,782.00
Unit of Measure: S.F.
Estimate: \$412,878.00
Assessor Name: Eduardo Lopez
Date Created: 10/06/2020

Notes: The branch and wiring system is beyond its expected service life and should be scheduled for replacement.

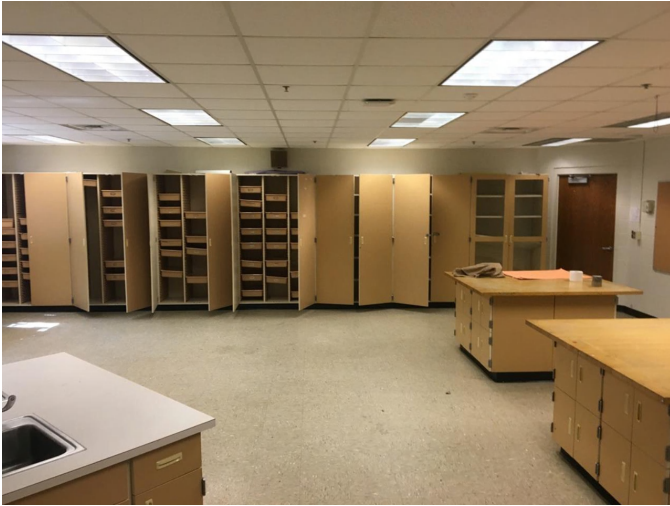
System: E2010 - Fixed Furnishings

Location: Throughout Building
Distress: Beyond Expected Life
Category: Deferred Maintenance
Priority: 3 - Necessary (Years 2-5)
Correction: Renew System
Qty: 83,782.00
Unit of Measure: S.F.
Estimate: \$176,026.00
Assessor Name: Eduardo Lopez
Date Created: 09/09/2013

Notes: Furnishings are worn and beyond expected. Replacing furnishings is recommended upon school reopening

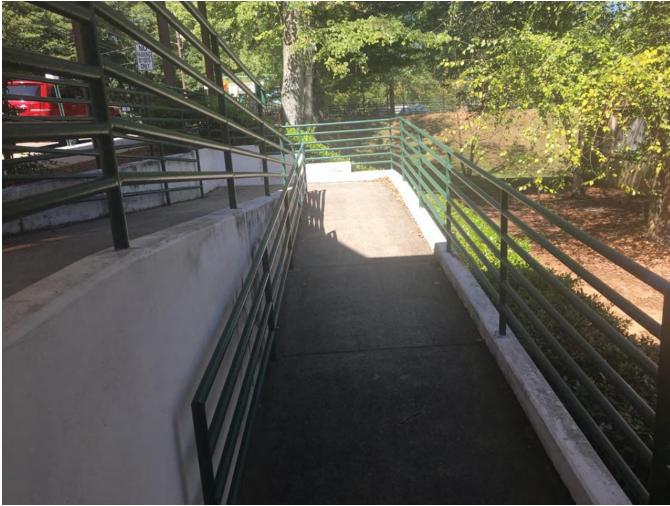
System: G2040105 - Fence & Guardrails

Location: Site
Distress: Beyond Expected Life
Category: Deferred Maintenance
Priority: 3 - Necessary (Years 2-5)
Correction: Renew System
Qty: 83,782.00
Unit of Measure: S.F.
Estimate: \$105,984.00
Assessor Name: Hayden Collins
Date Created: 10/03/2019

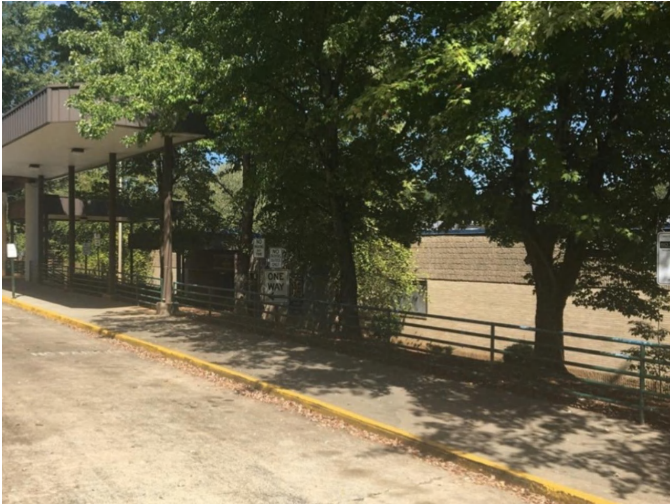
System: G2040950 - Covered Walkways

Location: Site
Distress: Beyond Expected Life
Category: Deferred Maintenance
Priority: 3 - Necessary (Years 2-5)
Correction: Renew System
Qty: 83,782.00
Unit of Measure: S.F.
Estimate: \$132,711.00
Assessor Name: Hayden Collins
Date Created: 10/03/2019

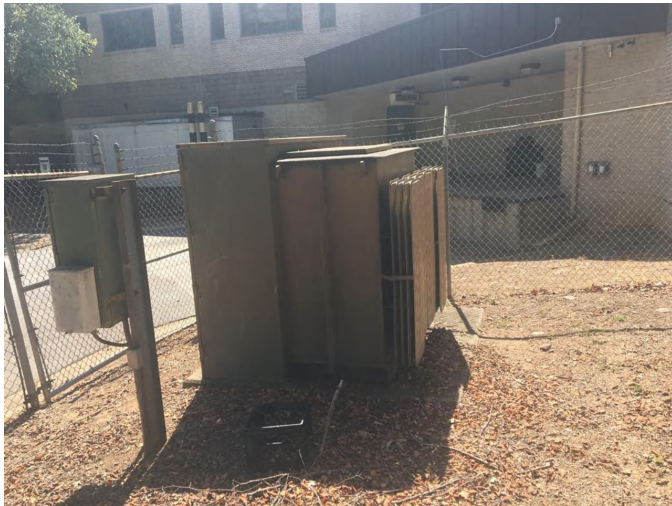
System: G4010 - Electrical Distribution

Location: Site
Distress: Beyond Expected Life
Category: Deferred Maintenance
Priority: 3 - Necessary (Years 2-5)
Correction: Renew System
Qty: 83,782.00
Unit of Measure: S.F.
Estimate: \$235,009.00
Assessor Name: Hayden Collins
Date Created: 09/28/2019

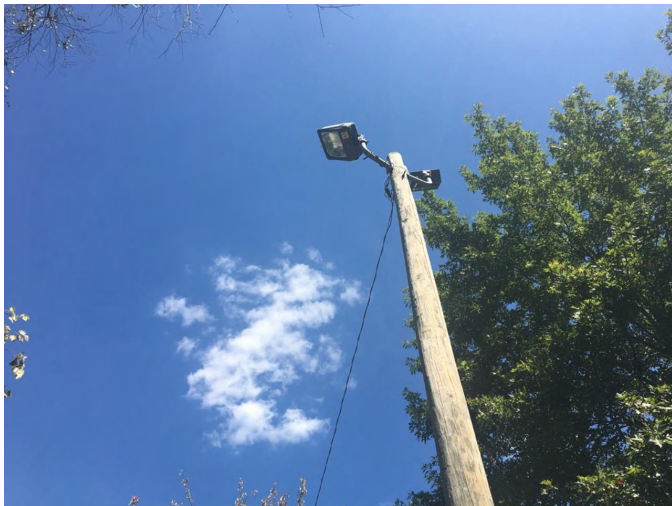
System: G4020 - Site Lighting

Location: Site
Distress: Beyond Expected Life
Category: Deferred Maintenance
Priority: 3 - Necessary (Years 2-5)
Correction: Renew System
Qty: 83,782.00
Unit of Measure: S.F.
Estimate: \$274,637.00
Assessor Name: Hayden Collins
Date Created: 09/28/2019

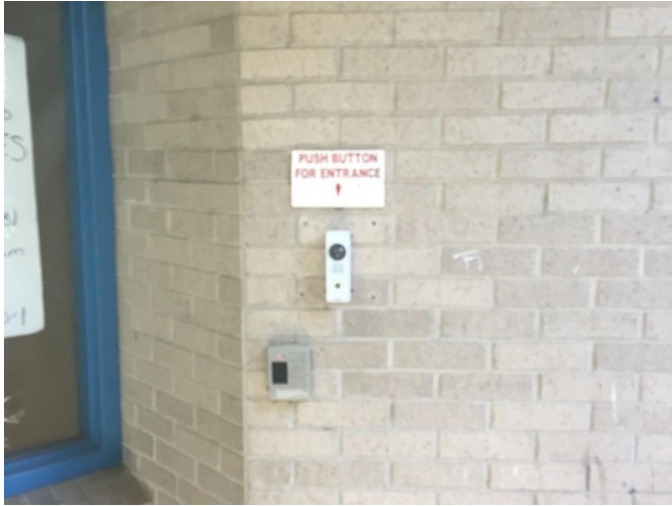
System: G4030 - Site Communication and Security

Location: Site
Distress: Beyond Expected Life
Category: Deferred Maintenance
Priority: 3 - Necessary (Years 2-5)
Correction: Renew System
Qty: 83,782.00
Unit of Measure: S.F.
Estimate: \$117,965.00
Assessor Name: Hayden Collins
Date Created: 09/28/2019
