Atlanta Public Schools/ Therrell Cluster

Fickett Elementary School

School Assessment Report

March 26, 2021

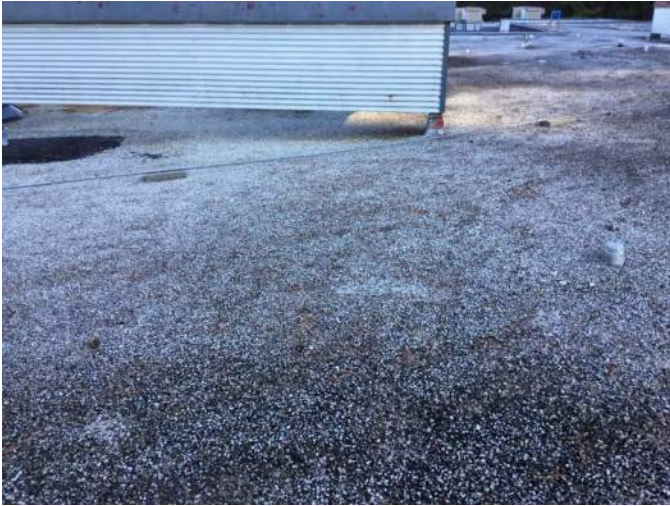
System: B3010105 - Built-Up

Location: Roof
Distress: Beyond Expected Life
Category: Deferred Maintenance
Priority: 3 - Necessary (Years 2-5)
Correction: Renew System
Qty: 27,397.00
Unit of Measure: S.F.
Estimate: \$307,545.00
Assessor Name: Eduardo Lopez
Date Created: 03/25/2021

Notes: The built-up roof covering is aged, showing signs of failure and should be scheduled for replacement.

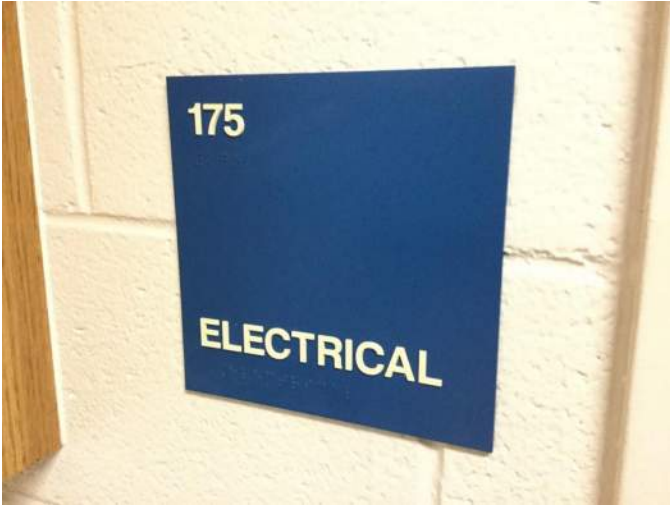
System: C1030 - Fittings

Location: Throughout Building
Distress: Beyond Expected Life
Category: Deferred Maintenance
Priority: 3 - Necessary (Years 2-5)
Correction: Renew System
Qty: 50,685.00
Unit of Measure: S.F.
Estimate: \$144,402.00
Assessor Name: Eduardo Lopez
Date Created: 03/25/2021

Notes: The system is beyond its expected service life and should be scheduled for replacement.

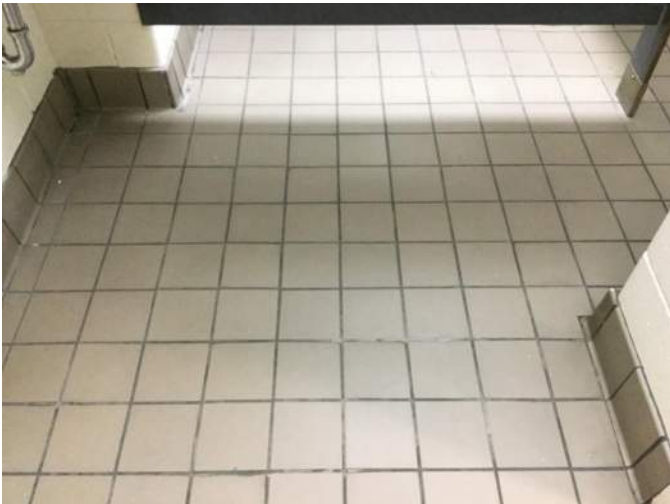
System: C3020420 - Ceramic Tile

Location: Restrooms
Distress: Beyond Expected Life
Category: Deferred Maintenance
Priority: 3 - Necessary (Years 2-5)
Correction: Renew System
Qty: 3,905.00
Unit of Measure: S.F.
Estimate: \$98,055.00
Assessor Name: Eduardo Lopez
Date Created: 03/25/2021

Notes: The system is beyond its expected service life and should be scheduled for replacement.

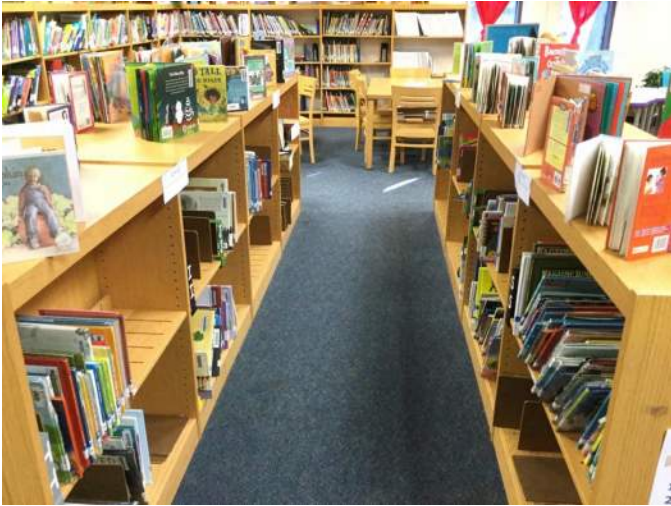
System: C3020901 - Carpet

Location: Media Center and Main office
Distress: Beyond Expected Life
Category: Deferred Maintenance
Priority: 3 - Necessary (Years 2-5)
Correction: Renew System
Qty: 6,301.00
Unit of Measure: S.F.
Estimate: \$51,983.00
Assessor Name: Eduardo Lopez
Date Created: 01/29/2020

Notes: The carpet is aged beyond its expected life and should be replaced.

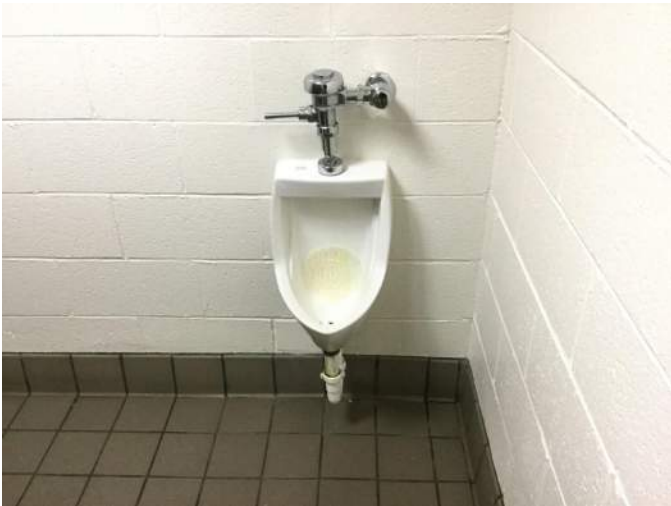
System: D2010 - Plumbing Fixtures

Location: Restrooms
Distress: Beyond Expected Life
Category: Deferred Maintenance
Priority: 3 - Necessary (Years 2-5)
Correction: Renew System
Qty: 50,685.00
Unit of Measure: S.F.
Estimate: \$359,053.00
Assessor Name: Eduardo Lopez
Date Created: 03/25/2021

Notes: Plumbing fixtures are in operational conditions. However, they are aged, and should be scheduled for replacement.

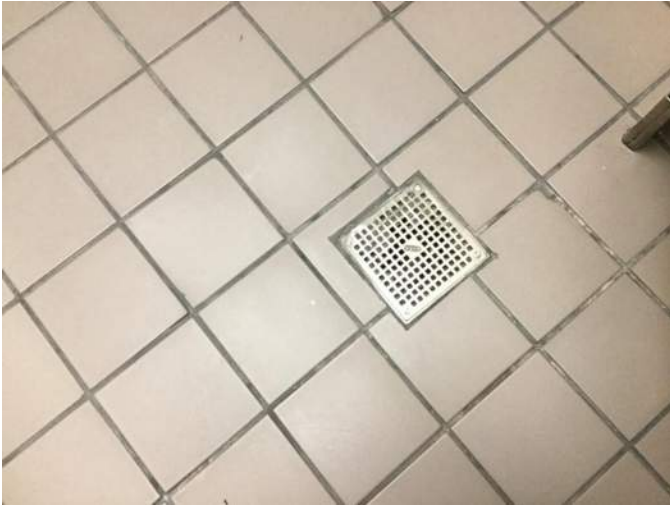
System: D2030 - Sanitary Waste

Location: Throughout Building
Distress: Beyond Expected Life
Category: Deferred Maintenance
Priority: 3 - Necessary (Years 2-5)
Correction: Renew System
Qty: 50,685.00
Unit of Measure: S.F.
Estimate: \$97,569.00
Assessor Name: Eduardo Lopez
Date Created: 02/22/2020

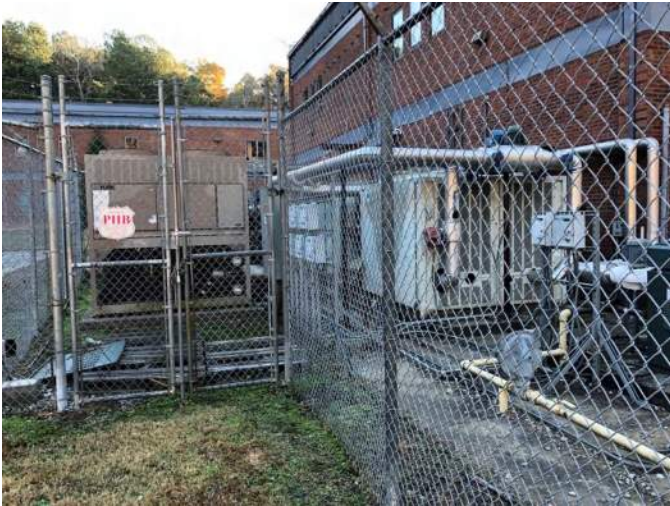
System: D3030 - Cooling Generating Systems

Location: Exterior of the Building
Distress: Beyond Expected Life
Category: Deferred Maintenance
Priority: 3 - Necessary (Years 2-5)
Correction: Renew System
Qty: 50,685.00
Unit of Measure: S.F.
Estimate: \$404,213.00
Assessor Name: Eduardo Lopez
Date Created: 03/24/2021

Notes: The system is beyond its expected service life and should be scheduled for replacement.

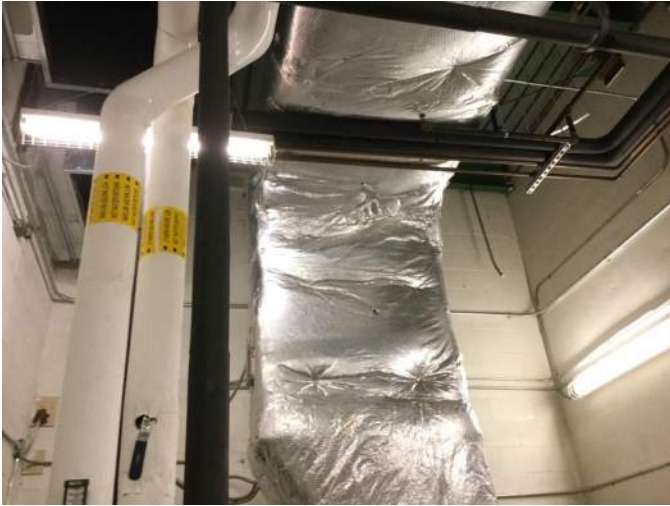
System: D3040 - Distribution Systems

Location: Throughout Building
Distress: Beyond Expected Life
Category: Deferred Maintenance
Priority: 3 - Necessary (Years 2-5)
Correction: Renew System
Qty: 50,685.00
Unit of Measure: S.F.
Estimate: \$836,303.00
Assessor Name: Eduardo Lopez
Date Created: 03/24/2021

Notes: The system is beyond its expected service life and should be scheduled for replacement.

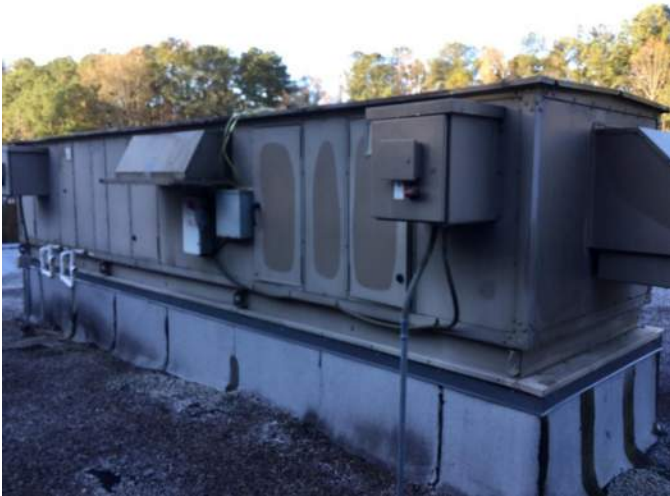
System: D3050 - Terminal & Package Units

Location: Throughout Building
Distress: Beyond Expected Life
Category: Deferred Maintenance
Priority: 3 - Necessary (Years 2-5)
Correction: Renew System
Qty: 50,685.00
Unit of Measure: S.F.
Estimate: \$533,561.00
Assessor Name: Eduardo Lopez
Date Created: 03/24/2021

Notes: The system is beyond its expected service life and should be scheduled for replacement.

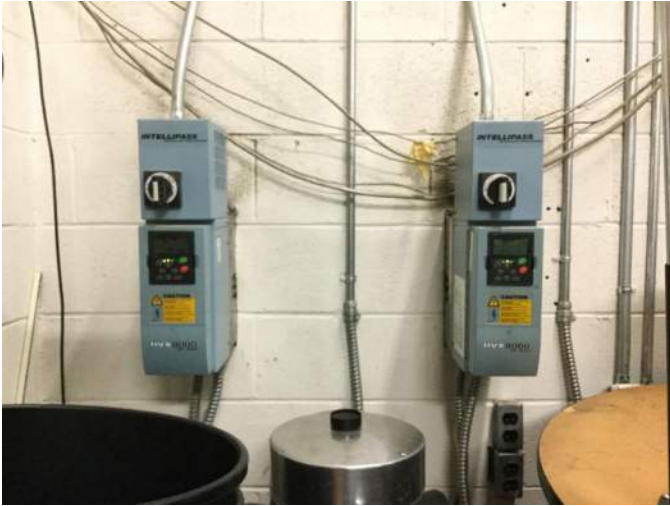
System: D3060 - Controls & Instrumentation

Location: Throughout Building
Distress: Beyond Expected Life
Category: Deferred Maintenance
Priority: 3 - Necessary (Years 2-5)
Correction: Renew System
Qty: 50,685.00
Unit of Measure: S.F.
Estimate: \$125,445.00
Assessor Name: Eduardo Lopez
Date Created: 03/24/2021

Notes: The system is beyond its expected service life and should be scheduled for replacement.

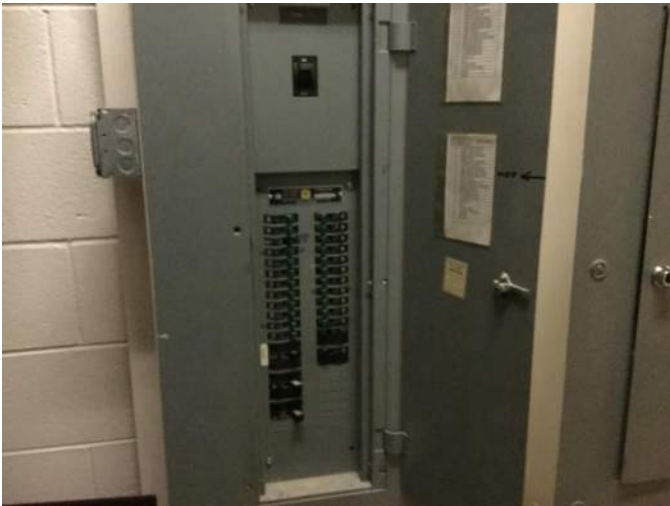
System: D5010 - Electrical Service/Distribution

Location: Throughout Building
Distress: Beyond Expected Life
Category: Deferred Maintenance
Priority: 3 - Necessary (Years 2-5)
Correction: Renew System
Qty: 50,685.00
Unit of Measure: S.F.
Estimate: \$127,676.00
Assessor Name: Eduardo Lopez
Date Created: 03/24/2021

Notes: The system is beyond its expected service life and should be scheduled for replacement.

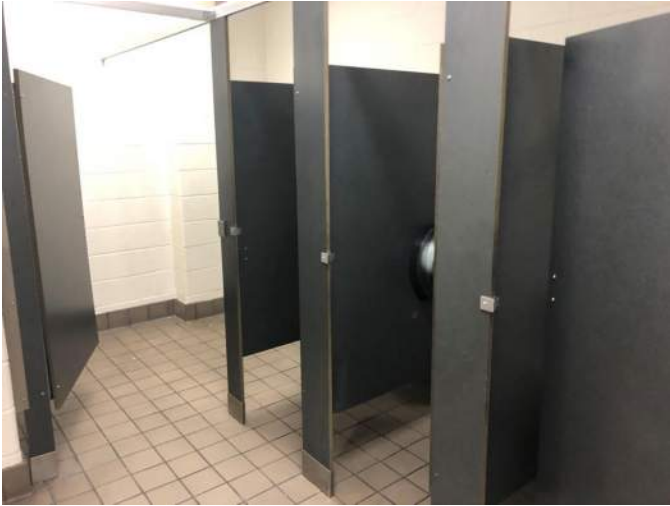
System: C1030 - Fittings

Location: Throughout Building
Distress: Beyond Expected Life
Category: Deferred Maintenance
Priority: 3 - Necessary (Years 2-5)
Correction: Renew System
Qty: 35,805.00
Unit of Measure: S.F.
Estimate: \$102,796.00
Assessor Name: Eduardo Lopez
Date Created: 03/25/2021

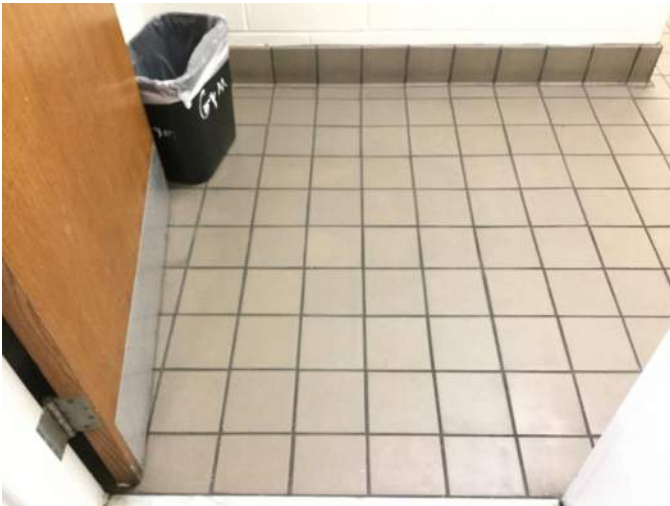
System: C3020420 - Ceramic Tile

Location: Restrooms
Distress: Beyond Expected Life
Category: Deferred Maintenance
Priority: 3 - Necessary (Years 2-5)
Correction: Renew System
Qty: 1,352.00
Unit of Measure: S.F.
Estimate: \$33,949.00
Assessor Name: Eduardo Lopez
Date Created: 03/25/2021

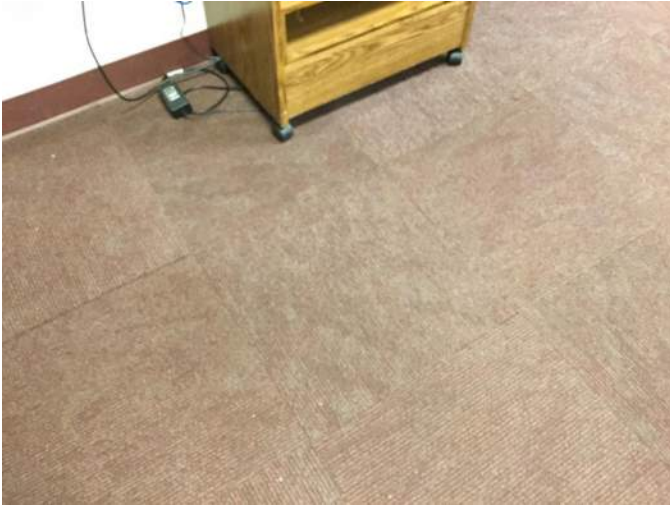
System: C3020901 - Carpet

Location: Lounge
Distress: Beyond Expected Life
Category: Deferred Maintenance
Priority: 3 - Necessary (Years 2-5)
Correction: Renew System
Qty: 3,248.00
Unit of Measure: S.F.
Estimate: \$26,796.00
Assessor Name: Eduardo Lopez
Date Created: 01/29/2020

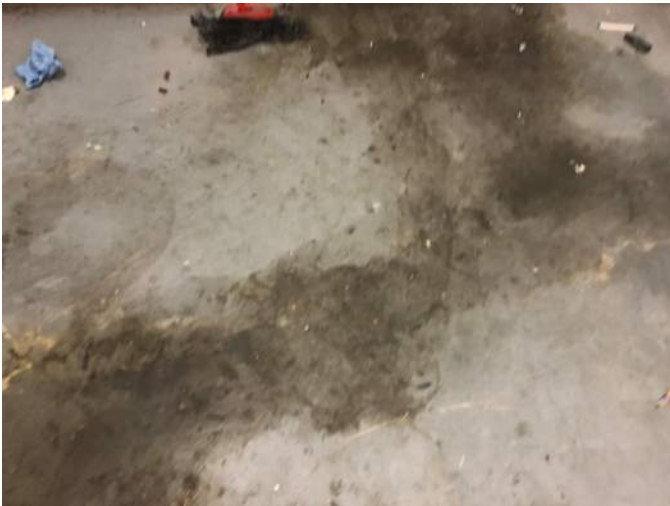
System: C3020999 - Other - Concrete Finish w/Sealer

Location: Throughout building
Distress: Beyond Expected Life
Category: Deferred Maintenance
Priority: 3 - Necessary (Years 2-5)
Correction: Renew System
Qty: 277.00
Unit of Measure: S.F.
Estimate: \$2,093.00
Assessor Name: Eduardo Lopez
Date Created: 01/31/2020

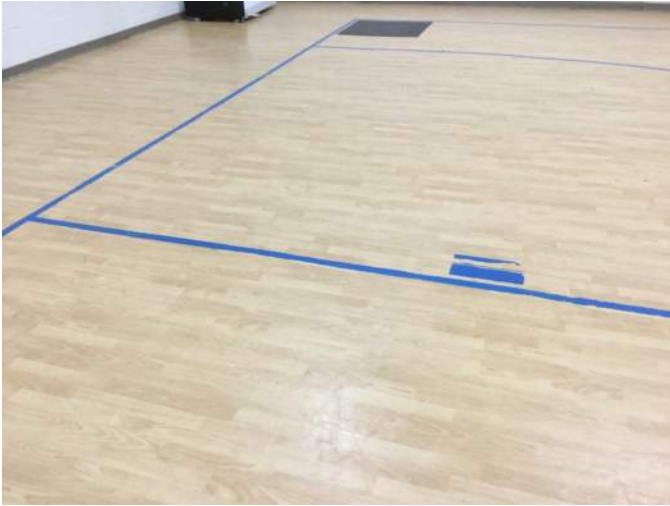
System: C3020999 - Other - Rubber or Neoprene

Location: Multi-purpose room
Distress: Beyond Expected Life
Category: Deferred Maintenance
Priority: 3 - Necessary (Years 2-5)
Correction: Renew System
Qty: 6,810.00
Unit of Measure: S.F.
Estimate: \$199,785.00
Assessor Name: Eduardo Lopez
Date Created: 01/29/2020

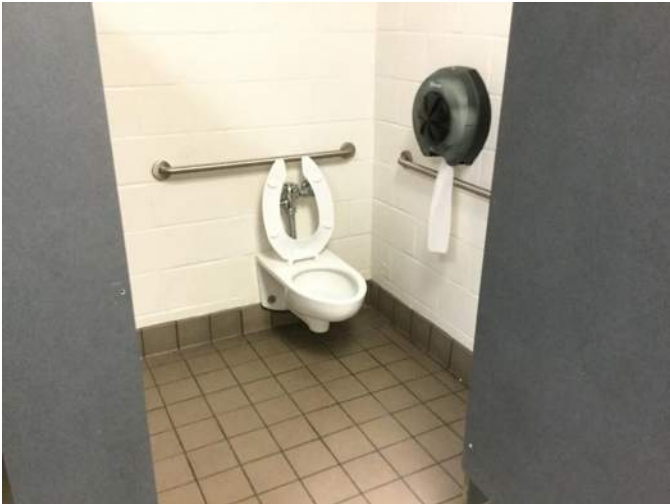
System: D2010 - Plumbing Fixtures

Location: Restrooms
Distress: Beyond Expected Life
Category: Deferred Maintenance
Priority: 3 - Necessary (Years 2-5)
Correction: Renew System
Qty: 35,805.00
Unit of Measure: S.F.
Estimate: \$255,612.00
Assessor Name: Eduardo Lopez
Date Created: 03/25/2021

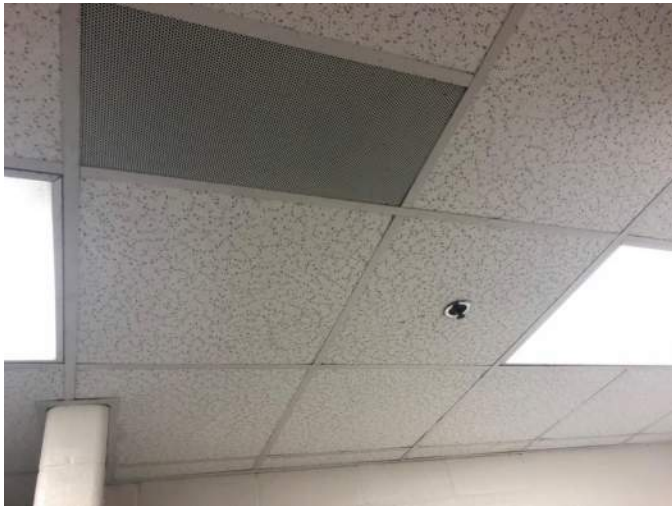
System: D3040 - Distribution Systems

Location: Throughout Building
Distress: Beyond Expected Life
Category: Deferred Maintenance
Priority: 3 - Necessary (Years 2-5)
Correction: Renew System
Qty: 35,805.00
Unit of Measure: S.F.
Estimate: \$597,084.00
Assessor Name: Eduardo Lopez
Date Created: 03/24/2021

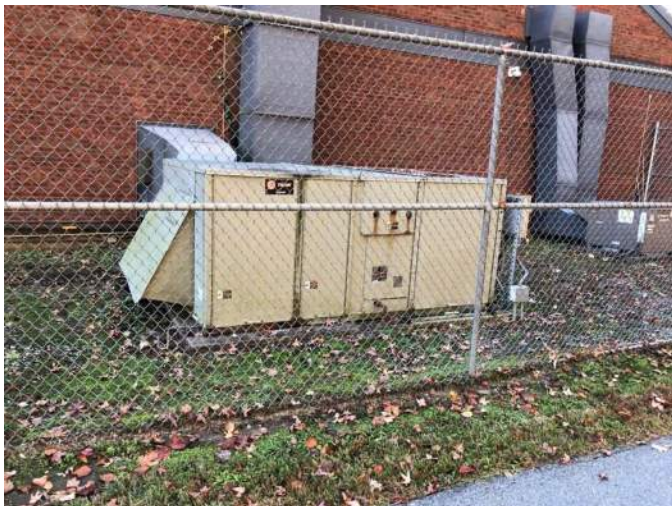
System: D3050 - Terminal & Package Units

Location: Exterior Elevation
Distress: Beyond Expected Life
Category: Deferred Maintenance
Priority: 3 - Necessary (Years 2-5)
Correction: Renew System
Qty: 35,805.00
Unit of Measure: S.F.
Estimate: \$427,333.00
Assessor Name: Eduardo Lopez
Date Created: 01/29/2020

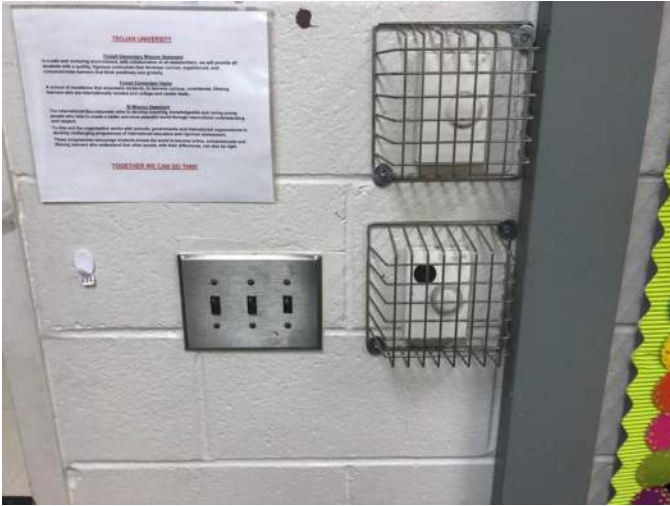
System: D3060 - Controls & Instrumentation

Location: Throughout Building
Distress: Beyond Expected Life
Category: Deferred Maintenance
Priority: 3 - Necessary (Years 2-5)
Correction: Renew System
Qty: 35,805.00
Unit of Measure: S.F.
Estimate: \$89,011.00
Assessor Name: Eduardo Lopez
Date Created: 03/24/2021

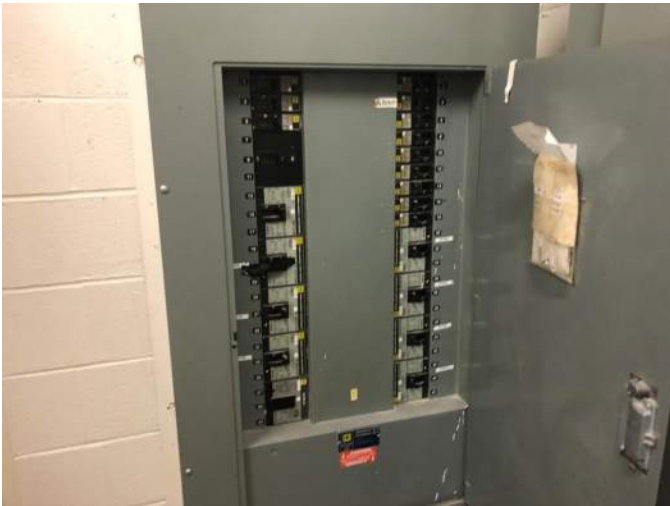
System: D5010 - Electrical Service/Distribution

Location: Throughout Building
Distress: Beyond Expected Life
Category: Deferred Maintenance
Priority: 3 - Necessary (Years 2-5)
Correction: Renew System
Qty: 35,805.00
Unit of Measure: S.F.
Estimate: \$90,193.00
Assessor Name: Eduardo Lopez
Date Created: 03/24/2021
