Atlanta Public Schools/ N. Atlanta Cluster

Garden Hills Elementary School

Revised
School Assessment Report

November 10, 2020

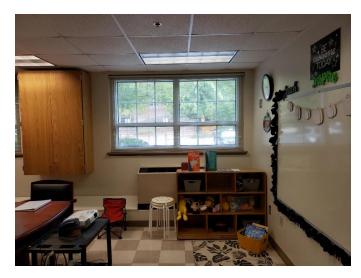
System: D3040 - Distribution Systems

Location: Bldg 2020 and Bldg 2011

Distress: Inadequate **Category:** Environmental

Notes: The Building 2020 area has poor ventilation with high moisture condition and its cause is unknown. Building 2011 in Classrooms 2230 and 228 have a strong moist smell and the cause is also unknown and is recommended to be inspected by a specialist.

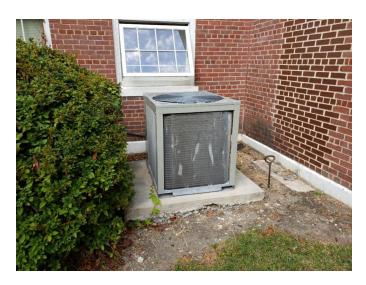
System: D3050 - Terminal & Package Units

Location: Throughout Building **Distress:** Beyond Expected Life **Category:** Deferred Maintenance **Priority:** 3 - Necessary (Years 2-5)

Notes: The terminal and package units are beyond its expected service life and should be scheduled for replacement.

Correction: Renew System

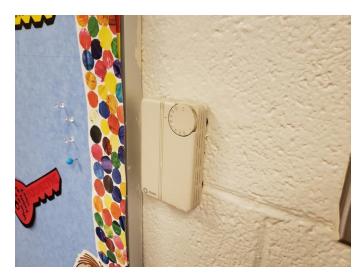
System: D3060 - Controls & Instrumentation

Location: Throughout BuildingDistress: Beyond Expected LifeCategory: Deferred MaintenancePriority: 3 - Necessary (Years 2-5)

Notes: The controls and instrumentation system is beyond its expected service life and should be scheduled for replacement.

Correction: Renew System

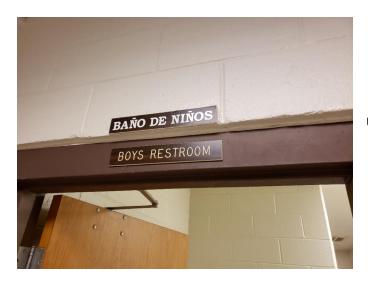
System: C1030 - Fittings

Location: Throughout Building **Distress:** Beyond Expected Life **Category:** ADA Compliance

Priority: 3 - Necessary (Years 2-5)

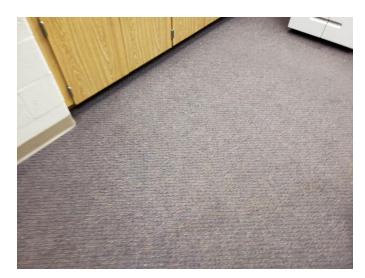
System: C3020901 - Carpet

Location: Media Center

Distress: Beyond Expected Life
Category: Deferred Maintenance
Priority: 3 - Necessary (Years 2-5)

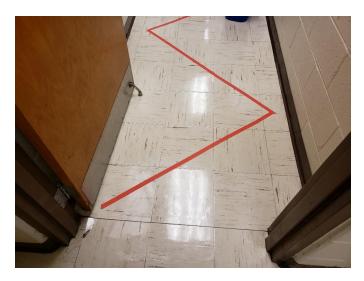
System: C3020903 - VCT

Location: Throughout Building
 Distress: Beyond Expected Life
 Category: Deferred Maintenance
 Priority: 3 - Necessary (Years 2-5)

Correction: Renew System

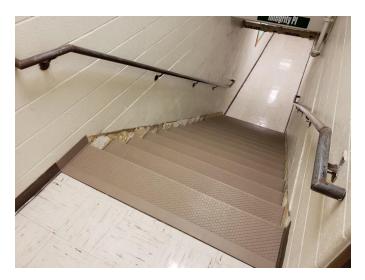
System: C3020999 - Other - Rubber or Neoprene

Location: Throughout BuildingDistress: Beyond Expected LifeCategory: Deferred MaintenancePriority: 3 - Necessary (Years 2-5)

Correction: Renew System

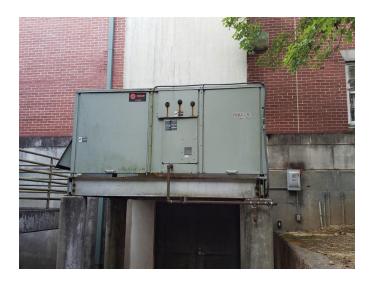
System: D3050 - Terminal & Package Units

Location: Throughout BuildingDistress: Beyond Expected LifeCategory: Deferred MaintenancePriority: 3 - Necessary (Years 2-5)

Correction: Renew System

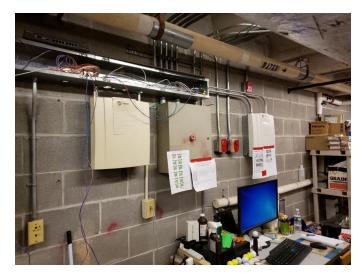
System: D3060 - Controls & Instrumentation

Location: Throughout BuildingDistress: Beyond Expected LifeCategory: Deferred MaintenancePriority: 3 - Necessary (Years 2-5)

Correction: Renew System

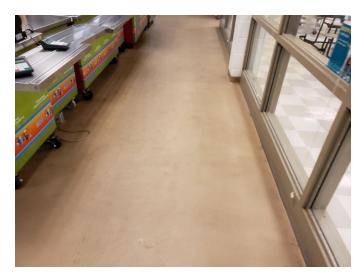
System: C3020405 - Epoxy

Location: Throughout BuildingDistress: Beyond Expected LifeCategory: Deferred MaintenancePriority: 3 - Necessary (Years 2-5)

Correction: Renew System

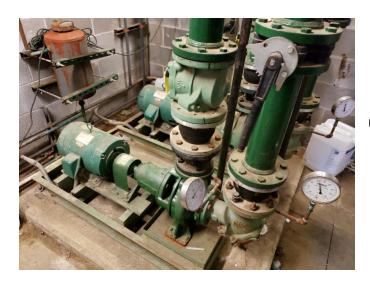
System: D3040 - Distribution Systems

Location: Throughout BuildingDistress: Beyond Expected LifeCategory: Deferred MaintenancePriority: 3 - Necessary (Years 2-5)

Correction: Renew System

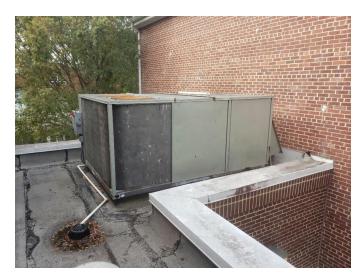
System: D3050 - Terminal & Package Units

Location: Throughout BuildingDistress: Beyond Expected LifeCategory: Deferred MaintenancePriority: 3 - Necessary (Years 2-5)

Correction: Renew System

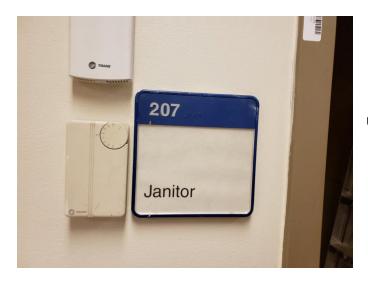
System: D3060 - Controls & Instrumentation

Location: Throughout BuildingDistress: Beyond Expected LifeCategory: Deferred MaintenancePriority: 3 - Necessary (Years 2-5)

Correction: Renew System

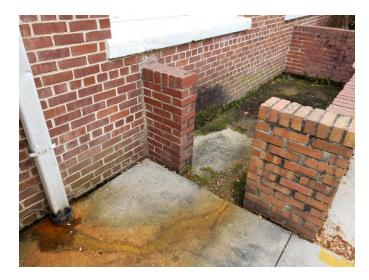
System: G3030 - Storm Sewer

Location: Exterior Wall, West.

Distress: Failing

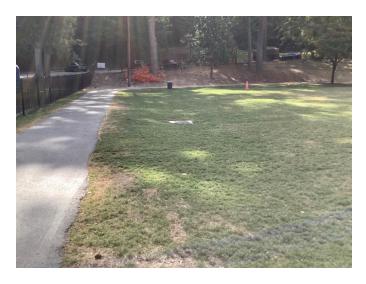
System: G2040950 - Track

Location: Throughout BuildingDistress: Beyond Expected LifeCategory: Deferred MaintenancePriority: 3 - Necessary (Years 2-5)

Correction: Renew System
