Atlanta Public Schools/ Carver Cluster

Gideons Elementary School

School Assessment Report

March 10, 2021

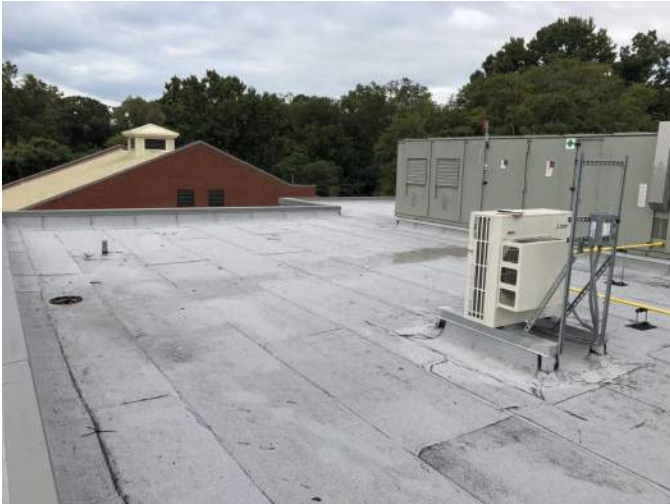
System: B3020 - Roof Openings

Location: Roof
Distress: Beyond Expected Life
Category: Deferred Maintenance
Priority: 3 - Necessary (Years 2-5)
Correction: Renew System
Qty: 17,248.00
Unit of Measure: S.F.
Estimate: \$9,866.00
Assessor Name: Jejuan Hall
Date Created: 02/19/2020

Notes: Improve roof openings during the recommended roof replacement.

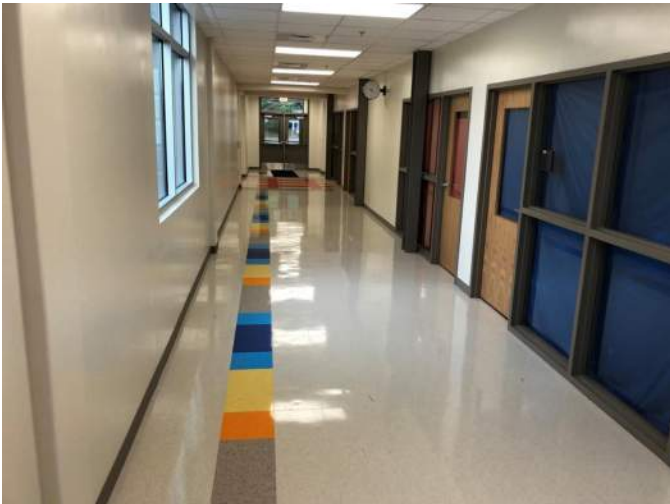
System: C3020903 - VCT

Location: Throughout Building
Distress: Beyond Expected Life
Category: Deferred Maintenance
Priority: 3 - Necessary (Years 2-5)
Correction: Renew System
Qty: 16,195.00
Unit of Measure: S.F.
Estimate: \$87,356.00
Assessor Name: Jejuan Hall
Date Created: 01/24/2020

Notes: The VCT floor finish is beyond its expected service life, faded and stained, and should be replaced.

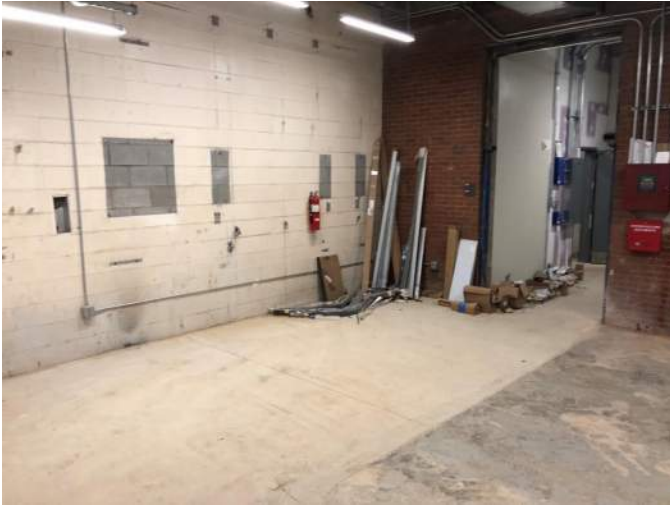
System: C3020999 - Other - Concrete Finish w/Sealer

Location: Mechanical room and electrical rooms
Distress: Beyond Expected Life
Category: Deferred Maintenance
Priority: 3 - Necessary (Years 2-5)
Correction: Renew System
Qty: 1,830.00
Unit of Measure: S.F.
Estimate: \$13,829.00
Assessor Name: Jejuan Hall
Date Created: 01/24/2020

Notes: The concrete finish is worn and should be resealed.

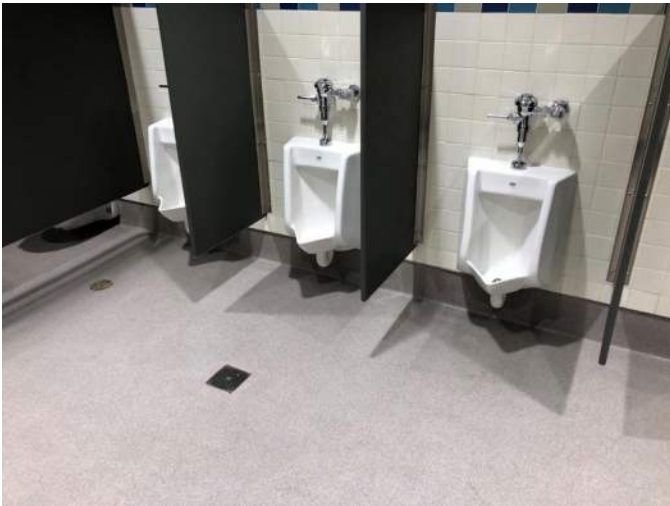
System: C3020999 - Other - Vinyl Sheet

Location: bathrooms
Distress: Beyond Expected Life
Category: Deferred Maintenance
Priority: 3 - Necessary (Years 2-5)
Correction: Renew System
Qty: 602.00
Unit of Measure: S.F.
Estimate: \$4,549.00
Assessor Name: Jejuan Hall
Date Created: 01/24/2020

Notes: The vinyl sheet floor finish is beyond its expected service life and is recommended for replacement.

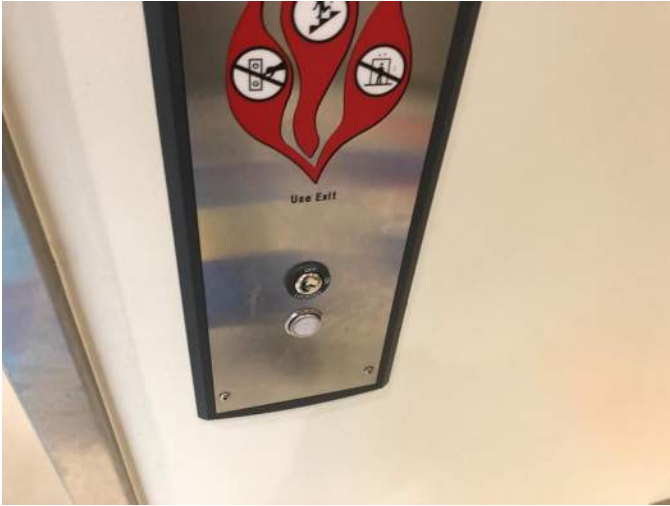
System: D1010 - Elevators and Lifts

Location: Throughout building
Distress: Beyond Expected Life
Category: Deferred Maintenance
Priority: 3 - Necessary (Years 2-5)
Correction: Renew System
Qty: 18,627.00
Unit of Measure: S.F.
Estimate: \$27,251.00
Assessor Name: Jejuan Hall
Date Created: 09/17/2015

Notes: The elevator system has exceeded its life cycle and recommended for upgrade. All aspects of the current ADA standards are expected to be included in the new installation.

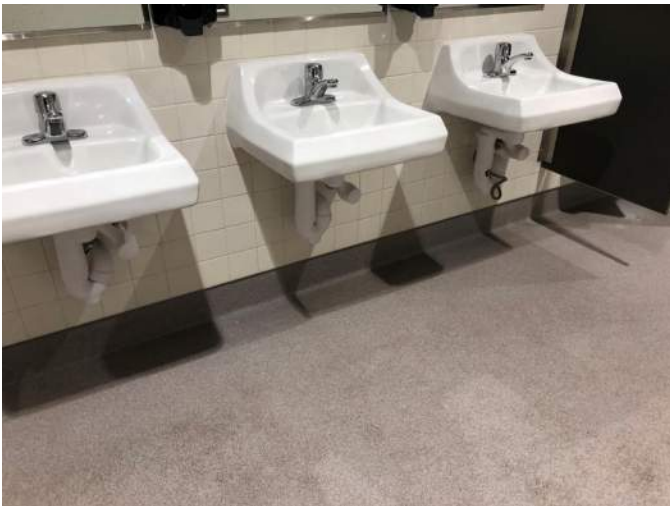
System: D2010 - Plumbing Fixtures

Location: Restroom
Distress: Beyond Expected Life
Category: ADA Compliance
Priority: 3 - Necessary (Years 2-5)
Correction: Renew System
Qty: 18,627.00
Unit of Measure: S.F.
Estimate: \$136,257.00
Assessor Name: Jejuan Hall
Date Created: 09/17/2015

Notes: Plumbing fixtures are beyond their expected service life and should be replaced and upgraded for ADA compliance.

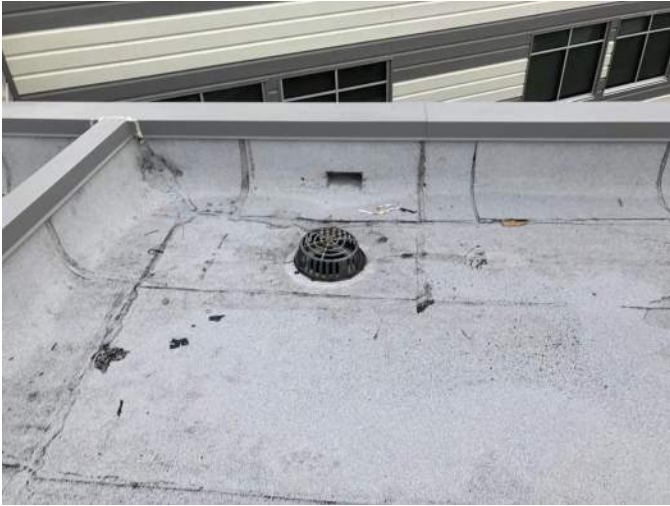
System: D2040 - Rain Water Drainage

Location: Roof
Distress: Beyond Expected Life
Category: Deferred Maintenance
Priority: 3 - Necessary (Years 2-5)
Correction: Renew System
Qty: 18,627.00
Unit of Measure: S.F.
Estimate: \$8,401.00
Assessor Name: Jejuan Hall
Date Created: 09/04/2013

Notes: The roof drains, insulation and fittings that support the water run off from this roof are original. The insulation is damaged from leaks and the drains have developed leaks. This deficiency provides a budgetary consideration for a new rainwater drainage system. This is expected to be completed as part of an overall effort to upgrade the roof and should be completed as part of the recommended roof upgrade also in this report.

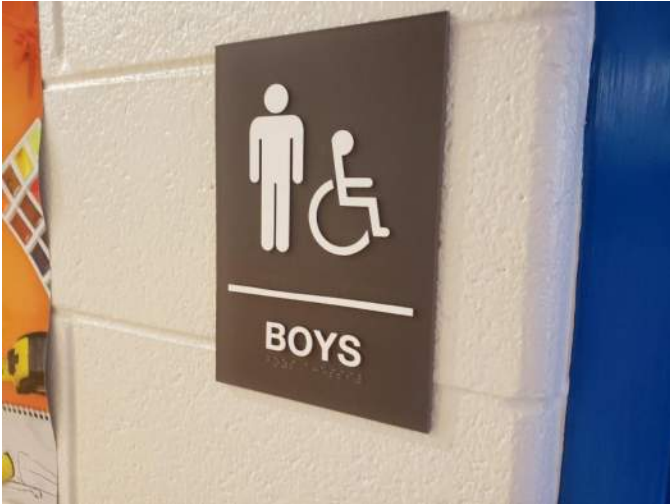
System: C1030 - Fittings

Location: Throughout Building
Distress: Beyond Expected Life
Category: ADA Compliance
Priority: 3 - Necessary (Years 2-5)
Correction: Renew System
Qty: 7,996.00
Unit of Measure: S.F.
Estimate: \$28,674.00
Assessor Name: Jejuan Hall
Date Created: 09/17/2015

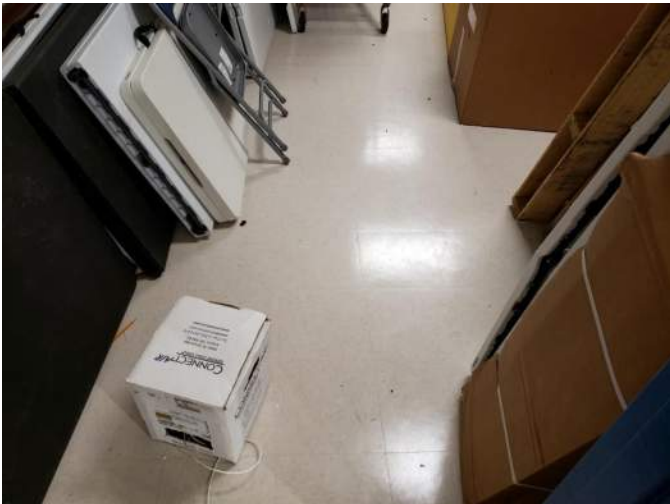
System: C3020903 - VCT

Location: Throughout Building
Distress: Beyond Expected Life
Category: Deferred Maintenance
Priority: 3 - Necessary (Years 2-5)
Correction: Renew System
Qty: 2,273.00
Unit of Measure: S.F.
Estimate: \$12,261.00
Assessor Name: Jejuan Hall
Date Created: 01/24/2020

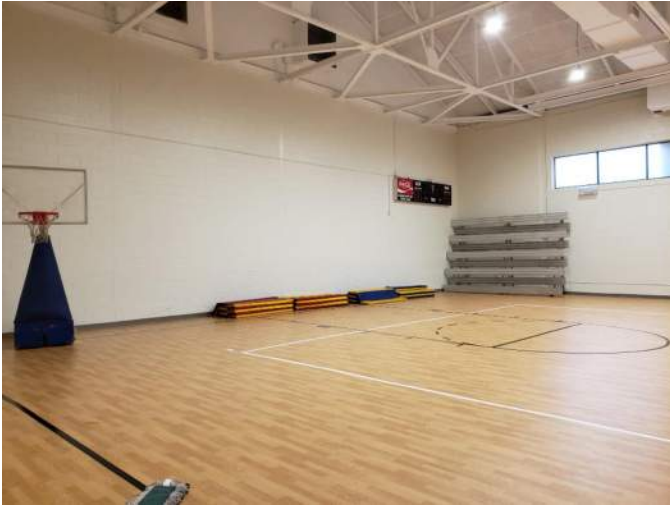
System: C3020999 - Other - Rubber or Neoprene

Location: Gym/ Multipurpose room
Distress: Beyond Expected Life
Category: Deferred Maintenance
Priority: 3 - Necessary (Years 2-5)
Correction: Renew System
Qty: 5,161.00
Unit of Measure: S.F.
Estimate: \$151,408.00
Assessor Name: Jejuan Hall
Date Created: 01/24/2020

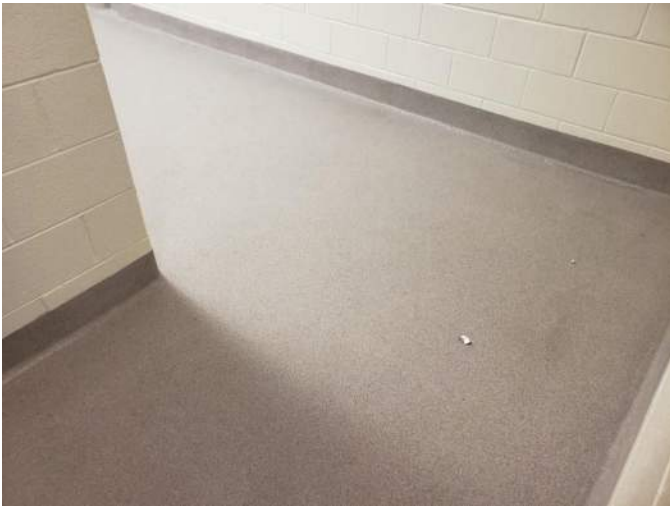
System: C3020999 - Other - Vinyl Sheet

Location: bathrooms
Distress: Beyond Expected Life
Category: Deferred Maintenance
Priority: 3 - Necessary (Years 2-5)
Correction: Renew System
Qty: 562.00
Unit of Measure: S.F.
Estimate: \$4,383.00
Assessor Name: Jejuan Hall
Date Created: 01/24/2020

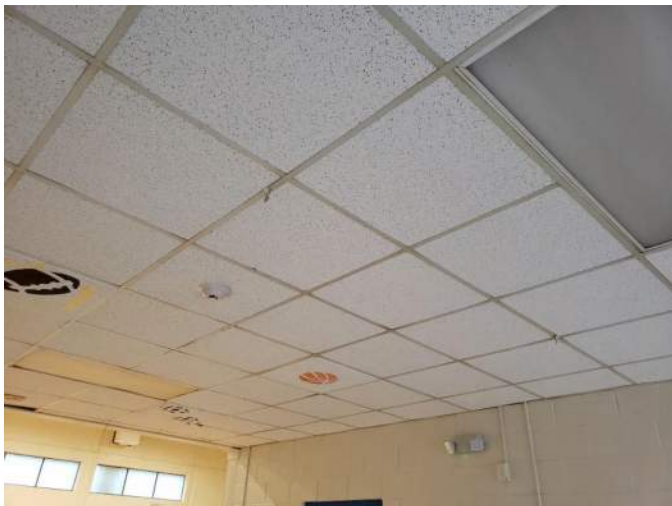
System: C3030 - Ceiling Finishes

Location: Throughout Building
Distress: Beyond Expected Life
Category: Deferred Maintenance
Priority: 3 - Necessary (Years 2-5)
Correction: Renew System
Qty: 7,996.00
Unit of Measure: S.F.
Estimate: \$97,191.00
Assessor Name: Jejuan Hall
Date Created: 09/17/2015

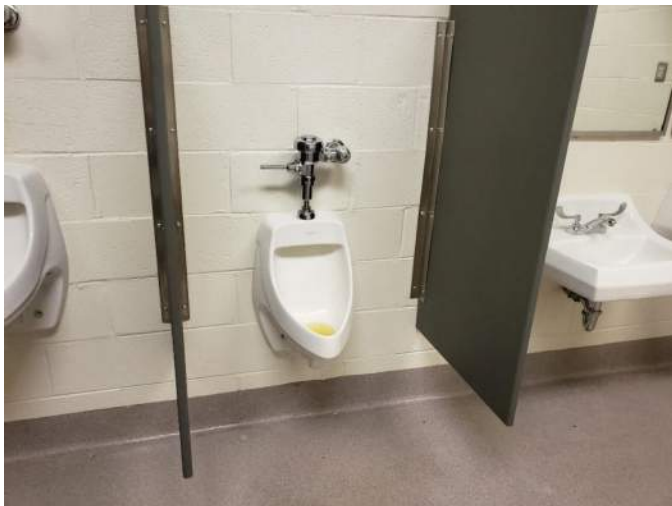
System: D2010 - Plumbing Fixtures

Location: bathrooms
Distress: Beyond Expected Life
Category: ADA Compliance
Priority: 3 - Necessary (Years 2-5)
Correction: Renew System
Qty: 7,996.00
Unit of Measure: S.F.
Estimate: \$68,870.00
Assessor Name: Jejuan Hall
Date Created: 09/17/2015

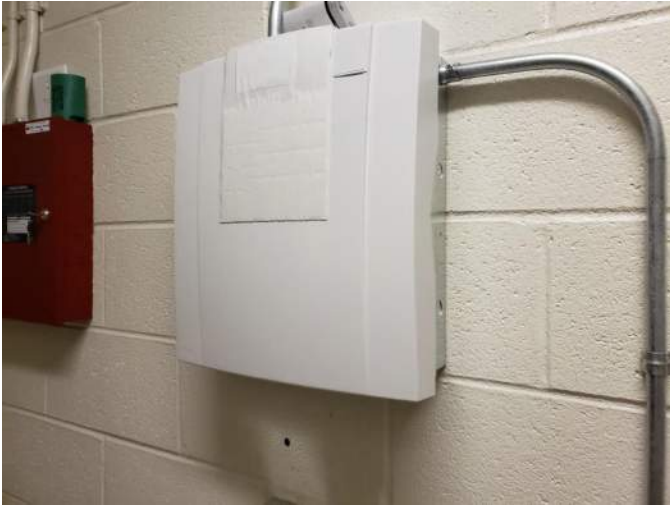
System: D3060 - Controls & Instrumentation

Location: Mechanical room
Distress: Beyond Expected Life
Category: Deferred Maintenance
Priority: 3 - Necessary (Years 2-5)
Correction: Renew System
Qty: 7,996.00
Unit of Measure: S.F.
Estimate: \$23,924.00
Assessor Name: Jejuan Hall
Date Created: 08/13/2014

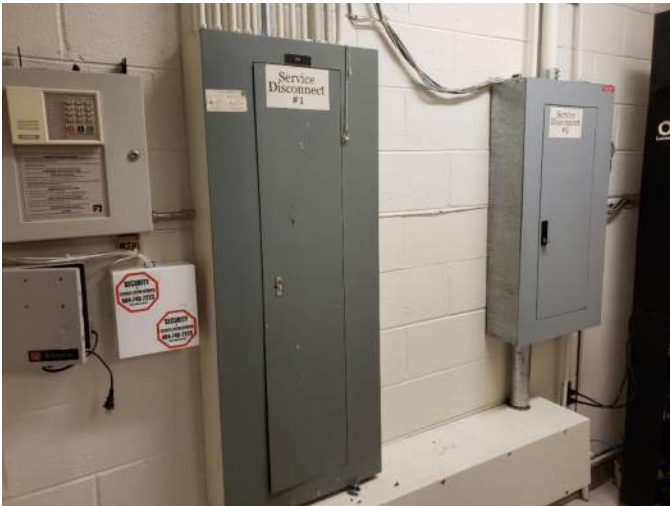
System: D5010 - Electrical Service/Distribution

Location: Throughout Building
Distress: Beyond Expected Life
Category: Deferred Maintenance
Priority: 3 - Necessary (Years 2-5)
Correction: Renew System
Qty: 7,996.00
Unit of Measure: S.F.
Estimate: \$24,716.00
Assessor Name: Jejuan Hall
Date Created: 09/17/2015

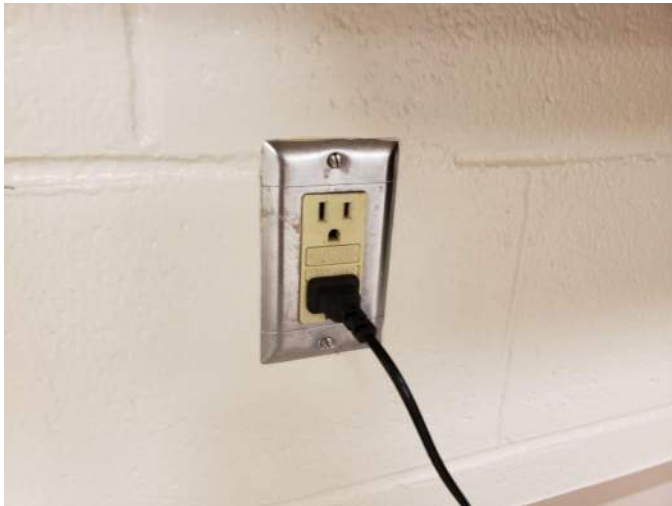
System: D5020 - Branch Wiring

Location: Throughout Building
Distress: Beyond Expected Life
Category: Deferred Maintenance
Priority: 3 - Necessary (Years 2-5)
Correction: Renew System
Qty: 7,996.00
Unit of Measure: S.F.
Estimate: \$51,366.00
Assessor Name: Jejuan Hall
Date Created: 09/17/2015

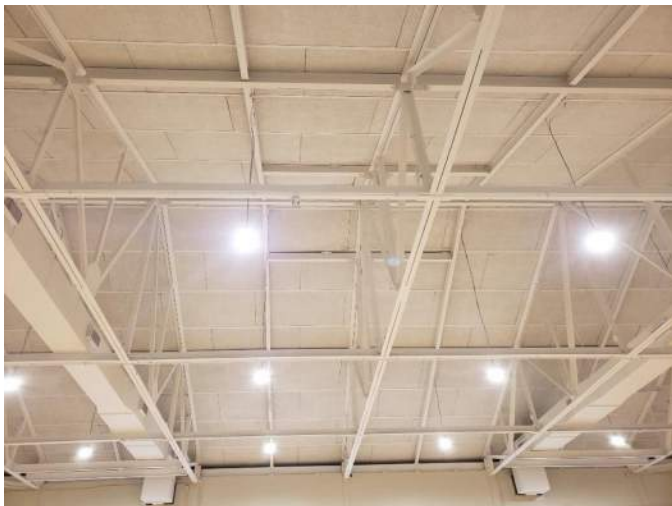
System: D5020 - Lighting

Location: Throughout Building
Distress: Beyond Expected Life
Category: Deferred Maintenance
Priority: 3 - Necessary (Years 2-5)
Correction: Renew System
Qty: 7,996.00
Unit of Measure: S.F.
Estimate: \$77,049.00
Assessor Name: Jejuan Hall
Date Created: 10/09/2019

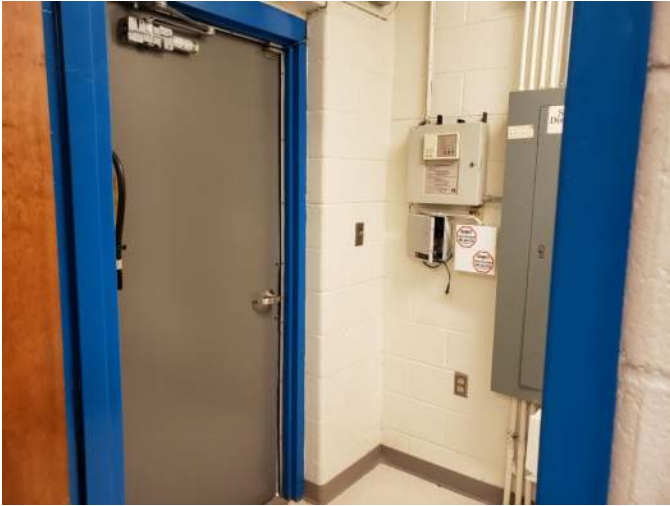
System: D5030810 - Security & Detection Systems

Location: Throughout Building
Distress: Beyond Expected Life
Category: Deferred Maintenance
Priority: 3 - Necessary (Years 2-5)
Correction: Renew System
Qty: 7,996.00
Unit of Measure: S.F.
Estimate: \$13,281.00
Assessor Name: Jejuan Hall
Date Created: 10/09/2019

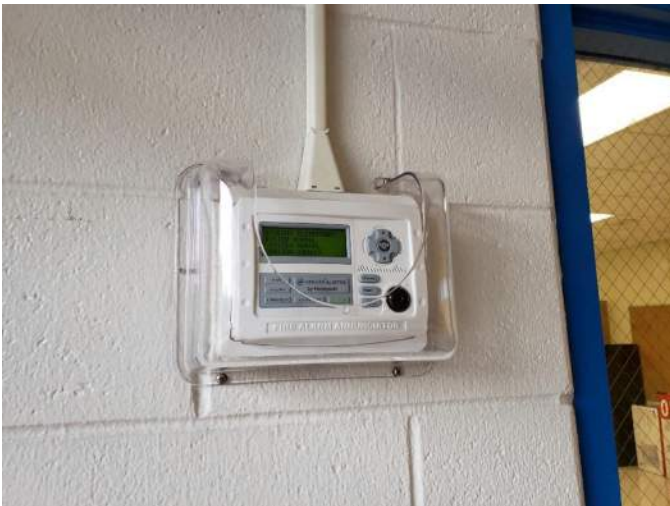
System: D5030910 - Fire Alarm Systems

Location: Throughout Building
Distress: Beyond Expected Life
Category: Deferred Maintenance
Priority: 3 - Necessary (Years 2-5)
Correction: Renew System
Qty: 7,996.00
Unit of Measure: S.F.
Estimate: \$24,100.00
Assessor Name: Jejuan Hall
Date Created: 10/09/2019

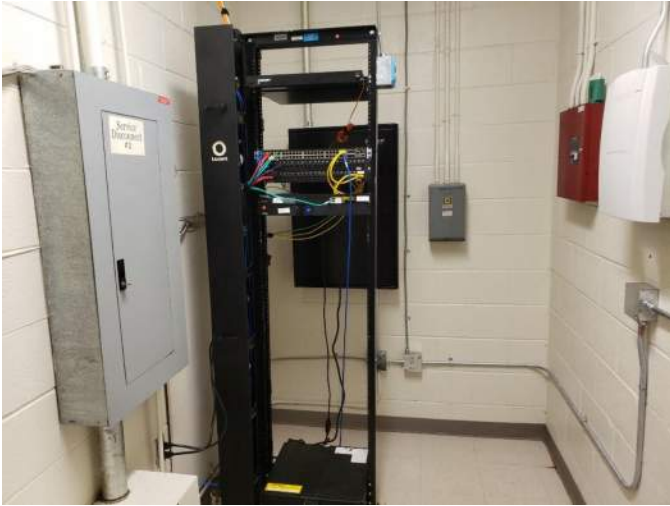
System: D5030920 - Data Communication

Location: MDF, IDF and Main Office
Distress: Beyond Expected Life
Category: Deferred Maintenance
Priority: 3 - Necessary (Years 2-5)
Correction: Renew System
Qty: 7,996.00
Unit of Measure: S.F.
Estimate: \$31,312.00
Assessor Name: Jejuan Hall
Date Created: 10/09/2019

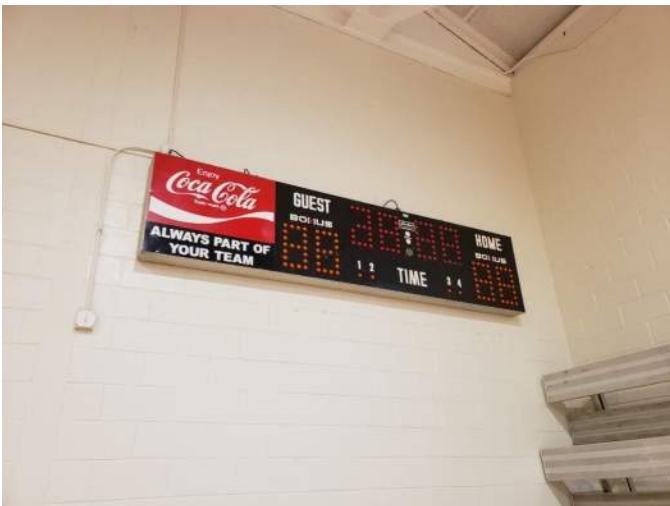
System: E1090 - Other Equipment

Location: Throughout Building
Distress: Beyond Expected Life
Category: Deferred Maintenance
Priority: 3 - Necessary (Years 2-5)
Correction: Renew System
Qty: 7,996.00
Unit of Measure: S.F.
Estimate: \$8,444.00
Assessor Name: Jejuan Hall
Date Created: 09/17/2015

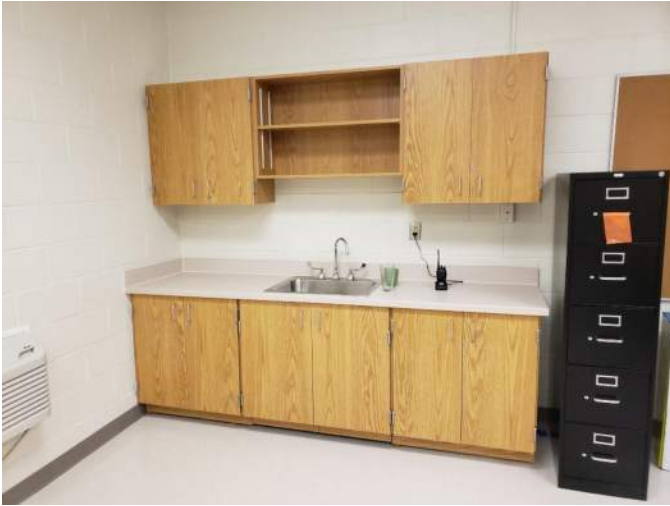
System: E2010 - Fixed Furnishings

Location: Throughout Building
Distress: Beyond Expected Life
Category: Deferred Maintenance
Priority: 3 - Necessary (Years 2-5)
Correction: Renew System
Qty: 7,996.00
Unit of Measure: S.F.
Estimate: \$20,670.00
Assessor Name: Jejuan Hall
Date Created: 09/17/2015
