Atlanta Public Schools/ Grady Cluster

Grady High School

School Assessment Report

November 10, 2020

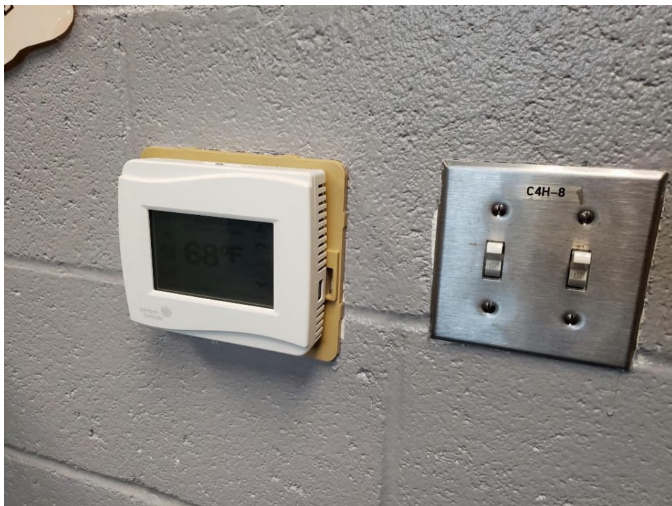
System: D3060 - Controls & Instrumentation

Location: Throughout Building
Distress: Beyond Expected Life
Category: Deferred Maintenance
Priority: 3 - Necessary (Years 2-5)
Correction: Renew System
Qty: 66,005.00
Unit of Measure: S.F.
Estimate: \$164,088.00
Assessor Name: Eduardo Lopez
Date Created: 10/01/2019

Notes: The system is beyond its expected service life and should be scheduled for replacement.

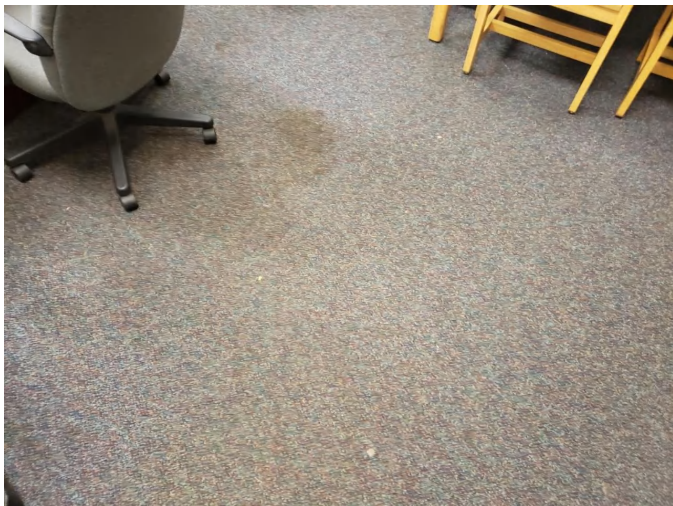
System: C3020901 - Carpet

Location: Throughout Building
Distress: Beyond Expected Life
Category: Deferred Maintenance
Priority: 3 - Necessary (Years 2-5)
Correction: Renew System
Qty: 406.00
Unit of Measure: S.F.
Estimate: \$3,350.00
Assessor Name: Homero Guerrero
Date Created: 01/30/2020

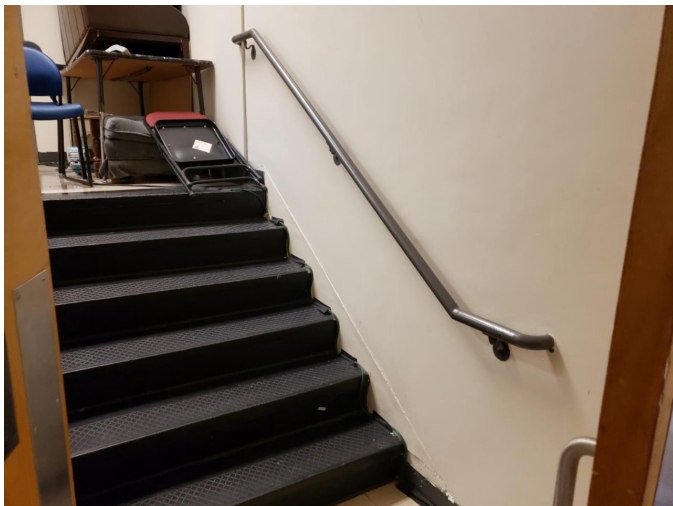
System: C3020999 - Other - Rubber or Neoprene

Location: Throughout Building
Distress: Beyond Expected Life
Category: Deferred Maintenance
Priority: 3 - Necessary (Years 2-5)
Correction: Renew System
Qty: 1,480.00
Unit of Measure: S.F.
Estimate: \$43,419.00
Assessor Name: Homero Guerrero
Date Created: 01/30/2020

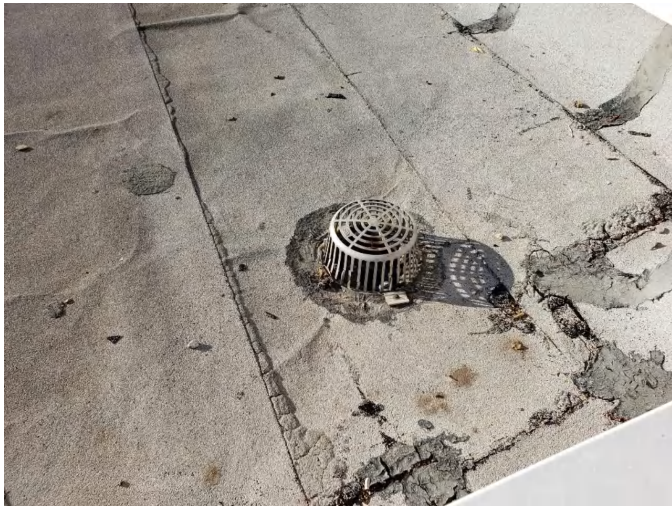
System: D2040 - Rain Water Drainage

Location: Roof
Distress: Beyond Expected Life
Category: Deferred Maintenance
Priority: 3 - Necessary (Years 2-5)
Correction: Renew System
Qty: 33,113.00
Unit of Measure: S.F.
Estimate: \$16,391.00
Assessor Name: Homero Guerrero
Date Created: 08/20/2013

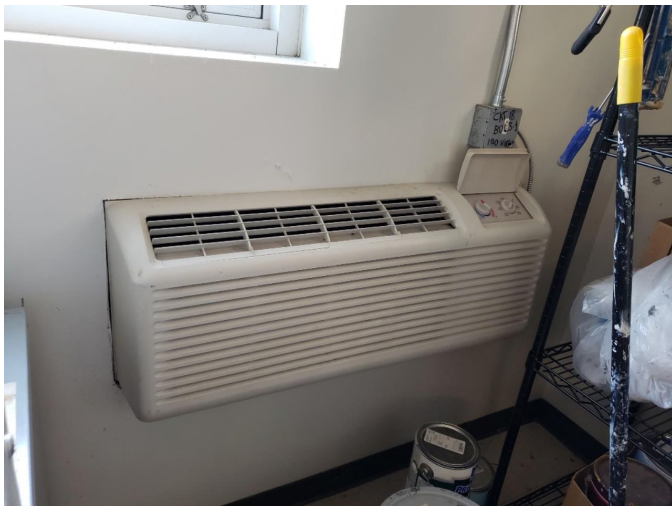
System: D3050 - Terminal & Package Units

Location: Throughout Building
Distress: Beyond Expected Life
Category: Deferred Maintenance
Priority: 3 - Necessary (Years 2-5)
Correction: Renew System
Qty: 33,113.00
Unit of Measure: S.F.
Estimate: \$232,023.00
Assessor Name: Homero Guerrero
Date Created: 09/27/2019

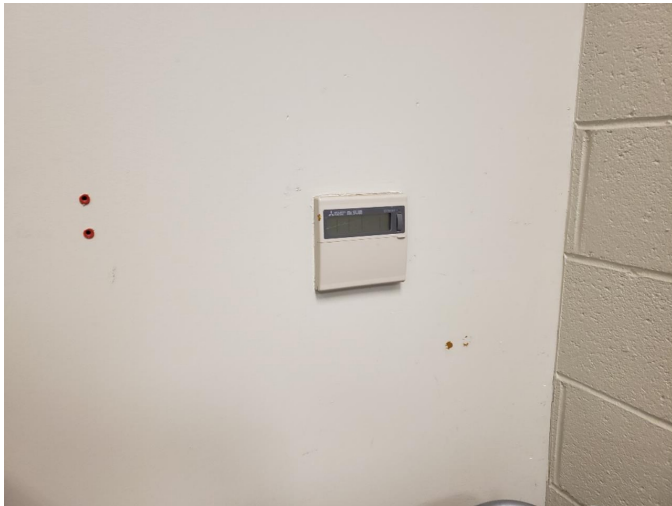
System: D3060 - Controls & Instrumentation

Location: Throughout Building
Distress: Beyond Expected Life
Category: Deferred Maintenance
Priority: 3 - Necessary (Years 2-5)
Correction: Renew System
Qty: 33,113.00
Unit of Measure: S.F.
Estimate: \$80,133.00
Assessor Name: Homero Guerrero
Date Created: 10/01/2019

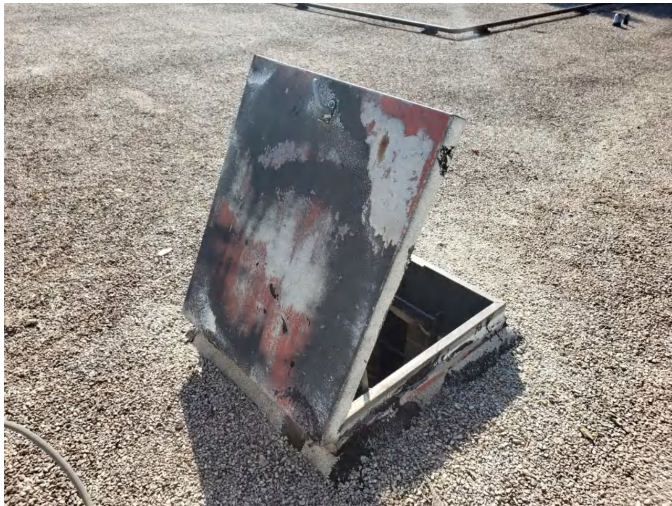
System: B3020 - Roof Openings

Location: Roof
Distress: Beyond Expected Life
Category: Deferred Maintenance
Priority: 2 - Trending Critical (Year 1)
Correction: Renew System
Qty: 44,588.00
Unit of Measure: S.F.
Estimate: \$27,466.00
Assessor Name: Homero Guerrero
Date Created: 08/20/2013

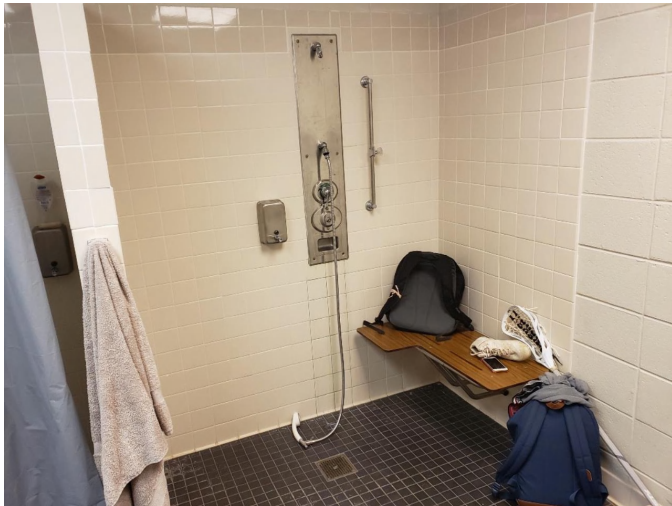
System: C3010220 - Tile

Location: Throughout Building
Distress: Beyond Expected Life
Category: Deferred Maintenance
Priority: 3 - Necessary (Years 2-5)
Correction: Renew System
Qty: 3,136.00
Unit of Measure: S.F.
Estimate: \$43,512.00
Assessor Name: Homero Guerrero
Date Created: 01/30/2020

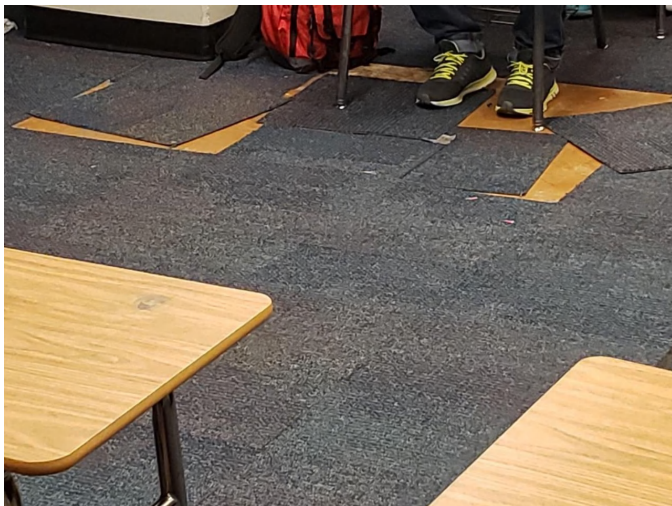
System: C3020901 - Carpet

Location: Throughout Building
Distress: Beyond Expected Life
Category: Deferred Maintenance
Priority: 3 - Necessary (Years 2-5)
Correction: Renew System
Qty: 980.00
Unit of Measure: S.F.
Estimate: \$8,085.00
Assessor Name: Homero Guerrero
Date Created: 01/30/2020

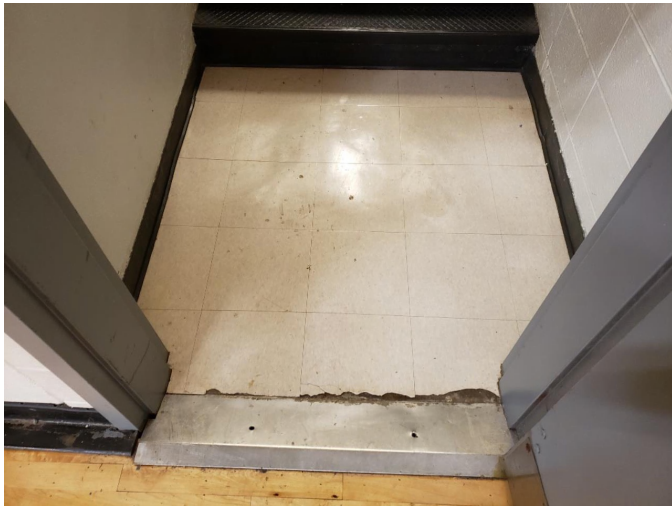
System: C3020903 - VCT

Location: Throughout Building
Distress: Beyond Expected Life
Category: Deferred Maintenance
Priority: 3 - Necessary (Years 2-5)
Correction: Renew System
Qty: 22,017.00
Unit of Measure: S.F.
Estimate: \$118,760.00
Assessor Name: Homero Guerrero
Date Created: 01/30/2020

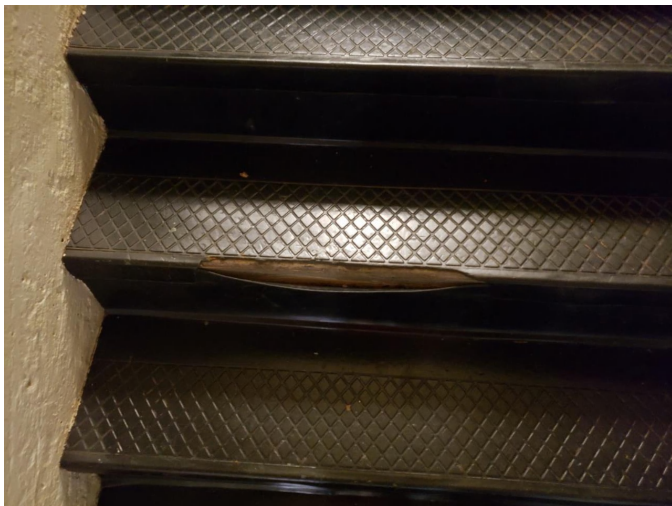
System: C3020999 - Other - Rubber or Neoprene

Location: Throughout Building
Distress: Beyond Expected Life
Category: Deferred Maintenance
Priority: 3 - Necessary (Years 2-5)
Correction: Renew System
Qty: 114.00
Unit of Measure: S.F.
Estimate: \$3,344.00
Assessor Name: Homero Guerrero
Date Created: 01/30/2020

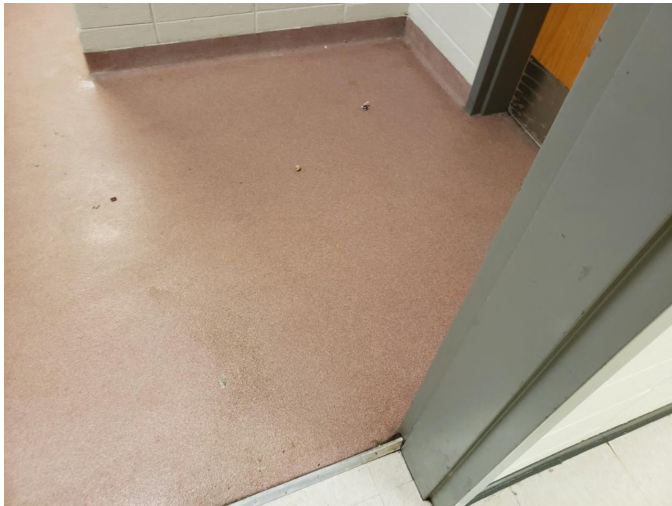
System: C3020999 - Other - Vinyl Sheet

Location: Throughout Building
Distress: Beyond Expected Life
Category: Deferred Maintenance
Priority: 3 - Necessary (Years 2-5)
Correction: Renew System
Qty: 3,392.00
Unit of Measure: S.F.
Estimate: \$26,454.00
Assessor Name: Homero Guerrero
Date Created: 01/30/2020

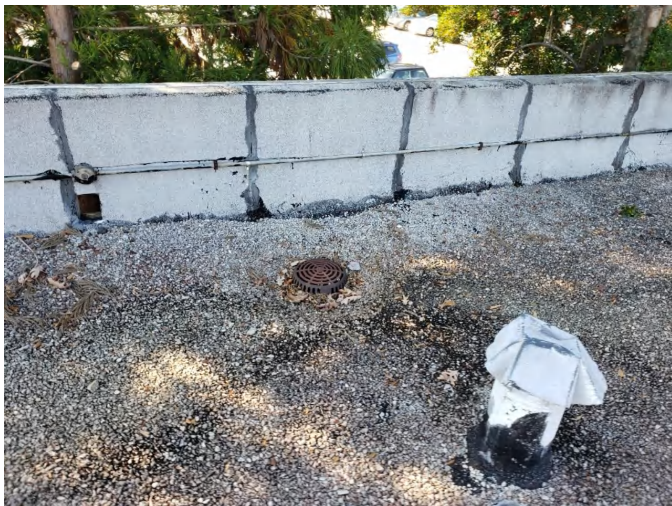
System: D2040 - Rain Water Drainage

Location: Roof
Distress: Beyond Expected Life
Category: Deferred Maintenance
Priority: 3 - Necessary (Years 2-5)
Correction: Renew System
Qty: 44,588.00
Unit of Measure: S.F.
Estimate: \$22,071.00
Assessor Name: Homero Guerrero
Date Created: 08/13/2014

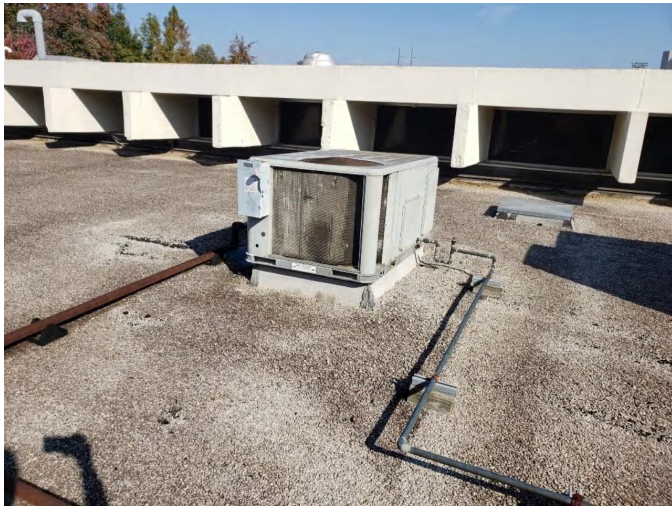
System: D3050 - Terminal & Package Units

Location: Throughout Building
Distress: Beyond Expected Life
Category: Deferred Maintenance
Priority: 3 - Necessary (Years 2-5)
Correction: Renew System
Qty: 44,588.00
Unit of Measure: S.F.
Estimate: \$109,374.00
Assessor Name: Homero Guerrero
Date Created: 10/01/2019

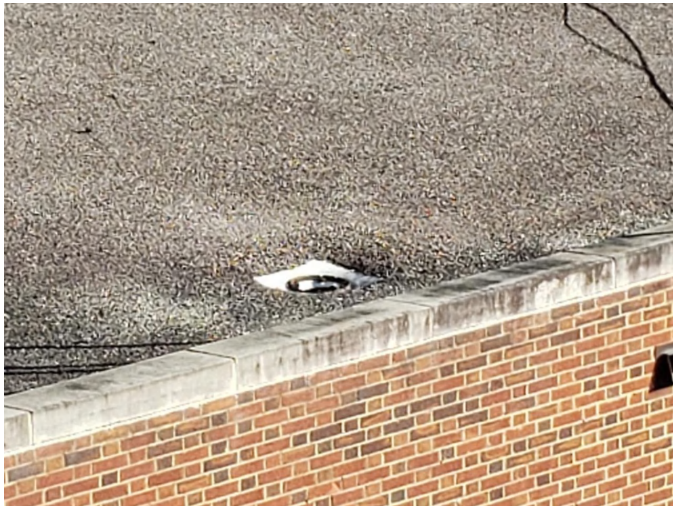
Location: Roof
Distress: Beyond Expected Life
Category: Deferred Maintenance
Priority: 3 - Necessary (Years 2-5)
Correction: Renew System
Qty: 25,891.00
Unit of Measure: S.F.
Estimate: \$12,816.00
Assessor Name: Homero Guerrero
Date Created: 08/13/2014

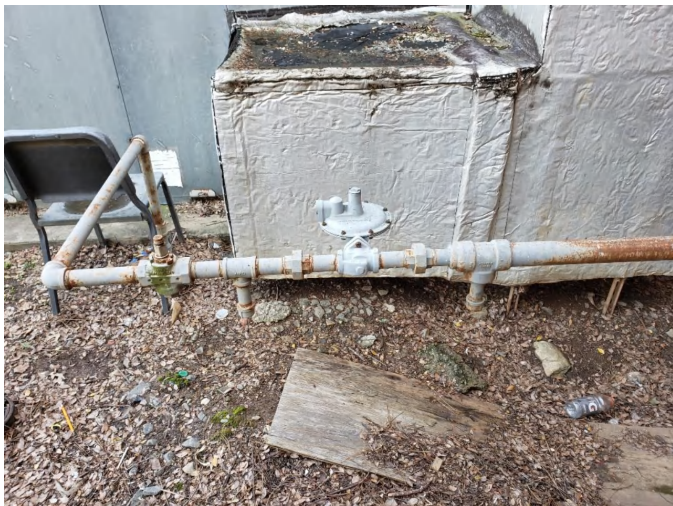
Location: Throughout Building
Distress: Beyond Expected Life
Category: Deferred Maintenance
Priority: 3 - Necessary (Years 2-5)
Correction: Renew System
Qty: 25,891.00
Unit of Measure: S.F.
Estimate: \$17,373.00
Assessor Name: Homero Guerrero
Date Created: 01/30/2020

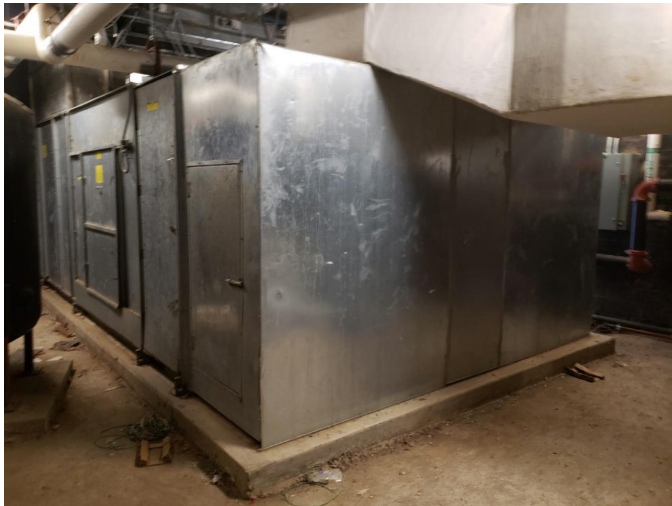
Location: Throughout Building
Distress: Beyond Expected Life
Category: Deferred Maintenance
Priority: 3 - Necessary (Years 2-5)
Correction: Renew System
Qty: 25,891.00
Unit of Measure: S.F.
Estimate: \$313,281.00
Assessor Name: Homero Guerrero
Date Created: 08/13/2014

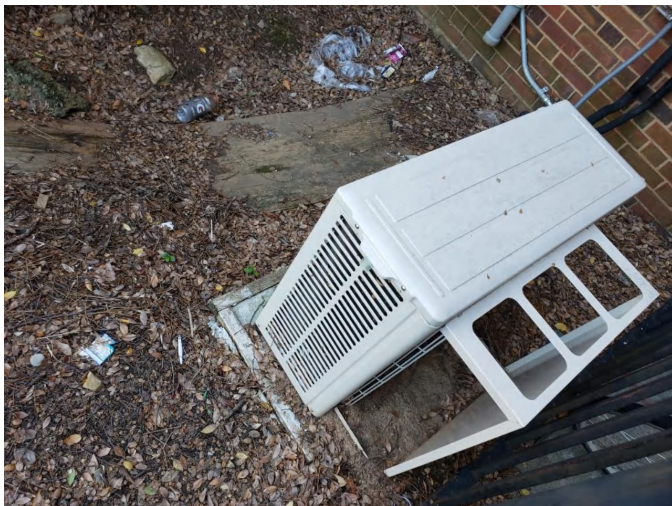
Location: Throughout Building
Distress: Beyond Expected Life
Category: Deferred Maintenance
Priority: 3 - Necessary (Years 2-5)
Correction: Renew System
Qty: 25,891.00
Unit of Measure: S.F.
Estimate: \$96,263.00
Assessor Name: Homero Guerrero
Date Created: 08/15/2013

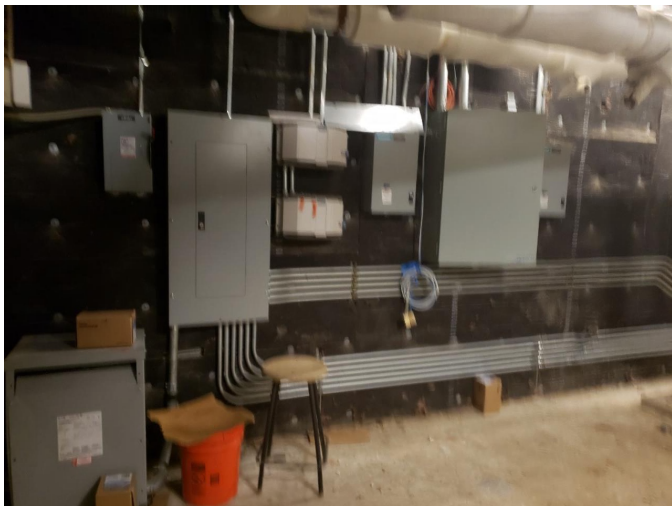
Location: Throughout Building
Distress: Beyond Expected Life
Category: Deferred Maintenance
Priority: 3 - Necessary (Years 2-5)
Correction: Renew System
Qty: 25,891.00
Unit of Measure: S.F.
Estimate: \$138,983.00
Assessor Name: Homero Guerrero
Date Created: 08/13/2014

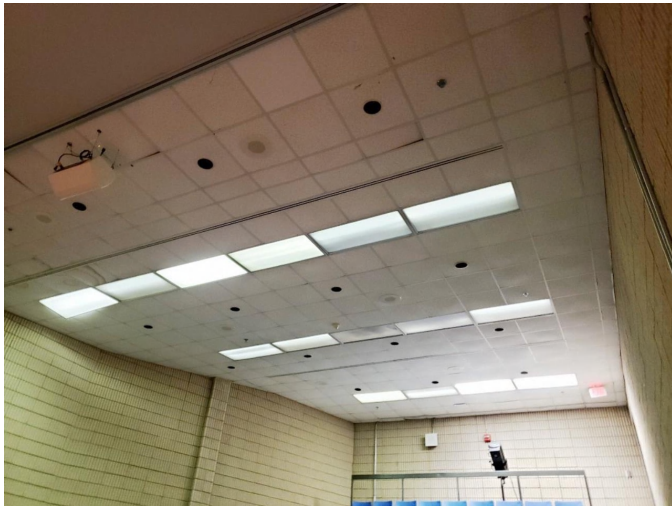
Location: Throughout Building
Distress: Beyond Expected Life
Category: Deferred Maintenance
Priority: 3 - Necessary (Years 2-5)
Correction: Renew System
Qty: 25,891.00
Unit of Measure: S.F.
Estimate: \$208,190.00
Assessor Name: Homero Guerrero
Date Created: 01/30/2020

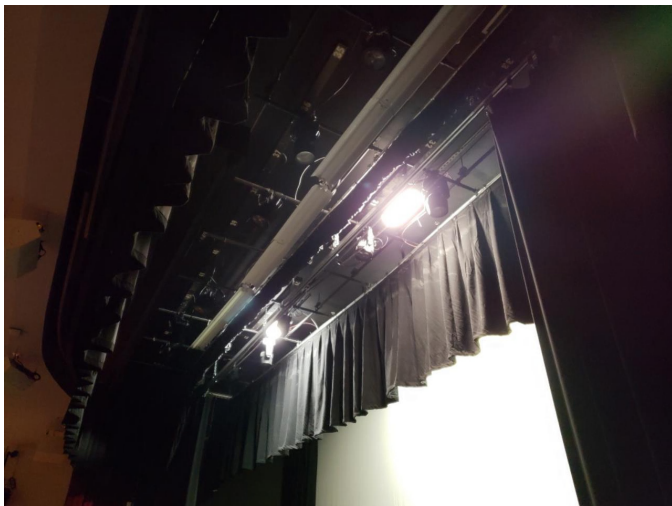
Location: Throughout Building
Distress: Beyond Expected Life
Category: Deferred Maintenance
Priority: 3 - Necessary (Years 2-5)
Correction: Renew System
Qty: 25,891.00
Unit of Measure: S.F.
Estimate: \$44,714.00
Assessor Name: Homero Guerrero
Date Created: 02/17/2020
