Atlanta Public Schools/Relocation Sites

Grove Park (Woodson Park Academy – KIPP)

School Assessment Report

November 10, 2020

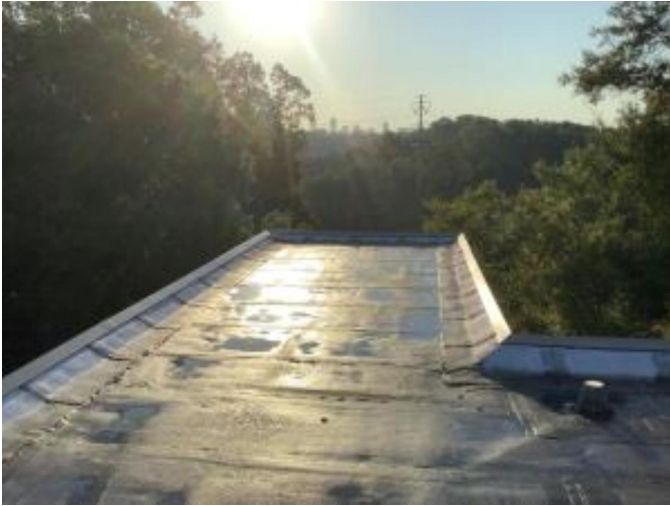
System: B3010105 - Built-Up

Location: Rooftop
Distress: Beyond Expected Life
Category: Deferred Maintenance
Priority: 3 - Necessary (Years 2-5)
Correction: Renew System
Qty: 49,328.00
Unit of Measure: S.F.
Estimate: \$553,731.00
Assessor Name: Eduardo Lopez
Date Created: 01/27/2020

Notes: The Built up roof system is beyond its expected service life and should be replaced.

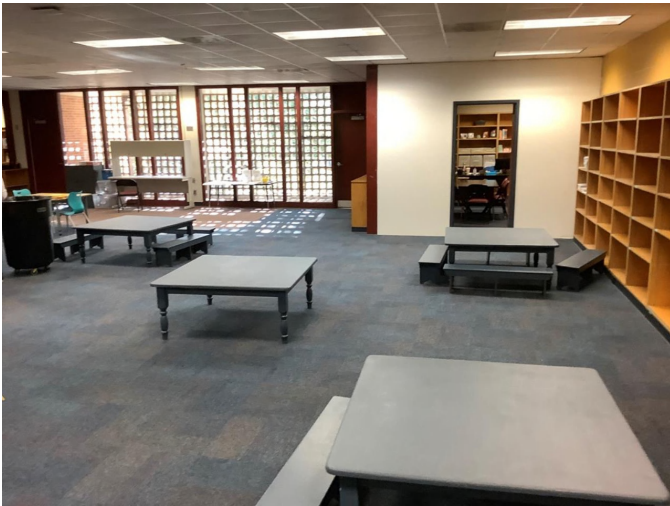
System: C3020901 - Carpet

Location: Gathering space
Distress: Beyond Expected Life
Category: Deferred Maintenance
Priority: 3 - Necessary (Years 2-5)
Correction: Renew System
Qty: 7,122.00
Unit of Measure: S.F.
Estimate: \$58,757.00
Assessor Name: Eduardo Lopez
Date Created: 12/12/2019

Notes: The carpet is aged, worn and stained, and should be replaced.

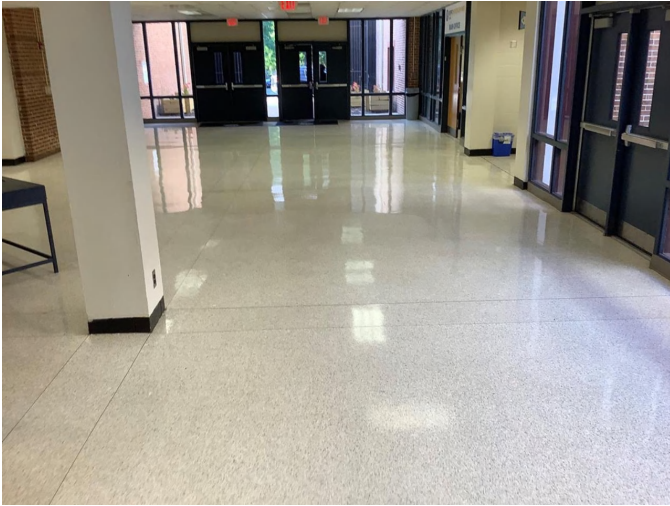
System: C3020903 - VCT

Location: Throughout Building
Distress: Beyond Expected Life
Category: Deferred Maintenance
Priority: 3 - Necessary (Years 2-5)
Correction: Renew System
Qty: 70,649.00
Unit of Measure: S.F.
Estimate: \$381,081.00
Assessor Name: Eduardo Lopez
Date Created: 01/27/2020

Notes: The VCT floor finish is beyond its expected service life, faded and stained, and should be replaced.

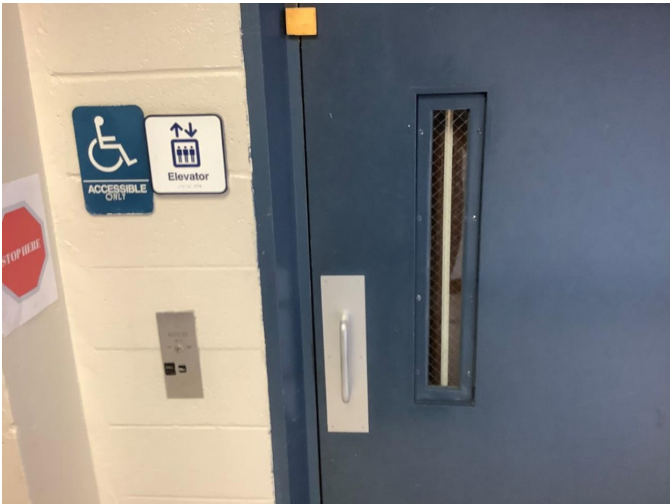
System: D1010 - Elevators and Lifts

Location: Main building
Distress: Beyond Expected Life
Category: Deferred Maintenance
Priority: 3 - Necessary (Years 2-5)
Correction: Renew System
Qty: 83,431.00
Unit of Measure: S.F.
Estimate: \$122,060.00
Assessor Name: Eduardo Lopez
Date Created: 01/27/2020

Notes: The elevator system has exceeded its life cycle and recommended for upgrade. All aspects of the current ADA standards are expected to be included in the new installation.

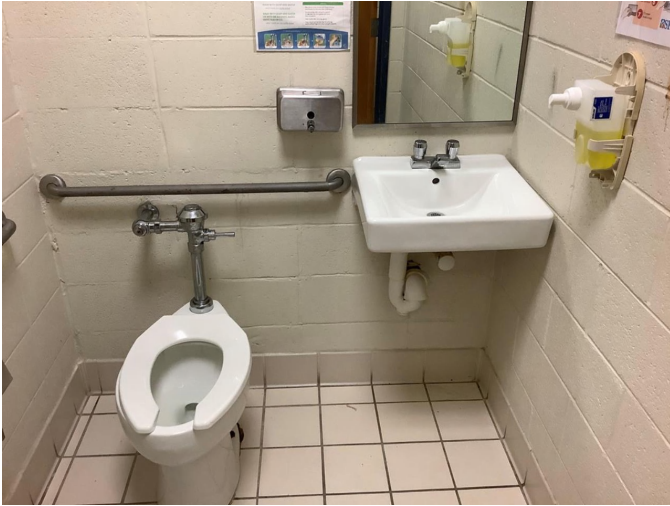
System: D2010 - Plumbing Fixtures

Location: Throughout Building
Distress: Beyond Expected Life
Category: Deferred Maintenance
Priority: 3 - Necessary (Years 2-5)
Correction: Renew System
Qty: 83,431.00
Unit of Measure: S.F.
Estimate: \$604,791.00
Assessor Name: Eduardo Lopez
Date Created: 10/06/2020

Notes: The plumbing fixtures are beyond its expected service life and should be scheduled for replacement.

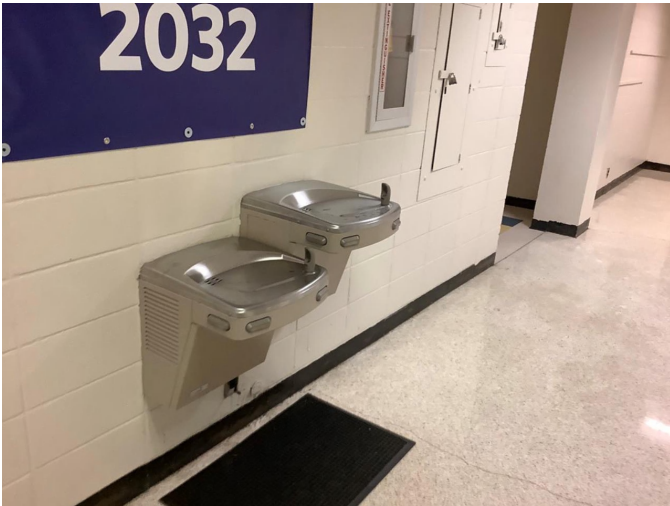
System: D2020 - Domestic Water Distribution

Location: Throughout Building
Distress: Beyond Expected Life
Category: Deferred Maintenance
Priority: 3 - Necessary (Years 2-5)
Correction: Renew System
Qty: 83,431.00
Unit of Measure: S.F.
Estimate: \$69,748.00
Assessor Name: Eduardo Lopez
Date Created: 10/06/2020

Notes: The water heater was installed in 2011. However, The the system is beyond its expected service life and should be scheduled for replacement.

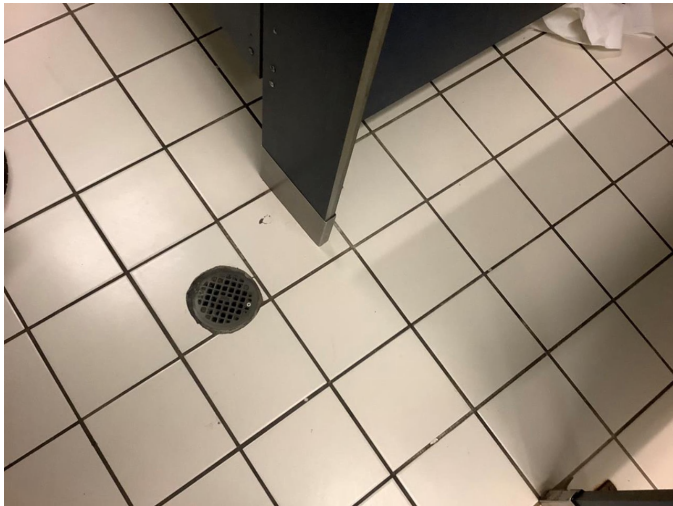
System: D2030 - Sanitary Waste

Location: Throughout Building
Distress: Beyond Expected Life
Category: Deferred Maintenance
Priority: 3 - Necessary (Years 2-5)
Correction: Renew System
Qty: 83,431.00
Unit of Measure: S.F.
Estimate: \$164,276.00
Assessor Name: Eduardo Lopez
Date Created: 10/06/2020

Notes: The sanitary waste is beyond its expected service life and should be scheduled for replacement.

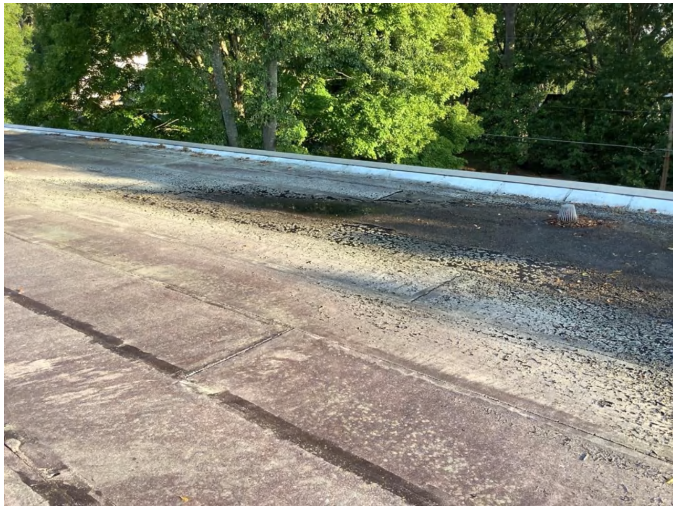
System: D2040 - Rain Water Drainage

Location: Roof
Distress: Beyond Expected Life
Category: Deferred Maintenance
Priority: 3 - Necessary (Years 2-5)
Correction: Renew System
Qty: 83,431.00
Unit of Measure: S.F.
Estimate: \$37,627.00
Assessor Name: Eduardo Lopez
Date Created: 10/06/2020

Notes: The rain water system is beyond its expected service life and should be scheduled for replacement.

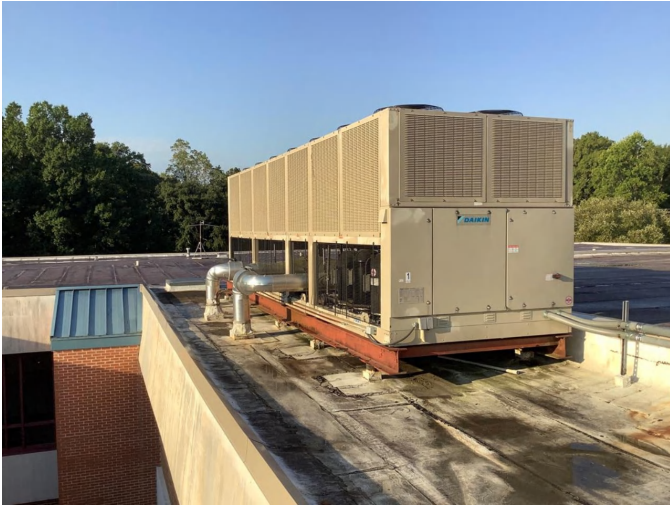
System: D3030 - Cooling Generating Systems

Location: Roof
Distress: Beyond Expected Life
Category: Deferred Maintenance
Priority: 3 - Necessary (Years 2-5)
Correction: Renew System
Qty: 83,431.00
Unit of Measure: S.F.
Estimate: \$582,766.00
Assessor Name: Eduardo Lopez
Date Created: 10/06/2020

Notes: The cooling generating system is beyond its expected service life and should be scheduled for replacement.

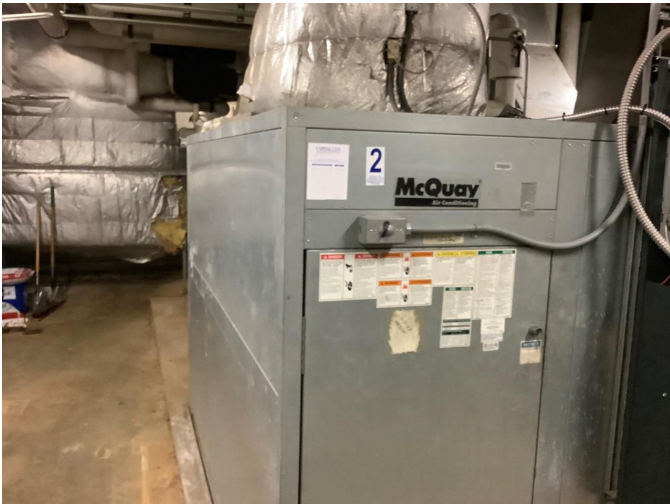
System: D3040 - Distribution Systems

Location: Throughout Building
Distress: Beyond Expected Life
Category: Deferred Maintenance
Priority: 3 - Necessary (Years 2-5)
Correction: Renew System
Qty: 83,431.00
Unit of Measure: S.F.
Estimate: \$1,137,081.00
Assessor Name: Eduardo Lopez
Date Created: 10/06/2020

Notes: The distribution system is beyond its expected service life and should be scheduled for replacement.

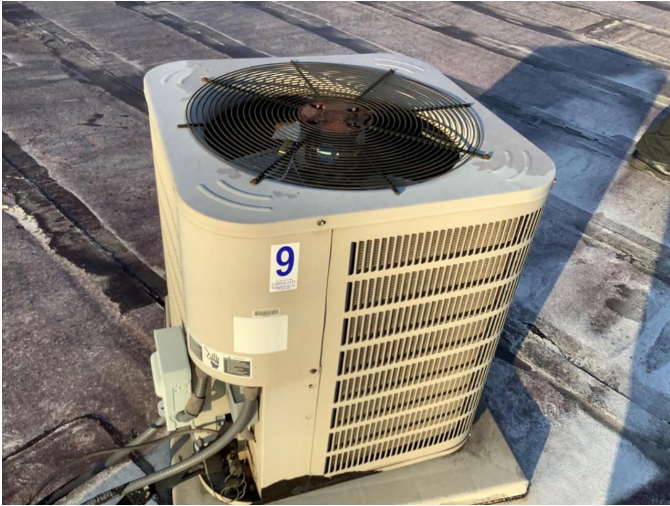
System: D3050 - Terminal & Package Units

Location: Rooftop
Distress: Beyond Expected Life
Category: Deferred Maintenance
Priority: 3 - Necessary (Years 2-5)
Correction: Renew System
Qty: 83,431.00
Unit of Measure: S.F.
Estimate: \$693,812.00
Assessor Name: Eduardo Lopez
Date Created: 09/17/2015

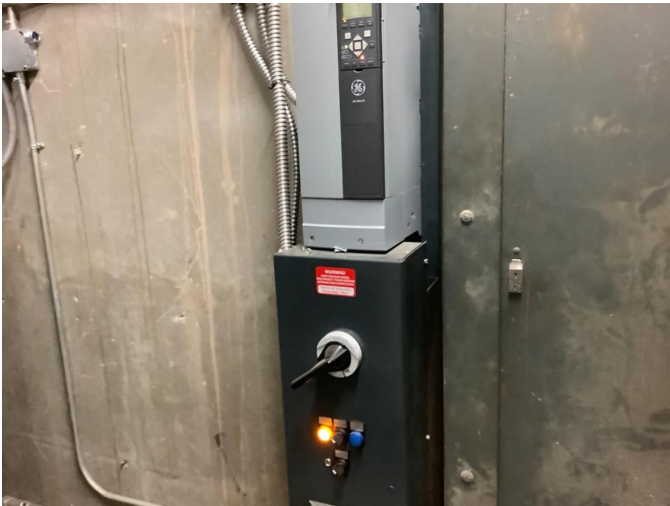
System: D3060 - Controls & Instrumentation

Location: Mechanical room
Distress: Beyond Expected Life
Category: Deferred Maintenance
Priority: 3 - Necessary (Years 2-5)
Correction: Renew System
Qty: 83,431.00
Unit of Measure: S.F.
Estimate: \$210,163.00
Assessor Name: Eduardo Lopez
Date Created: 09/17/2015

Notes: The heating generation systems, exhaust and ventilation systems, energy monitoring and controls as well as the building automation systems are beyond their expected service life and should be replaced.

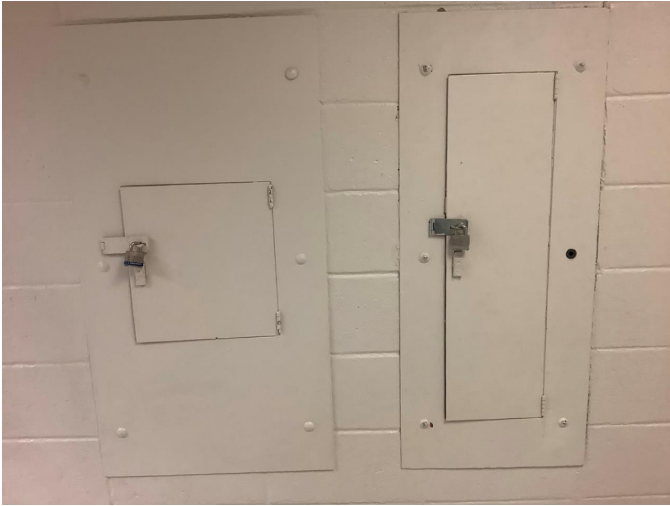
System: D5010 - Electrical Service/Distribution

Location: Throughout building
Distress: Beyond Expected Life
Category: Deferred Maintenance
Priority: 3 - Necessary (Years 2-5)
Correction: Renew System
Qty: 83,431.00
Unit of Measure: S.F.
Estimate: \$219,340.00
Assessor Name: Eduardo Lopez
Date Created: 02/21/2020

The electrical services and distribution systems consist of a service disconnect, primary main, breaker system, switch box and conduit and wiring to equipment, interior and exterior lights. This system is a mix of the old and new. However a majority of the system is original from original construction. Upgrades are recommended.

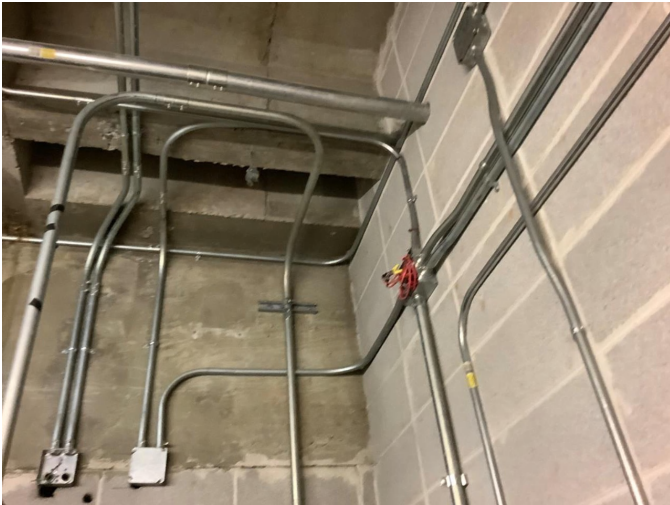
System: D5020 - Branch Wiring

Location: Throughout Building
Distress: Beyond Expected Life
Category: Deferred Maintenance
Priority: 3 - Necessary (Years 2-5)
Correction: Renew System
Qty: 83,431.00
Unit of Measure: S.F.
Estimate: \$360,672.00
Assessor Name: Eduardo Lopez
Date Created: 10/06/2020

Notes: The branch and wiring is beyond its expected service life and should be scheduled for replacement.

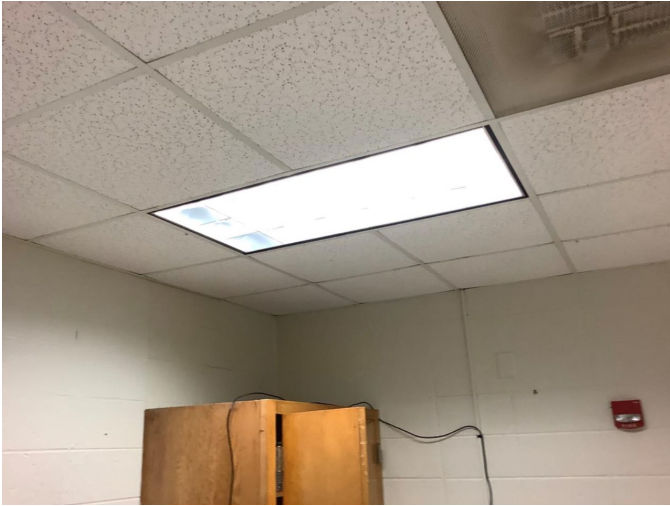
System: D5020 - Lighting

Location: Throughout Building
Distress: Beyond Expected Life
Category: Deferred Maintenance
Priority: 3 - Necessary (Years 2-5)
Correction: Renew System
Qty: 83,431.00
Unit of Measure: S.F.
Estimate: \$538,714.00
Assessor Name: Eduardo Lopez
Date Created: 10/06/2020

Notes: The lighting system is beyond its expected service life and should be scheduled for replacement.

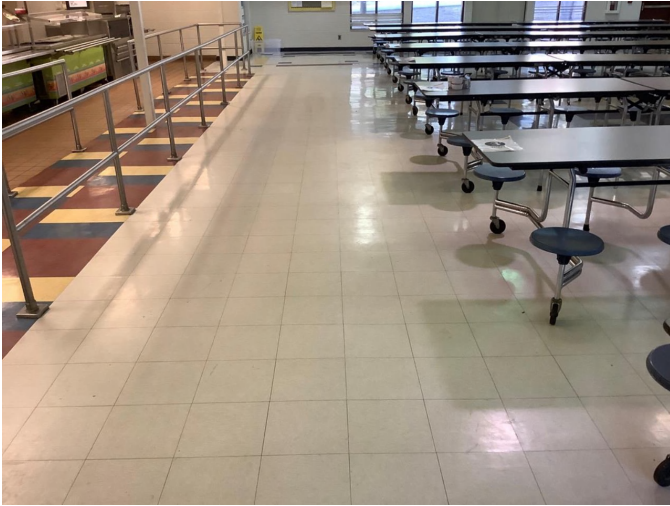
System: C3020903 - VCT

Location: Throughout Building
Distress: Beyond Expected Life
Category: Deferred Maintenance
Priority: 3 - Necessary (Years 2-5)
Correction: Renew System
Qty: 3,998.00
Unit of Measure: S.F.
Estimate: \$21,565.00
Assessor Name: Eduardo Lopez
Date Created: 01/27/2020

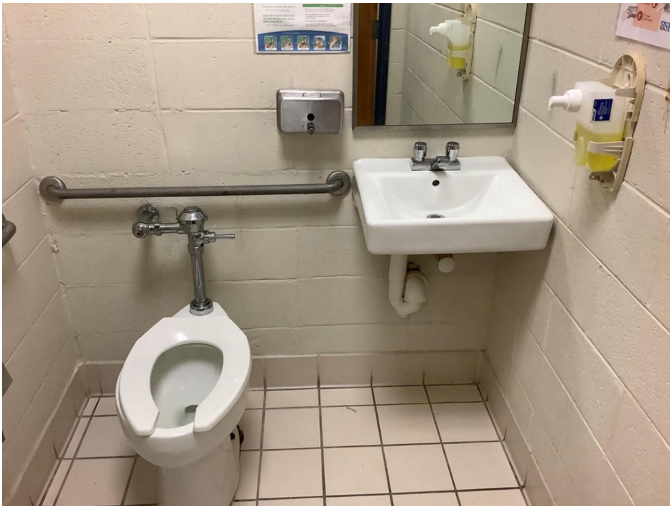
System: D2010 - Plumbing Fixtures

Location: Throughout Building
Distress: Beyond Expected Life
Category: Deferred Maintenance
Priority: 3 - Necessary (Years 2-5)
Correction: Renew System
Qty: 5,490.00
Unit of Measure: S.F.
Estimate: \$39,797.00
Assessor Name: Eduardo Lopez
Date Created: 10/06/2020

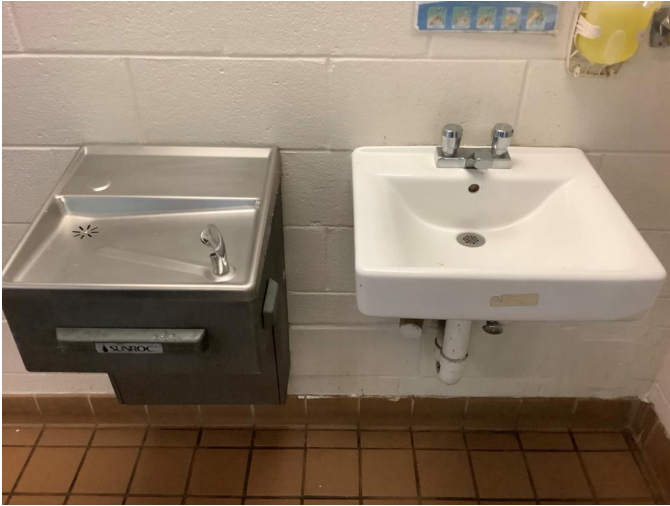
System: D2020 - Domestic Water Distribution

Location: Throughout Building
Distress: Beyond Expected Life
Category: Deferred Maintenance
Priority: 3 - Necessary (Years 2-5)
Correction: Renew System
Qty: 5,490.00
Unit of Measure: S.F.
Estimate: \$4,590.00
Assessor Name: Eduardo Lopez
Date Created: 10/06/2020

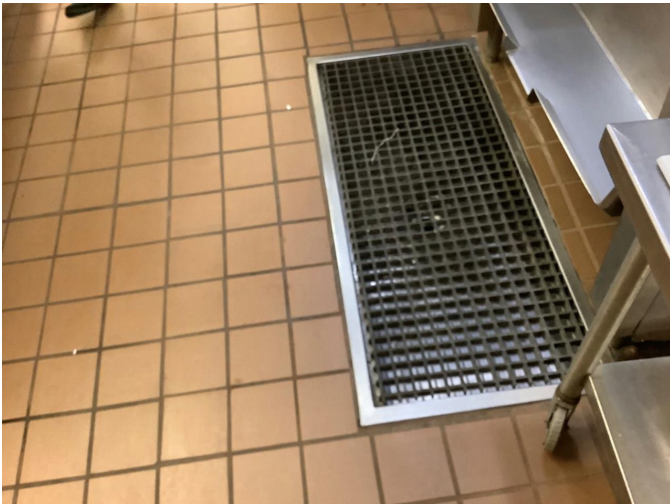
System: D2030 - Sanitary Waste

Location: Throughout Building
Distress: Beyond Expected Life
Category: Deferred Maintenance
Priority: 3 - Necessary (Years 2-5)
Correction: Renew System
Qty: 5,490.00
Unit of Measure: S.F.
Estimate: \$10,810.00
Assessor Name: Eduardo Lopez
Date Created: 10/06/2020

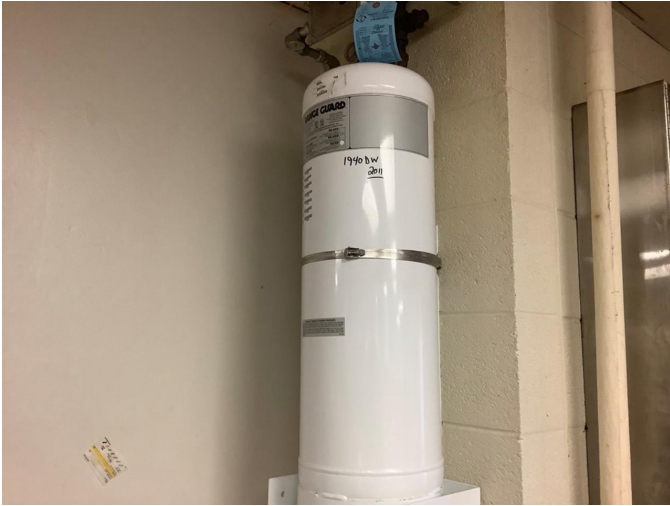
System: D4090 - Other Fire Protection Systems

Location: Kitchen
Distress: Beyond Expected Life
Category: Deferred Maintenance
Priority: 3 - Necessary (Years 2-5)
Correction: Renew System
Qty: 5,490.00
Unit of Measure: S.F.
Estimate: \$3,986.00
Assessor Name: Eduardo Lopez
Date Created: 01/27/2020

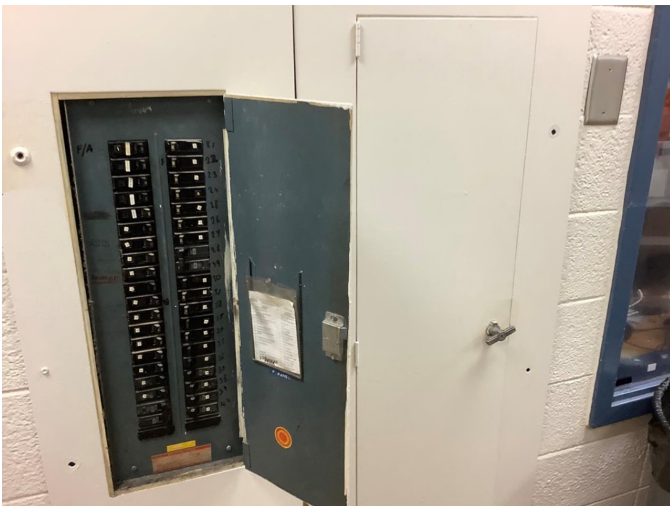
System: D5010 - Electrical Service/Distribution

Location: Throughout Building
Distress: Beyond Expected Life
Category: Deferred Maintenance
Priority: 3 - Necessary (Years 2-5)
Correction: Renew System
Qty: 5,490.00
Unit of Measure: S.F.
Estimate: \$14,433.00
Assessor Name: Eduardo Lopez
Date Created: 10/06/2020

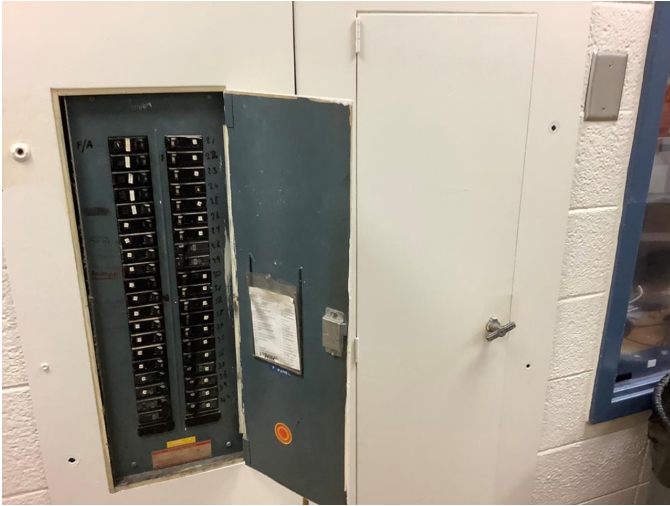
System: D5020 - Branch Wiring

Location: Throughout Building
Distress: Beyond Expected Life
Category: Deferred Maintenance
Priority: 3 - Necessary (Years 2-5)
Correction: Renew System
Qty: 5,490.00
Unit of Measure: S.F.
Estimate: \$23,733.00
Assessor Name: Eduardo Lopez
Date Created: 10/06/2020

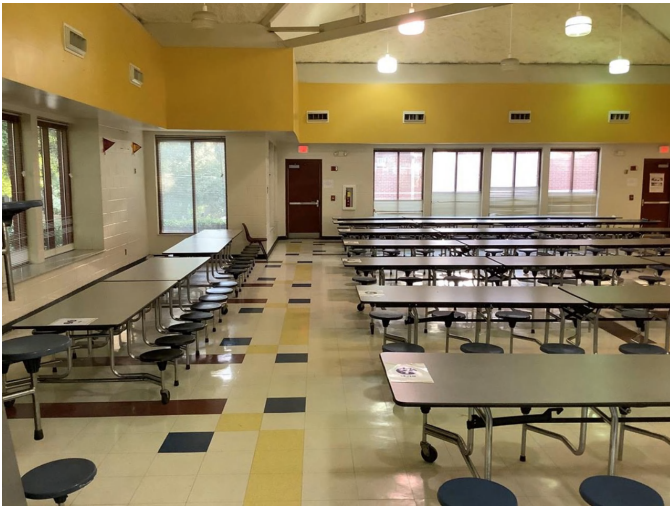
System: D5020 - Lighting

Location: Throughout Building
Distress: Beyond Expected Life
Category: Deferred Maintenance
Priority: 3 - Necessary (Years 2-5)
Correction: Renew System
Qty: 5,490.00
Unit of Measure: S.F.
Estimate: \$35,449.00
Assessor Name: Eduardo Lopez
Date Created: 10/06/2020

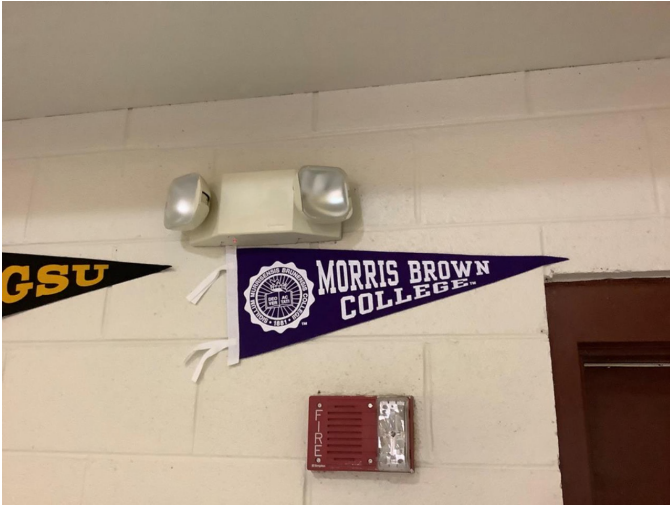
System: D5030910 - Fire Alarm Systems

Location: Throughout Building
Distress: Beyond Expected Life
Category: Deferred Maintenance
Priority: 3 - Necessary (Years 2-5)
Correction: Renew System
Qty: 5,490.00
Unit of Measure: S.F.
Estimate: \$16,547.00
Assessor Name: Eduardo Lopez
Date Created: 01/27/2020

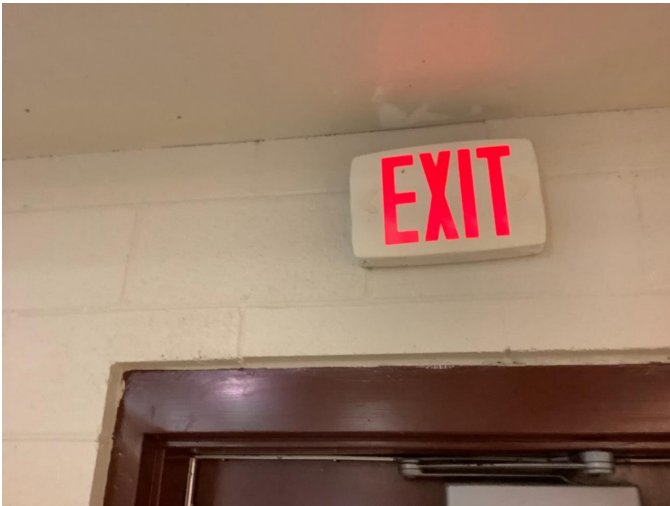
System: D5090 - Other Electrical Systems

Location: Throughout Building
Distress: Beyond Expected Life
Category: Deferred Maintenance
Priority: 3 - Necessary (Years 2-5)
Correction: Renew System
Qty: 5,490.00
Unit of Measure: S.F.
Estimate: \$2,295.00
Assessor Name: Eduardo Lopez
Date Created: 01/27/2020
