Atlanta Public Schools/Charter Schools
Herndon ES (KIPP Ways)

Revised
School Assessment Report

November 10, 2020

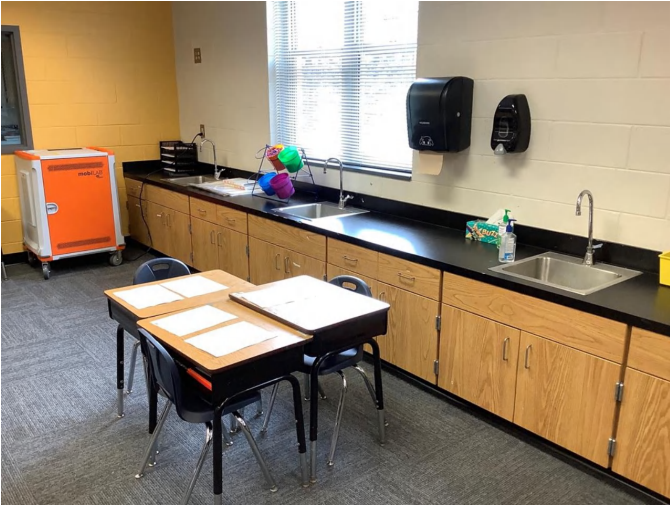
System: C3020901 - Carpet

Location: Throughout Building
Distress: Beyond Expected Life
Category: Deferred Maintenance
Priority: 3 - Necessary (Years 2-5)
Correction: Renew System
Qty: 14,000.00
Unit of Measure: S.F.
Estimate: \$115,500.00
Assessor Name: Homero Guerrero
Date Created: 12/16/2019

Notes: The carpet floor finish is beyond its expected service life, worn and damaged, and is recommended for replacement.

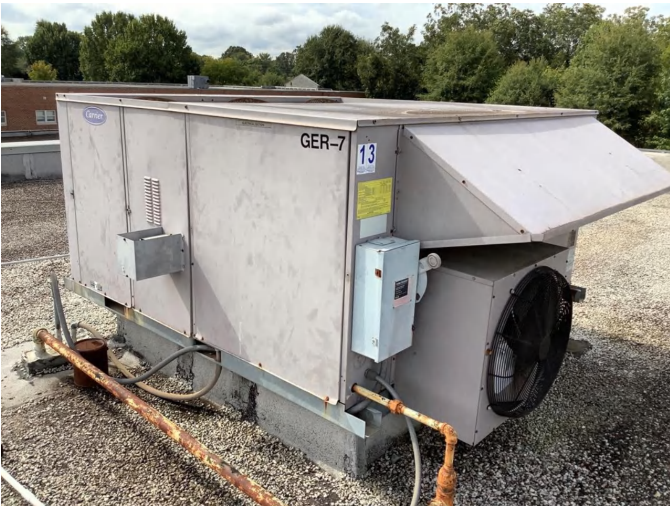
System: D3050 - Terminal & Package Units

Location: Roof
Distress: Beyond Expected Life
Category: Deferred Maintenance
Priority: 3 - Necessary (Years 2-5)
Correction: Renew System
Qty: 84,871.00
Unit of Measure: S.F.
Estimate: \$674,979.00
Assessor Name: Homero Guerrero
Date Created: 09/28/2019

Notes: The Terminal Package Units are original and nearing the end of the systems useful life. This deficiency provides a budgetary consideration upgrades.

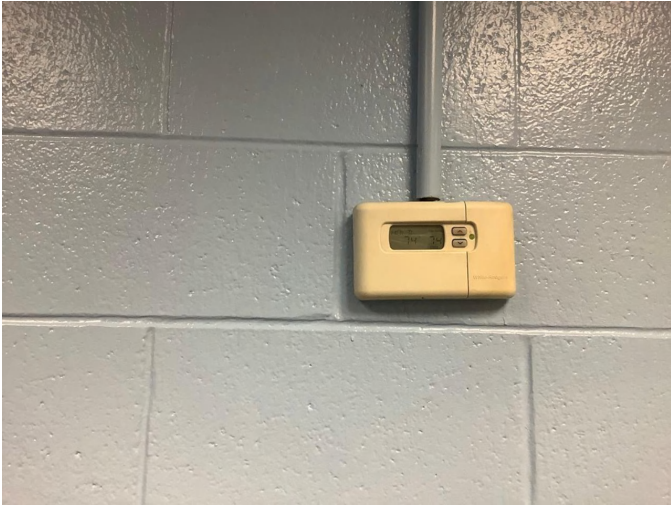
System: D3060 - Controls & Instrumentation

Location: Mechanical Rooms
Distress: Beyond Expected Life
Category: Deferred Maintenance
Priority: 3 - Necessary (Years 2-5)
Correction: Renew System
Qty: 84,871.00
Unit of Measure: S.F.
Estimate: \$214,724.00
Assessor Name: Homero Guerrero
Date Created: 09/28/2019

Notes: The energy monitoring and controls as well as the building automation systems are original. This deficiency provides a budgetary consideration for a universal upgrade.

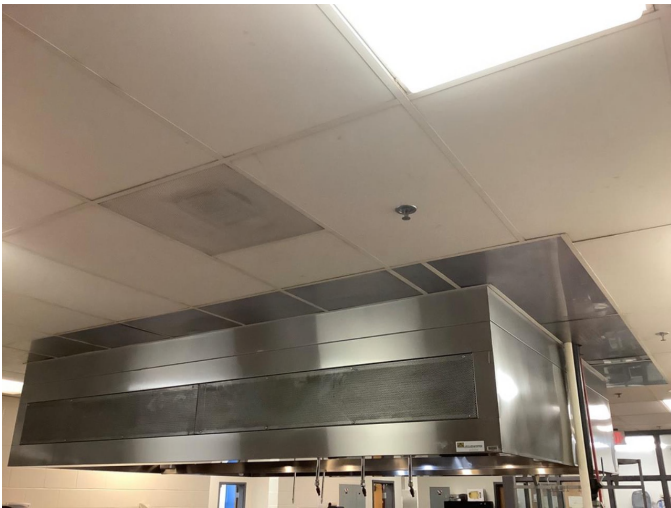
System: D4090 - Other Fire Protection Systems

Location: Kitchen
Distress: Beyond Expected Life
Category: Deferred Maintenance
Priority: 3 - Necessary (Years 2-5)
Correction: Renew System
Qty: 84,871.00
Unit of Measure: S.F.
Estimate: \$57,882.00
Assessor Name: Homero Guerrero
Date Created: 09/28/2019

Notes: This buildings high traffic use warrants upgrades to the kitchen hood fire suppression system based on usage and age. This deficiency provides a budgetary consideration for universal upgrades to the kitchen hood fire suppression system.

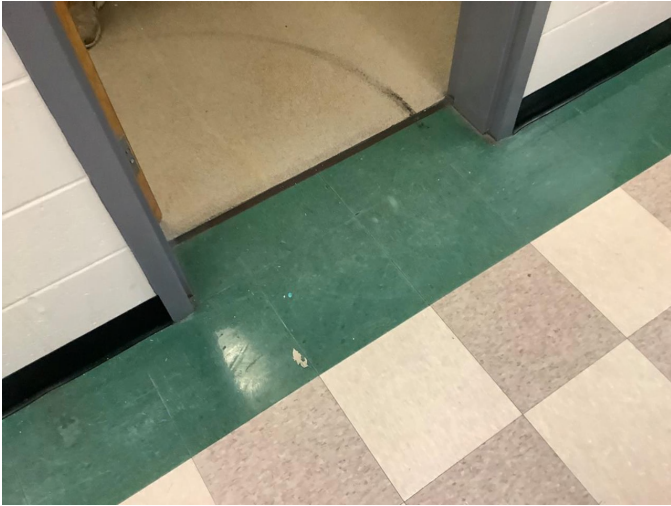
System: C3020405 - Epoxy

Location: Restrooms
Distress: Beyond Expected Life
Category: Deferred Maintenance
Priority: 4 - Recommended (Years 6-10)
Correction: Renew System
Qty: 9,000.00
Unit of Measure: S.F.
Estimate: \$183,726.00
Assessor Name: Homero Guerrero
Date Created: 12/16/2019

Notes: The Epoxy floor finish is beyond its expected service life, worn and damaged, and is recommended for replacement.

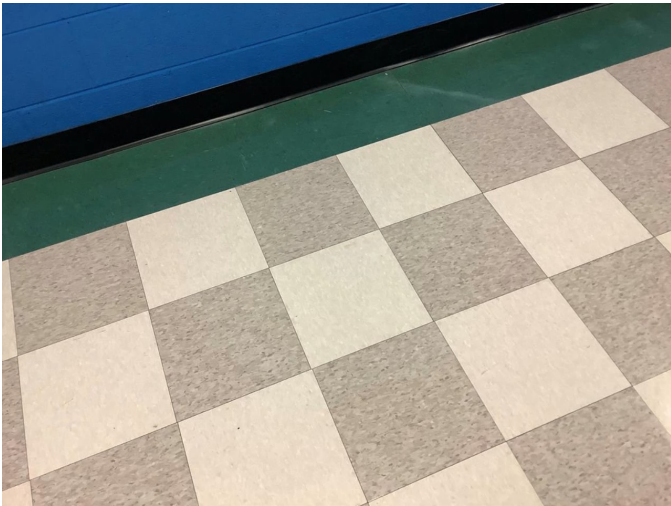
System: C3020903 - VCT

Location: Throughout Building
Distress: Beyond Expected Life
Category: Deferred Maintenance
Priority: 4 - Recommended (Years 6-10)
Correction: Renew System
Qty: 62,871.00
Unit of Measure: S.F.
Estimate: \$339,126.00
Assessor Name: Homero Guerrero
Date Created: 12/16/2019

Notes: The VCT floor finish is beyond its expected service life, worn and damaged, and is recommended for replacement.

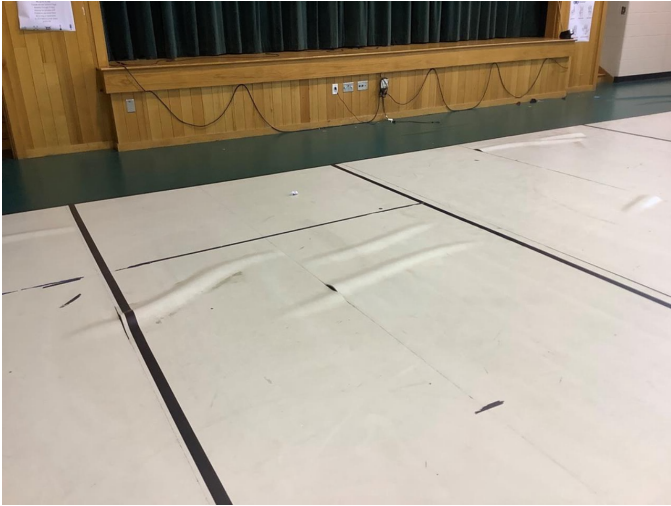
System: C3020999 - Other - Rubber or Neoprene

Location: Stairs / gym
Distress: Beyond Expected Life
Category: Deferred Maintenance
Priority: 4 - Recommended (Years 6-10)
Correction: Renew System
Qty: 1,000.00
Unit of Measure: S.F.
Estimate: \$29,337.00
Assessor Name: Homero Guerrero
Date Created: 12/16/2019

Notes: The Rubber or Neoprene floor finish is beyond its expected service life, worn and damaged, and is recommended for replacement.

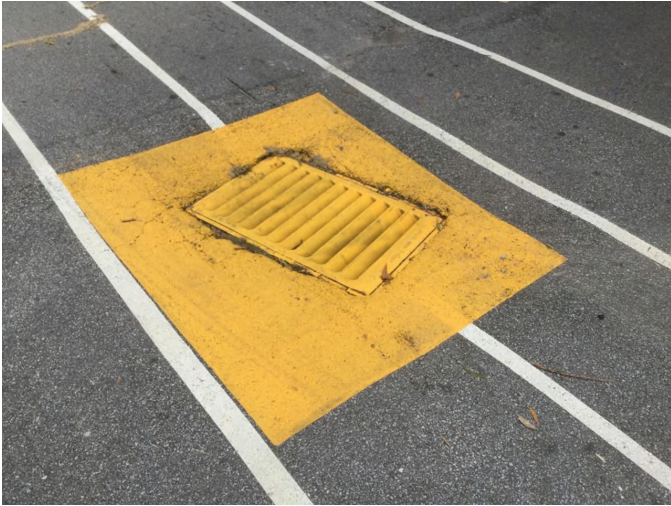
System: G2040950 - Track

Location: Site
Distress: Beyond Expected Life
Category: Deferred Maintenance
Priority: 3 - Necessary (Years 2-5)
Correction: Renew System
Qty: 84,871.00
Unit of Measure: S.F.
Estimate: \$74,686.00
Assessor Name: Homero Guerrero
Date Created: 12/17/2019
