Atlanta Public Schools/Charter Schools

Hill, C.W. ES (The Kindezi School)

School Assessment Report

November 10, 2020

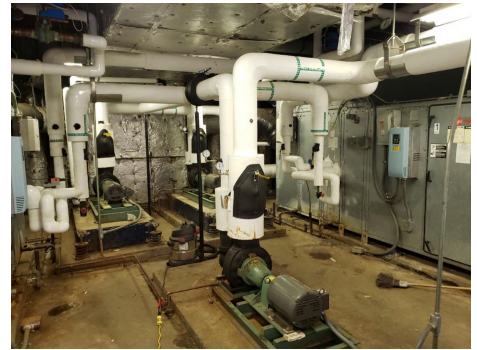
System: D3040 - Distribution Systems

Note: AHUs in mechanical penthouse were substantially renovated in 2000. However, little of the remainder of the Distribution Systems were upgraded in 2000.

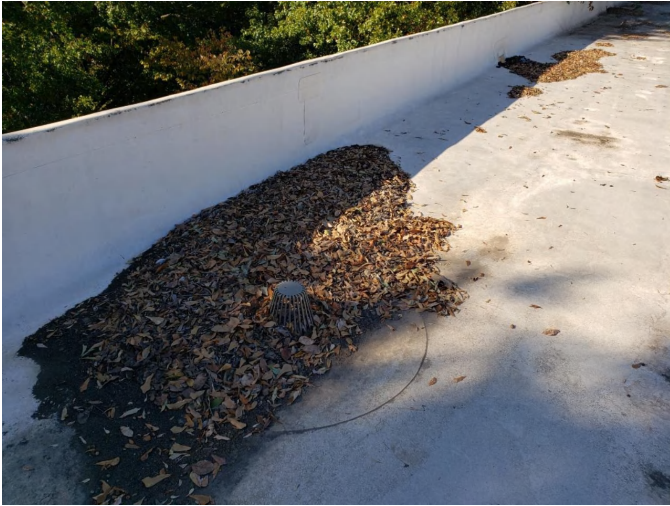
System: D2040 - Rain Water Drainage

Location: Roof
Distress: Beyond Expected Life
Category: Deferred Maintenance
Priority: 1 - Critical Immediate Need
Correction: Renew System
Qty: 79,042.00
Unit of Measure: S.F.
Estimate: \$34,778.00
Assessor Name: Homero Guerrero
Date Created: 10/23/2014

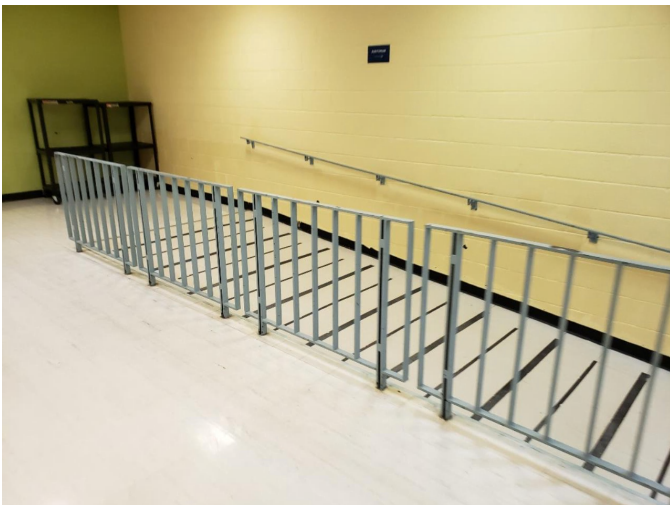
System: C1030 - Fittings

Location: First Floor, Auditorium Entrance
Distress: Non Compliant
Category: ADA Compliance
Priority: 2 - Trending Critical (Year 1)
Correction: Replace Handrails and Ornamental Metal
Qty: 40.00
Unit of Measure: L.F.
Estimate: \$26,505.82
Assessor Name: Homero Guerrero
Date Created: 02/14/2020

Notes: Both handrails by the auditorium entrance ramps are not ADA compliant and should be replaced.

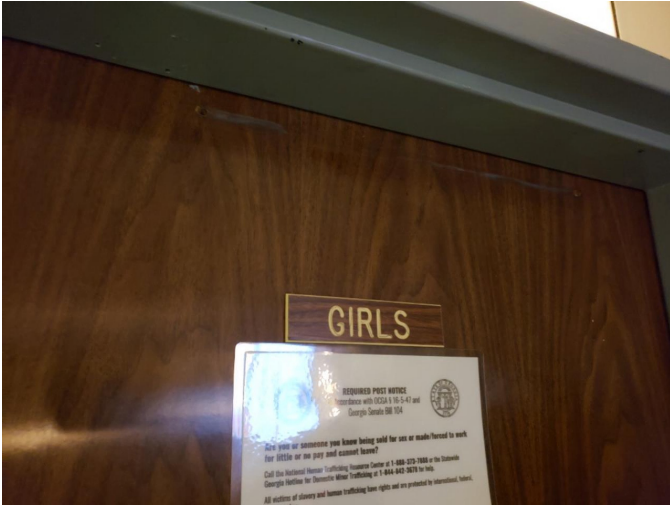
System: C1030 - Fittings

Location: Throughout Building
Distress: Non Compliant
Category: ADA Compliance
Priority: 2 - Trending Critical (Year 1)
Correction: Replace Identifying Devices
Qty: 100.00
Unit of Measure: Ea.
Estimate: \$7,659.30
Assessor Name: Homero Guerrero
Date Created: 02/14/2020

Notes: Room signage are not ADA compliant and should be replaced.

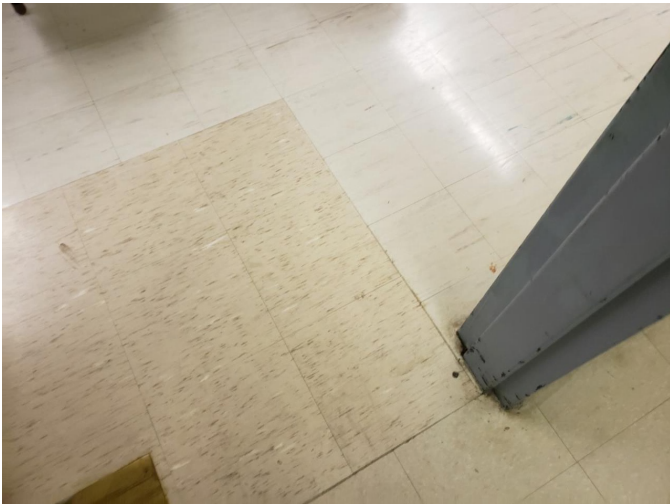
System: C3020903 - VCT

Location: Throughout Building
Distress: Beyond Expected Life
Category: Deferred Maintenance
Priority: 2 - Trending Critical (Year 1)
Correction: Renew System
Qty: 34,238.00
Unit of Measure: S.F.
Estimate: \$184,680.00
Assessor Name: Homero Guerrero
Date Created: 02/05/2020

Notes: The VCT flooring is in poor conditions, with different areas patched and cracked, and should be replaced.

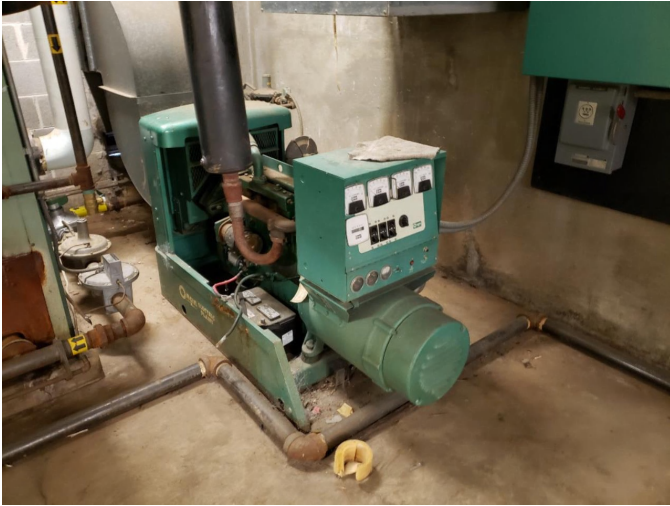
System: D5090 - Other Electrical Systems

Location: Mechanical Room
Distress: Abandoned
Category: Deferred Maintenance
Priority: 2 - Trending Critical (Year 1)
Correction: Renew System
Qty: 79,042.00
Unit of Measure: S.F.
Estimate: \$29,562.00
Assessor Name: Homero Guerrero
Date Created: 10/23/2014

Notes: The Emergency Generator is abandoned and should be replaced per client requested standards.

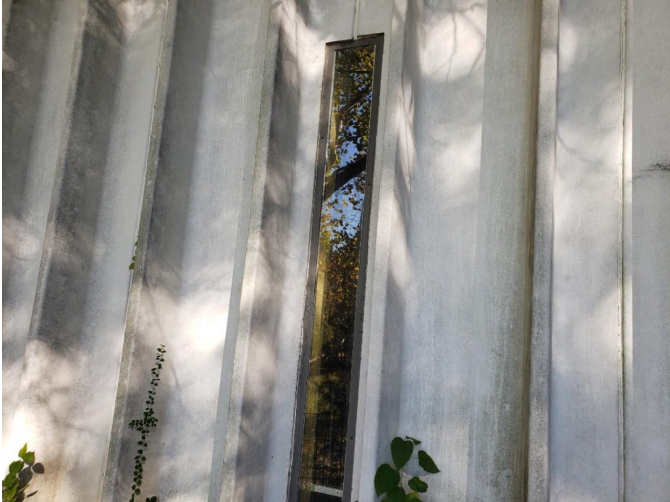
System: B2020 - Exterior Windows

Location: Exterior Walls
Distress: Beyond Expected Life
Category: Deferred Maintenance
Priority: 3 - Necessary (Years 2-5)
Correction: Renew System
Qty: 79,042.00
Unit of Measure: S.F.
Estimate: \$64,340.00
Assessor Name: Homero Guerrero
Date Created: 02/05/2020

Notes: The exterior windows are aged, rusted, not energy efficient, and should be replaced.

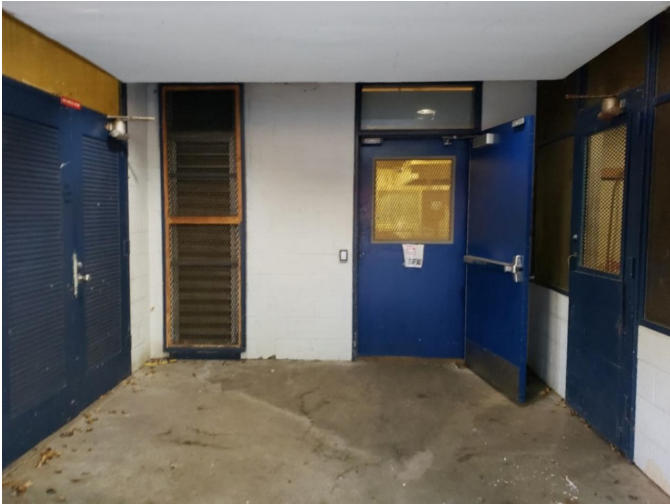
System: B2030 - Exterior Doors

Location: Exterior Walls
Distress: Beyond Expected Life
Category: ADA Compliance
Priority: 3 - Necessary (Years 2-5)
Correction: Renew System
Qty: 79,042.00
Unit of Measure: S.F.
Estimate: \$73,035.00
Assessor Name: Jejuan Hall
Date Created: 02/05/2020

Notes: The original exterior doors are aged, rusted, and should be replaced.

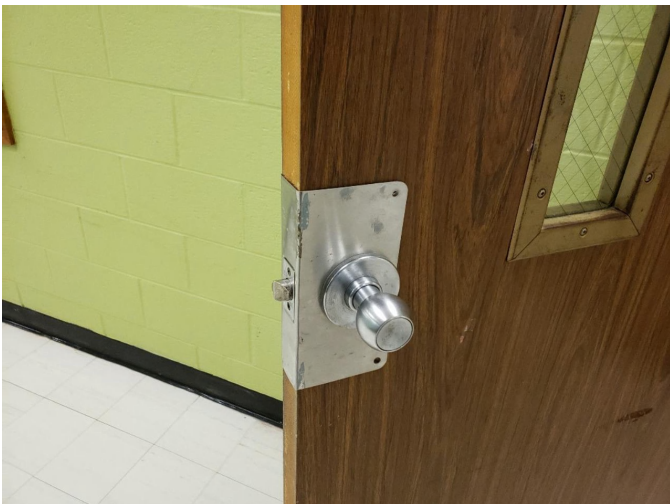
System: C1020 - Interior Doors

Location: Throughout Building
Distress: Beyond Expected Life
Category: Deferred Maintenance
Priority: 3 - Necessary (Years 2-5)
Correction: Renew System
Qty: 79,042.00
Unit of Measure: S.F.
Estimate: \$230,803.00
Assessor Name: Homero Guerrero
Date Created: 10/23/2014

Notes: The interior doors are aged, failing, not ADA compliant and should be replaced.

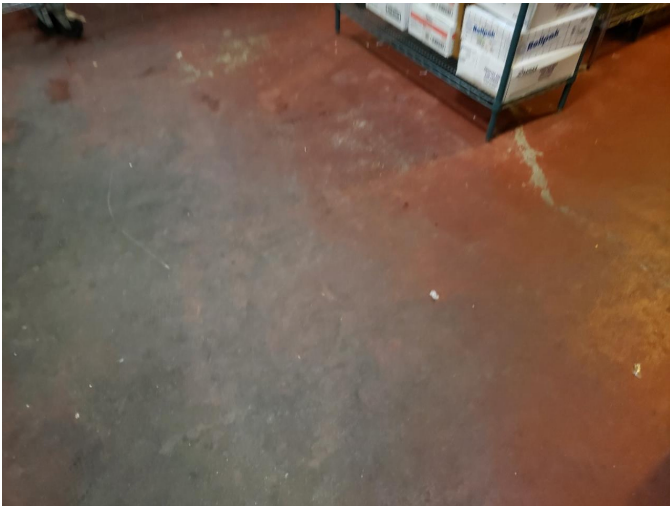
System: C3020405 - Epoxy

Location: Throughout Building
Distress: Beyond Expected Life
Category: Deferred Maintenance
Priority: 3 - Necessary (Years 2-5)
Correction: Renew System
Qty: 805.00
Unit of Measure: S.F.
Estimate: \$16,433.00
Assessor Name: Homero Guerrero
Date Created: 02/05/2020

Notes: The epoxy flooring is in deteriorating conditions, fading and should be scheduled for replacement.

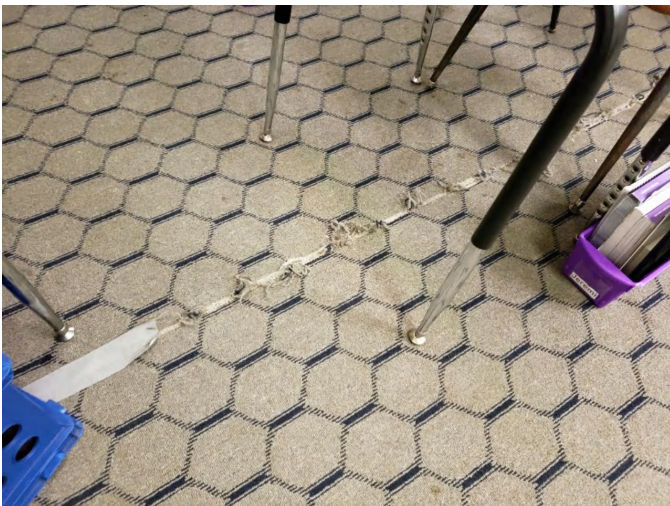
System: C3020901 - Carpet

Location: Throughout Building
Distress: Beyond Expected Life
Category: Deferred Maintenance
Priority: 3 - Necessary (Years 2-5)
Correction: Renew System
Qty: 37,650.00
Unit of Measure: S.F.
Estimate: \$310,613.00
Assessor Name: Homero Guerrero
Date Created: 02/05/2020

Notes: The carpet is stained, showing signs of early failure and should be replaced.

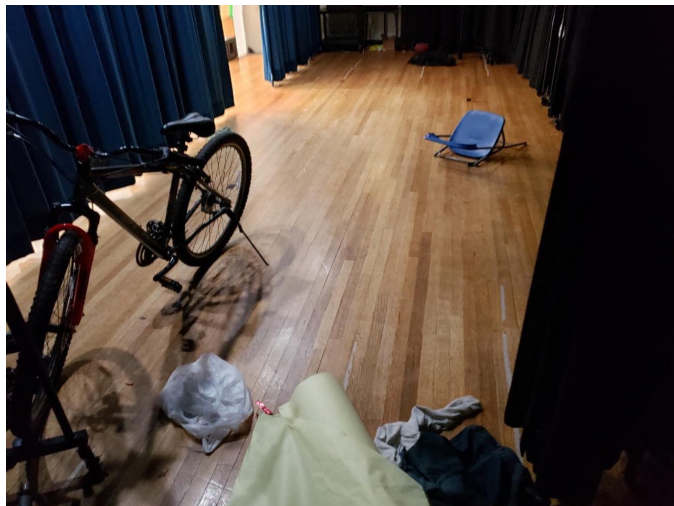
System: C3020999 - Other - Wood

Location: Auditorium Stage
Distress: Beyond Expected Life
Category: Deferred Maintenance
Priority: 3 - Necessary (Years 2-5)
Correction: Renew System
Qty: 690.00
Unit of Measure: S.F.
Estimate: \$13,036.00
Assessor Name: Homero Guerrero
Date Created: 02/05/2020

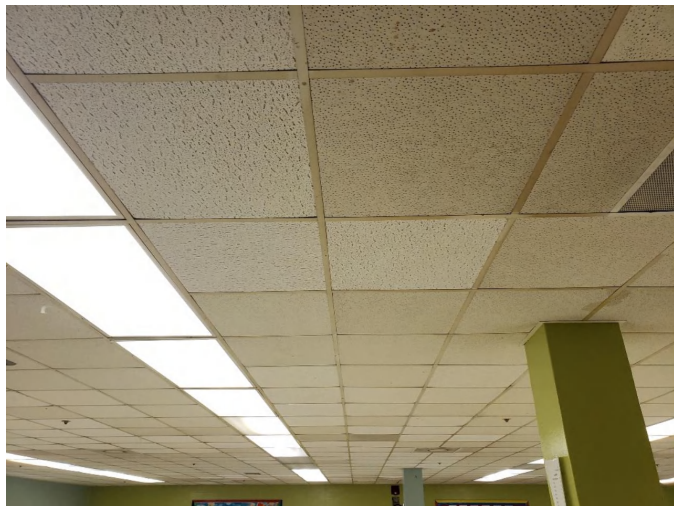
System: C3030 - Ceiling Finishes

Location: Throughout Building
Distress: Beyond Expected Life
Category: Deferred Maintenance
Priority: 3 - Necessary (Years 2-5)
Correction: Renew System
Qty: 79,042.00
Unit of Measure: S.F.
Estimate: \$782,516.00
Assessor Name: Homero Guerrero
Date Created: 02/05/2020

Notes: The ceiling tiles have been replaced as needed. However the grid shows signs of aging and most tiles are sagging, different color or damaged and should be replaced.

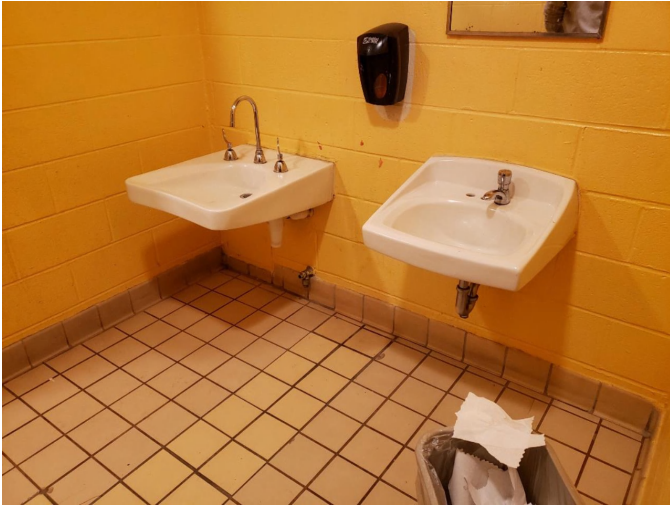
System: D2010 - Plumbing Fixtures

Location: Throughout Building
Distress: Beyond Expected Life
Category: ADA Compliance
Priority: 3 - Necessary (Years 2-5)
Correction: Renew System
Qty: 79,042.00
Unit of Measure: S.F.
Estimate: \$553,847.00
Assessor Name: Jejuan Hall
Date Created: 10/22/2014

Notes: Plumbing fixtures are in operational conditions. However, they are aged, beyond its expected service life and should be replaced with a low-flow water fixture.

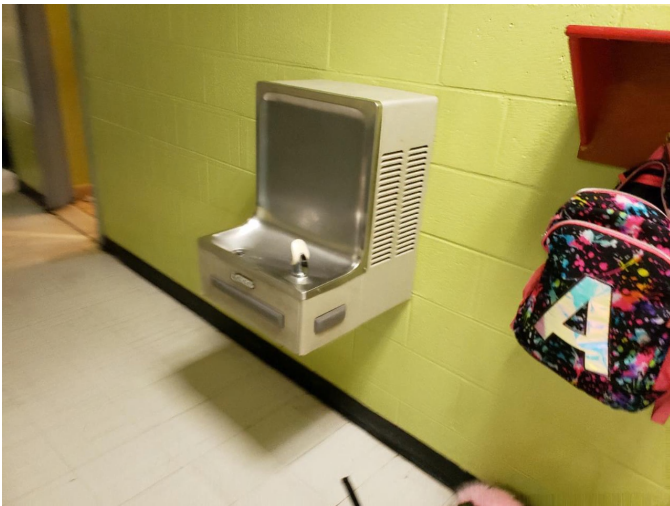
System: D2020 - Domestic Water Distribution

Location: Throughout Building
Distress: Beyond Expected Life
Category: Deferred Maintenance
Priority: 3 - Necessary (Years 2-5)
Correction: Renew System
Qty: 79,042.00
Unit of Measure: S.F.
Estimate: \$62,601.00
Assessor Name: Homero Guerrero
Date Created: 10/23/2014

Notes: The gas water heater was replaced in 2018. However, the domestic water distribution system is aged and should be replaced.

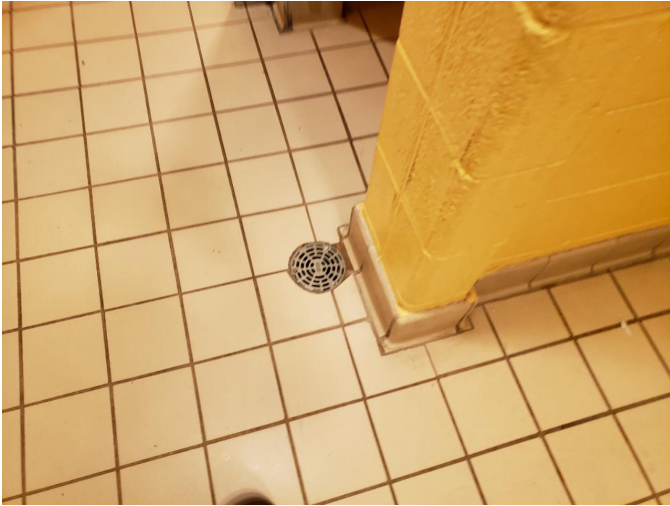
System: D2030 - Sanitary Waste

Location: Throughout Building
Distress: Beyond Expected Life
Category: Deferred Maintenance
Priority: 3 - Necessary (Years 2-5)
Correction: Renew System
Qty: 79,042.00
Unit of Measure: S.F.
Estimate: \$146,939.00
Assessor Name: Homero Guerrero
Date Created: 10/23/2014

Notes: The sanitary waste system is aged, has reported periodic failures, and should be replaced.

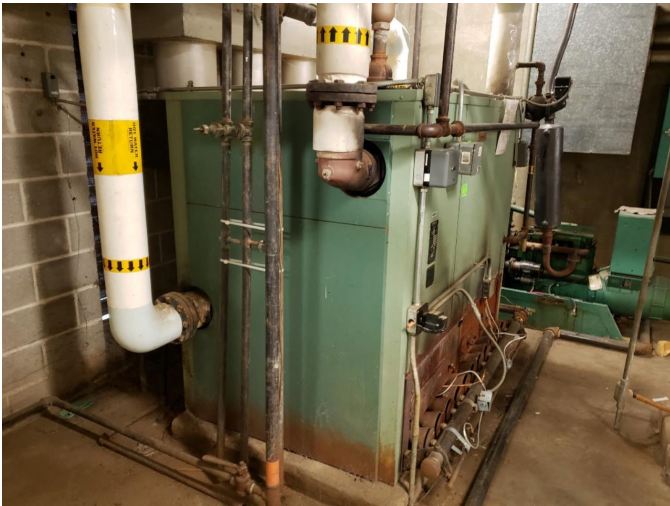
System: D3020 - Heat Generating Systems

Location: Mechanical Room
Distress: Beyond Expected Life
Category: Deferred Maintenance
Priority: 3 - Necessary (Years 2-5)
Correction: Renew System
Qty: 79,042.00
Unit of Measure: S.F.
Estimate: \$621,665.00
Assessor Name: Homero Guerrero
Date Created: 10/23/2014

Notes: The heating system is operating properly and are in fair condition but; are aging, inefficient, becoming logistically unsupportable, and should be replaced with energy efficient models.

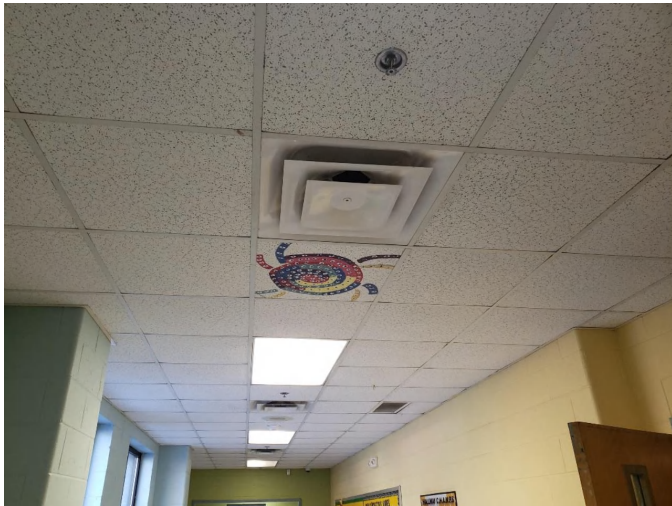
System: D3040 - Distribution Systems

Location: Throughout Building
Distress: Beyond Expected Life
Category: Deferred Maintenance
Priority: 3 - Necessary (Years 2-5)
Correction: Renew System
Qty: 79,042.00
Unit of Measure: S.F.
Estimate: \$1,683,278.00
Assessor Name: Homero Guerrero
Date Created: 02/14/2020

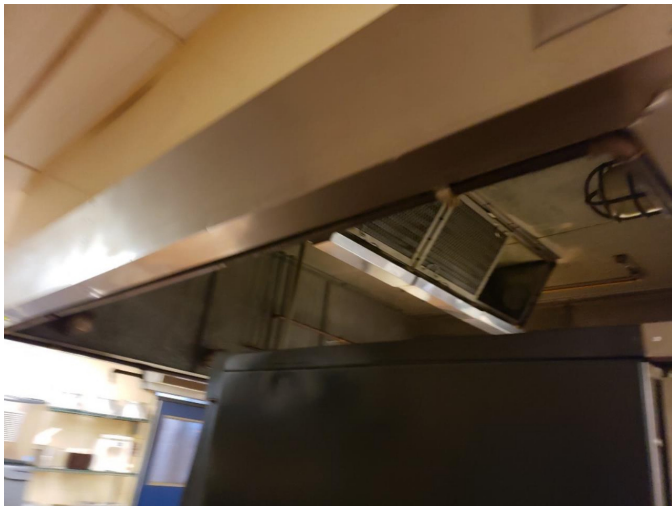
System: D4090 - Other Fire Protection Systems

Location: Throughout Building
Distress: Beyond Expected Life
Category: Deferred Maintenance
Priority: 3 - Necessary (Years 2-5)
Correction: Renew System
Qty: 79,042.00
Unit of Measure: S.F.
Estimate: \$52,168.00
Assessor Name: Homero Guerrero
Date Created: 09/17/2015

Notes: The system is beyond its expected service life and should be scheduled for replacement.

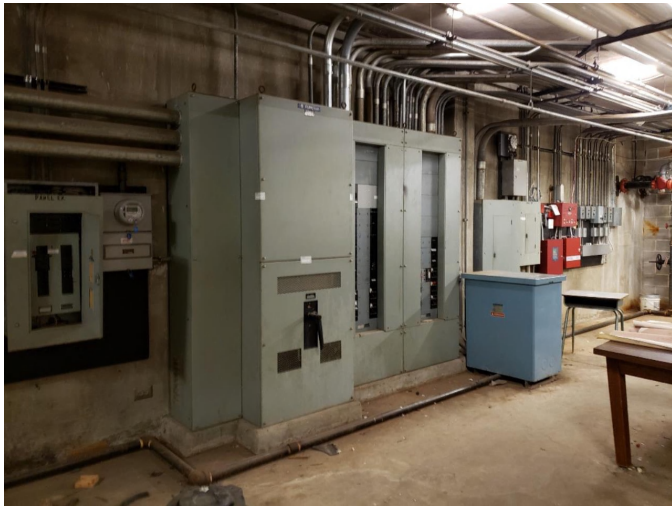
System: D5010 - Electrical Service/Distribution

Location: Throughout Building
Distress: Beyond Expected Life
Category: Deferred Maintenance
Priority: 3 - Necessary (Years 2-5)
Correction: Renew System
Qty: 79,042.00
Unit of Measure: S.F.
Estimate: \$199,976.00
Assessor Name: Homero Guerrero
Date Created: 10/23/2014

Notes: The original electrical service is operating but is in marginal condition and should be replaced.

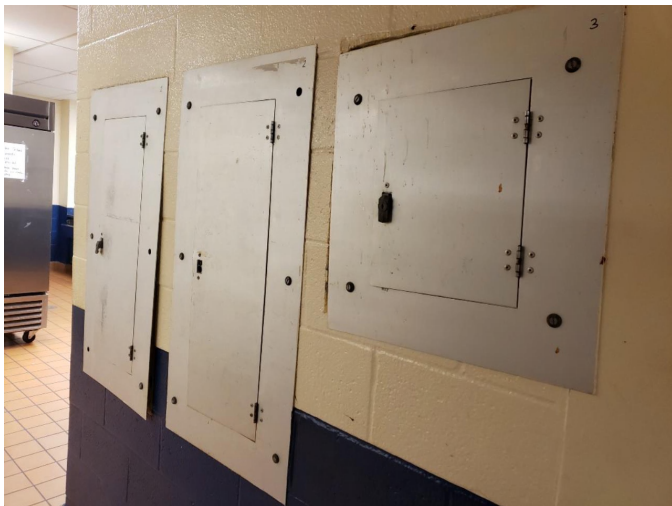
System: D5020 - Branch Wiring

Location: Throughout Building
Distress: Beyond Expected Life
Category: Deferred Maintenance
Priority: 3 - Necessary (Years 2-5)
Correction: Renew System
Qty: 79,042.00
Unit of Measure: S.F.
Estimate: \$412,994.00
Assessor Name: Homero Guerrero
Date Created: 10/23/2014

Notes: The original branch wiring system is operating, but is aged, in poor condition, and should be replaced.

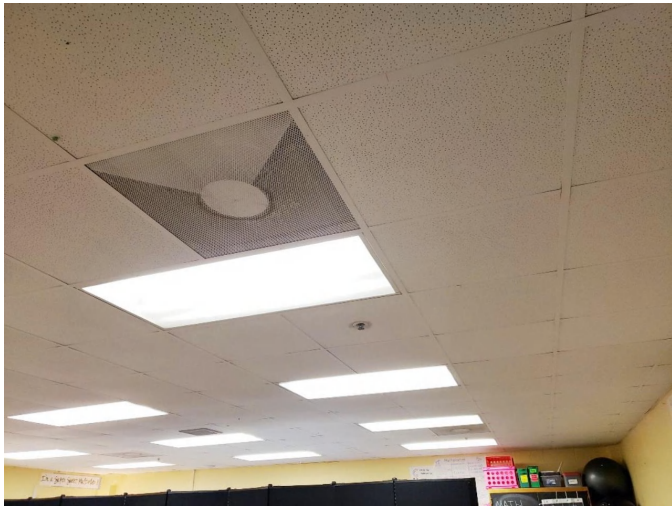
System: D5020 - Lighting

Location: Throughout Building
Distress: Beyond Expected Life
Category: Deferred Maintenance
Priority: 3 - Necessary (Years 2-5)
Correction: Renew System
Qty: 79,042.00
Unit of Measure: S.F.
Estimate: \$619,926.00
Assessor Name: Homero Guerrero
Date Created: 01/29/2020

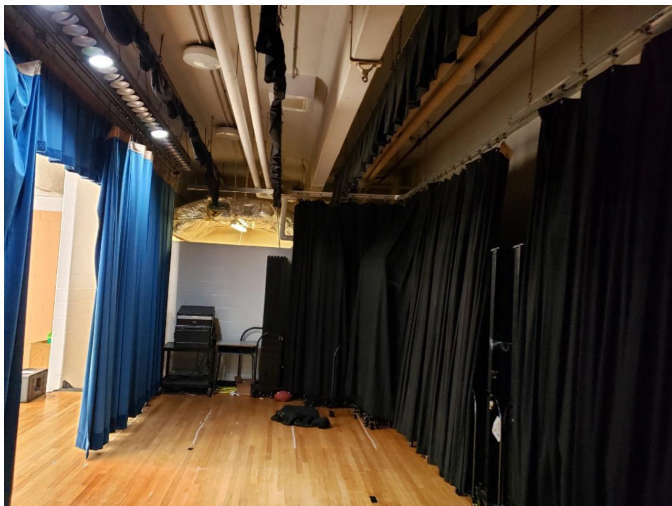
System: E1020 - Institutional Equipment

Location: Throughout Building
Distress: Beyond Expected Life
Category: Deferred Maintenance
Priority: 3 - Necessary (Years 2-5)
Correction: Renew System
Qty: 79,042.00
Unit of Measure: S.F.
Estimate: \$118,247.00
Assessor Name: Homero Guerrero
Date Created: 02/14/2020

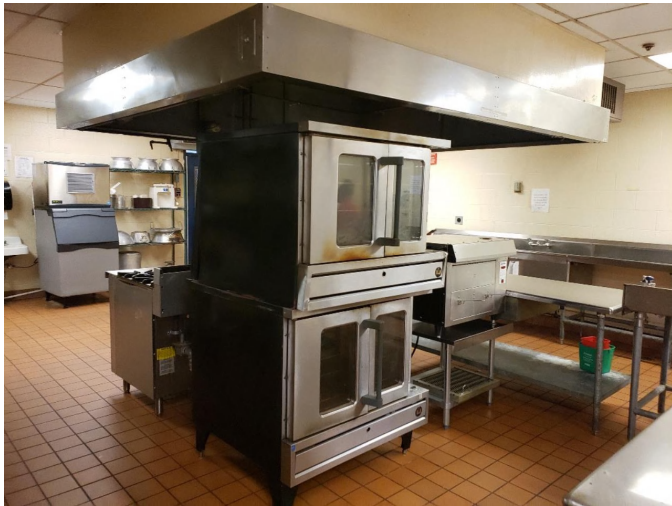
System: E1090 - Other Equipment

Location: Kitchen
Distress: Beyond Expected Life
Category: Deferred Maintenance
Priority: 3 - Necessary (Years 2-5)
Correction: Renew System
Qty: 79,042.00
Unit of Measure: S.F.
Estimate: \$179,109.00
Assessor Name: Homero Guerrero
Date Created: 02/14/2020

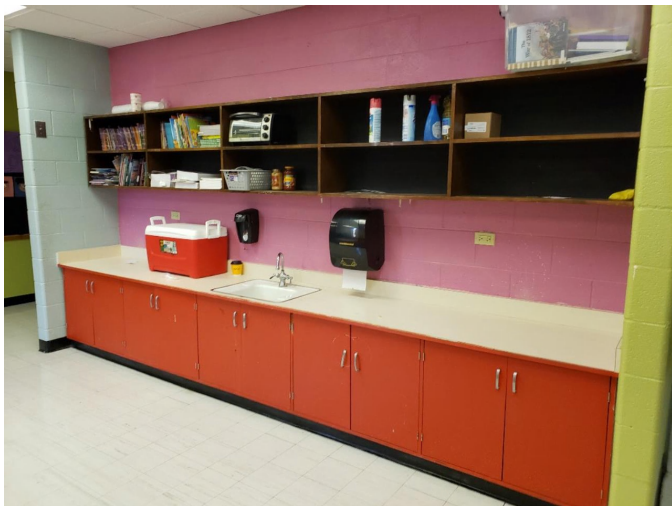
System: E2010 - Fixed Furnishings

Location: Throughout Building
Distress: Beyond Expected Life
Category: Deferred Maintenance
Priority: 3 - Necessary (Years 2-5)
Correction: Renew System
Qty: 79,042.00
Unit of Measure: S.F.
Estimate: \$166,067.00
Assessor Name: Homero Guerrero
Date Created: 02/14/2020

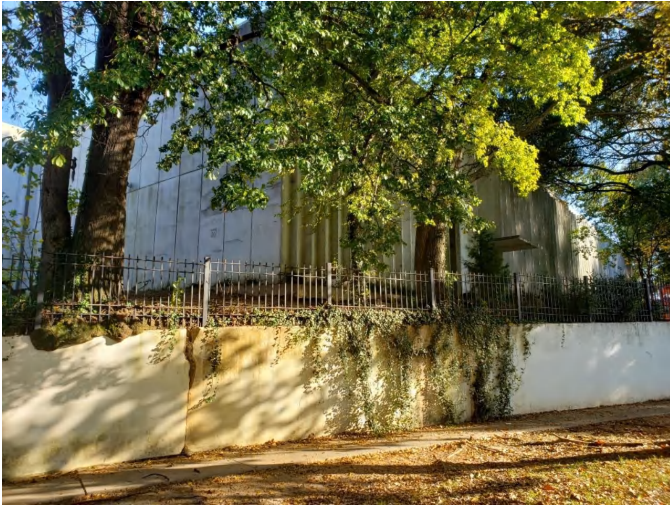
Location: Site
Distress: Failing
Category: Safety
Priority: 2 - Trending Critical (Year 1)
Correction: Replace brick retaining wall for walkways
Qty: 100.00
Unit of Measure: L.F.
Estimate: \$28,128.51
Assessor Name: Eduardo Lopez
Date Created: 10/23/2014

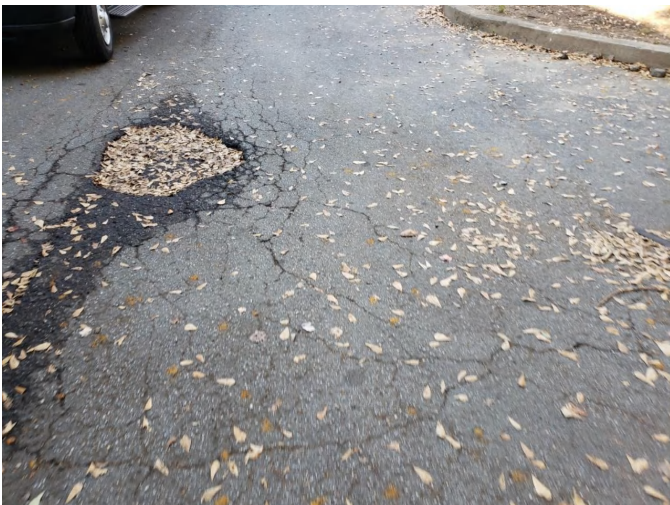
Location: Parking Lot
Distress: Beyond Expected Life
Category: Deferred Maintenance
Priority: 3 - Necessary (Years 2-5)
Correction: Renew System
Qty: 79,042.00
Unit of Measure: S.F.
Estimate: \$206,062.00
Assessor Name: Eduardo Lopez
Date Created: 02/14/2020

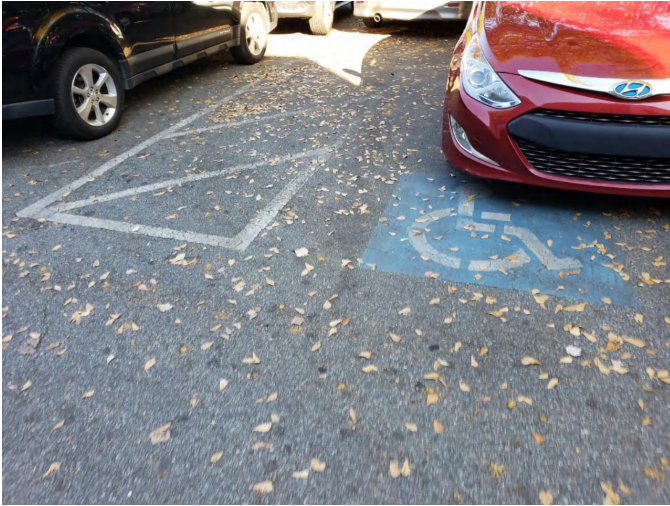
Location: Parking Lot
Distress: Beyond Expected Life
Category: Deferred Maintenance
Priority: 3 - Necessary (Years 2-5)
Correction: Renew System
Qty: 79,042.00
Unit of Measure: S.F.
Estimate: \$695,570.00
Assessor Name: Eduardo Lopez
Date Created: 02/14/2020

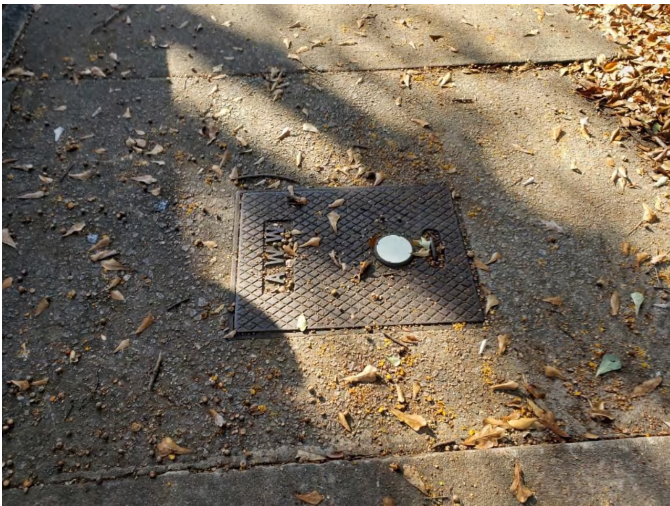
Location: Site
Distress: Beyond Expected Life
Category: Deferred Maintenance
Priority: 3 - Necessary (Years 2-5)
Correction: Renew System
Qty: 79,042.00
Unit of Measure: S.F.
Estimate: \$94,771.00
Assessor Name: Eduardo Lopez
Date Created: 02/05/2020

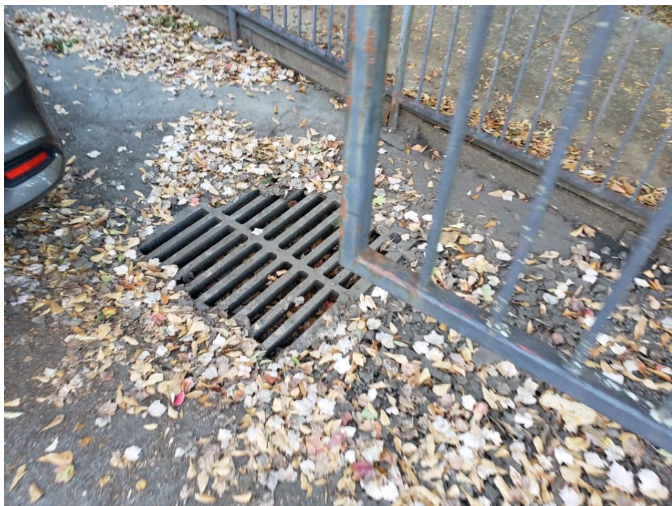
Location: Site
Distress: Beyond Expected Life
Category: Deferred Maintenance
Priority: 3 - Necessary (Years 2-5)
Correction: Renew System
Qty: 79,042.00
Unit of Measure: S.F.
Estimate: \$108,683.00
Assessor Name: Eduardo Lopez
Date Created: 02/05/2020

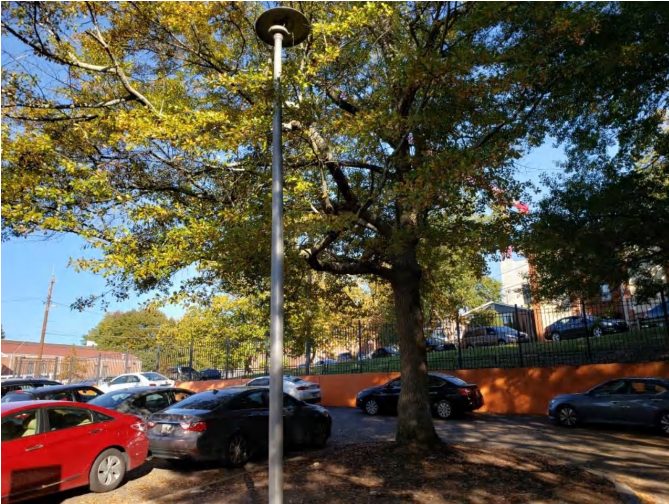
Location: Site
Distress: Beyond Expected Life
Category: Deferred Maintenance
Priority: 3 - Necessary (Years 2-5)
Correction: Renew System
Qty: 79,042.00
Unit of Measure: S.F.
Estimate: \$259,100.00
Assessor Name: Eduardo Lopez
Date Created: 10/17/2014
