Atlanta Public Schools/ Grady Cluster

Hope-Hill Elementary School

School Assessment Report

November 10, 2020

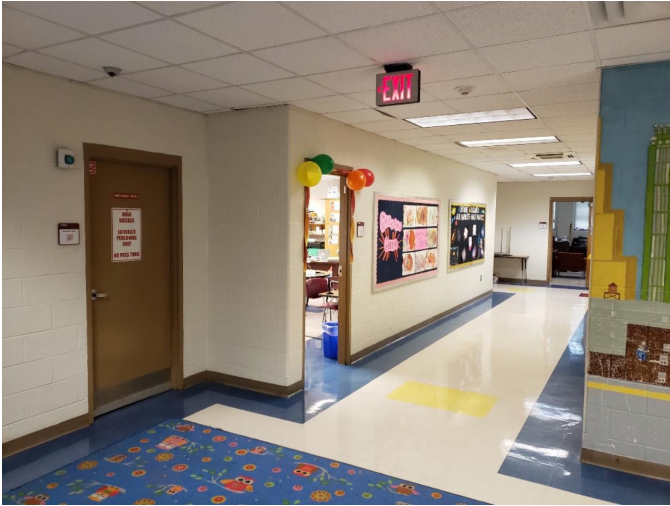
System: D5020 - Branch Wiring

Location: Corridor
Distress: Failing
Category: Code Compliance
Priority: 1 - Critical Immediate Need
Correction: Replace emergency egress light fixtures
Qty: 1.00
Unit of Measure: Ea.
Estimate: \$572.20
Assessor Name: Jejuan Hall
Date Created: 02/07/2020

Notes: Emergency Exit sign direction is leading to the mechanical room which is not the path of egress travel. Repair or replace signage to the correct direction.

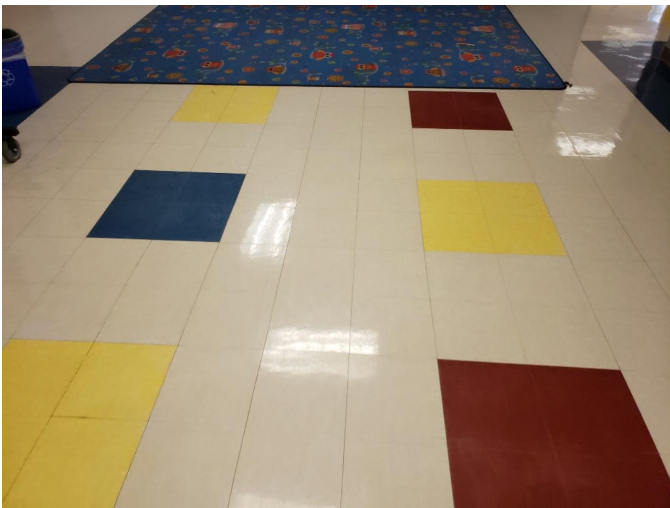
System: C3020903 - VCT

Location: Throughout Building
Distress: Beyond Expected Life
Category: Deferred Maintenance
Priority: 3 - Necessary (Years 2-5)
Correction: Renew System
Qty: 10,574.00
Unit of Measure: S.F.
Estimate: \$57,036.00
Assessor Name: Jejuan Hall
Date Created: 01/29/2020

Notes: The VCT flooring is in poor conditions, with different areas separating from the substrate, and should be replaced.

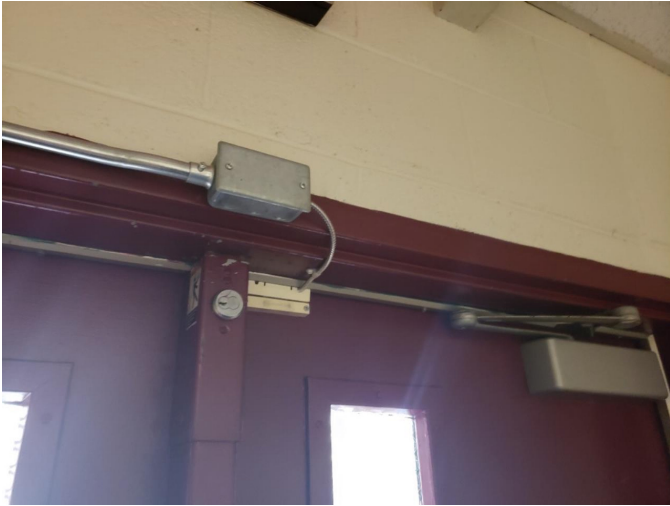
System: D5030810 - Security & Detection Systems

Location: Throughout Building
Distress: Beyond Expected Life
Category: Deferred Maintenance
Priority: 3 - Necessary (Years 2-5)
Correction: Renew System
Qty: 11,534.00
Unit of Measure: S.F.
Estimate: \$19,158.00
Assessor Name: Jejuan Hall
Date Created: 01/29/2020

Notes: The security system is beyond its expected service life and should be scheduled for replacement.

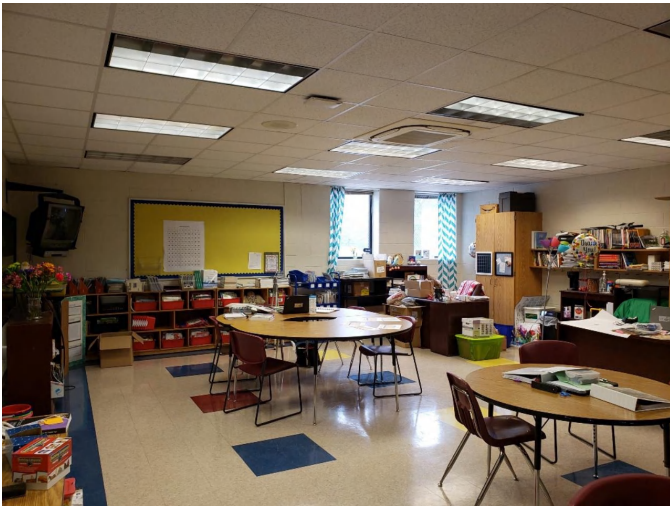
System: E1020 - Institutional Equipment

Location: Throughout Building
Distress: Beyond Expected Life
Category: Deferred Maintenance
Priority: 3 - Necessary (Years 2-5)
Correction: Renew System
Qty: 11,534.00
Unit of Measure: S.F.
Estimate: \$54,302.00
Assessor Name: Jejuan Hall
Date Created: 09/17/2015

Notes: The system is beyond its expected service life and should be scheduled for replacement.

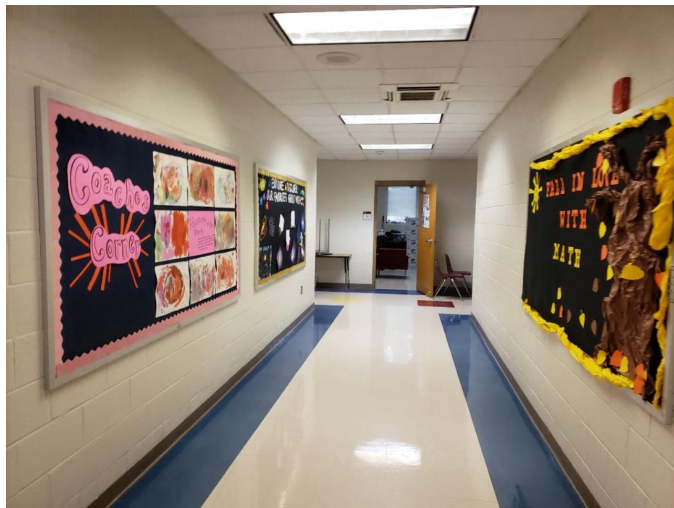
System: C1010 - Partitions

Location: Classroom C004 C001
Distress: Failing
Category: Code Compliance
Priority: 5 - Grandfathered Project triggered
Correction: Remodel space to comply with exit path requirement
Qty: 1,000.00
Unit of Measure: S.F.
Estimate: \$65,285.15
Assessor Name: Jejuan Hall
Date Created: 02/07/2020

Notes: The 1994 is a non-sprinklered building with a dead end corridor greater than 20'. Classrooms C004, C001 and Storage C003 are further the minimum allowable distance by code. Remodel this area either to create an exit where the storage C003 is or to reduce the corridor travel distance to comply with current codes.

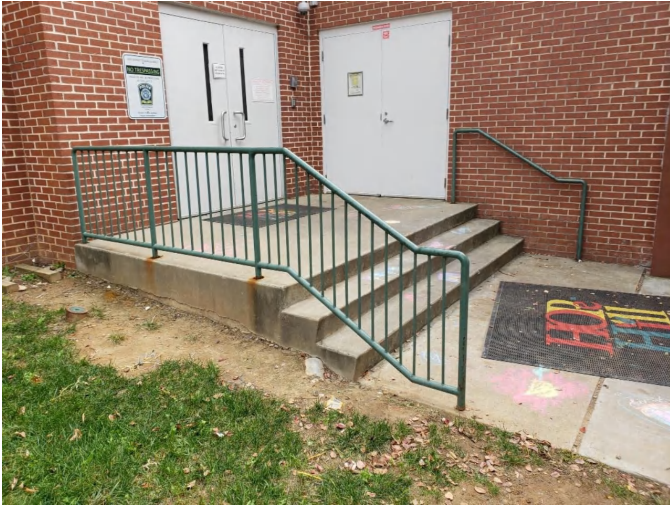
System: B2030 - Exterior Doors

Location: Exterior Door
Distress: Failing
Category: ADA Compliance
Priority: 1 - Critical Immediate Need
Correction: Replace 3'-0" x 7'-0" steel louvered door
Qty: 2.00
Unit of Measure: Ea.
Estimate: \$3,051.19
Assessor Name: Jejuan Hall
Date Created: 02/07/2020

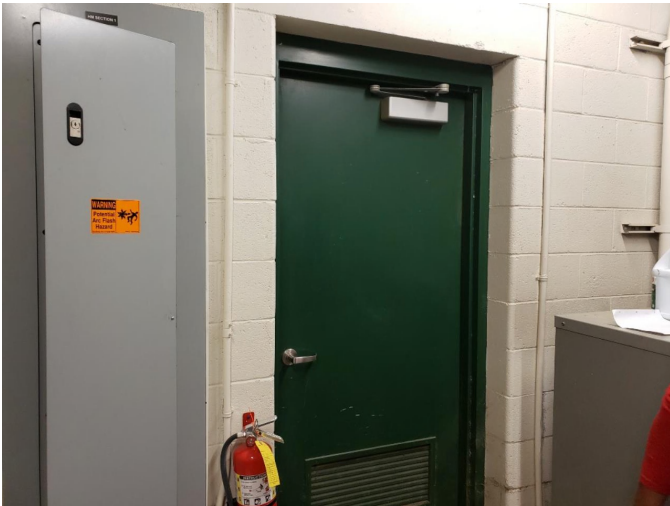
System: B2030 - Exterior Doors

Location: Electrical Room
Distress: Missing
Category: ADA Compliance
Priority: 1 - Critical Immediate Need
Correction: Replace door panic device
Qty: 1.00
Unit of Measure: Ea.
Estimate: \$1,885.26
Assessor Name: Jejuan Hall
Date Created: 02/07/2020

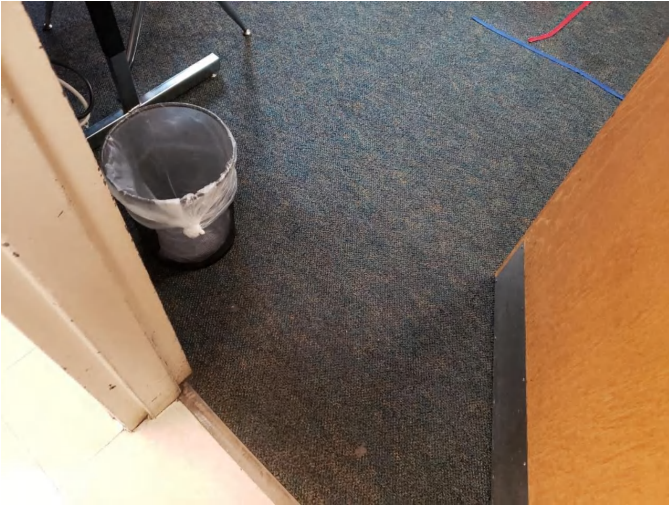
System: C3020901 - Carpet

Location: Throughout Building
Distress: Beyond Expected Life
Category: Deferred Maintenance
Priority: 3 - Necessary (Years 2-5)
Correction: Renew System
Qty: 3,940.00
Unit of Measure: S.F.
Estimate: \$32,505.00
Assessor Name: Jejuan Hall
Date Created: 02/05/2020

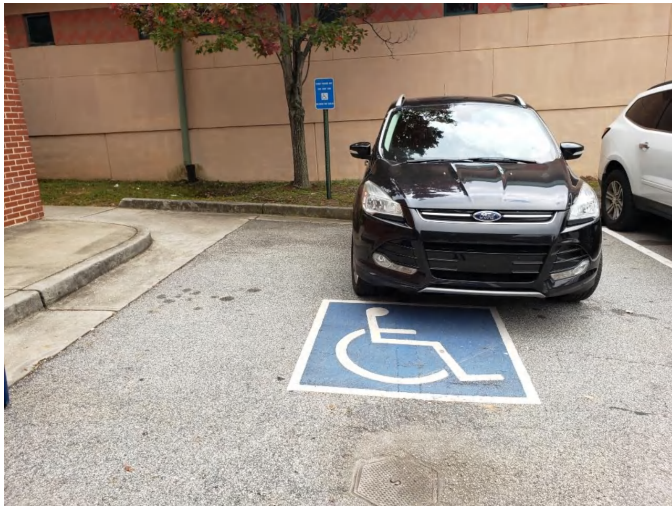
System: G2020 - Parking Lots

Location: Parking Lot
Distress: Missing
Category: ADA Compliance
Priority: 2 - Trending Critical (Year 1)
Correction: Add handicap parking space, incl. pavement markings, sign and post
Qty: 1.00
Unit of Measure: Ea.
Estimate: \$518.63
Assessor Name: Eduardo Lopez
Date Created: 02/07/2020
