Atlanta Public Schools/Relocation Sites

# Inman MS (Morningside relocation site)

## School Assessment Report

November 10, 2020

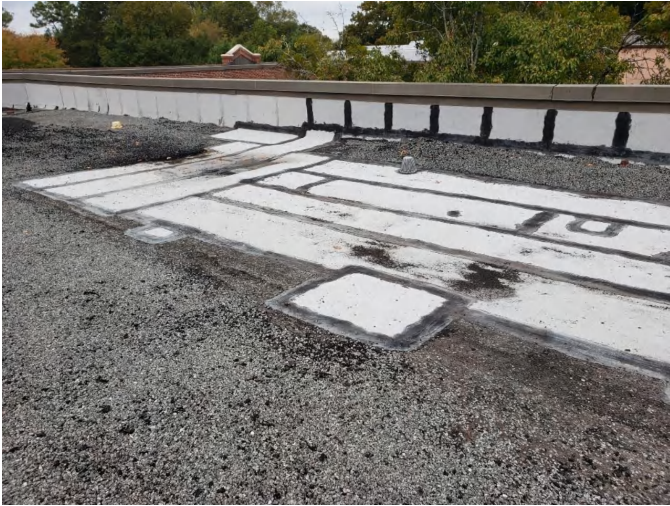
#### System: B3010105 - Built-Up

**Location:** Roof  
**Distress:** Beyond Expected Life  
**Category:** Deferred Maintenance  
**Priority:** 3 - Necessary (Years 2-5)  
**Correction:** Renew System  
**Qty:** 37,638.00  
**Unit of Measure:** S.F.  
**Estimate:** \$422,505.00  
**Assessor Name:** Eduardo Lopez  
**Date Created:** 10/06/2020

**Notes:** The roof covering system is beyond its expected service life and should be replaced.

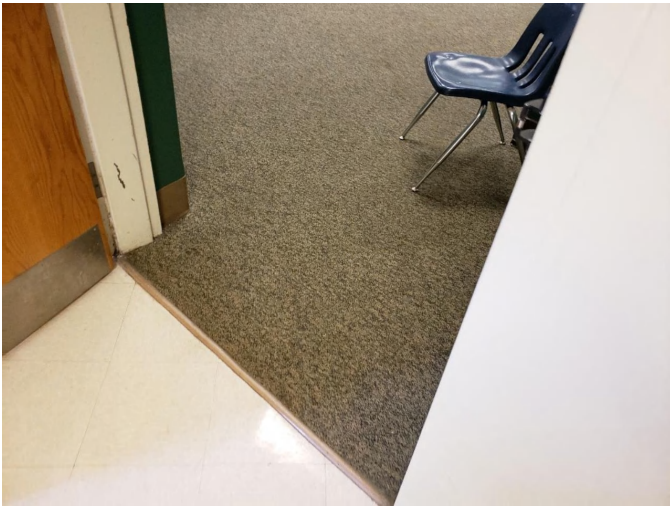
#### System: C3020901 - Carpet

**Location:** Throughout Building  
**Distress:** Beyond Expected Life  
**Category:** Deferred Maintenance  
**Priority:** 3 - Necessary (Years 2-5)  
**Correction:** Renew System  
**Qty:** 3,268.00  
**Unit of Measure:** S.F.  
**Estimate:** \$26,961.00  
**Assessor Name:** Eduardo Lopez  
**Date Created:** 01/29/2020

**Notes:** The carpet is stained, showing signs of early failure and should be replaced.

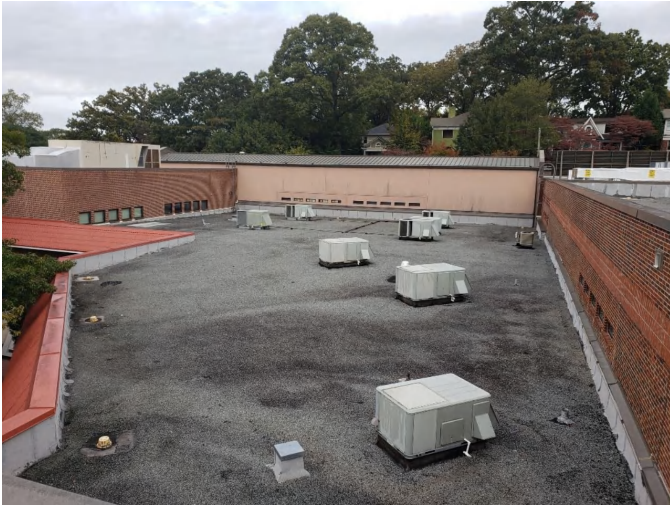
**System: D3050 - Terminal & Package Units**

**Location:** Throughout Building  
**Distress:** Beyond Expected Life  
**Category:** Deferred Maintenance  
**Priority:** 3 - Necessary (Years 2-5)  
**Correction:** Renew System  
**Qty:** 95,045.00  
**Unit of Measure:** S.F.  
**Estimate:** \$1,725,067.00  
**Assessor Name:** Eduardo Lopez  
**Date Created:** 10/01/2019

**Notes:** The terminal and package units are aged, rusted, not energy efficient, and should be replaced.

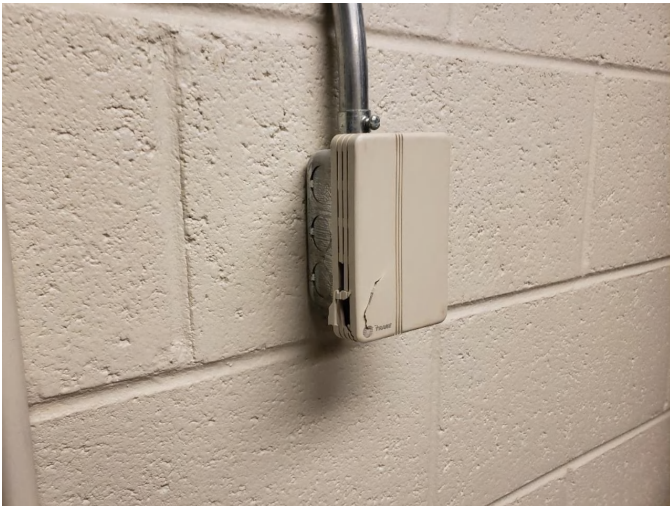
**System: D3060 - Controls & Instrumentation**

**Location:** Throughout Building  
**Distress:** Beyond Expected Life  
**Category:** Deferred Maintenance  
**Priority:** 3 - Necessary (Years 2-5)  
**Correction:** Renew System  
**Qty:** 95,045.00  
**Unit of Measure:** S.F.  
**Estimate:** \$231,054.00  
**Assessor Name:** Eduardo Lopez  
**Date Created:** 10/01/2019

**Notes:** The system is beyond its expected service life and should be scheduled for replacement.

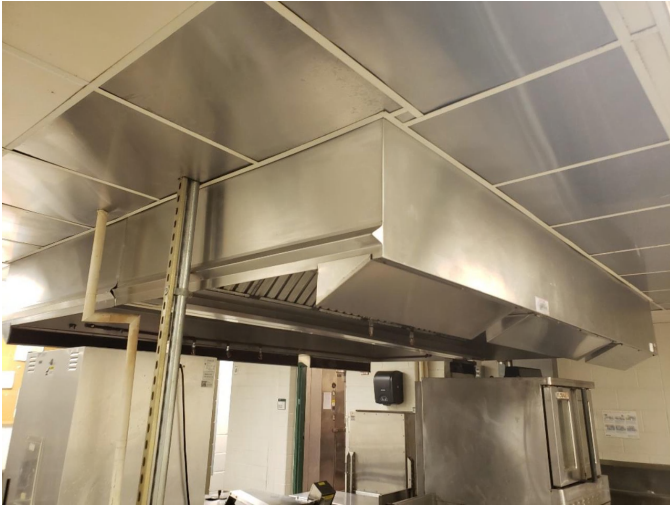
**System: D4090 - Other Fire Protection Systems**

**Location:** Throughout Building  
**Distress:** Beyond Expected Life  
**Category:** Deferred Maintenance  
**Priority:** 3 - Necessary (Years 2-5)  
**Correction:** Renew System  
**Qty:** 95,045.00  
**Unit of Measure:** S.F.  
**Estimate:** \$69,003.00  
**Assessor Name:** Eduardo Lopez  
**Date Created:** 10/01/2019

**Notes:** The system is beyond its expected service life and should be scheduled for replacement.

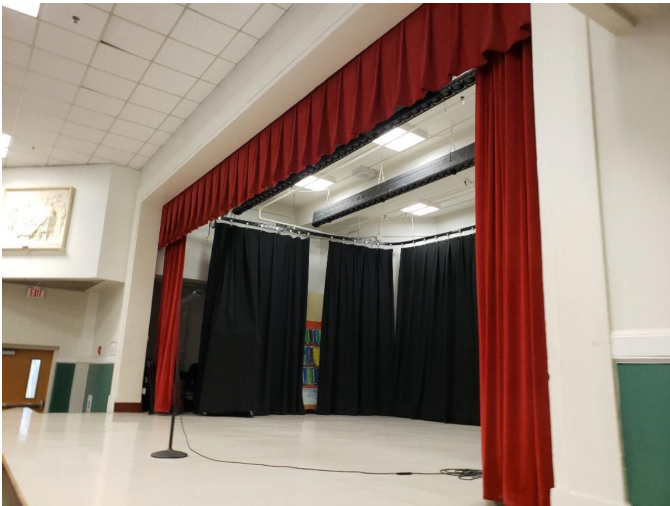
**System: E1020 - Institutional Equipment**

**Location:** Throughout Building  
**Distress:** Beyond Expected Life  
**Category:** Deferred Maintenance  
**Priority:** 3 - Necessary (Years 2-5)  
**Correction:** Renew System  
**Qty:** 95,045.00  
**Unit of Measure:** S.F.  
**Estimate:** \$12,546.00  
**Assessor Name:** Eduardo Lopez  
**Date Created:** 02/14/2020

**Notes:** The system is beyond its expected service life and should be scheduled for replacement.

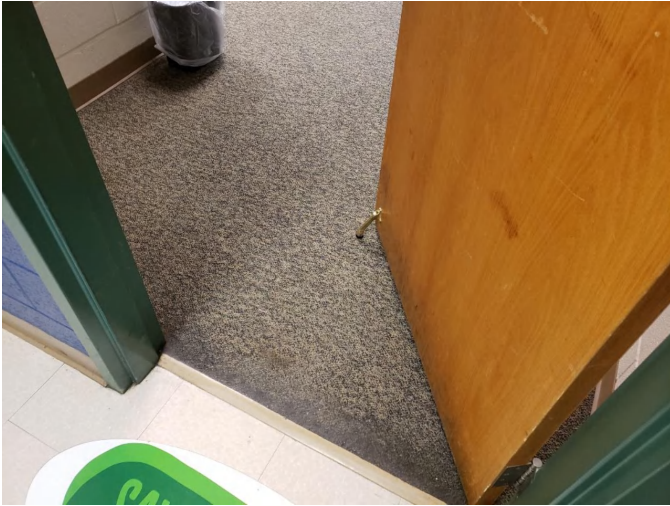
#### System: C3020901 - Carpet

**Location:** Throughout Building  
**Distress:** Beyond Expected Life  
**Category:** Deferred Maintenance  
**Priority:** 3 - Necessary (Years 2-5)  
**Correction:** Renew System  
**Qty:** 445.00  
**Unit of Measure:** S.F.  
**Estimate:** \$4,224.00  
**Assessor Name:** Eduardo Lopez  
**Date Created:** 01/29/2020

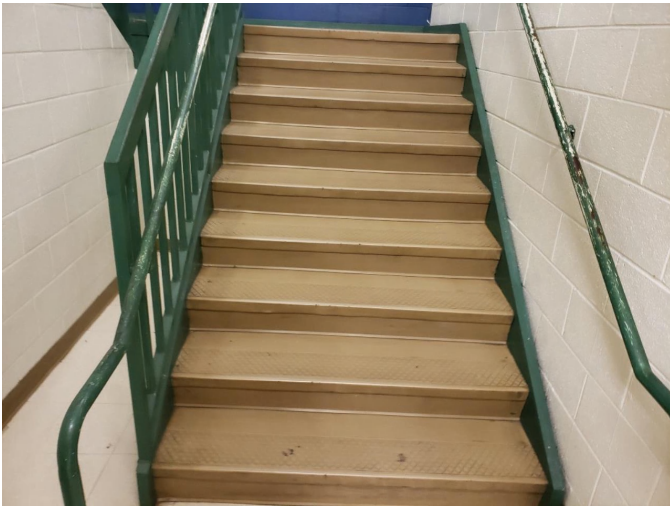
#### System: C3020999 - Other - Rubber or Neoprene

**Location:** Throughout Building  
**Distress:** Beyond Expected Life  
**Category:** Deferred Maintenance  
**Priority:** 3 - Necessary (Years 2-5)  
**Correction:** Renew System  
**Qty:** 95.00  
**Unit of Measure:** S.F.  
**Estimate:** \$2,787.00  
**Assessor Name:** Eduardo Lopez  
**Date Created:** 02/14/2020

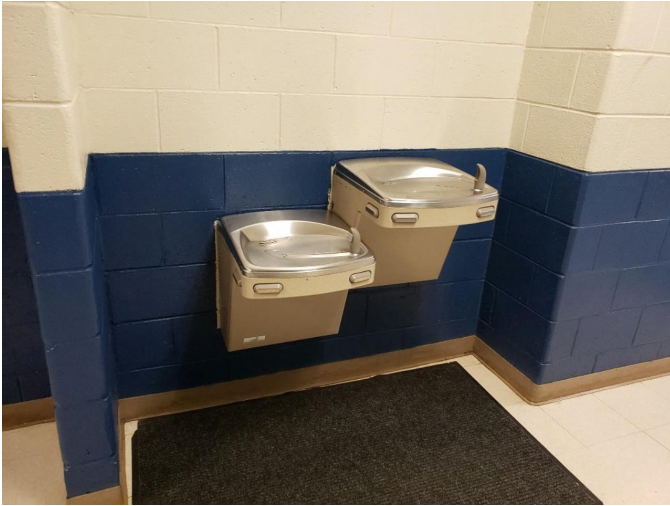
**System: D2010 - Plumbing Fixtures**

**Location:** Throughout Building  
**Distress:** Beyond Expected Life  
**Category:** ADA Compliance  
**Priority:** 3 - Necessary (Years 2-5)  
**Correction:** Renew System  
**Qty:** 10,662.00  
**Unit of Measure:** S.F.  
**Estimate:** \$74,943.00  
**Assessor Name:** Eduardo Lopez  
**Date Created:** 08/13/2014

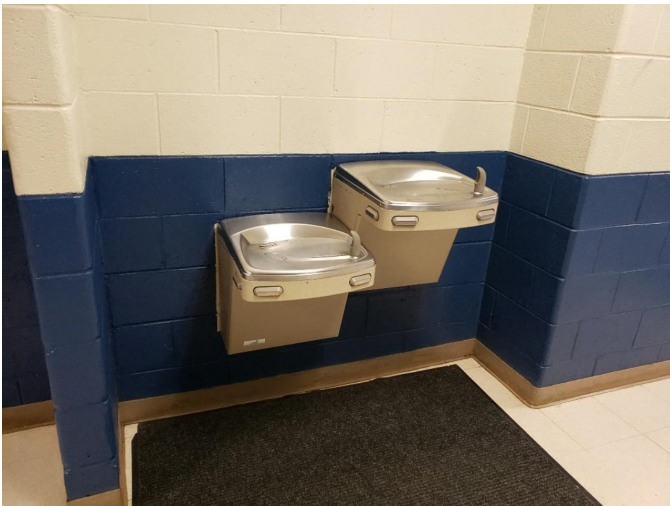
**System: D2020 - Domestic Water Distribution**

**Location:** Throughout Building  
**Distress:** Beyond Expected Life  
**Category:** Deferred Maintenance  
**Priority:** 3 - Necessary (Years 2-5)  
**Correction:** Renew System  
**Qty:** 10,662.00  
**Unit of Measure:** S.F.  
**Estimate:** \$8,796.00  
**Assessor Name:** Eduardo Lopez  
**Date Created:** 10/06/2020

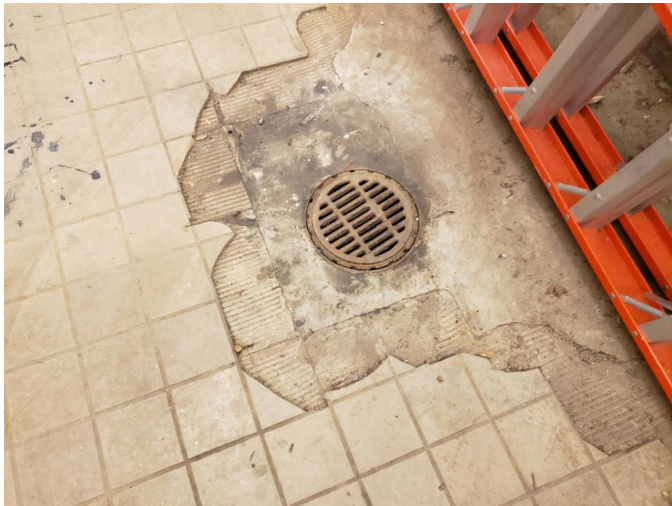
**System: D2030 - Sanitary Waste**

**Location:** Throughout Building  
**Distress:** Beyond Expected Life  
**Category:** Deferred Maintenance  
**Priority:** 3 - Necessary (Years 2-5)  
**Correction:** Renew System  
**Qty:** 10,662.00  
**Unit of Measure:** S.F.  
**Estimate:** \$19,821.00  
**Assessor Name:** Eduardo Lopez  
**Date Created:** 10/06/2020

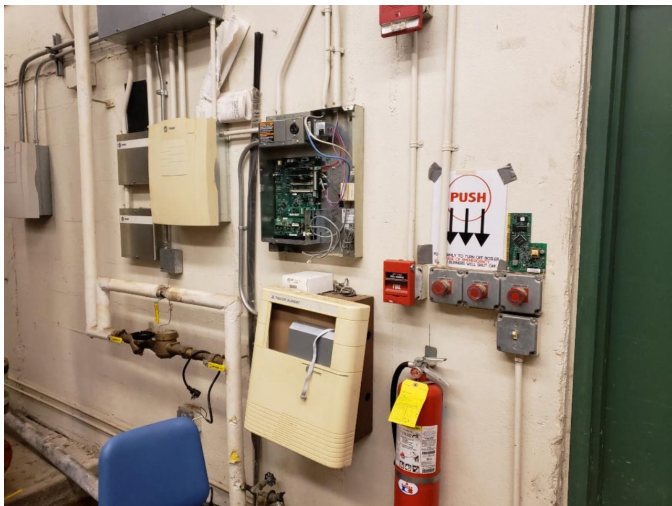
**System: D3060 - Controls & Instrumentation**

**Location:** Throughout Building  
**Distress:** Beyond Expected Life  
**Category:** Deferred Maintenance  
**Priority:** 3 - Necessary (Years 2-5)  
**Correction:** Renew System  
**Qty:** 10,662.00  
**Unit of Measure:** S.F.  
**Estimate:** \$25,802.00  
**Assessor Name:** Eduardo Lopez  
**Date Created:** 10/01/2019

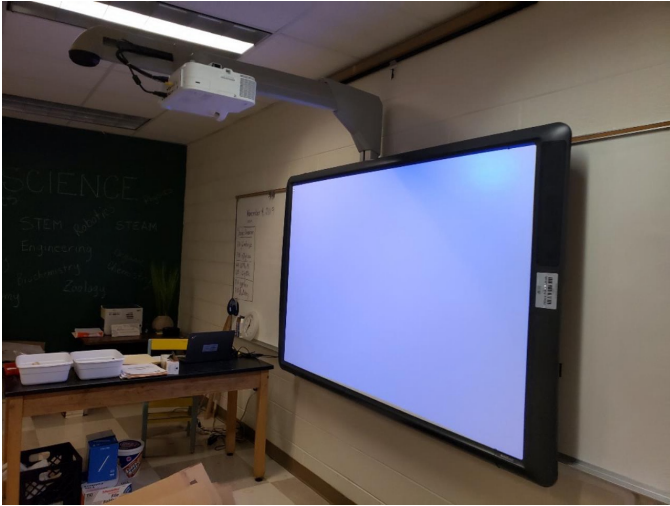
**System: E1020 - Institutional Equipment**

**Location:** Throughout Building  
**Distress:** Beyond Expected Life  
**Category:** Deferred Maintenance  
**Priority:** 3 - Necessary (Years 2-5)  
**Correction:** Renew System  
**Qty:** 10,662.00  
**Unit of Measure:** S.F.  
**Estimate:** \$31,314.00  
**Assessor Name:** Eduardo Lopez  
**Date Created:** 02/14/2020

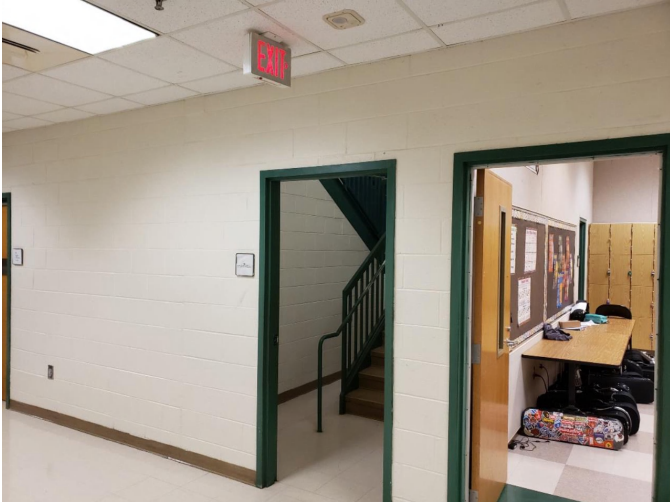
**System: C1020 - Interior Doors**

**Location:** Staircase, North  
**Distress:** Inadequate  
**Category:** Safety  
**Priority:** 4 - Recommended (Years 6-10)  
**Correction:** Replace 3'-0" x 7'-0" steel door w/ vision lite, & frame  
**Qty:** 2.00  
**Unit of Measure:** Ea.  
**Estimate:** \$3,529.15  
**Assessor Name:** Eduardo Lopez  
**Date Created:** 02/14/2020

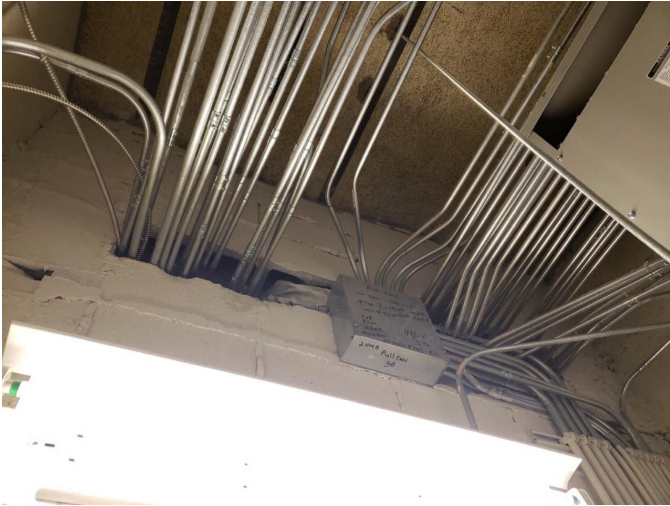
#### System: C1010 - Partitions

**Location:** Electrical 3088  
**Distress:** Failing  
**Category:** Code Compliance  
**Priority:** 1 - Critical Immediate Need  
**Correction:** Repair 8" concrete block wall - (2% of walls) painted  
**Qty:** 2.00  
**Unit of Measure:** C.S.F.  
**Estimate:** \$3,420.81  
**Assessor Name:** Eduardo Lopez  
**Date Created:** 02/15/2020

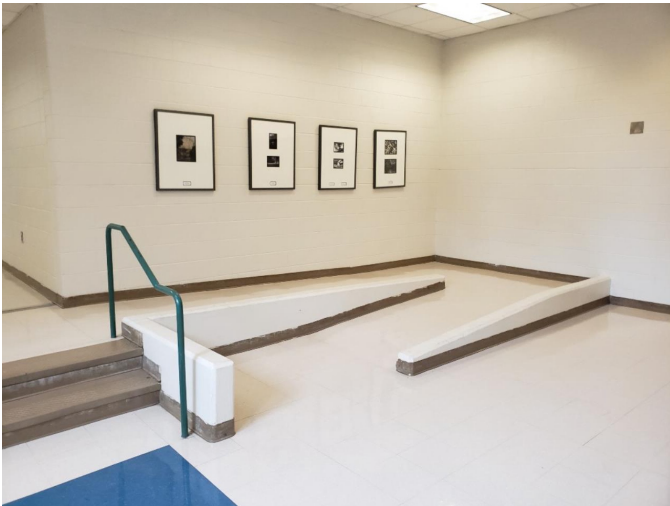
#### System: C1030 - Fittings

**Location:** Ramps  
**Distress:** Missing  
**Category:** ADA Compliance  
**Priority:** 1 - Critical Immediate Need  
**Correction:** Replace Handrails and Ornamental Metal  
**Qty:** 50.00  
**Unit of Measure:** L.F.  
**Estimate:** \$33,132.28  
**Assessor Name:** Eduardo Lopez  
**Date Created:** 02/15/2020

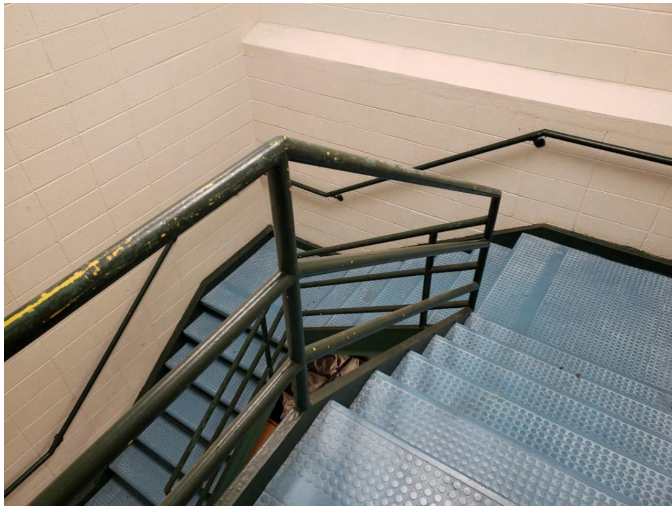
**System: C1030 - Fittings**

**Location:** Staircase, Northeast  
**Distress:** Non Compliant  
**Category:** ADA Compliance  
**Priority:** 2 - Trending Critical (Year 1)  
**Correction:** Replace Handrails and Ornamental Metal  
**Qty:** 80.00  
**Unit of Measure:** L.F.  
**Estimate:** \$53,011.64  
**Assessor Name:** Eduardo Lopez  
**Date Created:** 02/15/2020

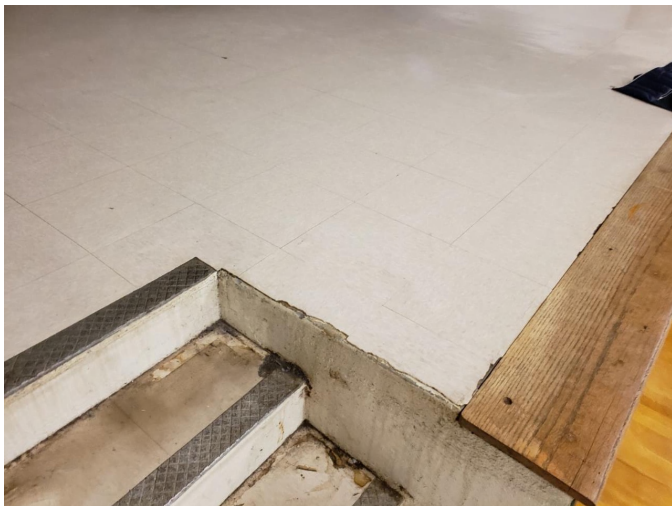
**System: C3020903 - VCT**

**Location:** Stage  
**Distress:** Failing  
**Category:** Deferred Maintenance  
**Priority:** 2 - Trending Critical (Year 1)  
**Correction:** Replace VCT Flooring  
**Qty:** 3,000.00  
**Unit of Measure:** S.F.  
**Estimate:** \$11,372.50  
**Assessor Name:** Eduardo Lopez  
**Date Created:** 02/15/2020

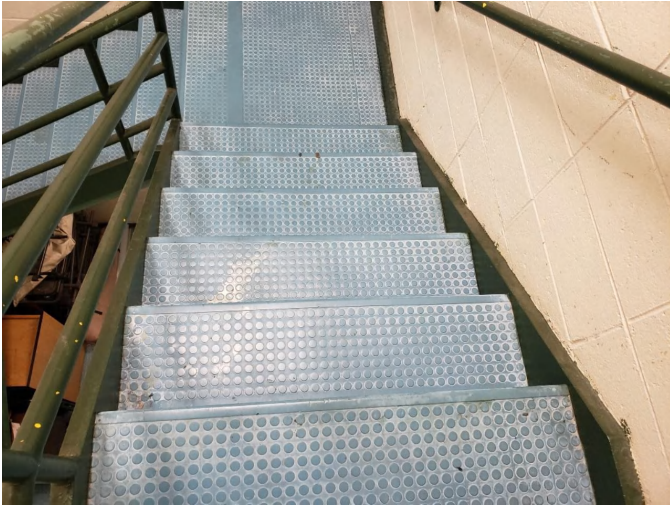
**System: C3020999 - Other - Rubber or Neoprene**

**Location:** Throughout Building  
**Distress:** Beyond Expected Life  
**Category:** Deferred Maintenance  
**Priority:** 3 - Necessary (Years 2-5)  
**Correction:** Renew System  
**Qty:** 240.00  
**Unit of Measure:** S.F.  
**Estimate:** \$7,041.00  
**Assessor Name:** Eduardo Lopez  
**Date Created:** 01/29/2020
