Atlanta Public Schools/ N. Atlanta Cluster

Jackson Elementary School

School Assessment Report

November 10, 2020

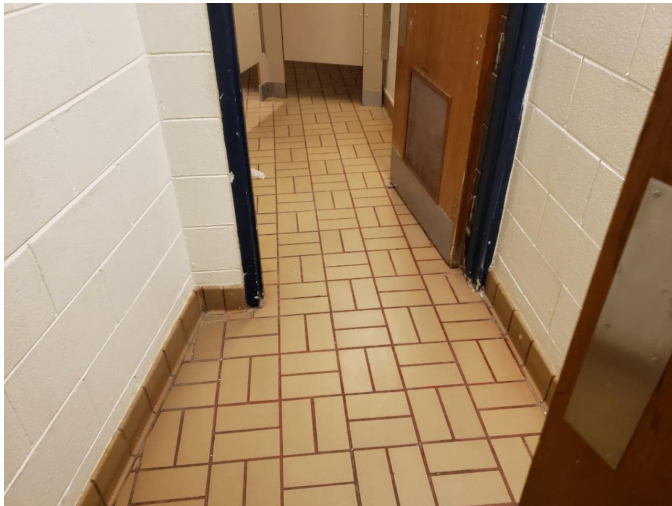
System: C3020420 - Ceramic Tile

Location: Throughout Building
Distress: Beyond Expected Life
Category: Deferred Maintenance
Priority: 3 - Necessary (Years 2-5)
Correction: Renew System
Qty: 3,566.00
Unit of Measure: S.F.
Estimate: \$89,542.00
Assessor Name: Eduardo Lopez
Date Created: 01/27/2020

Notes: The original tile is beyond its expected life and should be replaced.

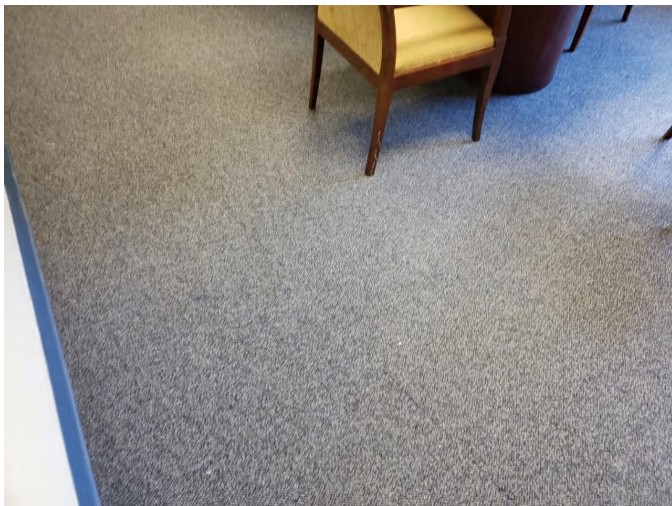
System: C3020901 - Carpet

Location: Throughout Building
Distress: Beyond Expected Life
Category: Deferred Maintenance
Priority: 3 - Necessary (Years 2-5)
Correction: Renew System
Qty: 6,139.00
Unit of Measure: S.F.
Estimate: \$50,647.00
Assessor Name: Eduardo Lopez
Date Created: 01/27/2020

Notes: The carpet is stained, worn, showing signs of early failure and should be replaced.

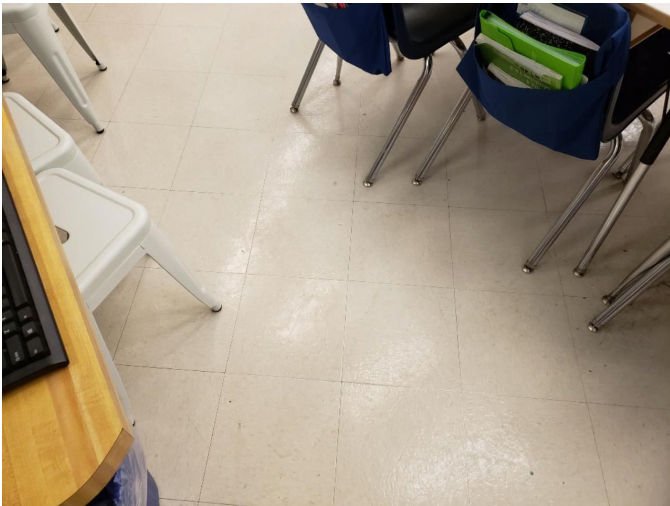
System: C3020903 - VCT

Location: Throughout Building
Distress: Beyond Expected Life
Category: Deferred Maintenance
Priority: 3 - Necessary (Years 2-5)
Correction: Renew System
Qty: 31,325.00
Unit of Measure: S.F.
Estimate: \$168,967.00
Assessor Name: Eduardo Lopez
Date Created: 01/27/2020

Notes: The VCT flooring is in poor conditions, and should be replaced.

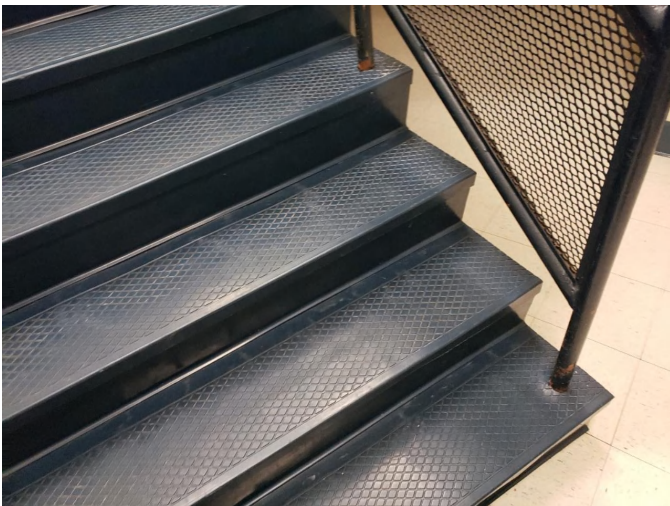
System: C3020999 - Other - Rubber or Neoprene

Location: Throughout Building
Distress: Beyond Expected Life
Category: Deferred Maintenance
Priority: 3 - Necessary (Years 2-5)
Correction: Renew System
Qty: 180.00
Unit of Measure: S.F.
Estimate: \$5,281.00
Assessor Name: Eduardo Lopez
Date Created: 01/27/2020

Notes: The rubber flooring system is beyond its expected service life and should be scheduled for replacement.

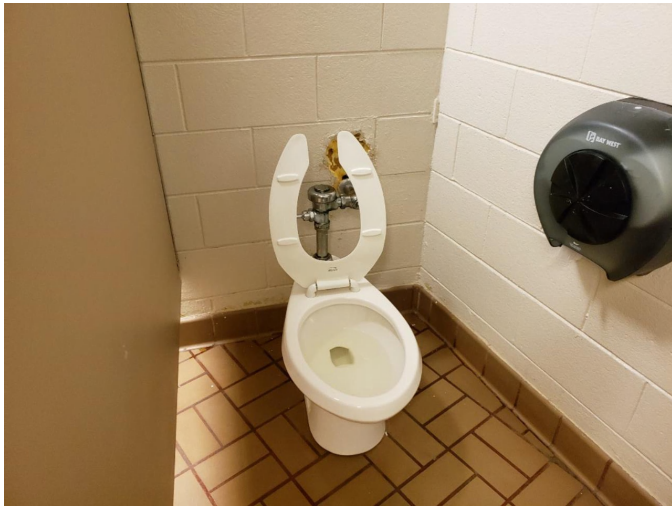
System: D2010 - Plumbing Fixtures

Location: Throughout Building
Distress: Beyond Expected Life
Category: ADA Compliance
Priority: 3 - Necessary (Years 2-5)
Correction: Renew System
Qty: 42,335.00
Unit of Measure: S.F.
Estimate: \$302,230.00
Assessor Name: Eduardo Lopez
Date Created: 08/13/2014

Notes: Plumbing fixtures are in operational conditions. However, they are aged, beyond its expected service life and should be replaced with a low-flow water fixture.

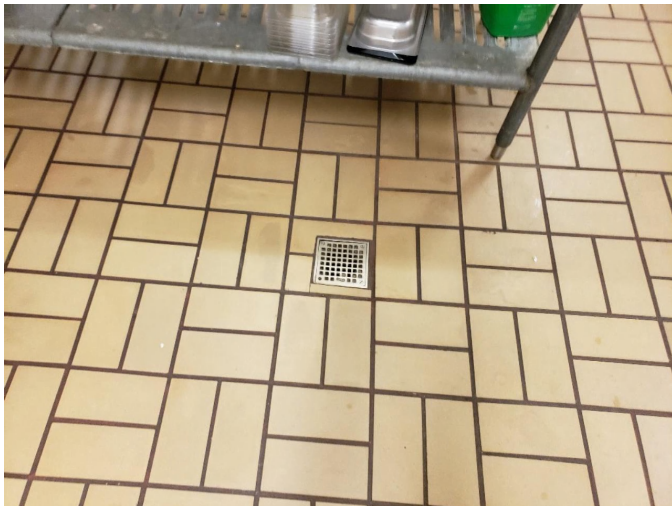
System: D2030 - Sanitary Waste

Location: Throughout Building
Distress: Beyond Expected Life
Category: Deferred Maintenance
Priority: 3 - Necessary (Years 2-5)
Correction: Renew System
Qty: 42,335.00
Unit of Measure: S.F.
Estimate: \$81,495.00
Assessor Name: Eduardo Lopez
Date Created: 08/19/2013

Notes: The sanitary waste system is aged, has reported periodic failures, and should be replaced.

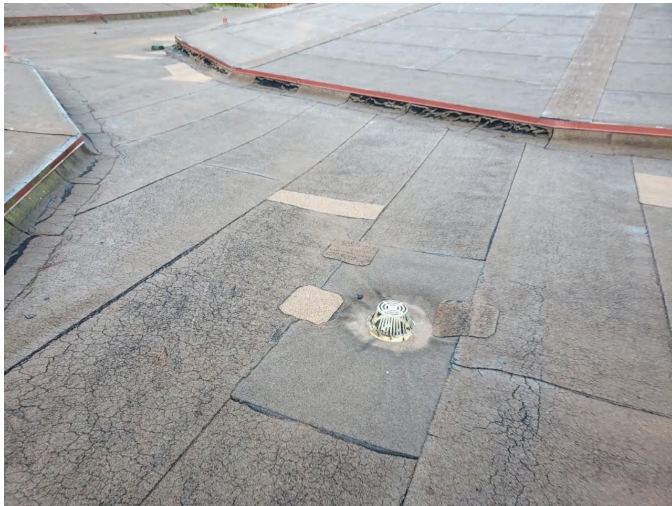
System: D2040 - Rain Water Drainage

Location: Throughout Building
Distress: Beyond Expected Life
Category: Deferred Maintenance
Priority: 3 - Necessary (Years 2-5)
Correction: Renew System
Qty: 42,335.00
Unit of Measure: S.F.
Estimate: \$19,093.00
Assessor Name: Eduardo Lopez
Date Created: 01/26/2020

Notes: The rainwater drainage system is aged, in marginal condition, and should be replaced.

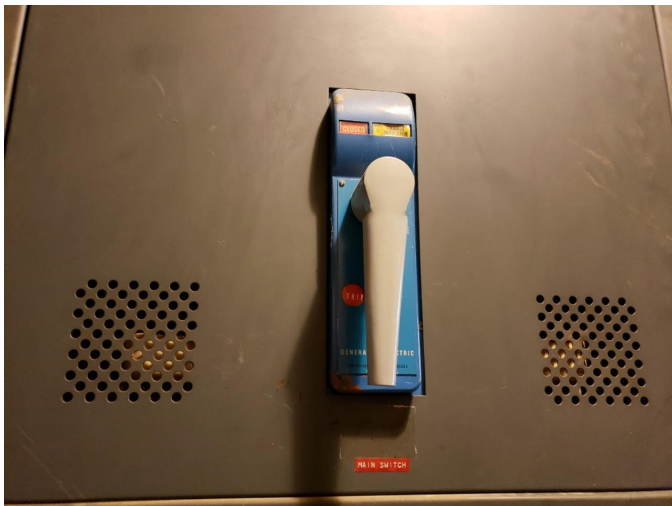
System: D5010 - Electrical Service/Distribution

Location: Throughout Building
Distress: Beyond Expected Life
Category: Deferred Maintenance
Priority: 3 - Necessary (Years 2-5)
Correction: Renew System
Qty: 42,335.00
Unit of Measure: S.F.
Estimate: \$108,970.00
Assessor Name: Eduardo Lopez
Date Created: 02/22/2020

Notes: The original electrical service is operating but is in marginal condition and should be replaced.

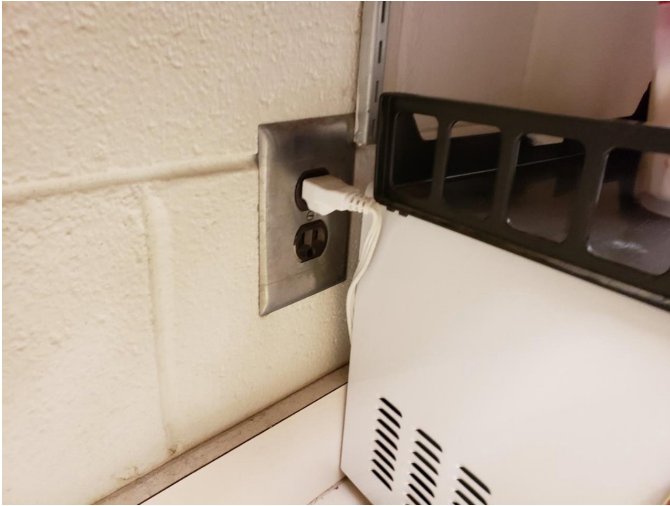
System: D5020 - Branch Wiring

Location: Throughout Building
Distress: Beyond Expected Life
Category: Deferred Maintenance
Priority: 3 - Necessary (Years 2-5)
Correction: Renew System
Qty: 42,335.00
Unit of Measure: S.F.
Estimate: \$211,887.00
Assessor Name: Eduardo Lopez
Date Created: 01/27/2020

Notes: The original branch wiring system is operating, but is aged, in poor condition, and should be replaced.

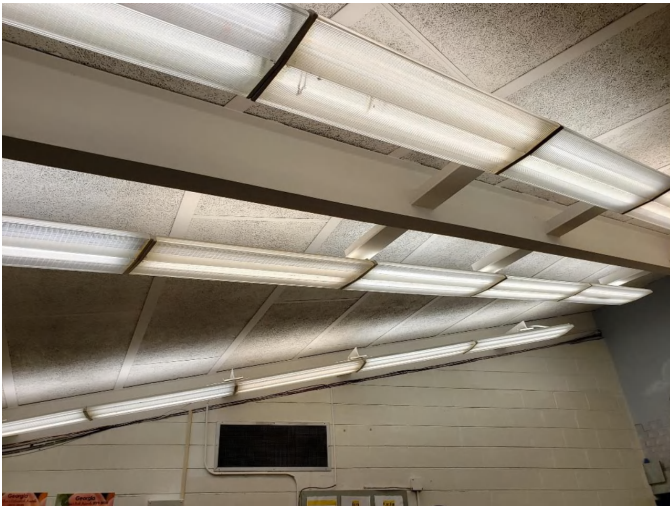
System: D5020 - Lighting

Location: Throughout Building
Distress: Beyond Expected Life
Category: Deferred Maintenance
Priority: 3 - Necessary (Years 2-5)
Correction: Renew System
Qty: 42,335.00
Unit of Measure: S.F.
Estimate: \$318,063.00
Assessor Name: Eduardo Lopez
Date Created: 08/13/2014

Notes: The original lighting system is operating, but is aged, in poor condition, and should be replaced.

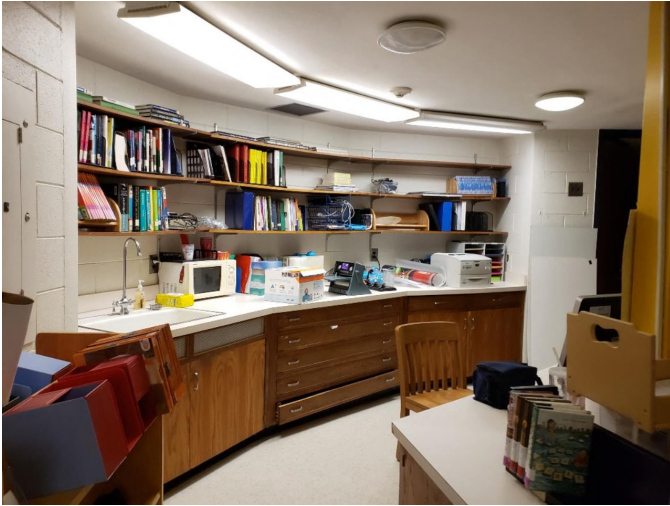
System: E2010 - Fixed Furnishings

Location: Throughout Building
Distress: Beyond Expected Life
Category: Deferred Maintenance
Priority: 3 - Necessary (Years 2-5)
Correction: Renew System
Qty: 42,335.00
Unit of Measure: S.F.
Estimate: \$90,343.00
Assessor Name: Eduardo Lopez
Date Created: 01/27/2020

Notes: The fixed furnishings are aged, in marginal condition, and should be replaced.

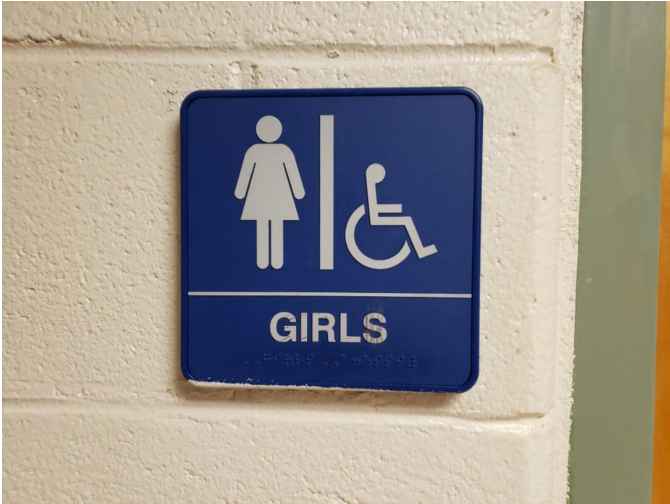
System: C1030 - Fittings

Location: Throughout Building
Distress: Beyond Expected Life
Category: ADA Compliance
Priority: 3 - Necessary (Years 2-5)
Correction: Renew System
Qty: 36,256.00
Unit of Measure: S.F.
Estimate: \$108,877.00
Assessor Name: Eduardo Lopez
Date Created: 09/17/2015

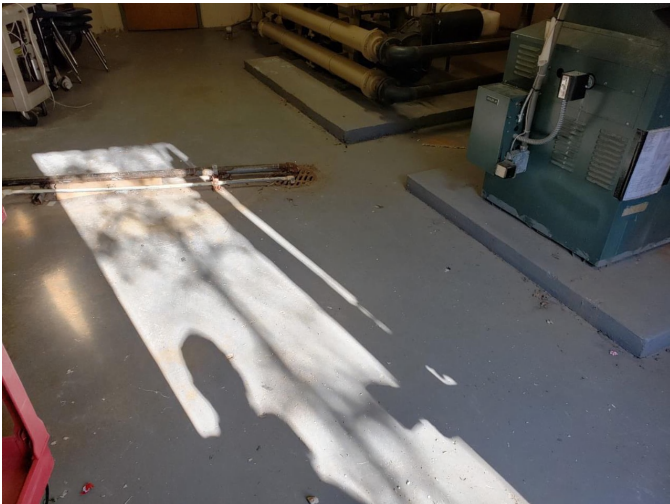
System: C3020405 - Epoxy

Location: Throughout Building
Distress: Beyond Expected Life
Category: Deferred Maintenance
Priority: 3 - Necessary (Years 2-5)
Correction: Renew System
Qty: 798.00
Unit of Measure: S.F.
Estimate: \$16,290.00
Assessor Name: Eduardo Lopez
Date Created: 01/27/2020

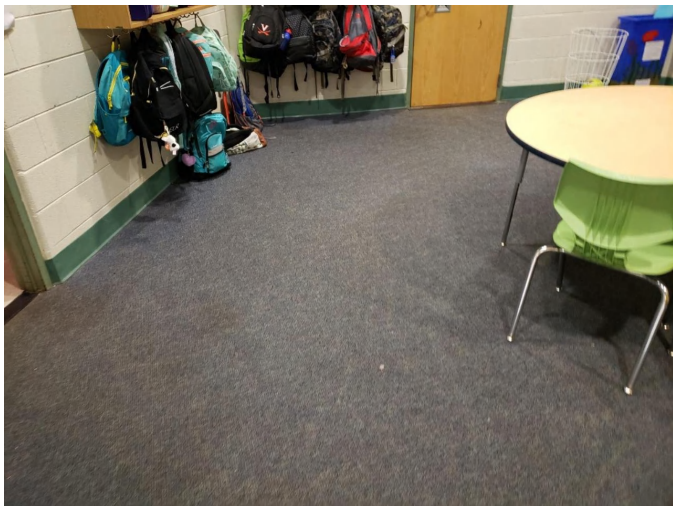
System: C3020901 - Carpet

Location: Throughout Building
Distress: Beyond Expected Life
Category: Deferred Maintenance
Priority: 3 - Necessary (Years 2-5)
Correction: Renew System
Qty: 1,650.00
Unit of Measure: S.F.
Estimate: \$13,613.00
Assessor Name: Eduardo Lopez
Date Created: 01/27/2020

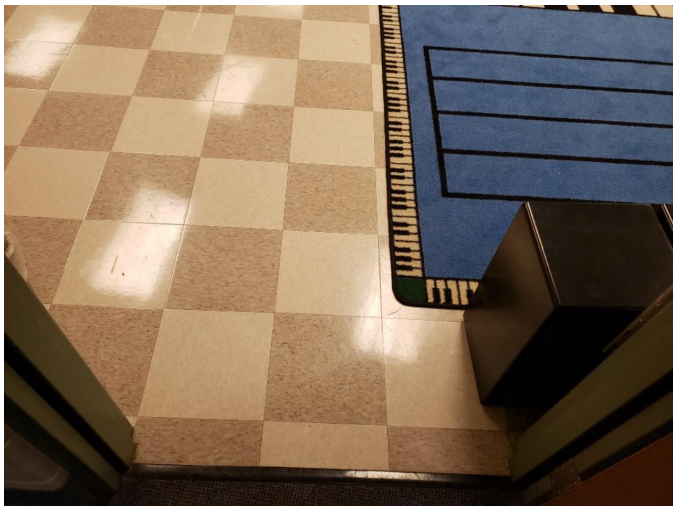
System: C3020903 - VCT

Location: Throughout Building
Distress: Beyond Expected Life
Category: Deferred Maintenance
Priority: 3 - Necessary (Years 2-5)
Correction: Renew System
Qty: 25,327.00
Unit of Measure: S.F.
Estimate: \$136,614.00
Assessor Name: Eduardo Lopez
Date Created: 01/27/2020

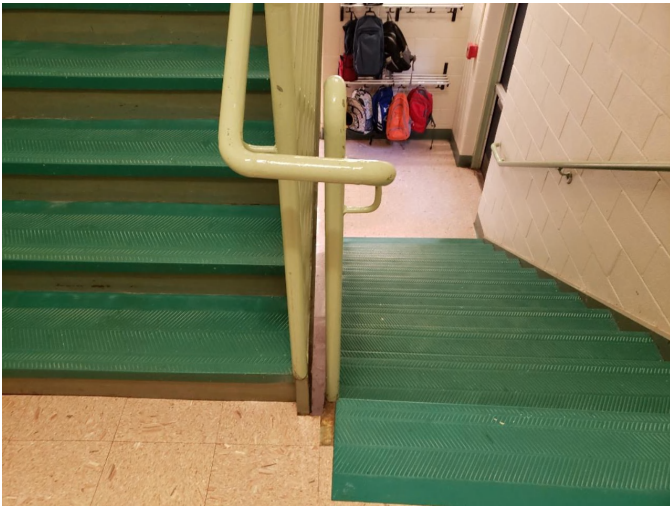
System: C3020999 - Other - Rubber or Neoprene

Location: 1993 Bldg 2011
Distress: Beyond Expected Life
Category: Deferred Maintenance
Priority: 3 - Necessary (Years 2-5)
Correction: Renew System
Qty: 5,482.00
Unit of Measure: S.F.
Estimate: \$160,825.00
Assessor Name: Eduardo Lopez
Date Created: 10/15/2020
