Atlanta Public Schools/ N. Atlanta Cluster

Jackson Primary

School Assessment Report

November 10, 2020

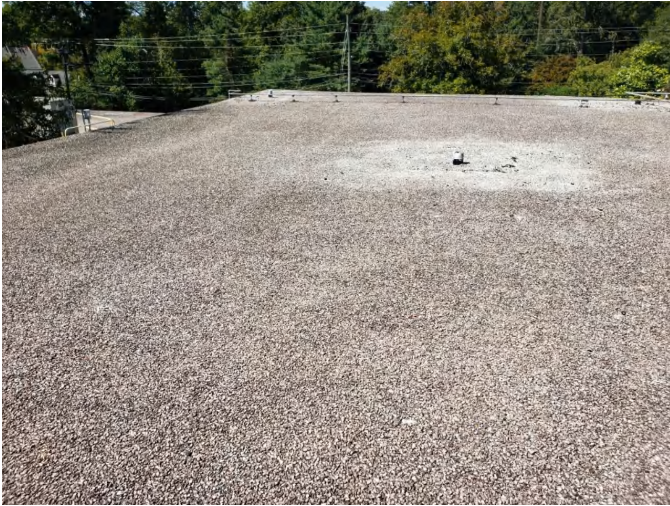
System: B3010105 - Built-Up

Location: Rooftop
Distress: Beyond Expected Life
Category: Deferred Maintenance
Priority: 3 - Necessary (Years 2-5)
Correction: Renew System
Qty: 23,529.00
Unit of Measure: S.F.
Estimate: \$264,125.00
Assessor Name: Jejuan Hall
Date Created: 02/21/2020

Notes: Built up roof is beyond its expected life and leaks have been reported.

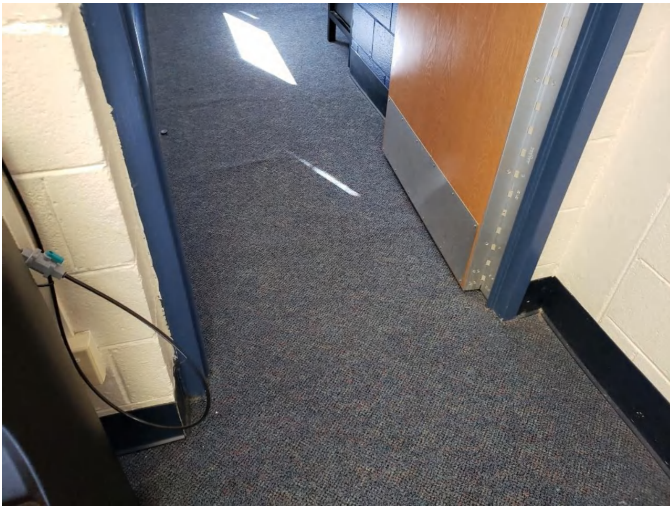
System: C3020901 - Carpet

Location: Throughout Building
Distress: Beyond Expected Life
Category: Deferred Maintenance
Priority: 3 - Necessary (Years 2-5)
Correction: Renew System
Qty: 793.00
Unit of Measure: S.F.
Estimate: \$6,542.00
Assessor Name: Jejuan Hall
Date Created: 01/26/2020

Notes: The carpet is frayed, showing signs of early failure and should be replaced.

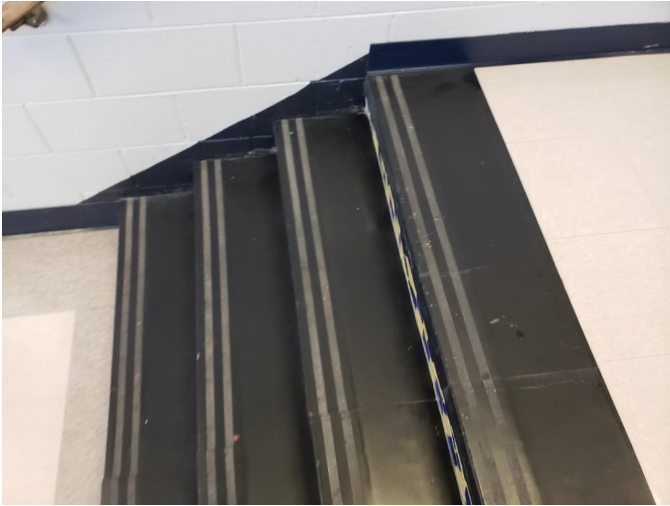
System: C3020999 - Other - Rubber or Neoprene

Location: Stairs
Distress: Beyond Expected Life
Category: Deferred Maintenance
Priority: 3 - Necessary (Years 2-5)
Correction: Renew System
Qty: 190.00
Unit of Measure: S.F.
Estimate: \$5,574.00
Assessor Name: Jejuan Hall
Date Created: 01/26/2020

Notes: The rubber flooring system is beyond its expected service life and should be scheduled for replacement.
