Atlanta Public Schools/ Mays Cluster

# Mays High School

## School Assessment Report

November 10, 2020

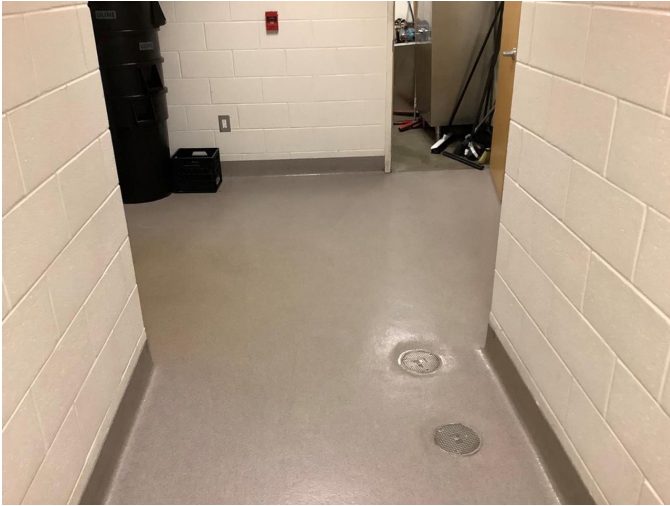
#### System: C3020405 - Epoxy

**Location:** Throughout building  
**Distress:** Beyond Expected Life  
**Category:** Deferred Maintenance  
**Priority:** 3 - Necessary (Years 2-5)  
**Correction:** Renew System  
**Qty:** 5,000.00  
**Unit of Measure:** S.F.  
**Estimate:** \$102,070.00  
**Assessor Name:** Homero Guerrero  
**Date Created:** 12/17/2019

**Notes:** The Epoxy finish is beyond its expected service life, worn and damaged, and is recommended for replacement.

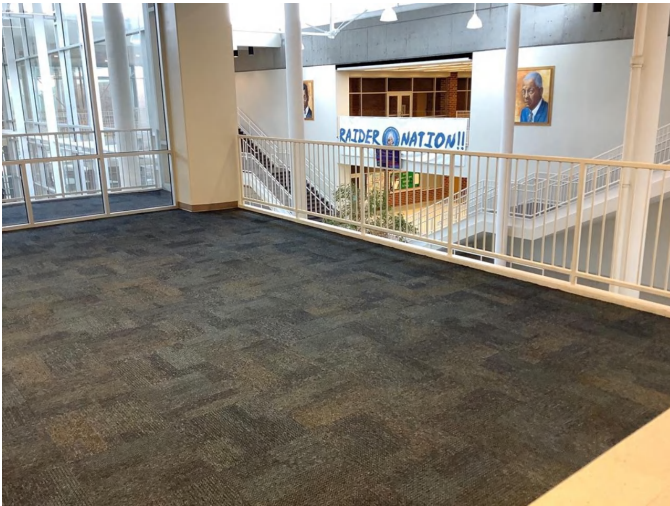
#### System: C3020901 - Carpet

**Location:** Throughout building  
**Distress:** Beyond Expected Life  
**Category:** Deferred Maintenance  
**Priority:** 3 - Necessary (Years 2-5)  
**Correction:** Renew System  
**Qty:** 10,000.00  
**Unit of Measure:** S.F.  
**Estimate:** \$82,500.00  
**Assessor Name:** Homero Guerrero  
**Date Created:** 12/17/2019

**Notes:** The carpet floor finish is beyond its expected service life, worn and damaged, and is recommended for replacement.

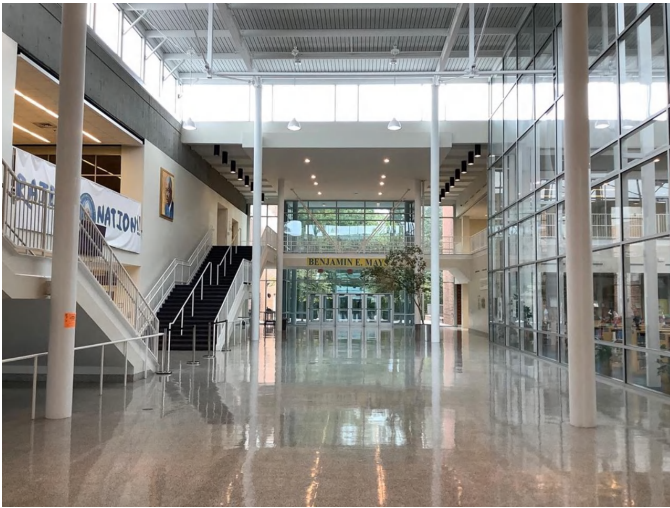
**System: C3020903 - VCT**

**Location:** Throughout building  
**Distress:** Beyond Expected Life  
**Category:** Deferred Maintenance  
**Priority:** 3 - Necessary (Years 2-5)  
**Correction:** Renew System  
**Qty:** 226,270.00  
**Unit of Measure:** S.F.  
**Estimate:** \$1,220,500.00  
**Assessor Name:** Homero Guerrero  
**Date Created:** 12/17/2019

**Notes:** The VCT floor finish is beyond its expected service life, worn and damaged, and is recommended for replacement.

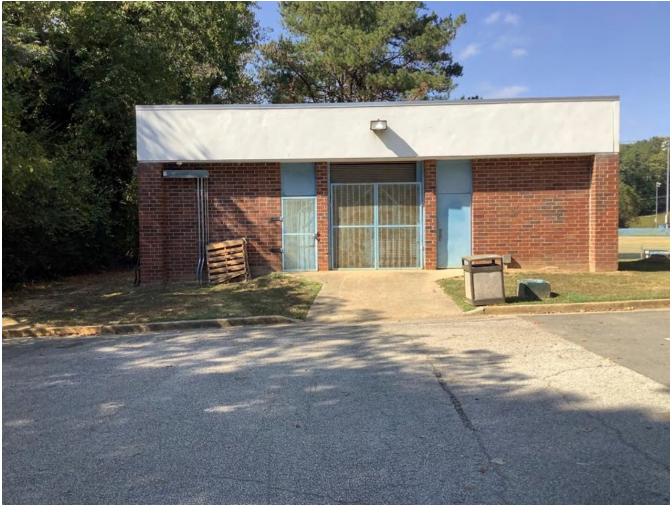
#### System: B2030 - Exterior Doors

**Location:** Throughout building  
**Distress:** Beyond Expected Life  
**Category:** ADA Compliance  
**Priority:** 3 - Necessary (Years 2-5)  
**Correction:** Renew System  
**Qty:** 1,394.00  
**Unit of Measure:** S.F.  
**Estimate:** \$5,074.00  
**Assessor Name:** Jejuan Hall  
**Date Created:** 09/09/2013

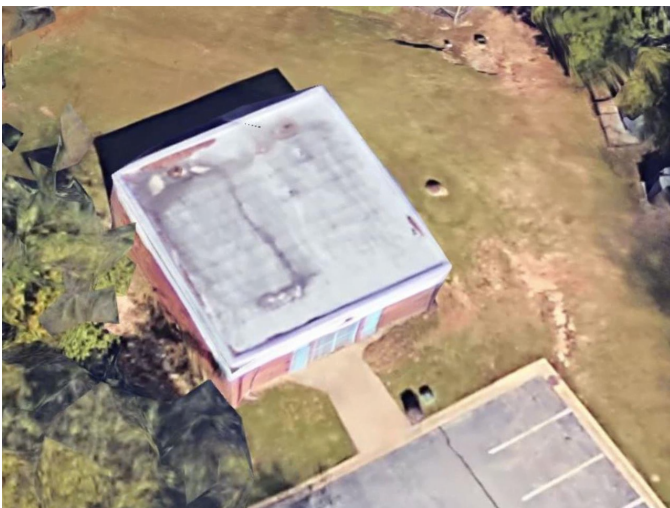
#### System: B3010105 - Built-Up

**Location:** Roof  
**Distress:** Beyond Expected Life  
**Category:** Deferred Maintenance  
**Priority:** 3 - Necessary (Years 2-5)  
**Correction:** Renew System  
**Qty:** 1,394.00  
**Unit of Measure:** S.F.  
**Estimate:** \$15,648.00  
**Assessor Name:** Homero Guerrero  
**Date Created:** 01/31/2020

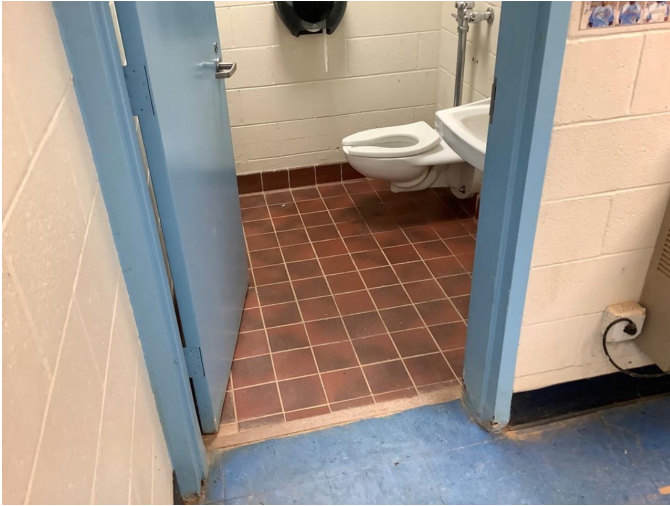
### **System: C3020903 - VCT**

**Location:** Restroom Kitchen  
**Distress:** Beyond Expected Life  
**Category:** Deferred Maintenance  
**Priority:** 3 - Necessary (Years 2-5)  
**Correction:** Renew System  
**Qty:** 500.00  
**Unit of Measure:** S.F.  
**Estimate:** \$2,697.00  
**Assessor Name:** Homero Guerrero  
**Date Created:** 12/17/2019

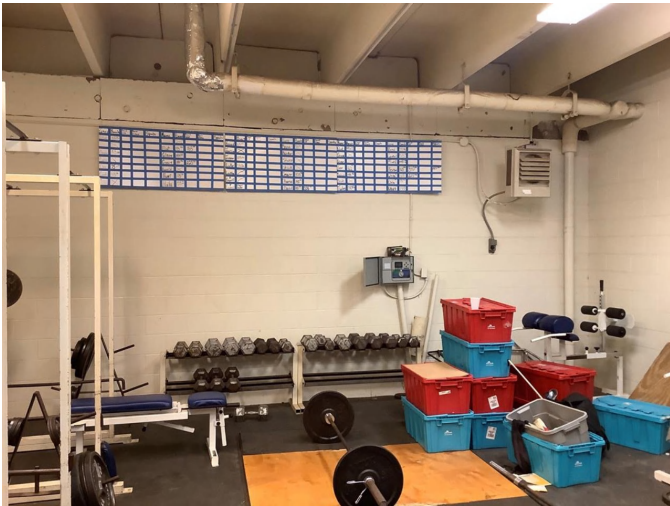
### **System: C3020999 - Other - Rubber or Neoprene**

**Location:** Gym  
**Distress:** Beyond Expected Life  
**Category:** Deferred Maintenance  
**Priority:** 3 - Necessary (Years 2-5)  
**Correction:** Renew System  
**Qty:** 600.00  
**Unit of Measure:** S.F.  
**Estimate:** \$17,602.00  
**Assessor Name:** Homero Guerrero  
**Date Created:** 12/17/2019

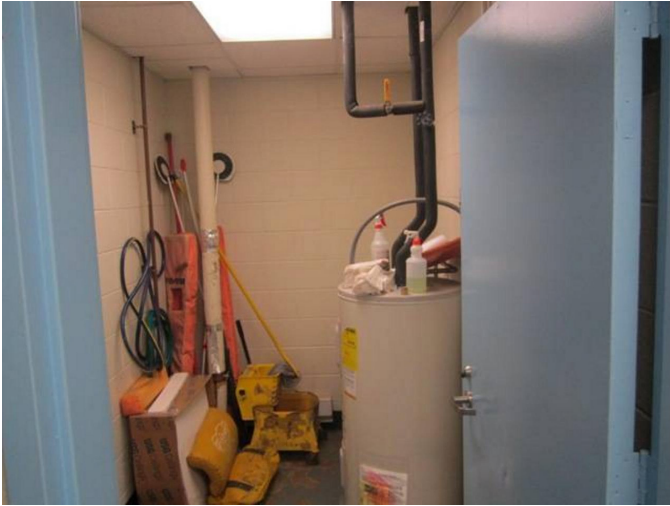
**System: D2020 - Domestic Water Distribution**

**Location:** Throughout building  
**Distress:** Beyond Expected Life  
**Category:** Deferred Maintenance  
**Priority:** 3 - Necessary (Years 2-5)  
**Correction:** Renew System  
**Qty:** 1,394.00  
**Unit of Measure:** S.F.  
**Estimate:** \$6,839.00  
**Assessor Name:** Homero Guerrero  
**Date Created:** 09/09/2013

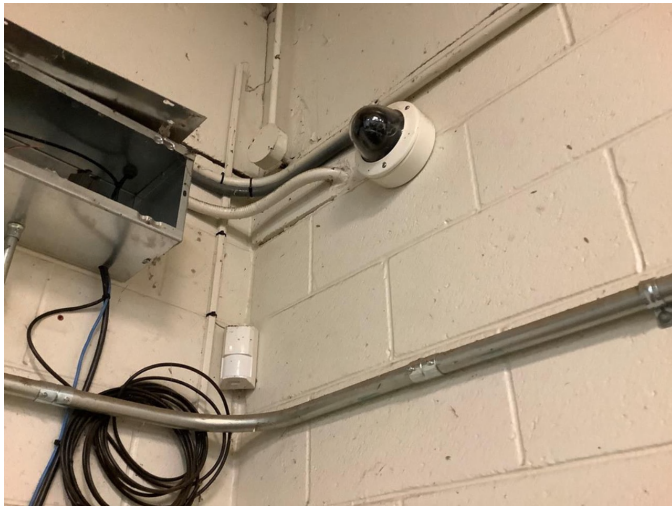
**System: D5030810 - Security & Detection Systems**

**Location:** Throughout building  
**Distress:** Beyond Expected Life  
**Category:** Deferred Maintenance  
**Priority:** 3 - Necessary (Years 2-5)  
**Correction:** Renew System  
**Qty:** 1,394.00  
**Unit of Measure:** S.F.  
**Estimate:** \$2,315.00  
**Assessor Name:** Homero Guerrero  
**Date Created:** 02/19/2020

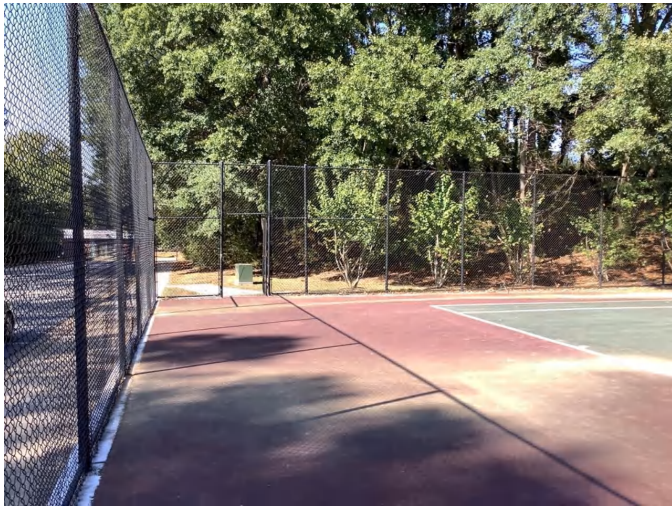
#### System: G2040950 - Tennis Courts

**Location:** Tennis Court  
**Distress:** Beyond Expected Life  
**Category:** Deferred Maintenance  
**Priority:** 3 - Necessary (Years 2-5)  
**Correction:** Renew System  
**Qty:** 341,952.00  
**Unit of Measure:** S.F.  
**Estimate:** \$635,689.00  
**Assessor Name:** Hayden Collins  
**Date Created:** 12/18/2019
