Atlanta Public Schools/ Grady Cluster

Morningside Elementary School

School Assessment Report

November 10, 2020

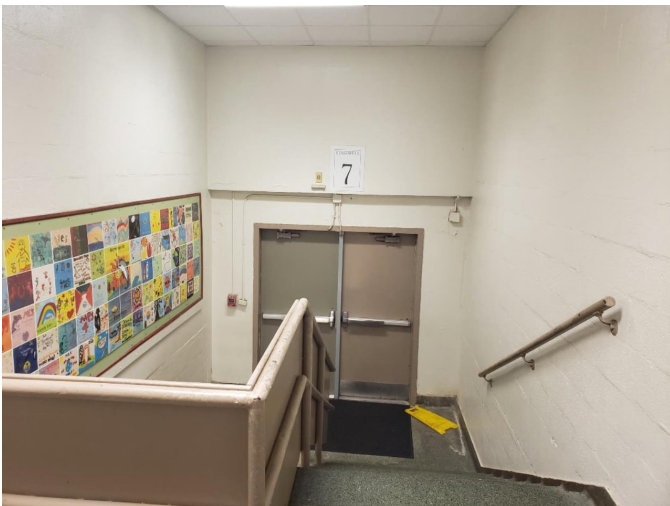
System: C1030 - Fittings

Location: Throughout building
Distress: Beyond Expected Life
Category: ADA Compliance
Priority: 2 - Trending Critical (Year 1)
Correction: Renew System
Qty: 56,340.00
Unit of Measure: S.F.
Estimate: \$161,752.00
Assessor Name: Sam Mandola
Date Created: 09/17/2015

Notes: The fittings throughout the building are aged and in marginal condition and should be replaced. Handrails and room signage are not ADA compliance.

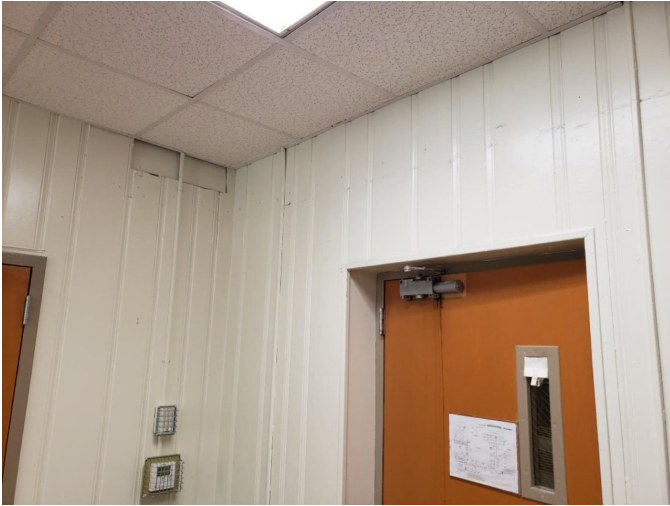
Location: Conference room 1134A
Distress: Beyond Expected Life
Category: Deferred Maintenance
Priority: 3 - Necessary (Years 2-5)
Correction: Renew System
Qty: 1,734.00
Unit of Measure: S.F.
Estimate: \$14,320.00
Assessor Name: Sam Mandola
Date Created: 12/05/2019

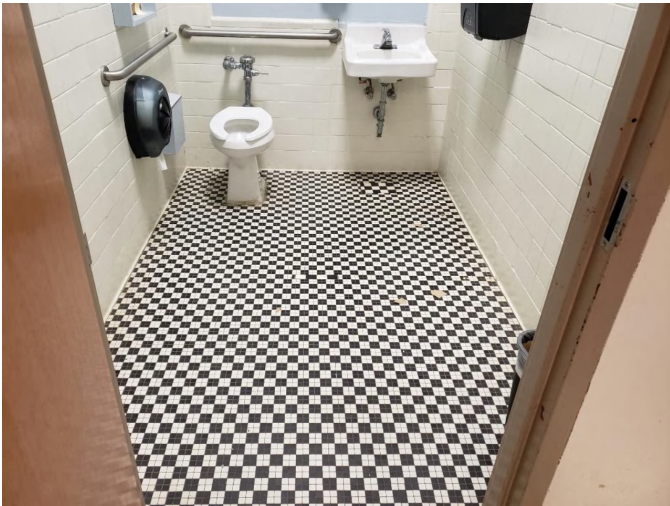
Location: Restrooms
Distress: Beyond Expected Life
Category: Deferred Maintenance
Priority: 3 - Necessary (Years 2-5)
Correction: Renew System
Qty: 2,260.00
Unit of Measure: S.F.
Estimate: \$56,749.00
Assessor Name: Sam Mandola
Date Created: 12/05/2019

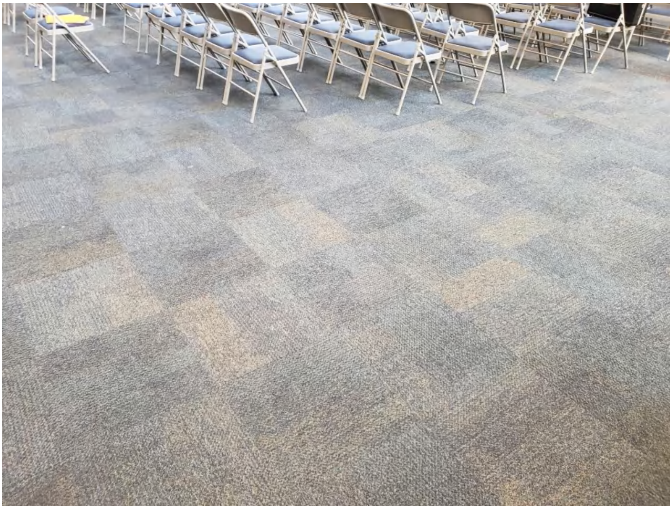
Location: Multi-purpose room and balcony
Distress: Beyond Expected Life
Category: Deferred Maintenance
Priority: 3 - Necessary (Years 2-5)
Correction: Renew System
Qty: 5,742.00
Unit of Measure: S.F.
Estimate: \$47,372.00
Assessor Name: Sam Mandola
Date Created: 12/05/2019

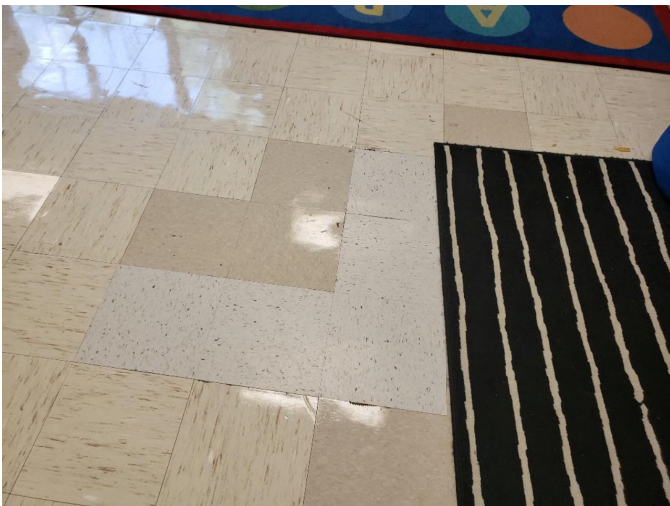
Location: Throughout building
Distress: Beyond Expected Life
Category: Deferred Maintenance
Priority: 3 - Necessary (Years 2-5)
Correction: Renew System
Qty: 38,409.00
Unit of Measure: S.F.
Estimate: \$207,178.00
Assessor Name: Sam Mandola
Date Created: 12/05/2019

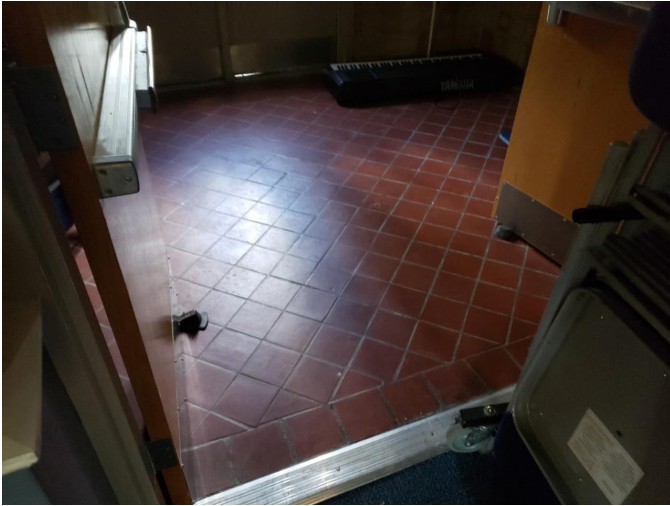
Location: Multi-purpose room lobby and staircase
Distress: Beyond Expected Life
Category: Deferred Maintenance
Priority: 3 - Necessary (Years 2-5)
Correction: Renew System
Qty: 845.00
Unit of Measure: S.F.
Estimate: \$28,126.00
Assessor Name: Sam Mandola
Date Created: 12/05/2019

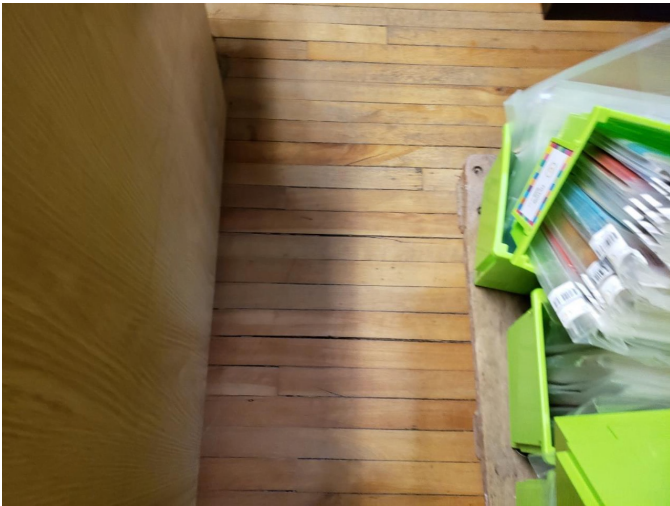
Location: Throughout building
Distress: Beyond Expected Life
Category: Deferred Maintenance
Priority: 3 - Necessary (Years 2-5)
Correction: Renew System
Qty: 5,090.00
Unit of Measure: S.F.
Estimate: \$96,162.00
Assessor Name: Homero Guerrero
Date Created: 12/05/2019

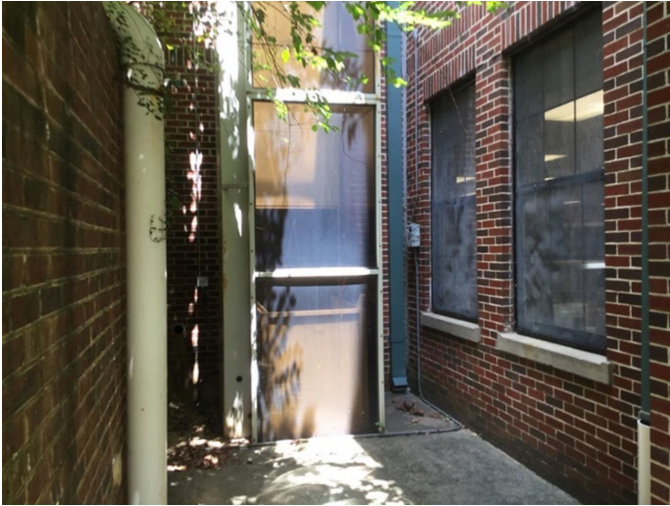
Location: Exterior wall
Distress: Beyond Expected Life
Category: Deferred Maintenance
Priority: 3 - Necessary (Years 2-5)
Correction: Renew System
Qty: 56,340.00
Unit of Measure: S.F.
Estimate: \$262,150.00
Assessor Name: Sam Mandola
Date Created: 09/17/2015

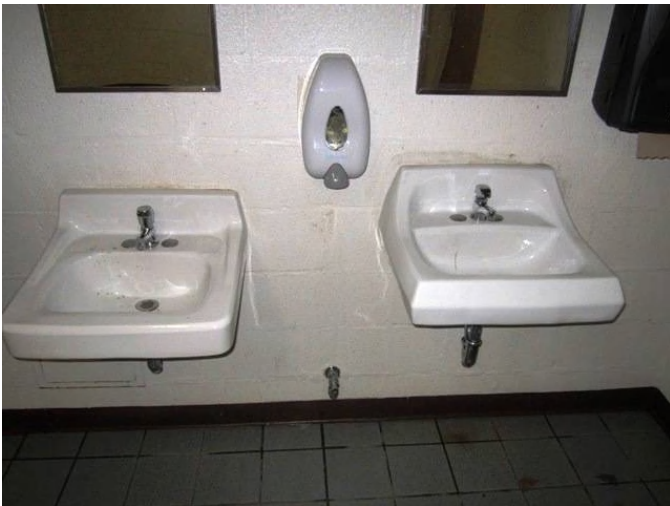
Location: Throughout building
Distress: Beyond Expected Life
Category: ADA Compliance
Priority: 3 - Necessary (Years 2-5)
Correction: Renew System
Qty: 56,340.00
Unit of Measure: S.F.
Estimate: \$387,338.00
Assessor Name: Sam Mandola
Date Created: 08/19/2013

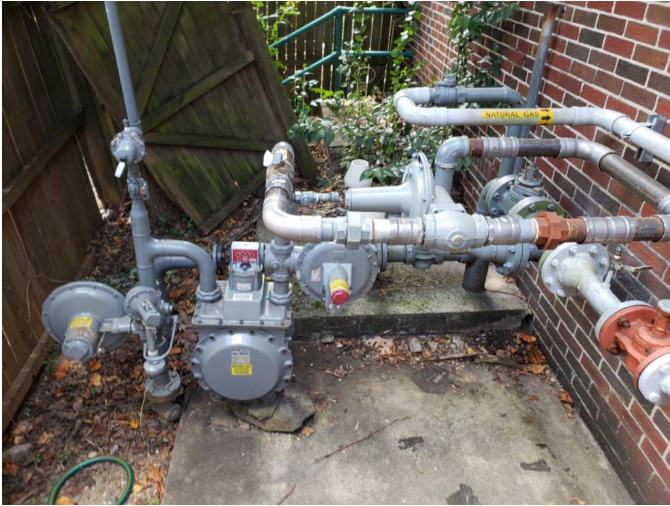
Location: Throughout building
Distress: Beyond Expected Life
Category: Deferred Maintenance
Priority: 3 - Necessary (Years 2-5)
Correction: Renew System
Qty: 56,340.00
Unit of Measure: S.F.
Estimate: \$37,804.00
Assessor Name: Homero Guerrero
Date Created: 10/17/2019

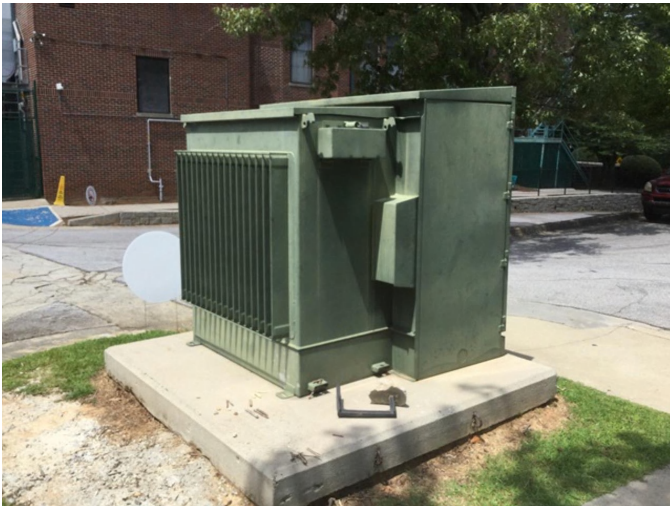
Location: Site
Distress: Beyond Expected Life
Category: Deferred Maintenance
Priority: 3 - Necessary (Years 2-5)
Correction: Renew System
Qty: 56,340.00
Unit of Measure: S.F.
Estimate: \$141,301.00
Assessor Name: Sam Mandola
Date Created: 09/17/2015

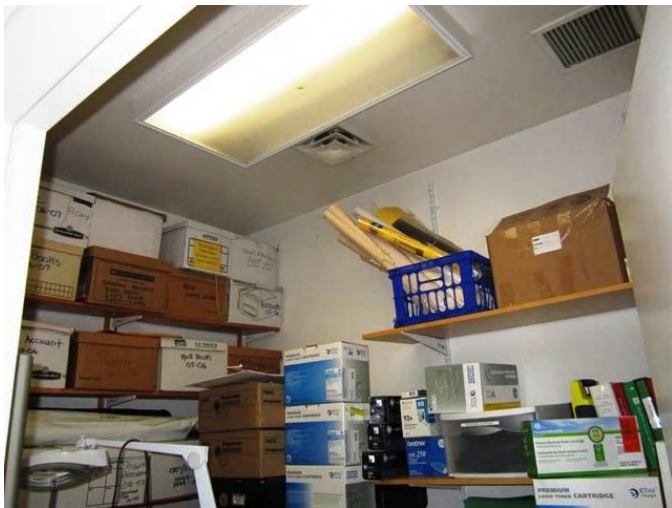
Location: Throughout building
Distress: Beyond Expected Life
Category: Deferred Maintenance
Priority: 3 - Necessary (Years 2-5)
Correction: Renew System
Qty: 56,340.00
Unit of Measure: S.F.
Estimate: \$289,419.00
Assessor Name: Sam Mandola
Date Created: 08/19/2013

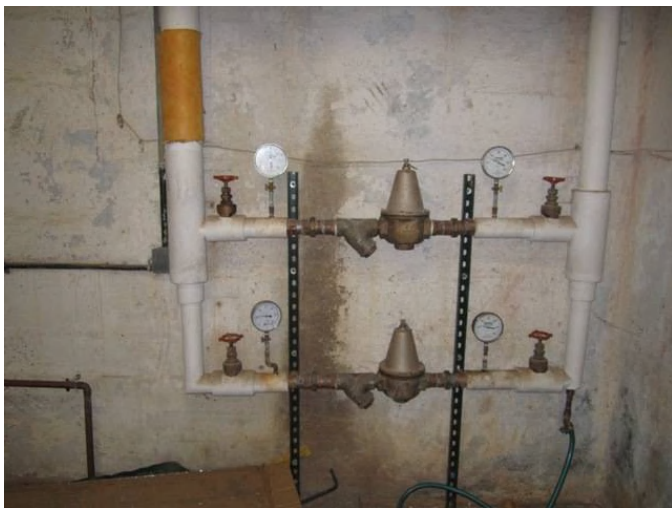
Location: Throughout building
Distress: Beyond Expected Life
Category: Deferred Maintenance
Priority: 4 - Recommended (Years 6-10)
Correction: Renew System
Qty: 56,340.00
Unit of Measure: S.F.
Estimate: \$44,002.00
Assessor Name: Sam Mandola
Date Created: 08/19/2013

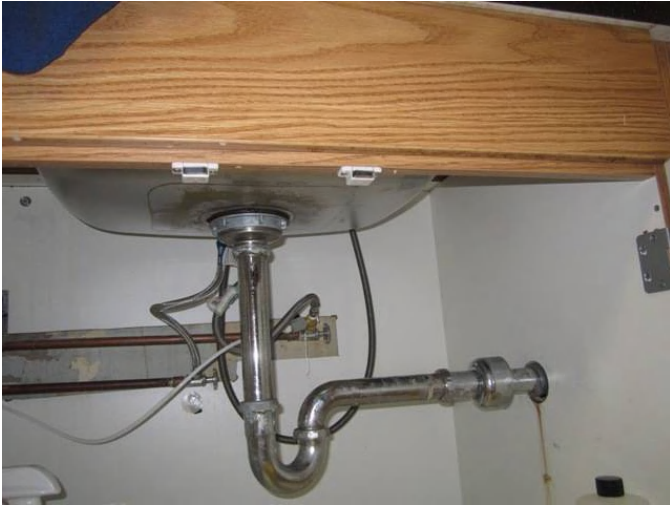
Location: Throughout building
Distress: Beyond Expected Life
Category: Deferred Maintenance
Priority: 4 - Recommended (Years 6-10)
Correction: Renew System
Qty: 56,340.00
Unit of Measure: S.F.
Estimate: \$104,116.00
Assessor Name: Homero Guerrero
Date Created: 08/19/2013

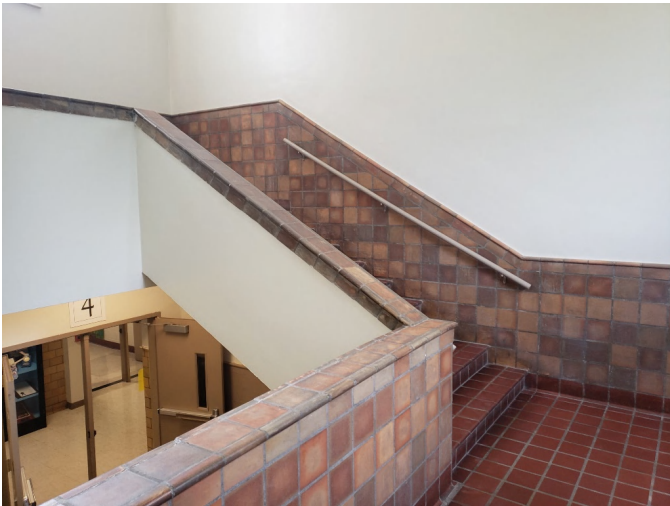
Location: Throughout building
Distress: Missing
Category: Code Compliance
Priority: 4 - Recommended (Years 6-10)
Correction: Renew System
Qty: 56,340.00
Unit of Measure: S.F.
Estimate: \$21,071.00
Assessor Name: Homero Guerrero
Date Created: 08/19/2013

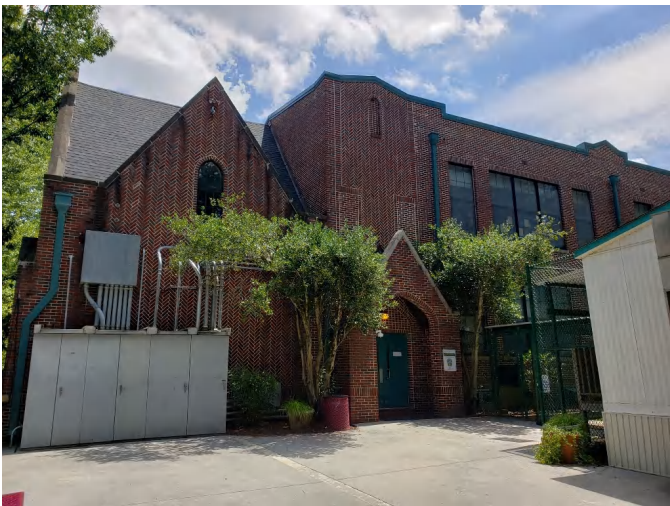
Location: Throughout building
Distress: Missing
Category: Reliability
Priority: 4 - Recommended (Years 6-10)
Correction: Renew System
Qty: 56,340.00
Unit of Measure: S.F.
Estimate: \$21,071.00
Assessor Name: Sam Mandola
Date Created: 08/19/2013

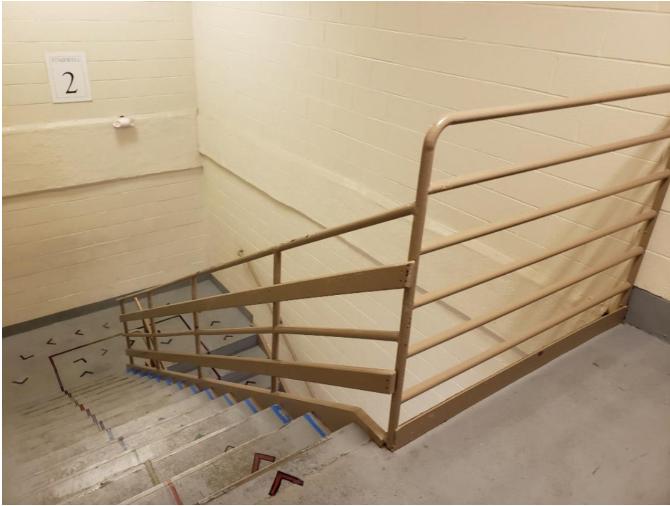
Location: Throughout building
Distress: Beyond Expected Life
Category: ADA Compliance
Priority: 2 - Trending Critical (Year 1)
Correction: Renew System
Qty: 30,152.00
Unit of Measure: S.F.
Estimate: \$87,230.00
Assessor Name: Sam Mandola
Date Created: 09/17/2015

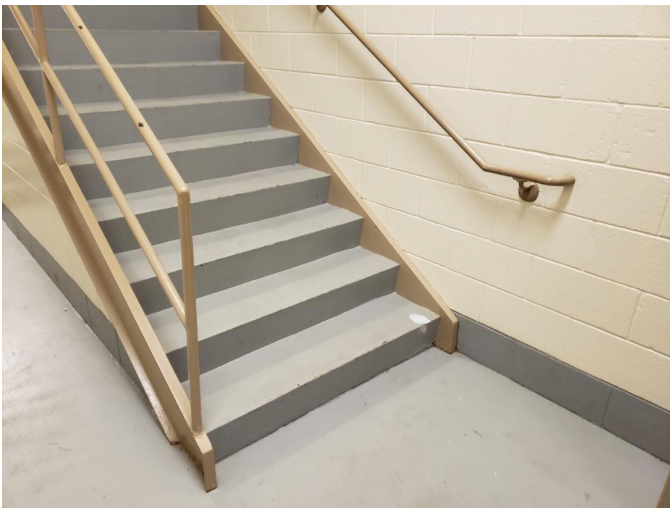
Location: Staircase
Distress: Beyond Expected Life
Category: Deferred Maintenance
Priority: 3 - Necessary (Years 2-5)
Correction: Renew System
Qty: 1,175.00
Unit of Measure: S.F.
Estimate: \$23,986.00
Assessor Name: Sam Mandola
Date Created: 12/05/2019

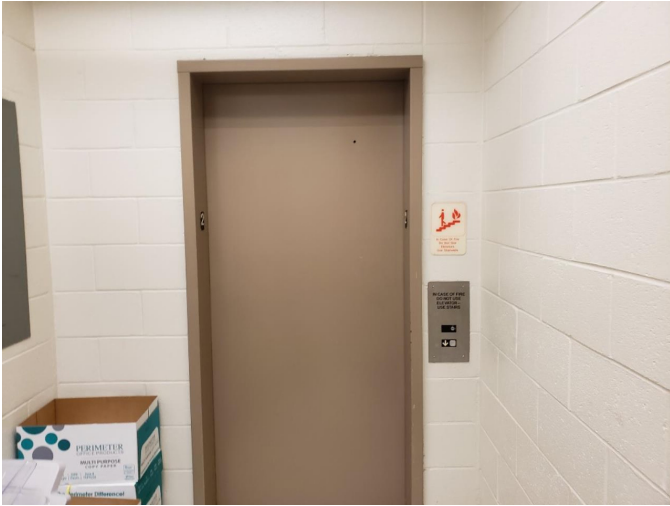
Location: Throughout building
Distress: Beyond Expected Life
Category: Deferred Maintenance
Priority: 3 - Necessary (Years 2-5)
Correction: Renew System
Qty: 30,152.00
Unit of Measure: S.F.
Estimate: \$220,894.00
Assessor Name: Hayden Collins
Date Created: 09/17/2015

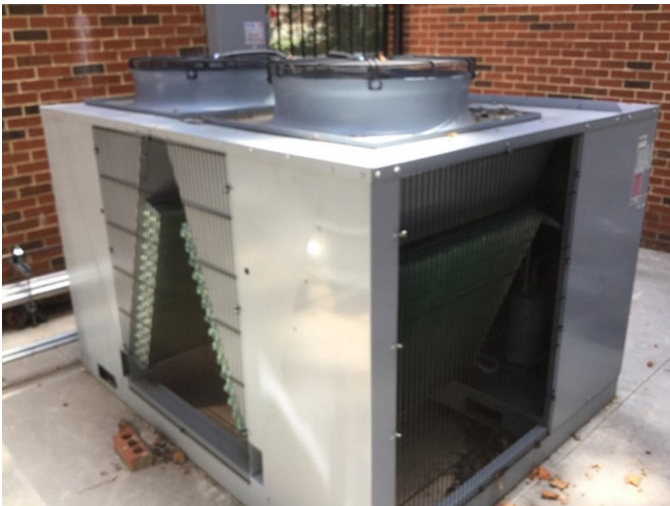
Location: Throughout building
Distress: Beyond Expected Life
Category: Deferred Maintenance
Priority: 3 - Necessary (Years 2-5)
Correction: Renew System
Qty: 30,152.00
Unit of Measure: S.F.
Estimate: \$536,314.00
Assessor Name: Sam Mandola
Date Created: 09/17/2015

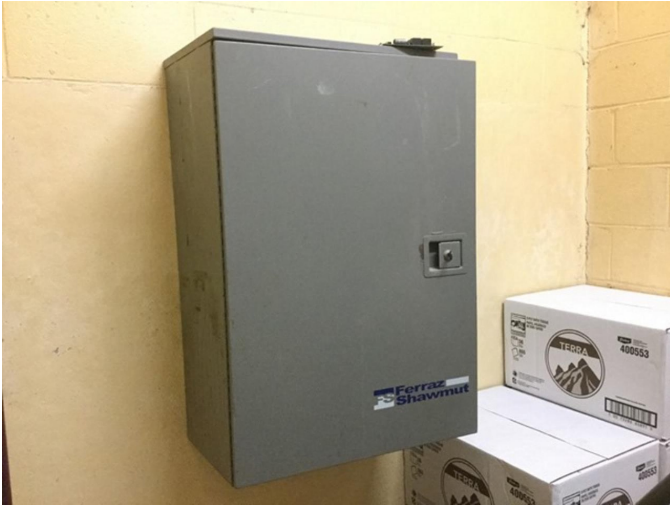
Location: Throughout building
Distress: Beyond Expected Life
Category: Deferred Maintenance
Priority: 3 - Necessary (Years 2-5)
Correction: Renew System
Qty: 30,152.00
Unit of Measure: S.F.
Estimate: \$72,636.00
Assessor Name: Sam Mandola
Date Created: 09/17/2015

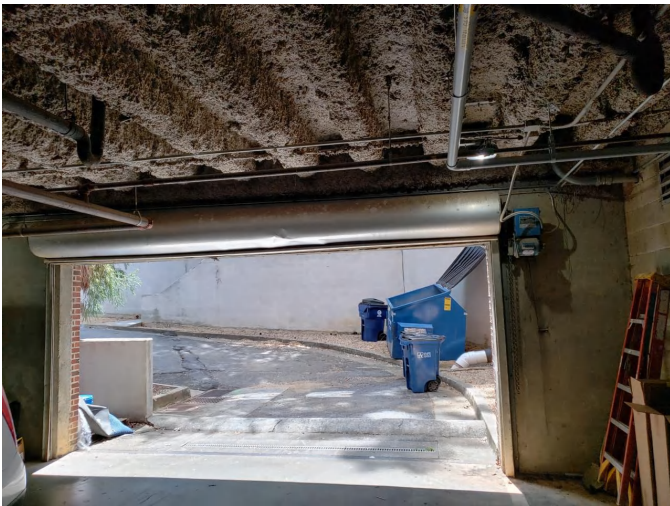
Location: Parking area
Distress: Beyond Expected Life
Category: Deferred Maintenance
Priority: 3 - Necessary (Years 2-5)
Correction: Renew System
Qty: 30,152.00
Unit of Measure: S.F.
Estimate: \$133,995.00
Assessor Name: Sam Mandola
Date Created: 12/18/2019

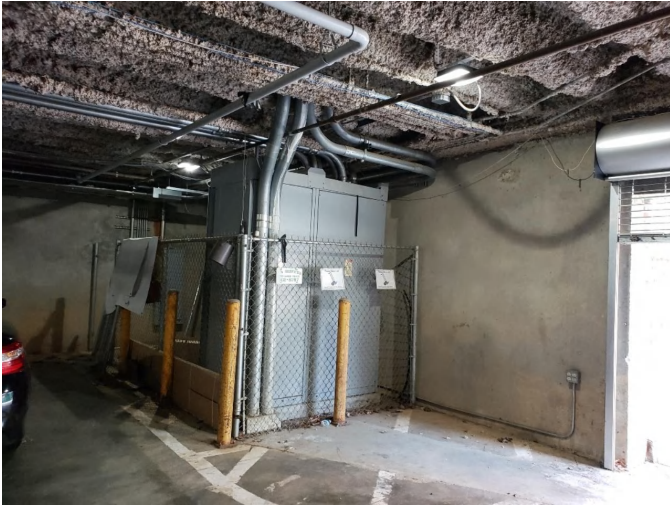
Location: Throughout building
Distress: Beyond Expected Life
Category: Deferred Maintenance
Priority: 3 - Necessary (Years 2-5)
Correction: Renew System
Qty: 30,152.00
Unit of Measure: S.F.
Estimate: \$75,621.00
Assessor Name: Sam Mandola
Date Created: 09/17/2015

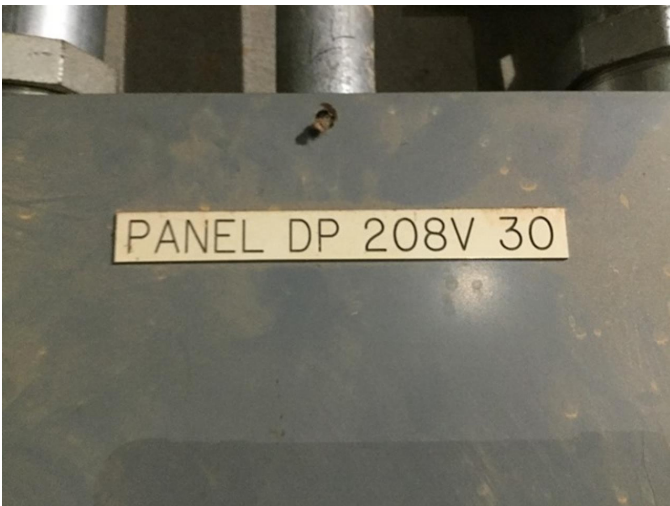
Location: Throughout building
Distress: Beyond Expected Life
Category: Deferred Maintenance
Priority: 3 - Necessary (Years 2-5)
Correction: Renew System
Qty: 30,152.00
Unit of Measure: S.F.
Estimate: \$155,223.00
Assessor Name: Sam Mandola
Date Created: 09/17/2015

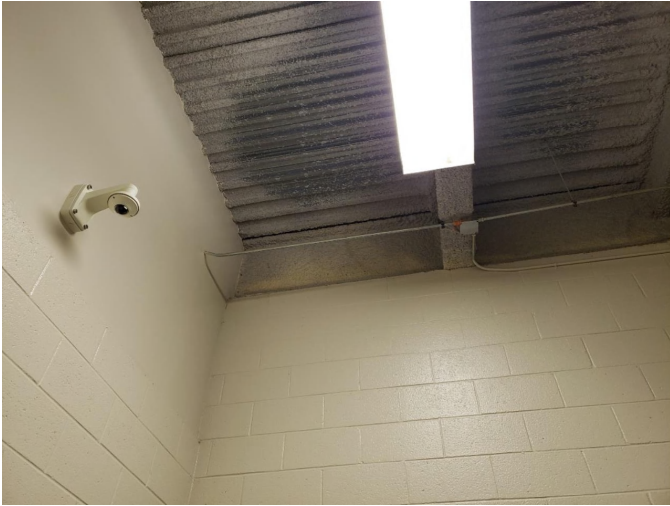
Location: Throughout building
Distress: Beyond Expected Life
Category: Deferred Maintenance
Priority: 3 - Necessary (Years 2-5)
Correction: Renew System
Qty: 30,152.00
Unit of Measure: S.F.
Estimate: \$233,497.00
Assessor Name: Hayden Collins
Date Created: 10/04/2019

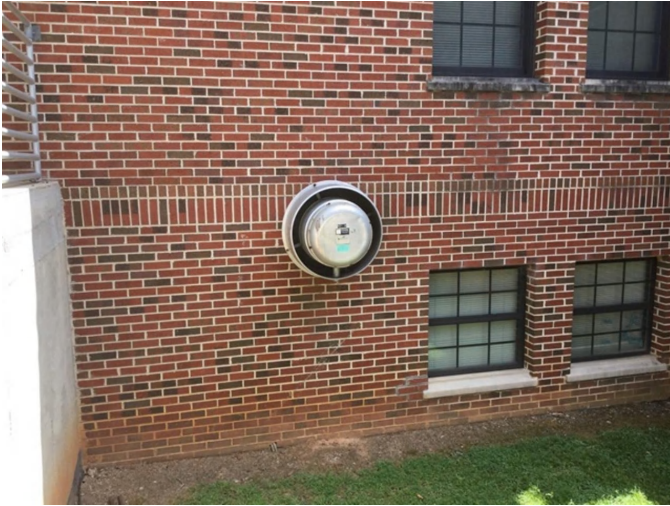
Location: Throughout building
Distress: Beyond Expected Life
Category: Deferred Maintenance
Priority: 4 - Recommended (Years 6-10)
Correction: Renew System
Qty: 30,152.00
Unit of Measure: S.F.
Estimate: \$348,587.00
Assessor Name: Hayden Collins
Date Created: 09/17/2015

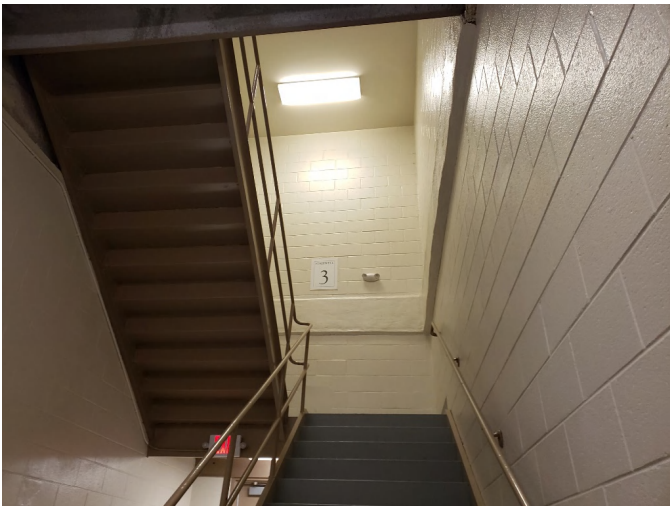
Location: Throughout building
Distress: Missing
Category: Code Compliance
Priority: 4 - Recommended (Years 6-10)
Correction: Renew System
Qty: 30,152.00
Unit of Measure: S.F.
Estimate: \$11,277.00
Assessor Name: Hayden Collins
Date Created: 08/20/2013

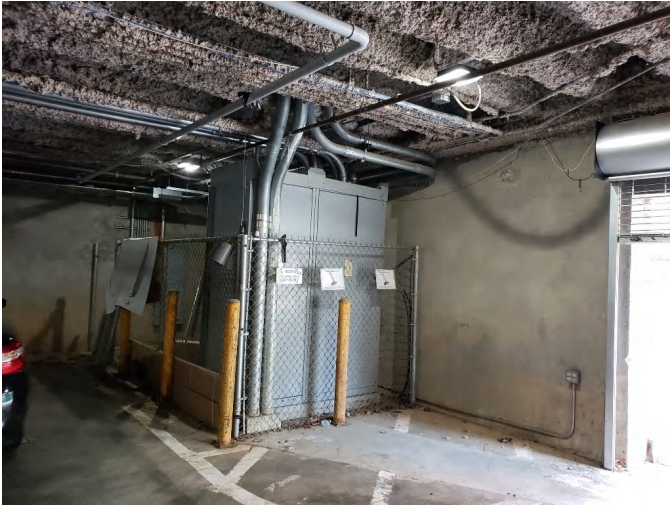
Location: Throughout building
Distress: Missing
Category: Reliability
Priority: 4 - Recommended (Years 6-10)
Correction: Renew System
Qty: 30,152.00
Unit of Measure: S.F.
Estimate: \$11,277.00
Assessor Name: Sam Mandola
Date Created: 08/19/2013

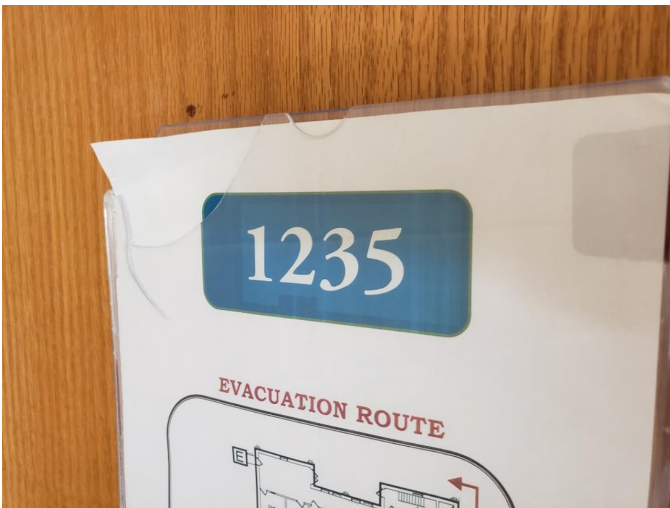
Location: Throughout building
Distress: Non Compliant
Category: ADA Compliance
Priority: 3 - Necessary (Years 2-5)
Correction: Replace missing or damaged signage - insert the number of rooms
Qty: 20.00
Unit of Measure: Ea.
Estimate: \$1,455.78
Assessor Name: Sam Mandola
Date Created: 11/20/2019

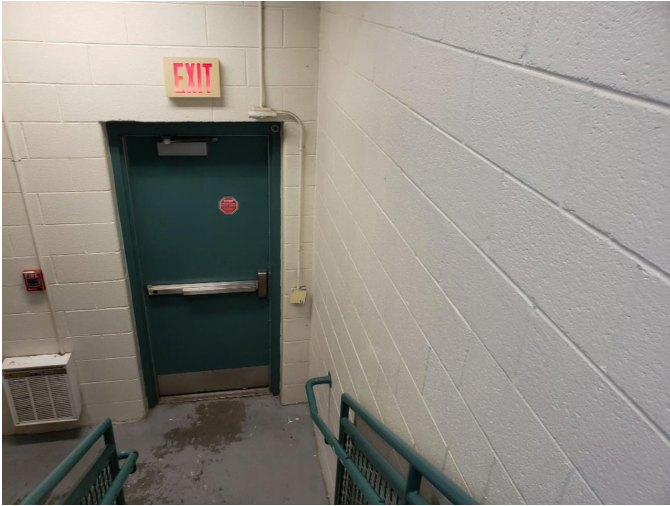
Location: Staircase
Distress: Beyond Expected Life
Category: Deferred Maintenance
Priority: 3 - Necessary (Years 2-5)
Correction: Renew System
Qty: 150.00
Unit of Measure: S.F.
Estimate: \$3,062.00
Assessor Name: Sam Mandola
Date Created: 11/20/2019

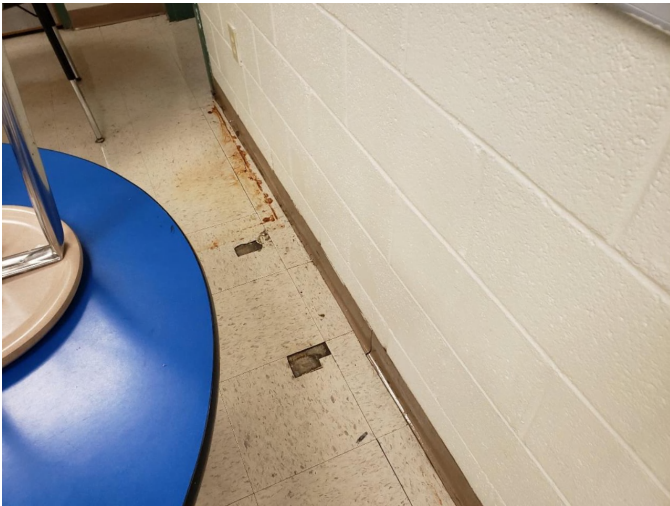
Location: Throughout building
Distress: Beyond Expected Life
Category: Deferred Maintenance
Priority: 3 - Necessary (Years 2-5)
Correction: Renew System
Qty: 6,215.00
Unit of Measure: S.F.
Estimate: \$33,524.00
Assessor Name: Sam Mandola
Date Created: 11/20/2019

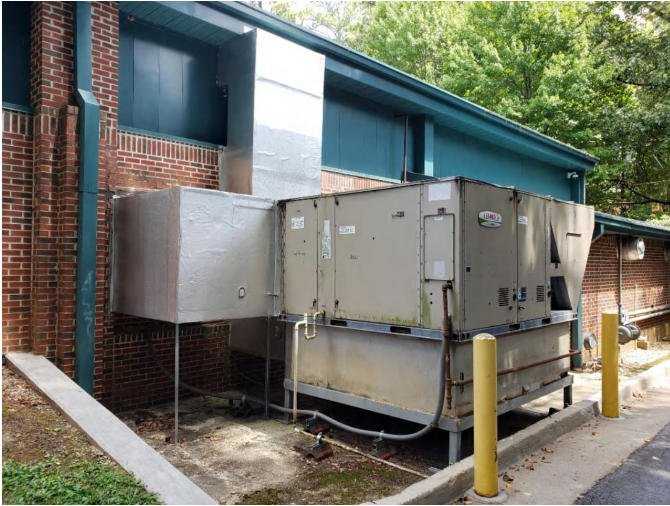
Location: Throughout building
Distress: Beyond Expected Life
Category: Deferred Maintenance
Priority: 3 - Necessary (Years 2-5)
Correction: Renew System
Qty: 11,503.00
Unit of Measure: S.F.
Estimate: \$210,045.00
Assessor Name: Sam Mandola
Date Created: 09/17/2015

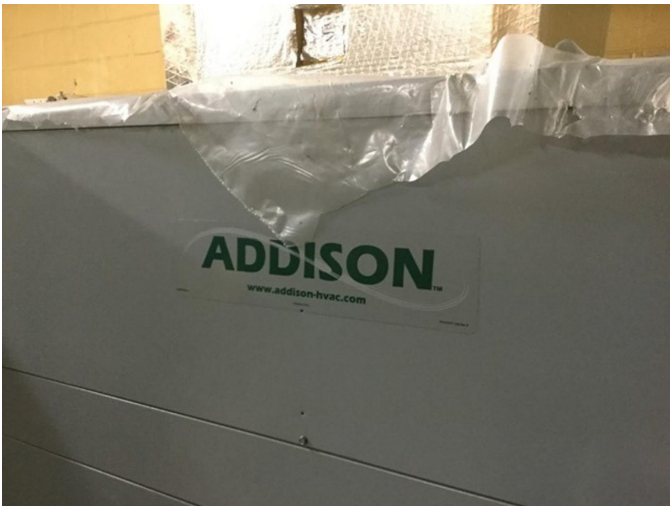
Location: Throughout building
Distress: Beyond Expected Life
Category: Deferred Maintenance
Priority: 3 - Necessary (Years 2-5)
Correction: Renew System
Qty: 11,503.00
Unit of Measure: S.F.
Estimate: \$28,470.00
Assessor Name: Sam Mandola
Date Created: 09/17/2015

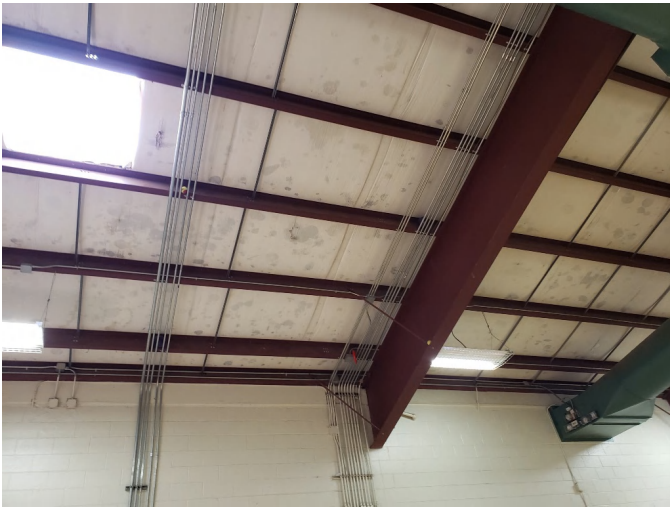
Location: Throughout building
Distress: Missing
Category: Code Compliance
Priority: 4 - Recommended (Years 6-10)
Correction: Renew System
Qty: 11,503.00
Unit of Measure: S.F.
Estimate: \$52,385.00
Assessor Name: Homero Guerrero
Date Created: 08/20/2013

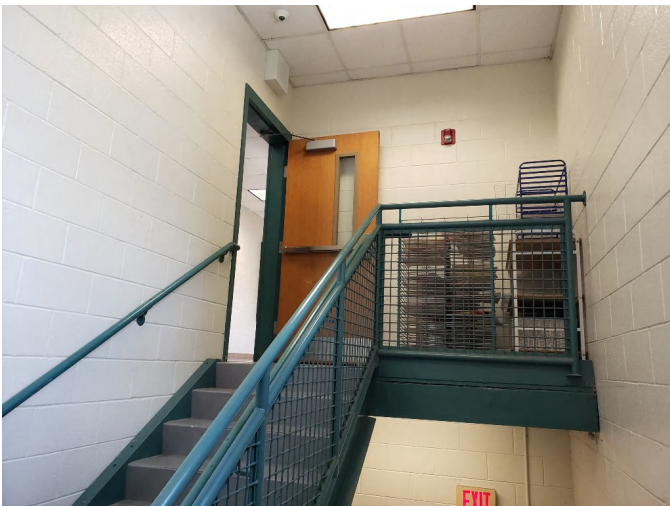
Location: Throughout building
Distress: Missing
Category: Code Compliance
Priority: 4 - Recommended (Years 6-10)
Correction: Renew System
Qty: 11,503.00
Unit of Measure: S.F.
Estimate: \$4,429.00
Assessor Name: Homero Guerrero
Date Created: 08/20/2013

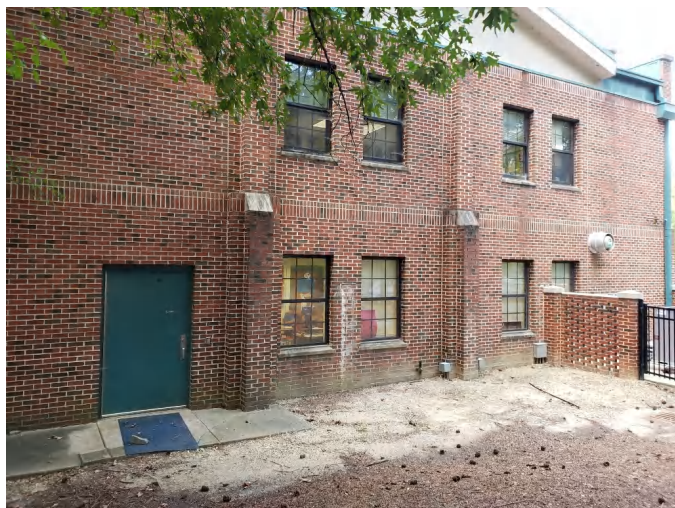
Location: Throughout building
Distress: Missing
Category: Reliability
Priority: 4 - Recommended (Years 6-10)
Correction: Renew System
Qty: 11,503.00
Unit of Measure: S.F.
Estimate: \$4,429.00
Assessor Name: Sam Mandola
Date Created: 08/20/2013

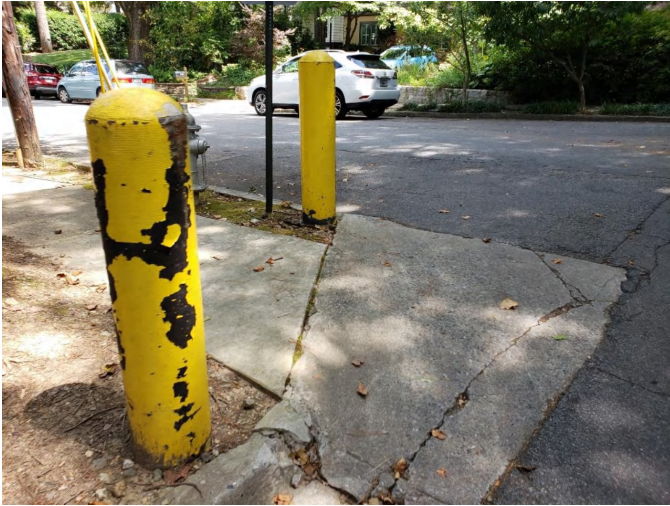
Location: Site
Distress: Beyond Expected Life
Category: Deferred Maintenance
Priority: 3 - Necessary (Years 2-5)
Correction: Renew System
Qty: 96,463.00
Unit of Measure: S.F.
Estimate: \$115,659.00
Assessor Name: Sam Mandola
Date Created: 02/21/2020

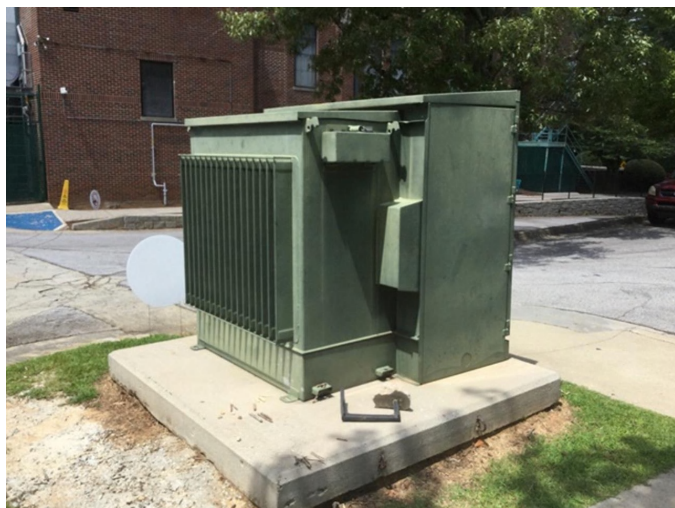
Location: Site
Distress: Beyond Expected Life
Category: Deferred Maintenance
Priority: 3 - Necessary (Years 2-5)
Correction: Renew System
Qty: 96,463.00
Unit of Measure: S.F.
Estimate: \$270,579.00
Assessor Name: Sam Mandola
Date Created: 02/21/2020
