**Atlanta Public Schools/ Washington Cluster**

# **Oglethorpe (North Metro)**

Revised
School Assessment Report

**November 10, 2020**

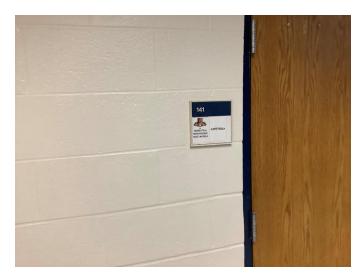
System: C1030 - Fittings

**Location:** Throughout Building **Distress:** Beyond Expected Life **Category:** ADA Compliance

**Priority:** 3 - Necessary (Years 2-5)

**Notes:** The ADA signage, lockers and storage shelving is from original construction and beyond the expected life for this application. The system in outdated and not current with the ADA standard, universal upgrades are recommended.

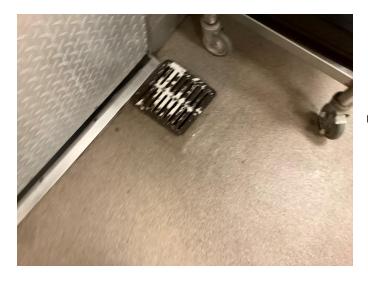
#### **System: C3020405 - Epoxy**

**Location:** Kitchen

**Distress:** Beyond Expected Life **Category:** Deferred Maintenance **Priority:** 3 - Necessary (Years 2-5)

Notes: The Epoxy floor finish is beyond its expected service life, worn and damaged, and is recommended for replacement.

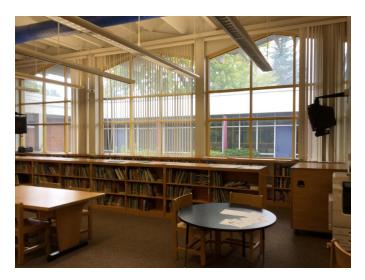
#### System: C3020901 - Carpet

**Location:** Media Center

Distress: Beyond Expected Life
Category: Deferred Maintenance
Priority: 3 - Necessary (Years 2-5)

**Notes:** The carpet floor finish is beyond its expected service life, worn and damaged, and is recommended for replacement.

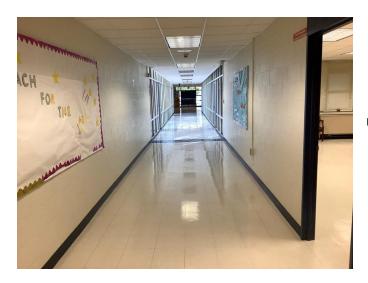
#### System: C3020903 - VCT

Location: Throughout BuildingDistress: Beyond Expected LifeCategory: Deferred MaintenancePriority: 3 - Necessary (Years 2-5)

Notes: The VCT floor finish is beyond its expected service life, worn and damaged, and is recommended for replacement.

**Correction:** Renew System

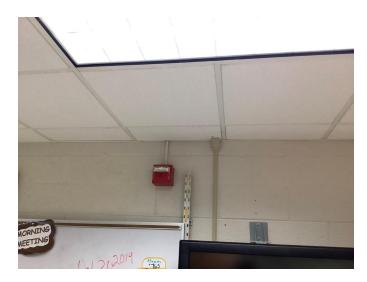
#### System: C3030 - Ceiling Finishes

Location: Throughout BuildingDistress: Beyond Expected LifeCategory: Deferred MaintenancePriority: 3 - Necessary (Years 2-5)

**Notes:** The acoustic ceilings are aged and stained and should be scheduled for replacement.

Correction: Renew System

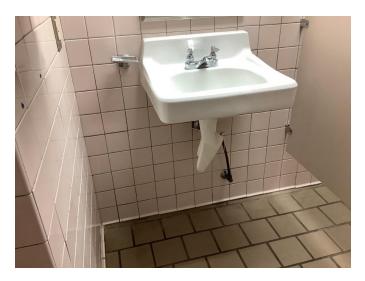
#### System: D2010 - Plumbing Fixtures

**Location:** Restrooms

**Distress:** Beyond Expected Life **Category:** ADA Compliance

Notes: Plumbing fixtures are beyond their expected service life and should be replaced and upgraded for ADA compliance.

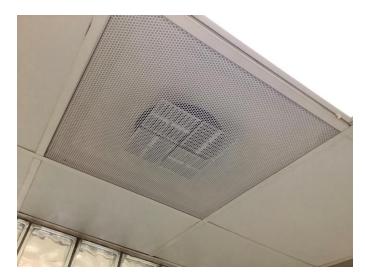
#### System: D3040 - Distribution Systems

Location: Throughout BuildingDistress: Beyond Expected LifeCategory: Deferred MaintenancePriority: 3 - Necessary (Years 2-5)

**Correction:** Renew System

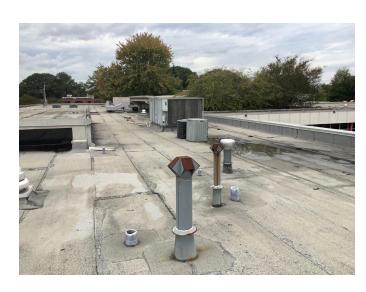
#### System: D3050 - Terminal & Package Units

Location: Roof

**Distress:** Beyond Expected Life **Category:** Deferred Maintenance **Priority:** 3 - Necessary (Years 2-5)

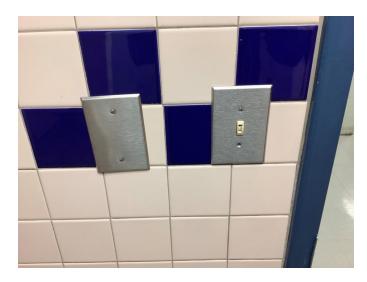
#### System: D3060 - Controls & Instrumentation

Location: Throughout BuildingDistress: Beyond Expected LifeCategory: Deferred MaintenancePriority: 3 - Necessary (Years 2-5)

**Notes:** The Controls and Instrumentation are from 1999 and have reached their expected life cycle. This deficiency provides a budgetary consideration for an upgrade.

**Correction:** Renew System

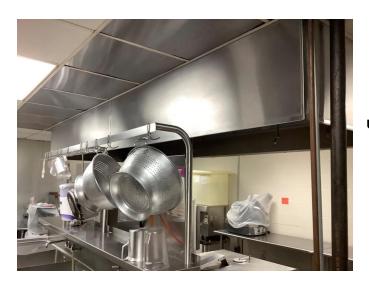
#### **System: D4090 - Other Fire Protection Systems**

Location: Kitchen

**Distress:** Beyond Expected Life **Category:** Deferred Maintenance **Priority:** 3 - Necessary (Years 2-5)

**Notes:** The exhaust hood system is original. This building high traffic use warrants upgrades to this system based on usage and age. This deficiency provides a budgetary consideration for upgrades to the system.

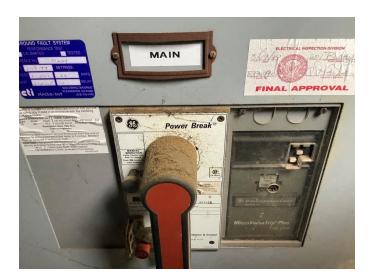
### System: D5010 - Electrical Service/Distribution

Location: Electrical Room

Distress: Beyond Expected Life

**Notes:** The electrical services and distribution systems consist of an 1800 AMP service disconnect, primary main, breaker system, switch box and conduit and wiring to equipment, interior and exterior lights. This system is a mix of the old and new. Some of the system was recently upgraded, however a majority of the system is original from original construction. Upgrades are recommended.

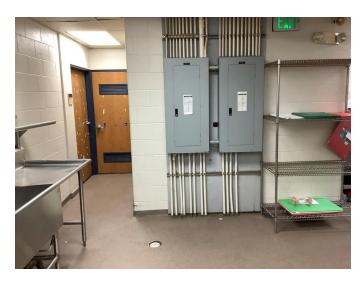
#### System: D5020 - Branch Wiring

Location:Electrical RoomDistress:Beyond Expected LifeCategory:Deferred MaintenancePriority:3 - Necessary (Years 2-5)

**Notes:** Most of the branch wire system appears to be from the original construction. The age of the system warrants upgrades. Universal upgrades are recommended.

Correction: Renew System

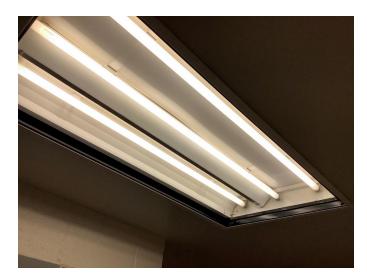
#### System: D5020 - Lighting

Location: Throughout BuildingDistress: Beyond Expected LifeCategory: Deferred MaintenancePriority: 3 - Necessary (Years 2-5)

Notes: Most of the lighting system appears to be from the original construction. Universal upgrades are recommended.

**Correction:** Renew System

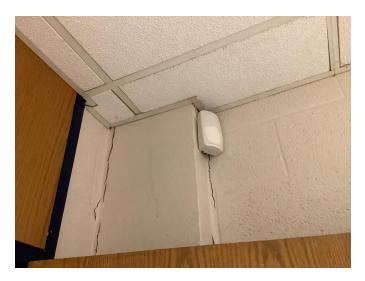
#### System: D5030810 - Security & Detection Systems

Location: Throughout BuildingDistress: Beyond Expected LifeCategory: Deferred MaintenancePriority: 3 - Necessary (Years 2-5)

**Notes:** The Security Detection Systems is beyond the expected life cycle. This deficiency provides a budgetary consideration to improve the alarm and security system.

**Correction:** Renew System

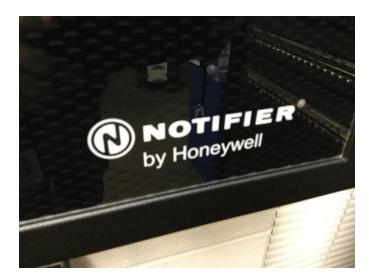
#### System: D5030910 - Fire Alarm Systems

Location: Throughout BuildingDistress: Beyond Expected LifeCategory: Deferred MaintenancePriority: 3 - Necessary (Years 2-5)

**Notes:** This school's "Honeywell Notifier" has components such as push stations, lights and alarm bells installed to support the fire life safety for this building. This system is nearing the end of its expected life and upgrades are warranted. This deficiency provides a budgetary consideration for upgrades to the fire alarm system.

Correction: Renew System

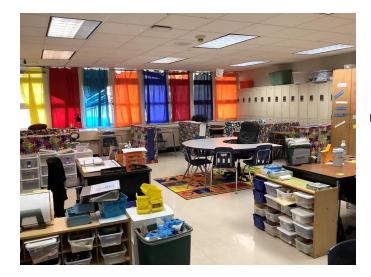
#### System: E1020 - Institutional Equipment

Location: Throughout BuildingDistress: Beyond Expected LifeCategory: Deferred MaintenancePriority: 3 - Necessary (Years 2-5)

Correction: Renew System

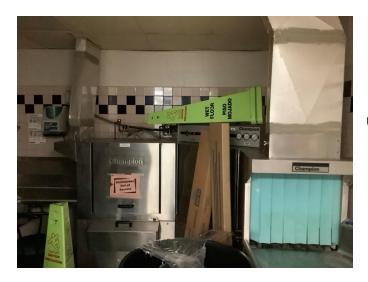
#### System: E1090 - Other Equipment

Location: Throughout BuildingDistress: Beyond Expected LifeCategory: Deferred MaintenancePriority: 3 - Necessary (Years 2-5)

**Notes:** The Food Service Equipment equipment is well maintained however is showing signs of age. This deficiency provides a budgetary consideration for a universal upgrade to these systems.

**Correction:** Renew System

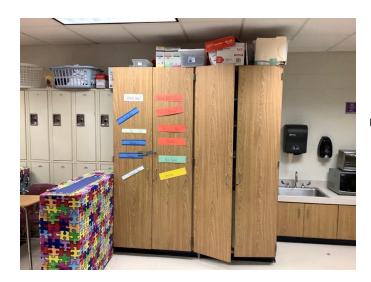
#### System: E2010 - Fixed Furnishings

Location: Throughout BuildingDistress: Beyond Expected LifeCategory: Deferred MaintenancePriority: 3 - Necessary (Years 2-5)

Notes: Fixed furnishings are aged, worn and damaged, and should be scheduled for replacement.

**Correction:** Renew System

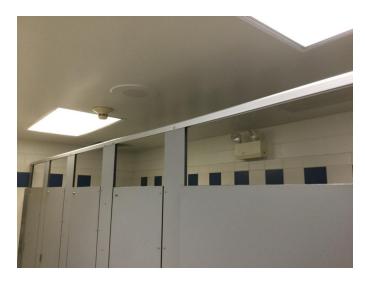
System: C1030 - Fittings

**Location:** Throughout Building **Distress:** Beyond Expected Life **Category:** ADA Compliance

**Priority:** 3 - Necessary (Years 2-5)

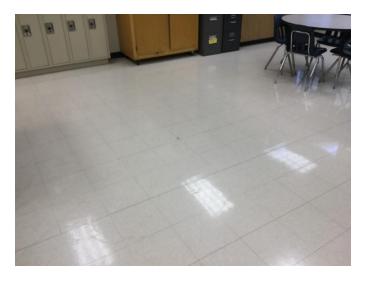
#### **System: C3020903 - VCT**

**Distress:** Beyond Expected Life **Category:** Deferred Maintenance **Priority:** 3 - Necessary (Years 2-5)

**Correction:** Renew System

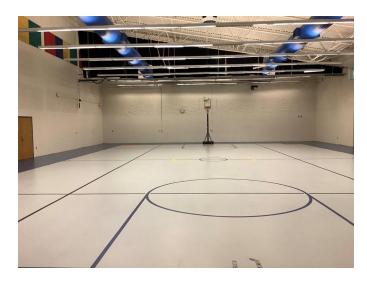
#### System: C3020999 - Other - Rubber or Neoprene

Location: Throughout building
 Distress: Beyond Expected Life
 Category: Deferred Maintenance
 Priority: 3 - Necessary (Years 2-5)

**Correction:** Renew System

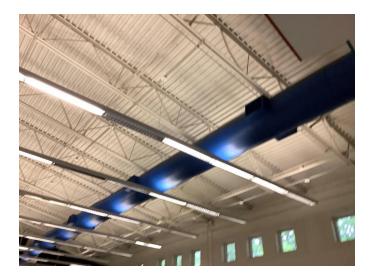
## System: C3030 - Ceiling Finishes

Location: Throughout BuildingDistress: Beyond Expected LifeCategory: Deferred MaintenancePriority: 3 - Necessary (Years 2-5)

**Correction:** Renew System

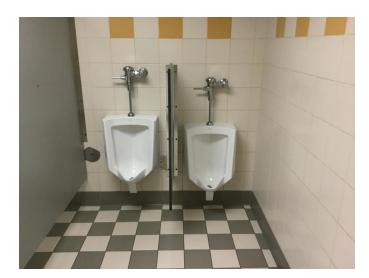
## System: D2010 - Plumbing Fixtures

**Location:** Restrooms

**Distress:** Beyond Expected Life **Category:** ADA Compliance

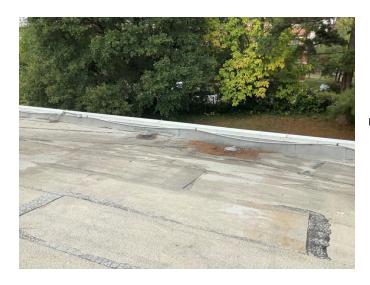
#### System: D2040 - Rain Water Drainage

Location: Roof

**Distress:** Beyond Expected Life **Category:** Deferred Maintenance **Priority:** 3 - Necessary (Years 2-5)

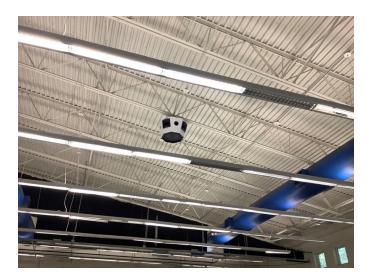
#### System: D3040 - Distribution Systems

Location: Throughout Building
 Distress: Beyond Expected Life
 Category: Deferred Maintenance
 Priority: 3 - Necessary (Years 2-5)

**Correction:** Renew System

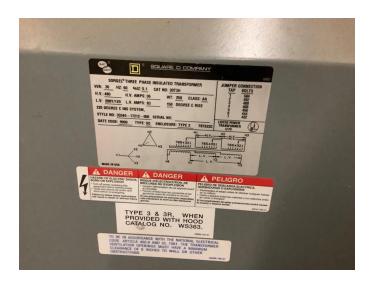
#### System: D5010 - Electrical Service/Distribution

Location: Electrical Room

Distress: Beyond Expected Life

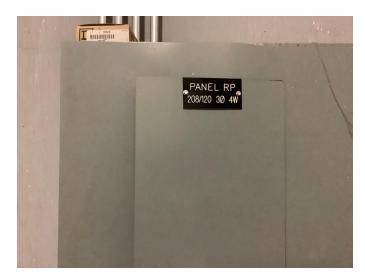
#### System: D5020 - Branch Wiring

Location: Electrical Room

Distress: Beyond Expected Life

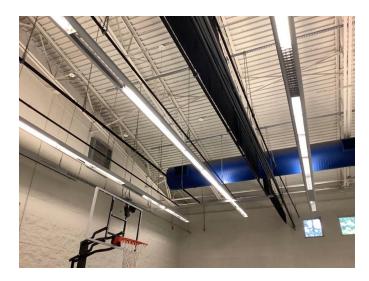
#### System: D5020 - Lighting

Location: Throughout BuildingDistress: Beyond Expected LifeCategory: Deferred MaintenancePriority: 3 - Necessary (Years 2-5)

**Correction:** Renew System

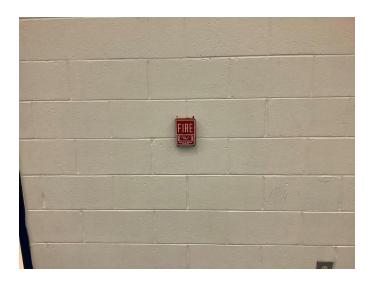
#### System: D5030910 - Fire Alarm Systems

Location: Throughout BuildingDistress: Beyond Expected LifeCategory: Deferred MaintenancePriority: 3 - Necessary (Years 2-5)

Correction: Renew System

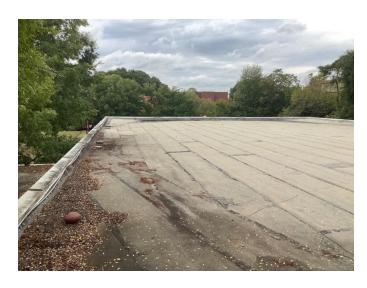
#### System: B3010105 - Built-Up

Location: Roof

**Distress:** Beyond Expected Life **Category:** Deferred Maintenance

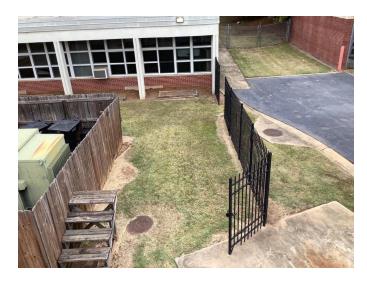
System: G2040105 - Fence & Guardrails

Location: Site

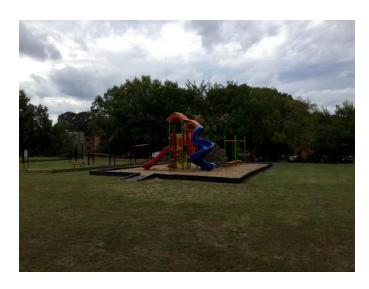
#### System: G2040950 - Playing Field

Location: Site
