Atlanta Public Schools/ Carver Cluster

Perkerson Elementary School

Revised
School Assessment Report

November 10, 2020

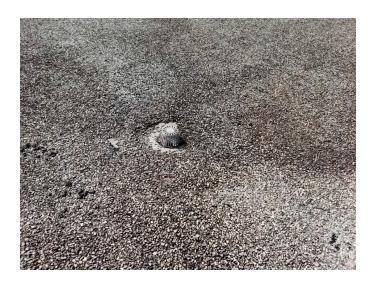
System: D2040 - Rain Water Drainage

Location: Roof

Distress: Beyond Expected Life **Category:** Deferred Maintenance **Priority:** 1 - Critical Immediate Need

Notes: The roof drains, insulation and fittings that support the water run off from this roof are beyond expected life. Replacing the drains is recommended.

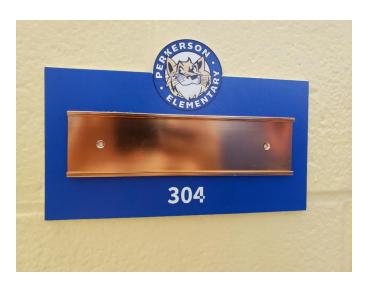
System: C1030 - Fittings

Location: Throughout building **Distress:** Beyond Expected Life **Category:** ADA Compliance

Priority: 3 - Necessary (Years 2-5)

Notes: Fittings, such as toilet partitions, lockers, signage and railing, are beyond their expected service life, outdated and missing in areas, and should be replaced and upgraded for compliance with ADA standards.

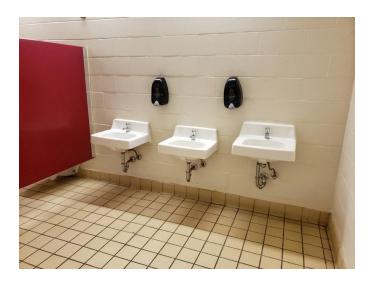
System: D2010 - Plumbing Fixtures

Location: Restroom

Distress: Beyond Expected Life **Category:** ADA Compliance

Notes: The restroom fixtures are from original construction with few exceptions. The systems are beyond the expected life cycle and upgrades are warranted.

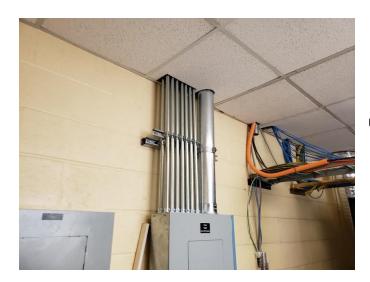
System: D5020 - Branch Wiring

Distress: Beyond Expected Life **Category:** Deferred Maintenance **Priority:** 3 - Necessary (Years 2-5)

Notes: The original lighting and branch wiring system is operational but is aged and should be replaced with an energy efficient system.

Correction: Renew System

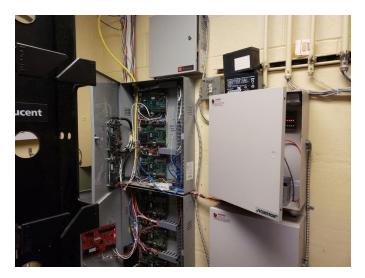
System: D5030810 - Security & Detection Systems

Distress: Beyond Expected Life **Category:** Deferred Maintenance **Priority:** 3 - Necessary (Years 2-5)

Notes: The security and alarm system is beyond its expected life. It needs to be upgraded or replaced

Correction: Renew System

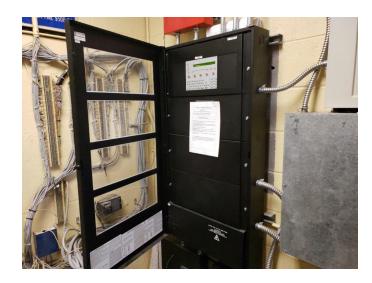
System: D5030910 - Fire Alarm Systems

Location: Throughout building **Distress:** Beyond Expected Life **Category:** Deferred Maintenance **Priority:** 3 - Necessary (Years 2-5)

Notes: The fire alarm system appears to be from original construction. There are components such as push stations, lights and alarm bells installed to support the fire life safety for this building. This system is nearing the end of its expected life and upgrades are warranted. This deficiency provides a budgetary consideration for universal upgrades to the fire alarm system.

Correction: Renew System

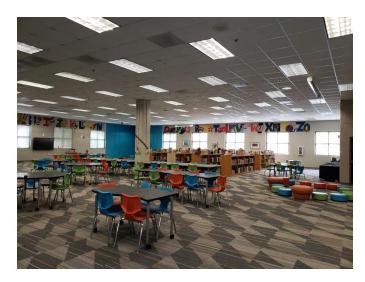
System: E1020 - Institutional Equipment

Location: Throughout buildingDistress: Beyond Expected LifeCategory: Deferred MaintenancePriority: 3 - Necessary (Years 2-5)

Notes: Institutional Equipment is well maintained however is showing signs of age related to a high level of usage. This project provides a budgetary consideration for a universal upgrade to these systems.

Correction: Renew System

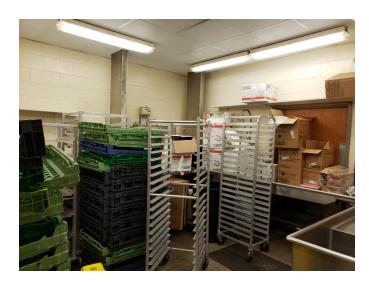
System: E1090 - Other Equipment

Location: Throughout buildingDistress: Beyond Expected LifeCategory: Deferred MaintenancePriority: 3 - Necessary (Years 2-5)

Notes: The Food Service Equipment appears to be from the original construction of the school. The equipment is well maintained however is showing signs of age related to a high level of usage. This project provides a budgetary consideration for a universal upgrade to these systems.

Correction: Renew System

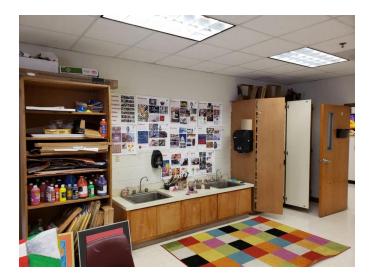
System: E2010 - Fixed Furnishings

Location: Throughout building
 Distress: Beyond Expected Life
 Category: Deferred Maintenance
 Priority: 3 - Necessary (Years 2-5)

Notes: Fixed furnishings are aged and beyond their expected life and should be scheduled for replacement.

Correction: Renew System

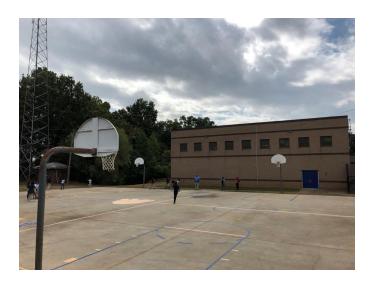
System: G2040950 - Hard Surface Play Area

Location: Site

Distress: Beyond Expected Life **Category:** Deferred Maintenance **Priority:** 3 - Necessary (Years 2-5)

Notes: The Hard Surfaces Play Area is beyond its expected life. Upgrading then area is recommended
