School Assessment Report

School: Peterson (Adult Education)

Report: Nov 17, 2015

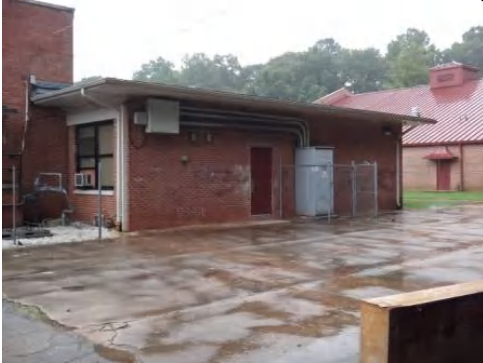
System: B3010 - Roof Coverings

Analysis: The system age is either beyond expected life or does not meet its intended performance under the Guidelines. The system may be in service and functioning but it is recommended to be replaced due to probable increased condition budget needs, the potential failure of its components, or in order to meet the performance Guidelines for this system. The system was installed in 1979. It has a 20-year service life which expired in 1999.

Location: 1959 Bldg 201A
Distress: Beyond Expected Life
Category: Deferred Maintenance
Priority: 3 - Necessary (Years 2-5)
Notes: No access to sloped roof
Correction: Renew System
Qty: 1-Ea.
Condition Budget: \$498,693

Recomm.: The system should be replaced.

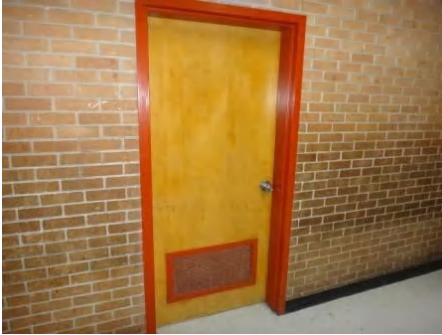
Analysis: The system age is either beyond expected life or does not meet its intended performance under the Guidelines. The system may be in service and functioning but it is recommended to be replaced due to probable increased condition budget needs, the potential failure of its components, or in order to meet the performance Guidelines for this system. The system was installed in 1959. It has a 40-year service life which expired in 1999.

Location: 1959 Bldg 201A
Distress: Beyond Expected Life
Category: Deferred Maintenance
Priority: 3 - Necessary (Years 2-5)
Correction: Renew System
Qty: 1-Ea.
Condition Budget: \$86,207

Recomm.: The system should be replaced.

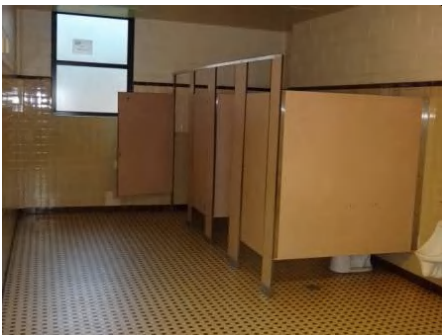
Analysis: The system age is either beyond expected life or does not meet its intended performance under the Guidelines. The system may be in service and functioning but it is recommended to be replaced due to probable increased condition budget needs, the potential failure of its components, or in order to meet the performance Guidelines for this system. The system was installed in 1959. It has a 20-year service life which expired in 1979.

Location: 1959 Bldg 201A
Distress: Beyond Expected Life
Category: Deferred Maintenance
Priority: 3 - Necessary (Years 2-5)
Correction: Renew System
Qty: 1-Ea.
Condition Budget: \$90,595

Recomm.: The system should be replaced.

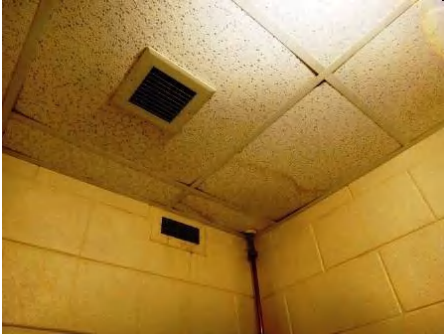
Analysis: The system age is either beyond expected life or does not meet its intended performance under the Guidelines. The system may be in service and functioning but it is recommended to be replaced due to probable increased condition budget needs, the potential failure of its components, or in order to meet the performance Guidelines for this system. The system was installed in 1993. It has a 20-year service life which expired in 2013.

Location: 1959 Bldg 201A
Distress: Beyond Expected Life
Category: Deferred Maintenance
Priority: 3 - Necessary (Years 2-5)
Correction: Renew System
Qty: 1-Ea.
Condition Budget: \$291,681

Recomm.: The system should be replaced.

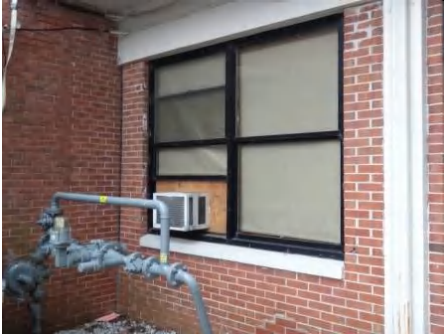
Analysis: The system age is either beyond expected life or does not meet its intended performance under the Guidelines. The system may be in service and functioning but it is recommended to be replaced due to probable increased condition budget needs, the potential failure of its components, or in order to meet the performance Guidelines for this system. The system was installed in 1993. It has a 20-year service life which expired in 2013.

Location: 1959 Bldg 201A
Distress: Beyond Expected Life
Category: Deferred Maintenance
Priority: 3 - Necessary (Years 2-5)
Correction: Renew System
Qty: 1-Ea.
Condition Budget: \$19,050

Recomm.: The system should be replaced.

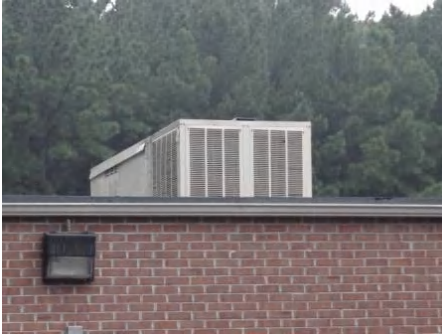
Analysis: The system age is either beyond expected life or does not meet its intended performance under the Guidelines. The system may be in service and functioning but it is recommended to be replaced due to probable increased condition budget needs, the potential failure of its components, or in order to meet the performance Guidelines for this system. The system was installed in 1994. It has a 15-year service life which expired in 2009.

Location: 1959 Bldg 201A
Distress: Beyond Expected Life
Category: Deferred Maintenance
Priority: 3 - Necessary (Years 2-5)
Correction: Renew System
Qty: 1-Ea.
Condition Budget: \$929,229

Recomm.: The system should be replaced.

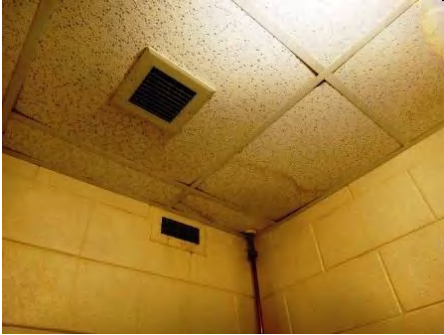
Analysis: The system age is either beyond expected life or does not meet its intended performance under the Guidelines. The system may be in service and functioning but it is recommended to be replaced due to probable increased condition budget needs, the potential failure of its components, or in order to meet the performance Guidelines for this system. The system was installed in 1983. It has a 15-year service life which expired in 1998.

Location: 1959 Bldg 201A
Distress: Beyond Expected Life
Category: Deferred Maintenance
Priority: 3 - Necessary (Years 2-5)
Correction: Renew System
Qty: 1-Ea.
Condition Budget: \$20,744

Recomm.: The system should be replaced.

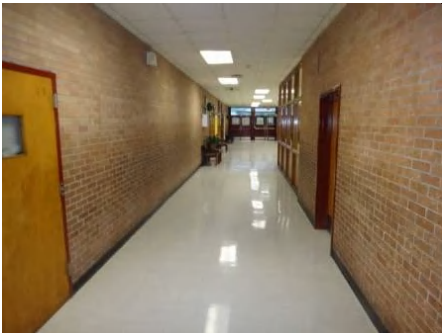
Analysis: The system age is either beyond expected life or does not meet its intended performance under the Guidelines. The system may be in service and functioning but it is recommended to be replaced due to probable increased condition budget needs, the potential failure of its components, or in order to meet the performance Guidelines for this system. The system was installed in 1959. It has a 20-year service life which expired in 1979.

Location: 1959 Bldg 201A
Distress: Beyond Expected Life
Category: Deferred Maintenance
Priority: 3 - Necessary (Years 2-5)
Correction: Renew System
Qty: 1-Ea.
Condition Budget: \$409,369

Recomm.: The system should be replaced.

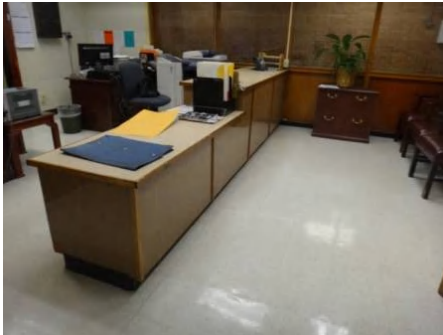
Analysis: The system age is either beyond expected life or does not meet its intended performance under the Guidelines. The system may be in service and functioning but it is recommended to be replaced due to probable increased condition budget needs, the potential failure of its components, or in order to meet the performance Guidelines for this system. The system was installed in 1959. It has a 20-year service life which expired in 1979.

Location: 1959 Bldg 201A

Condition Budget: \$61,384

Recomm.: The system should be replaced.
