Atlanta Public Schools/ Carver Cluster

Price Middle School

School Assessment Report

November 10, 2020

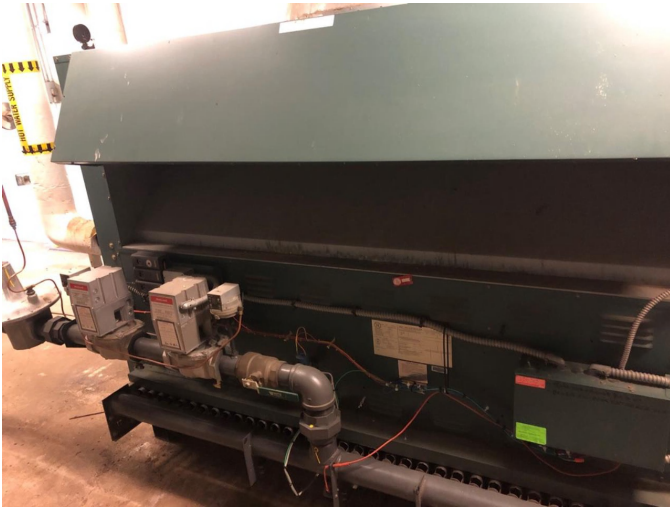
System: D3020 - Heat Generating Systems

Location: Throughout Building
Distress: Beyond Expected Life
Category: Deferred Maintenance
Priority: 3 - Necessary (Years 2-5)
Correction: Renew System
Qty: 86,242.00
Unit of Measure: S.F.
Estimate: \$350,056.00
Assessor Name: Eduardo Lopez
Date Created: 10/06/2020

Notes: The heat generating system is beyond its expected service life and should be scheduled for replacement.

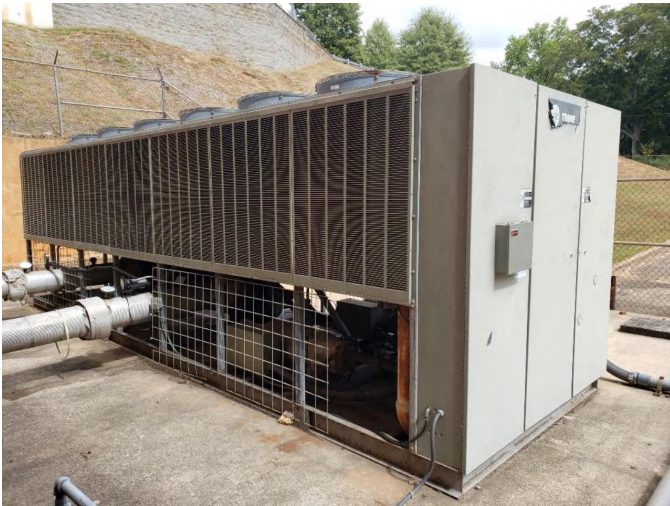
System: D3030 - Cooling Generating Systems

Location: Site
Distress: Beyond Expected Life
Category: Deferred Maintenance
Priority: 3 - Necessary (Years 2-5)
Correction: Renew System
Qty: 86,242.00
Unit of Measure: S.F.
Estimate: \$588,170.00
Assessor Name: Eduardo Lopez
Date Created: 10/06/2020

Notes: The cooling generating system is beyond its expected service life and should be scheduled for replacement.

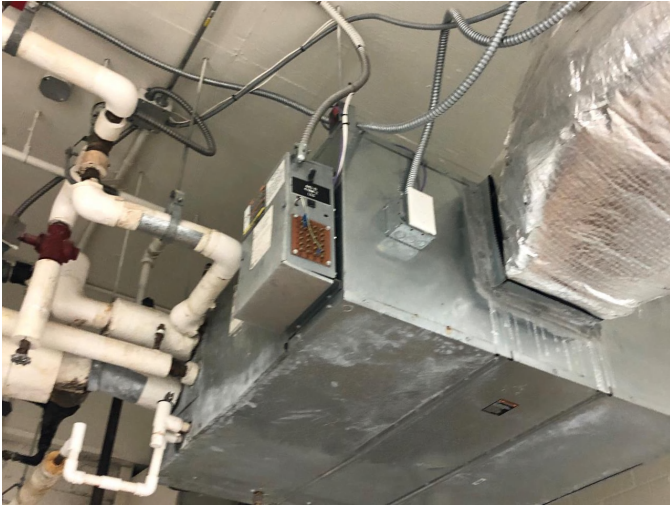
System: D3040 - Distribution Systems

Location: Throughout Building
Distress: Beyond Expected Life
Category: Deferred Maintenance
Priority: 3 - Necessary (Years 2-5)
Correction: Renew System
Qty: 86,242.00
Unit of Measure: S.F.
Estimate: \$1,031,196.00
Assessor Name: Eduardo Lopez
Date Created: 10/06/2020

Notes: The distribution system is beyond its expected service life and should be scheduled for replacement.

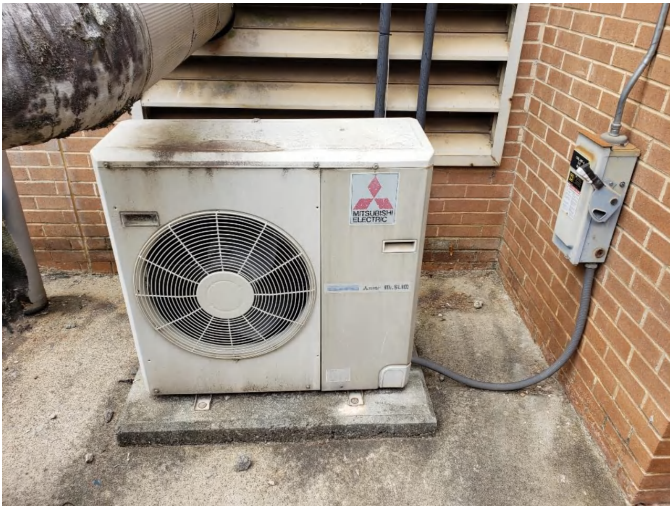
System: D3050 - Terminal & Package Units

Location: Throughout the building
Distress: Beyond Expected Life
Category: Deferred Maintenance
Priority: 3 - Necessary (Years 2-5)
Correction: Renew System
Qty: 86,242.00
Unit of Measure: S.F.
Estimate: \$650,782.00
Assessor Name: Eduardo Lopez
Date Created: 09/28/2019

Notes: The system is beyond its expected service life and should be scheduled for replacement.

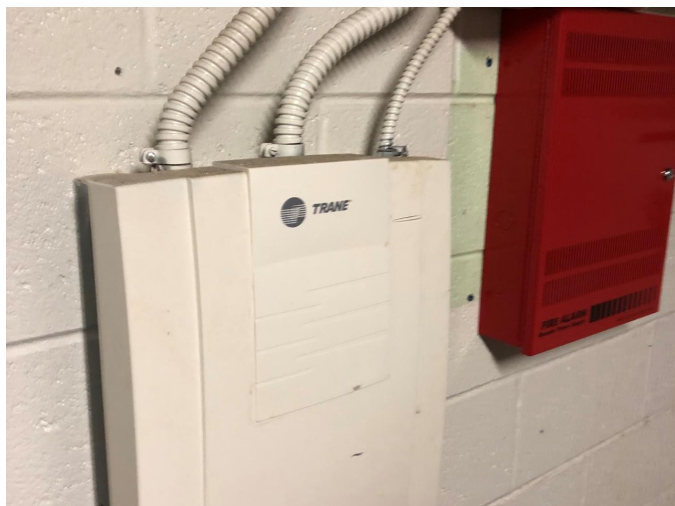
System: D3060 - Controls & Instrumentation

Location: Mechanical room
Distress: Beyond Expected Life
Category: Deferred Maintenance
Priority: 3 - Necessary (Years 2-5)
Correction: Renew System
Qty: 86,242.00
Unit of Measure: S.F.
Estimate: \$214,398.00
Assessor Name: Eduardo Lopez
Date Created: 09/28/2019

Notes: Controls and Instrumentation are two years beyond life expectancy. Replacement of Controls and Instrumentation should be considered.

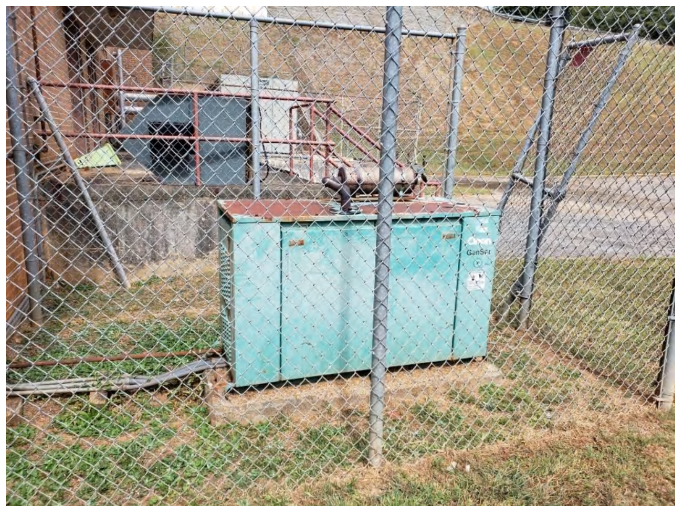
System: D5090 - Other Electrical Systems

Location: Southeast Elevation
Distress: Beyond Expected Life
Category: Deferred Maintenance
Priority: 3 - Necessary (Years 2-5)
Correction: Renew System
Qty: 86,242.00
Unit of Measure: S.F.
Estimate: \$34,152.00
Assessor Name: Eduardo Lopez
Date Created: 09/28/2019

Notes: The emergency generator is aged, in marginal condition and should be scheduled for replacement.

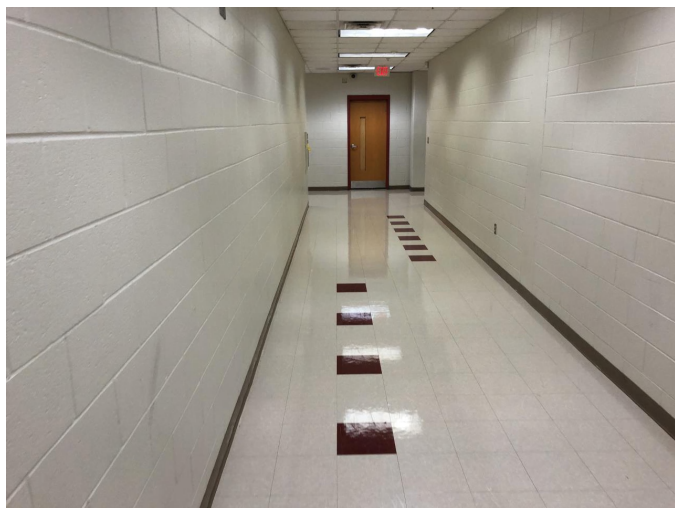
System: C3020903 - VCT

Location: Throughout building
Distress: Beyond Expected Life
Category: Deferred Maintenance
Priority: 4 - Recommended (Years 6-10)
Correction: Renew System
Qty: 60,752.00
Unit of Measure: S.F.
Estimate: \$327,696.00
Assessor Name: Eduardo Lopez
Date Created: 10/15/2019

Notes: The vinyl tile finish is original to the buildings construction. This finish is damaged and nearing the end of its useful life. This finish is recommended for upgrade based on life cycle.

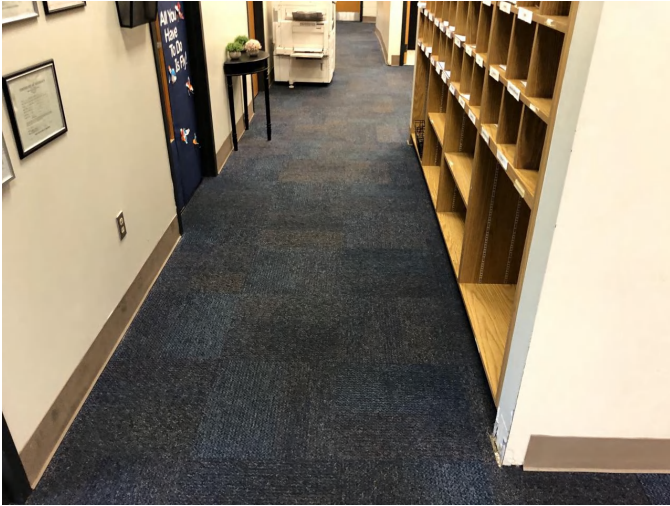
System: C3020901 - Carpet

Location: Throughout Building
Distress: Beyond Expected Life
Category: Deferred Maintenance
Priority: 3 - Necessary (Years 2-5)
Correction: Renew System
Qty: 8,871.00
Unit of Measure: S.F.
Estimate: \$73,186.00
Assessor Name: Eduardo Lopez
Date Created: 10/16/2019

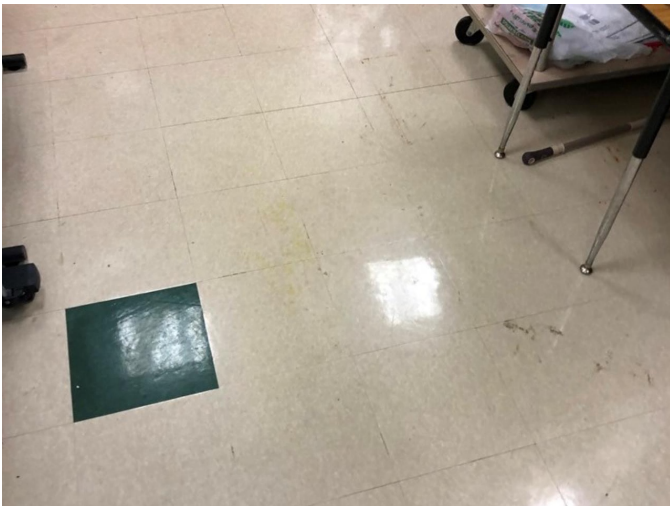
System: C3020903 - VCT

Location: Throughout Building
Distress: Beyond Expected Life
Category: Deferred Maintenance
Priority: 3 - Necessary (Years 2-5)
Correction: Renew System
Qty: 59,479.00
Unit of Measure: S.F.
Estimate: \$320,830.00
Assessor Name: Eduardo Lopez
Date Created: 10/16/2019

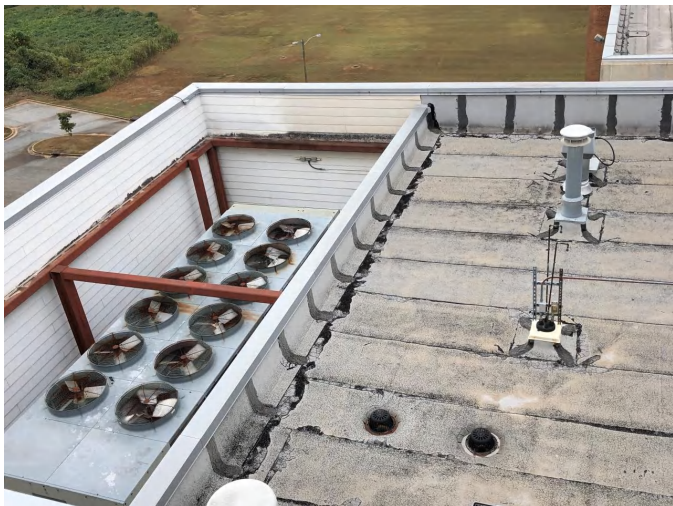
System: D3030 - Cooling Generating Systems

Location: Site
Distress: Beyond Expected Life
Category: Deferred Maintenance
Priority: 3 - Necessary (Years 2-5)
Correction: Renew System
Qty: 69,619.00
Unit of Measure: S.F.
Estimate: \$474,802.00
Assessor Name: Eduardo Lopez
Date Created: 10/06/2020

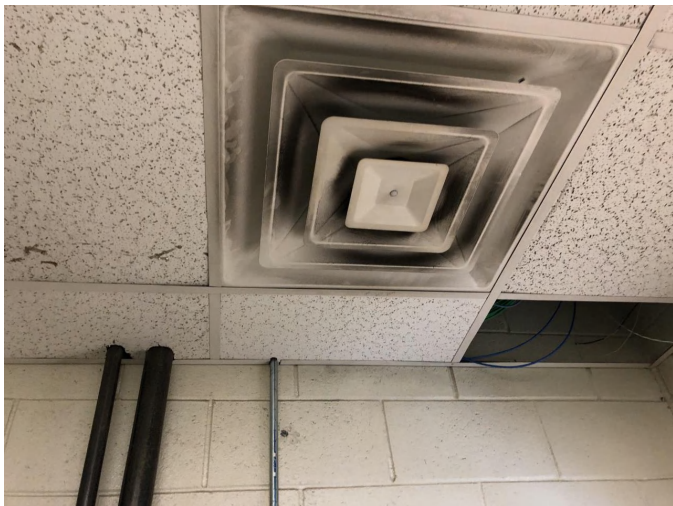
System: D3040 - Distribution Systems

Location: Throughout Building
Distress: Beyond Expected Life
Category: Deferred Maintenance
Priority: 3 - Necessary (Years 2-5)
Correction: Renew System
Qty: 69,619.00
Unit of Measure: S.F.
Estimate: \$832,434.00
Assessor Name: Eduardo Lopez
Date Created: 10/06/2020

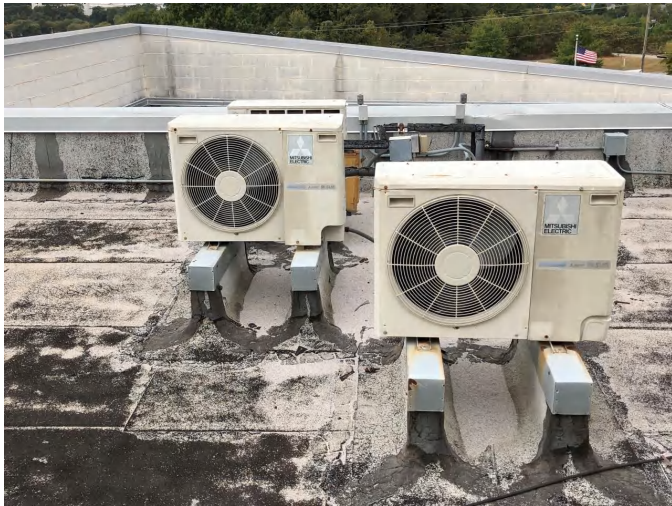
System: D3050 - Terminal & Package Units

Location: Rooftop
Distress: Beyond Expected Life
Category: Deferred Maintenance
Priority: 3 - Necessary (Years 2-5)
Correction: Renew System
Qty: 69,619.00
Unit of Measure: S.F.
Estimate: \$799,505.00
Assessor Name: Eduardo Lopez
Date Created: 09/28/2019

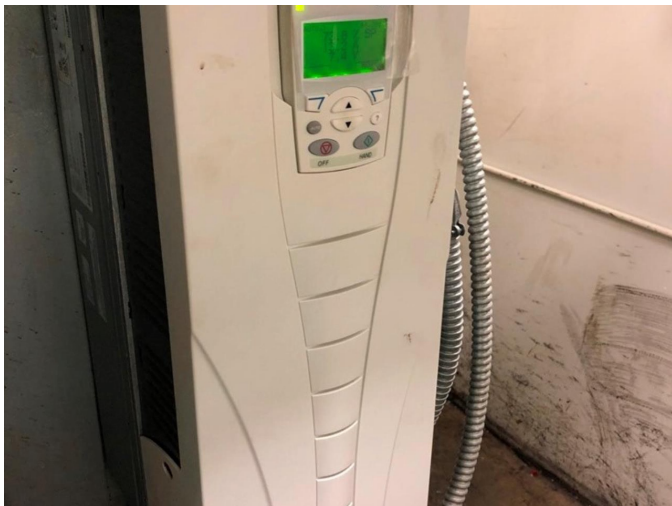
System: D3060 - Controls & Instrumentation

Location: Throughout Building
Distress: Beyond Expected Life
Category: Deferred Maintenance
Priority: 3 - Necessary (Years 2-5)
Correction: Renew System
Qty: 69,619.00
Unit of Measure: S.F.
Estimate: \$173,073.00
Assessor Name: Eduardo Lopez
Date Created: 09/28/2019

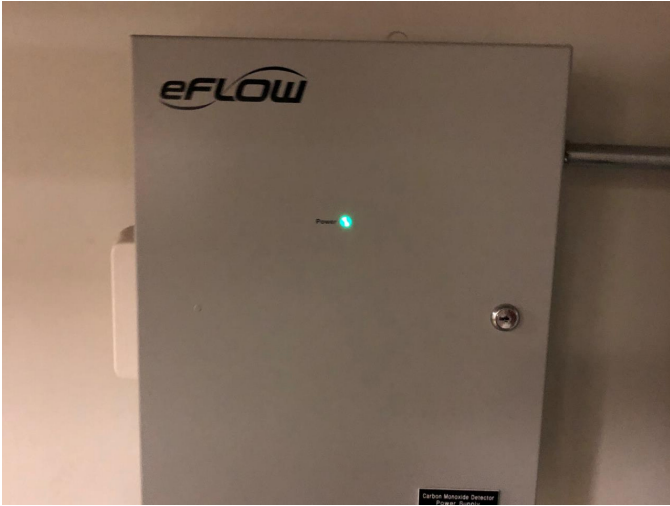
System: D4090 - Other Fire Protection Systems

Location: Kitchen
Distress: Beyond Expected Life
Category: Deferred Maintenance
Priority: 3 - Necessary (Years 2-5)
Correction: Renew System
Qty: 69,619.00
Unit of Measure: S.F.
Estimate: \$47,480.00
Assessor Name: Eduardo Lopez
Date Created: 09/28/2019

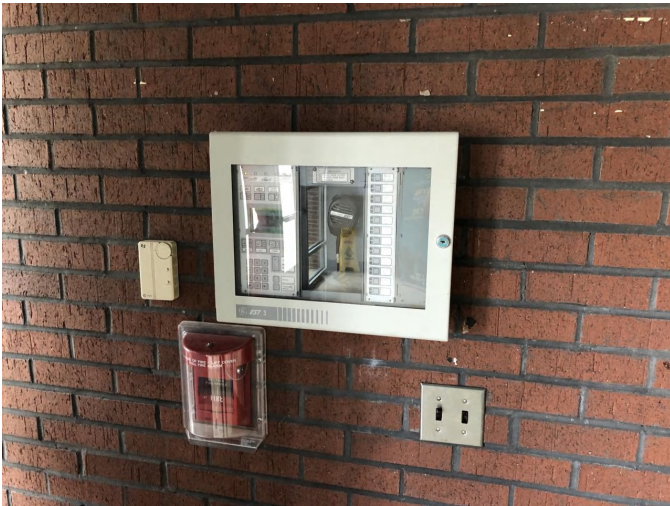
System: D5030910 - Fire Alarm Systems

Location: Throughout Building
Distress: Beyond Expected Life
Category: Deferred Maintenance
Priority: 3 - Necessary (Years 2-5)
Correction: Renew System
Qty: 69,619.00
Unit of Measure: S.F.
Estimate: \$177,668.00
Assessor Name: Eduardo Lopez
Date Created: 10/17/2019

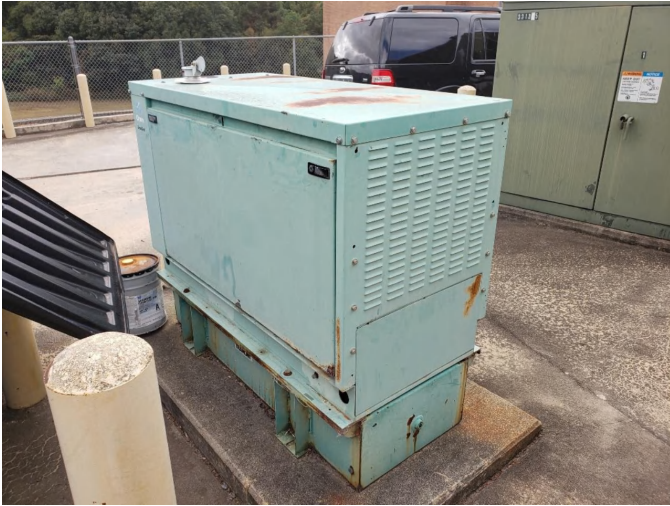
System: D5090 - Other Electrical Systems

Location: East side of the building
Distress: Beyond Expected Life
Category: Deferred Maintenance
Priority: 3 - Necessary (Years 2-5)
Correction: Renew System
Qty: 69,619.00
Unit of Measure: S.F.
Estimate: \$27,569.00
Assessor Name: Eduardo Lopez
Date Created: 09/28/2019

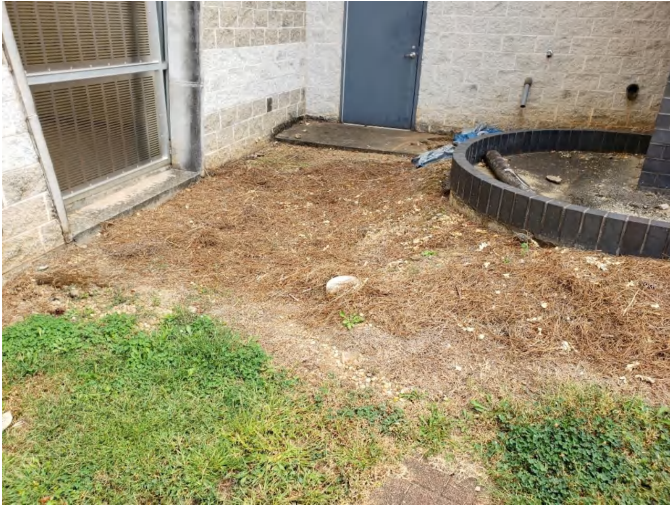
System: G3030 - Storm Sewer

Location: Northwest corner of 2002 Building
Distress: Failing
Category: Facility Integrity
Priority: 1 - Critical Immediate Need
Correction: Replace/Add catch basin and drain
Qty: 1.00
Unit of Measure: Ea.
Estimate: \$15,369.00
Assessor Name: Eduardo Lopez
Date Created: 10/08/2019

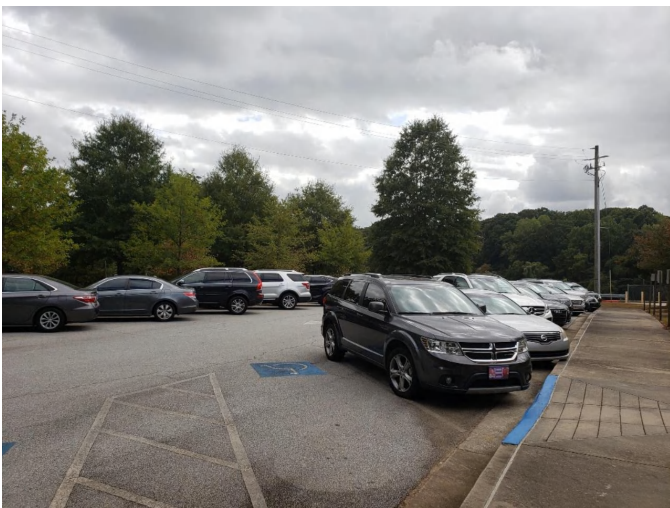
System: G4020 - Site Lighting

Location: Site
Distress: Missing
Category: Safety
Priority: 1 - Critical Immediate Need
Correction: Add Site Lighting
Qty: 6.00
Unit of Measure: Ea.
Estimate: \$38,832.63
Assessor Name: Eduardo Lopez
Date Created: 10/08/2019

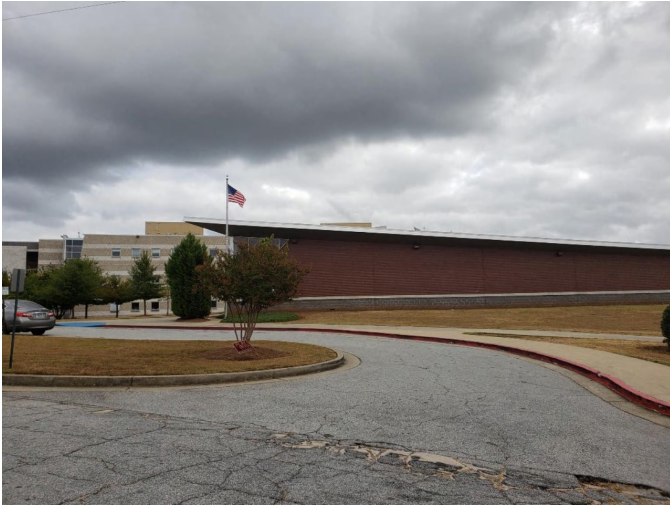
System: G2010 - Roadways

Location: Throughout Site
Distress: Inadequate
Category: Code Compliance
Priority: 2 - Trending Critical (Year 1)
Correction: Fire lane marking, incl. curb painting and with the words "No Parking, Fire Lane" painted in black
Qty: 2,000.00
Unit of Measure: L.F.
Estimate: \$4,770.60
Assessor Name: Eduardo Lopez
Date Created: 10/07/2019

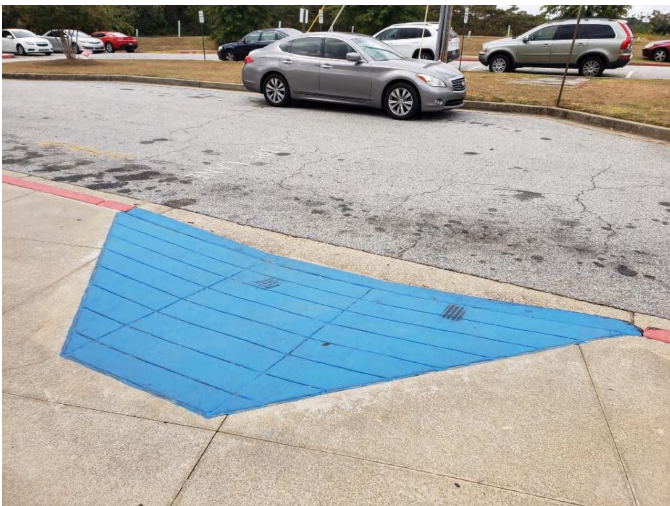
System: G2010 - Roadways

Location: Roadway, West
Distress: Missing
Category: ADA Compliance
Priority: 2 - Trending Critical (Year 1)
Correction: Add handicap compliant striping at roadway crossing
Qty: 1.00
Unit of Measure: Ea.
Estimate: \$1,064.69
Assessor Name: Eduardo Lopez
Date Created: 10/07/2019

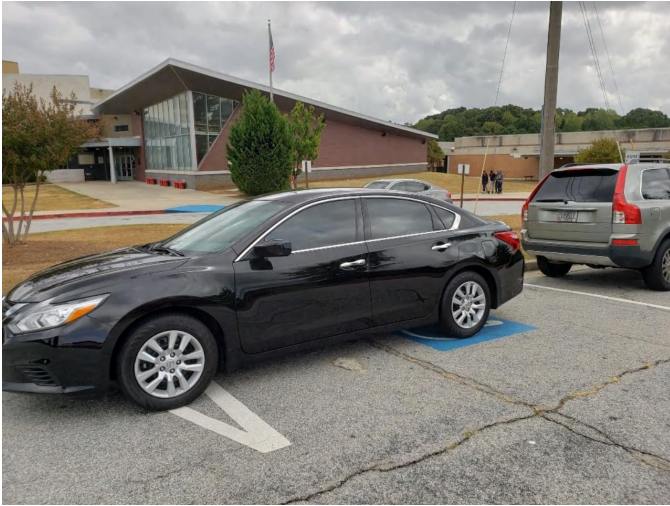
System: G2020 - Parking Lots

Location: Site
Distress: Non Compliant
Category: ADA Compliance
Priority: 2 - Trending Critical (Year 1)
Correction: Add handicap parking space, incl. pavement markings, sign and post
Qty: 1.00
Unit of Measure: Ea.
Estimate: \$518.63
Assessor Name: Eduardo Lopez
Date Created: 10/07/2019

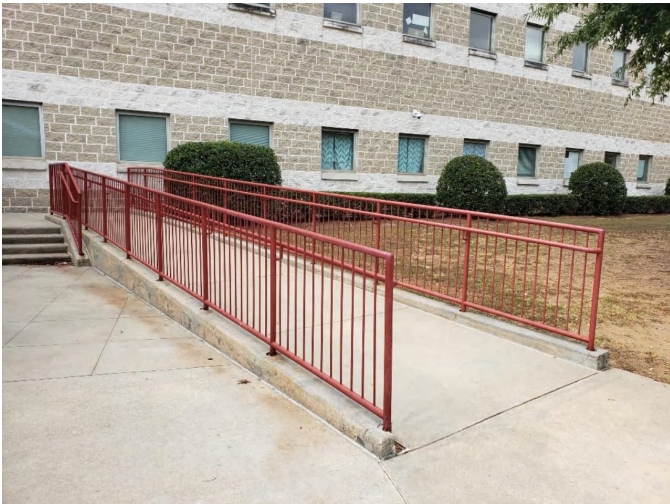
System: G2030 - Pedestrian Paving

Location: Site, East Entrance
Distress: Non Compliant
Category: ADA Compliance
Priority: 2 - Trending Critical (Year 1)
Correction: Add handicap ramp with railing
Qty: 45.00
Unit of Measure: L.F.
Estimate: \$20,891.44
Assessor Name: Eduardo Lopez
Date Created: 10/07/2019

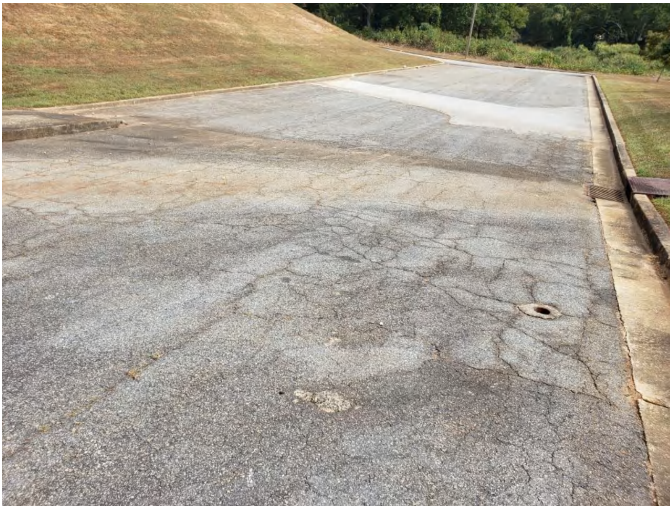
System: G2010 - Roadways

Location: East and West Roadway
Distress: Damaged
Category: Deferred Maintenance
Priority: 3 - Necessary (Years 2-5)
Correction: Replace or resurface asphalt paving 20ft wide X 4"
Qty: 500.00
Unit of Measure: L.F.
Estimate: \$92,674.89
Assessor Name: Eduardo Lopez
Date Created: 10/07/2019
