Atlanta Public Schools/ Douglass Cluster

Scott Elementary School

School Assessment Report

November 10, 2020

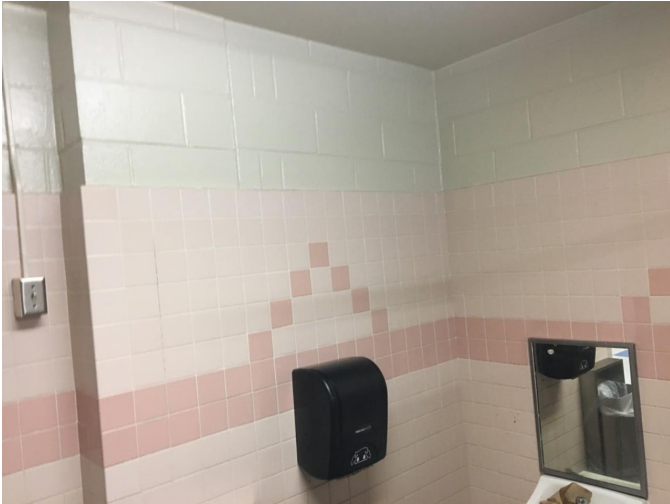
System: C3010220 - Tile

Location: Throughout Building
Distress: Beyond Expected Life
Category: Deferred Maintenance
Priority: 3 - Necessary (Years 2-5)
Correction: Renew System
Qty: 900.00
Unit of Measure: S.F.
Estimate: \$12,488.00
Assessor Name: Eduardo Lopez
Date Created: 10/06/2020

Notes: The tile is beyond its expected service life and should be scheduled for replacement.

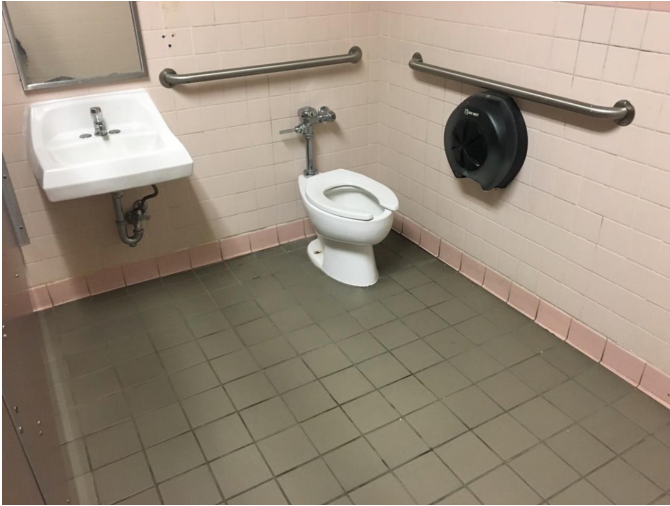
System: C3020420 - Ceramic Tile

Location: Throughout Building
Distress: Beyond Expected Life
Category: Deferred Maintenance
Priority: 3 - Necessary (Years 2-5)
Correction: Renew System
Qty: 900.00
Unit of Measure: S.F.
Estimate: \$22,599.00
Assessor Name: Eduardo Lopez
Date Created: 10/06/2020

Notes: The ceramic tile is beyond its expected service life and should be scheduled for replacement.

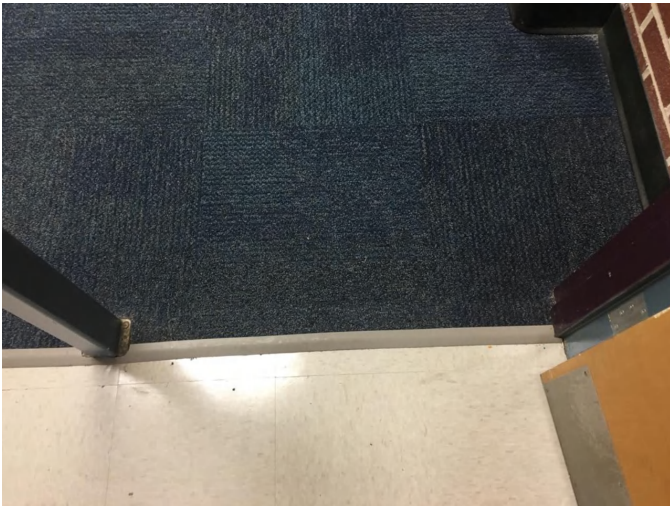
System: C3020901 - Carpet

Location: Media Center and Main office
Distress: Beyond Expected Life
Category: Deferred Maintenance
Priority: 3 - Necessary (Years 2-5)
Correction: Renew System
Qty: 4,300.00
Unit of Measure: S.F.
Estimate: \$35,475.00
Assessor Name: Eduardo Lopez
Date Created: 11/01/2019

Notes: The carpet is aged, worn and stained, and should be replaced.

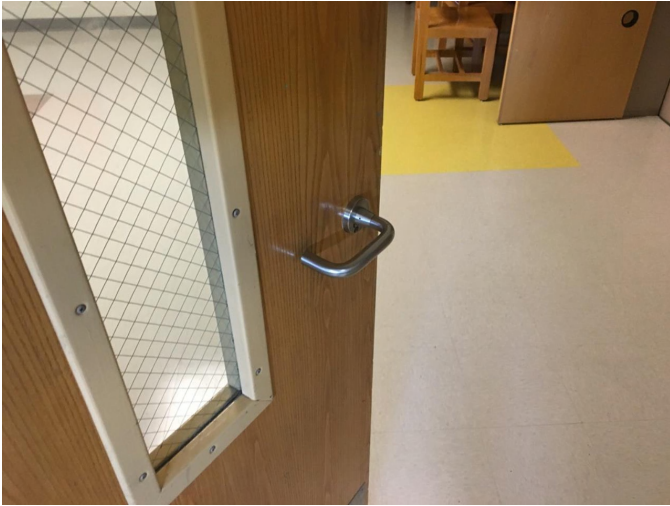
System: C3020903 - VCT

Location: Throughout Building
Distress: Beyond Expected Life
Category: Deferred Maintenance
Priority: 3 - Necessary (Years 2-5)
Correction: Renew System
Qty: 41,773.00
Unit of Measure: S.F.
Estimate: \$225,324.00
Assessor Name: Eduardo Lopez
Date Created: 01/22/2020

Notes: The VCT floor finish is beyond its expected service life, worn and damaged, and is recommended for replacement.

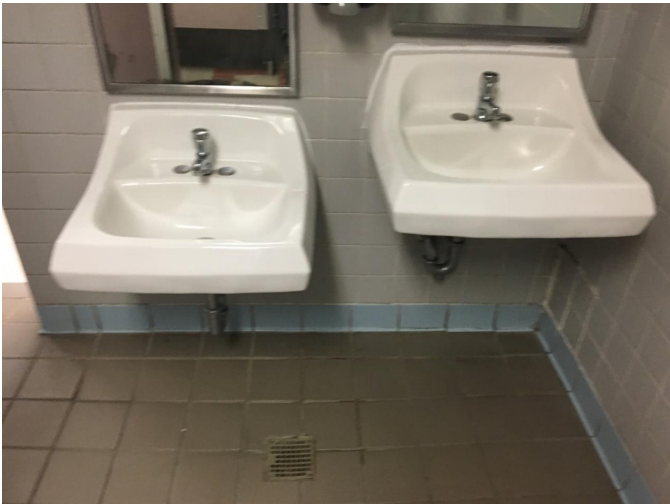
System: D2010 - Plumbing Fixtures

Location: Throughout Building
Distress: Beyond Expected Life
Category: Deferred Maintenance
Priority: 3 - Necessary (Years 2-5)
Correction: Renew System
Qty: 49,353.00
Unit of Measure: S.F.
Estimate: \$345,816.00
Assessor Name: Eduardo Lopez
Date Created: 10/06/2020

Notes: The plumbing fixtures are beyond its expected service life and should be scheduled for replacement.

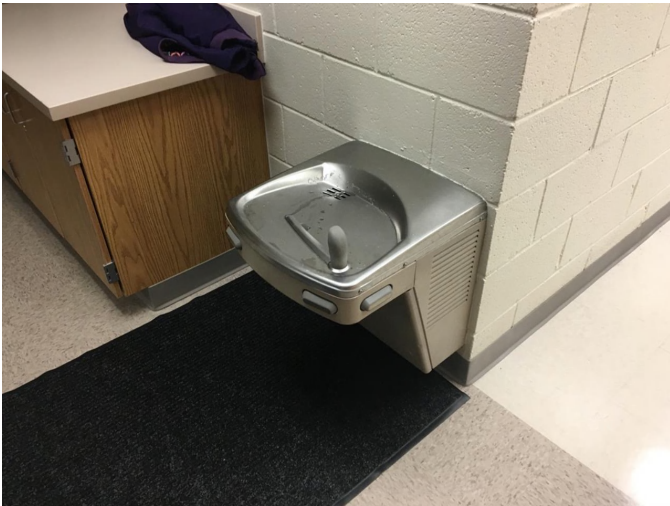
System: D2020 - Domestic Water Distribution

Location: Throughout Building
Distress: Beyond Expected Life
Category: Deferred Maintenance
Priority: 3 - Necessary (Years 2-5)
Correction: Renew System
Qty: 49,353.00
Unit of Measure: S.F.
Estimate: \$39,088.00
Assessor Name: Eduardo Lopez
Date Created: 10/06/2020

Notes: The domestic water distribution system is beyond its expected service life and should be scheduled for replacement.

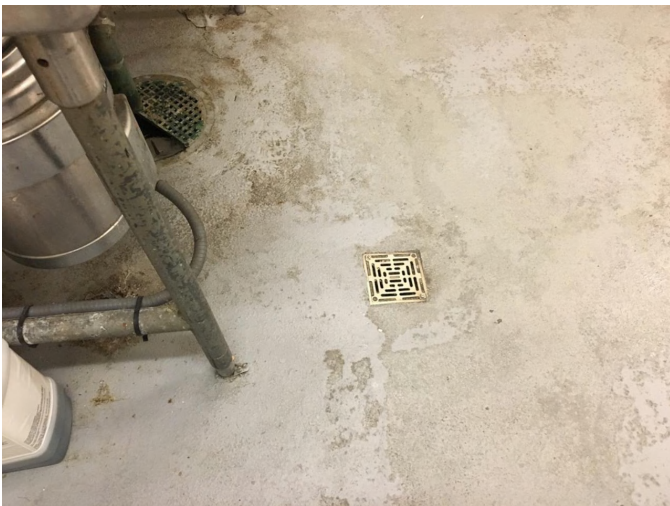
System: D2030 - Sanitary Waste

Location: Throughout Building
Distress: Beyond Expected Life
Category: Deferred Maintenance
Priority: 3 - Necessary (Years 2-5)
Correction: Renew System
Qty: 49,353.00
Unit of Measure: S.F.
Estimate: \$91,747.00
Assessor Name: Eduardo Lopez
Date Created: 10/06/2020

Notes: The sanitary waste is beyond its expected service life and should be scheduled for replacement.

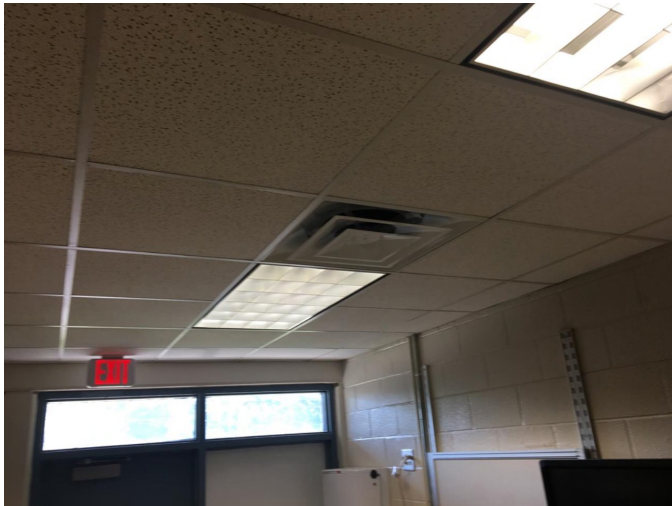
System: D3040 - Distribution Systems

Location: Throughout Building
Distress: Beyond Expected Life
Category: Deferred Maintenance
Priority: 3 - Necessary (Years 2-5)
Correction: Renew System
Qty: 49,353.00
Unit of Measure: S.F.
Estimate: \$1,211,715.00
Assessor Name: Eduardo Lopez
Date Created: 10/06/2020

Notes: The distribution system is beyond its expected service life and should be scheduled for replacement.

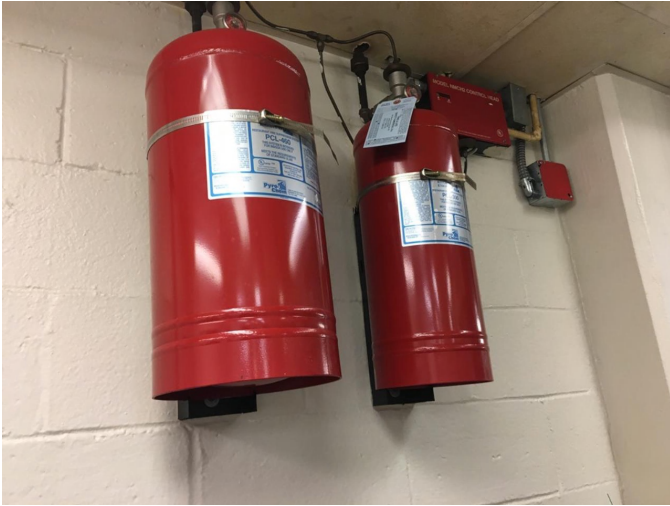
System: D4090 - Other Fire Protection Systems

Location: Kitchen
Distress: Beyond Expected Life
Category: Deferred Maintenance
Priority: 3 - Necessary (Years 2-5)
Correction: Renew System
Qty: 49,353.00
Unit of Measure: S.F.
Estimate: \$32,573.00
Assessor Name: Eduardo Lopez
Date Created: 09/28/2019

Notes: The Ansul Fire Suppression system is beyond expected life. This building's high traffic use warrants upgrades to this system based on usage and age. Replacing or upgrading the system is recommended

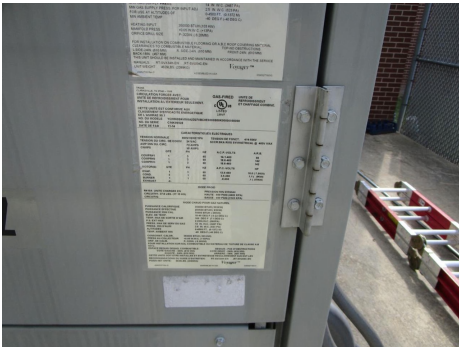
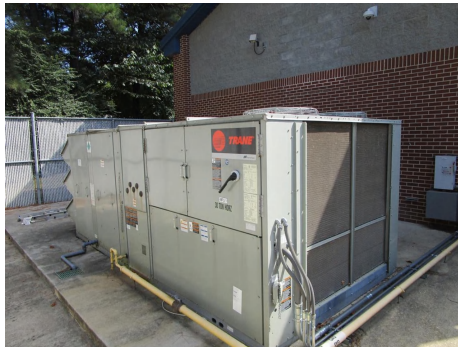
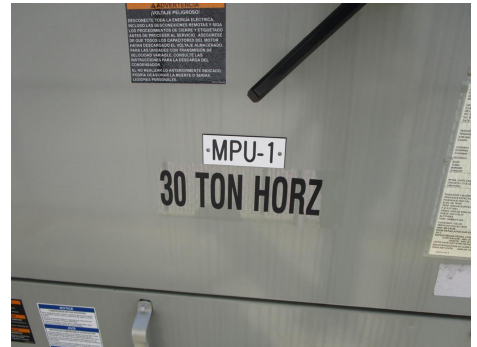
System: D3050 - Terminal & Package Units

Note: Two 12.5-ton condensing units serving Multipurpose air handling units installed 2011.-- Replaced with one 30 Ton unit.

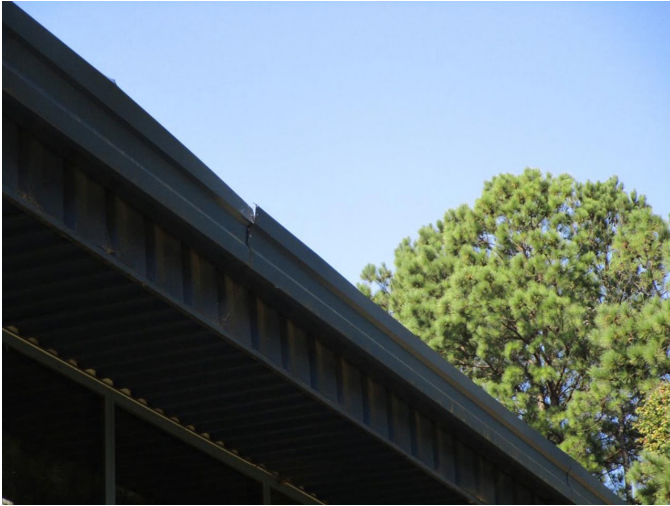
System: B3010130 - Preformed Metal Roofing

Location: North and west side of the building
Distress: Damaged
Category: Deferred Maintenance
Priority: 3 - Necessary (Years 2-5)
Correction: Replace vinyl box gutter, 5" wide
Qty: 160.00
Unit of Measure: L.F.
Estimate: \$2,041.10
Assessor Name: Eduardo Lopez
Date Created: 11/01/2019

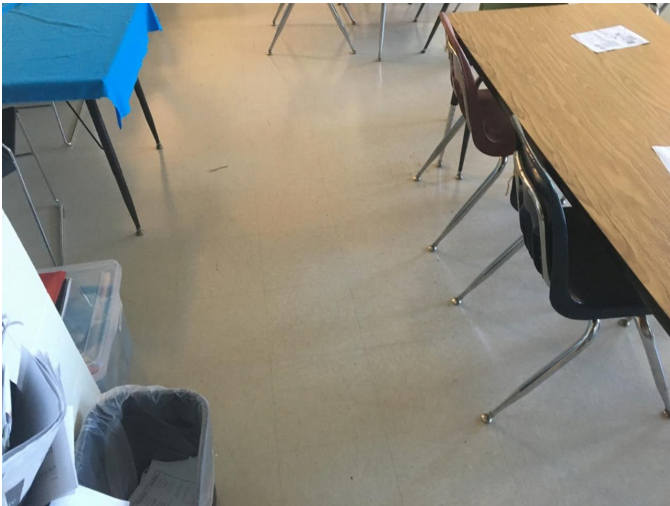
System: C3020903 - VCT

Location: Throughout Building
Distress: Beyond Expected Life
Category: Deferred Maintenance
Priority: 3 - Necessary (Years 2-5)
Correction: Renew System
Qty: 16,986.00
Unit of Measure: S.F.
Estimate: \$91,622.00
Assessor Name: Eduardo Lopez
Date Created: 11/01/2019

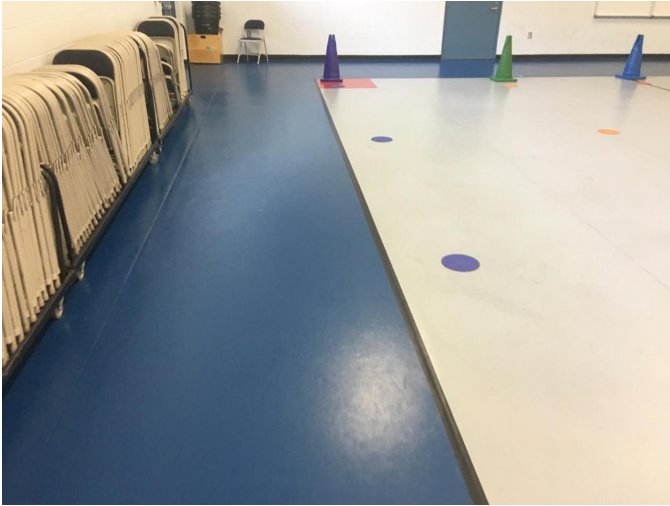
System: C3020999 - Other - Rubber or Neoprene

Location: Multi-purpose room
Distress: Beyond Expected Life
Category: Deferred Maintenance
Priority: 3 - Necessary (Years 2-5)
Correction: Renew System
Qty: 6,128.00
Unit of Measure: S.F.
Estimate: \$179,777.00
Assessor Name: Eduardo Lopez
Date Created: 11/01/2019

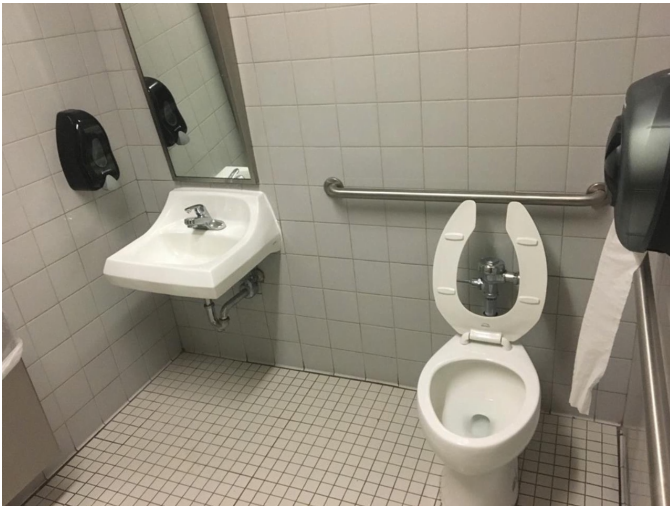
System: D2010 - Plumbing Fixtures

Location: Throughout Building
Distress: Beyond Expected Life
Category: Deferred Maintenance
Priority: 3 - Necessary (Years 2-5)
Correction: Renew System
Qty: 24,038.00
Unit of Measure: S.F.
Estimate: \$176,896.00
Assessor Name: Eduardo Lopez
Date Created: 10/06/2020

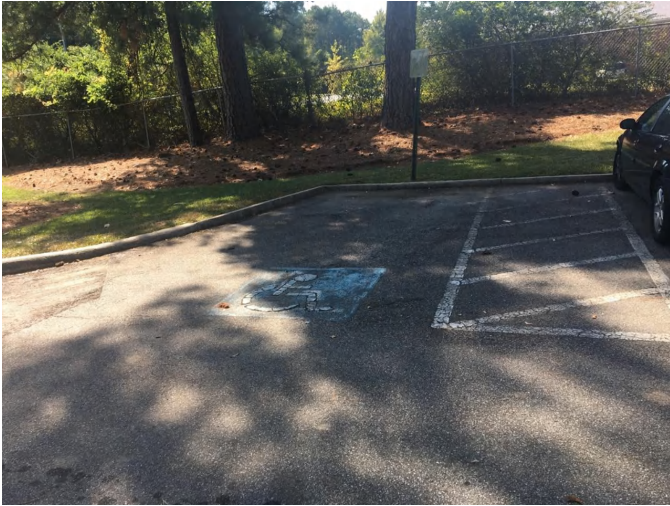
System: G2040105 - Fence & Guardrails

Location: Perimeter of the site property
Distress: Beyond Expected Life
Category: Deferred Maintenance
Priority: 3 - Necessary (Years 2-5)
Correction: Renew System
Qty: 5,334.00
Unit of Measure: S.F.
Estimate: \$6,748.00
Assessor Name: Eduardo Lopez
Date Created: 01/22/2020
