Atlanta Public Schools/ Carver Cluster

# Slater Elementary School

## School Assessment Report

November 10, 2020

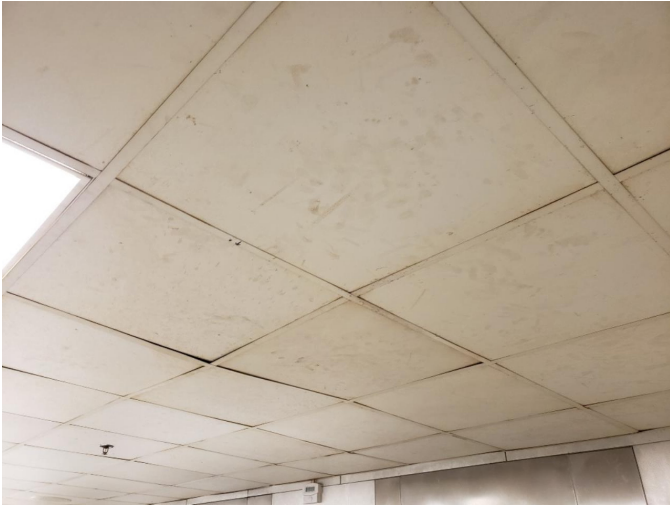
#### System: C3030 - Ceiling Finishes

**Location:** Kitchen  
**Distress:** Inadequate  
**Category:** Deferred Maintenance  
**Priority:** 2 - Trending Critical (Year 1)  
**Correction:** Replace acoustic tile ceiling, fire-rated  
**Qty:** 2.00  
**Unit of Measure:** C.S.F.  
**Estimate:** \$1,415.74  
**Assessor Name:** Jejuan Hall  
**Date Created:** 02/08/2020

**Notes:** Ceiling tiles in kitchen area are in poor condition and should be replaced.

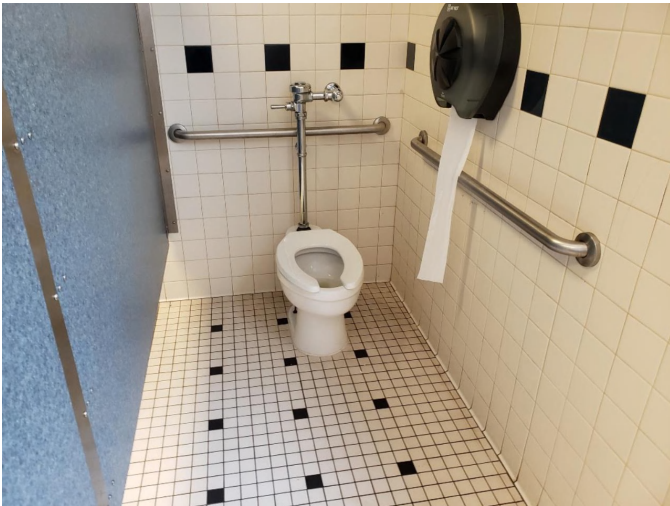
#### System: D2010 - Plumbing Fixtures

**Location:** Girls Restroom, East 102  
**Distress:** Non Compliant  
**Category:** ADA Compliance  
**Priority:** 2 - Trending Critical (Year 1)  
**Correction:** Add handicap compliant restroom  
**Qty:** 1.00  
**Unit of Measure:** Ea.  
**Estimate:** \$4,824.27  
**Assessor Name:** Jejuan Hall  
**Date Created:** 02/08/2020

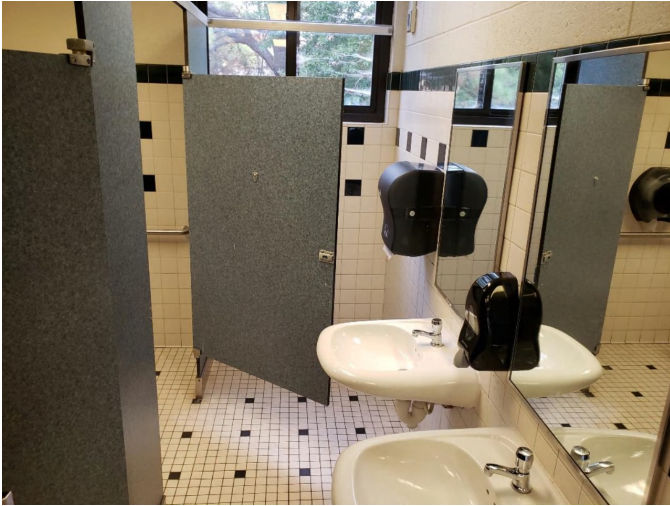
**System: D2010 - Plumbing Fixtures**

**Location:** Girls Restroom, East 202  
**Distress:** Non Compliant  
**Category:** ADA Compliance  
**Priority:** 2 - Trending Critical (Year 1)  
**Correction:** Add handicap compliant restroom  
**Qty:** 1.00  
**Unit of Measure:** Ea.  
**Estimate:** \$4,824.27  
**Assessor Name:** Jejuan Hall  
**Date Created:** 02/08/2020

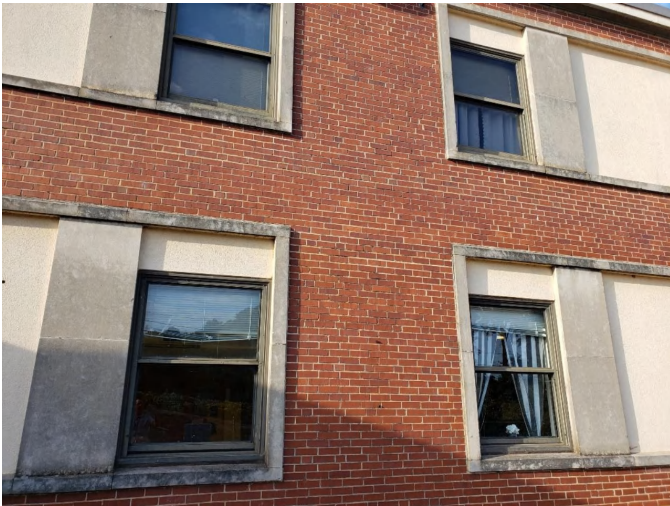
**System: B2020 - Exterior Windows**

**Location:** Exterior Walls  
**Distress:** Beyond Expected Life  
**Category:** Deferred Maintenance  
**Priority:** 3 - Necessary (Years 2-5)  
**Correction:** Renew System  
**Qty:** 60,418.00  
**Unit of Measure:** S.F.  
**Estimate:** \$571,554.00  
**Assessor Name:** Jejuan Hall  
**Date Created:** 09/11/2013

**Notes:** The aluminum frame, operable, single pane windows are aged, rusted, not energy efficient, and should be replaced.

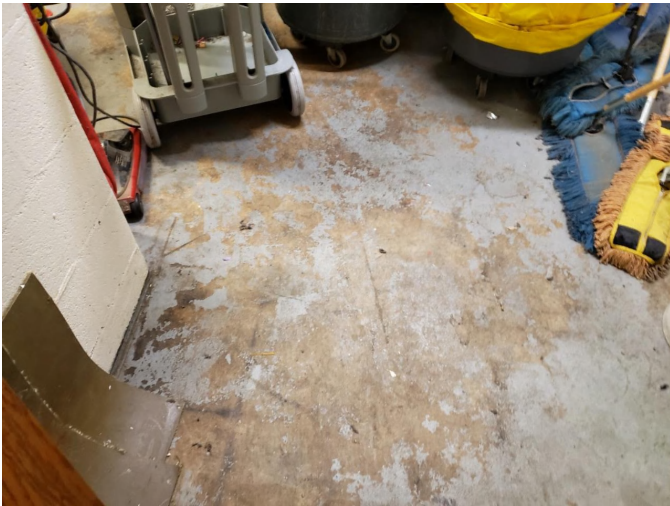
**System: C3020405 - Epoxy**

**Location:** Throughout Building  
**Distress:** Beyond Expected Life  
**Category:** Deferred Maintenance  
**Priority:** 3 - Necessary (Years 2-5)  
**Correction:** Renew System  
**Qty:** 1,282.00  
**Unit of Measure:** S.F.  
**Estimate:** \$26,171.00  
**Assessor Name:** Jejuan Hall  
**Date Created:** 02/02/2020

**Notes:** The epoxy flooring is beyond its expected service life and should be scheduled for replacement.

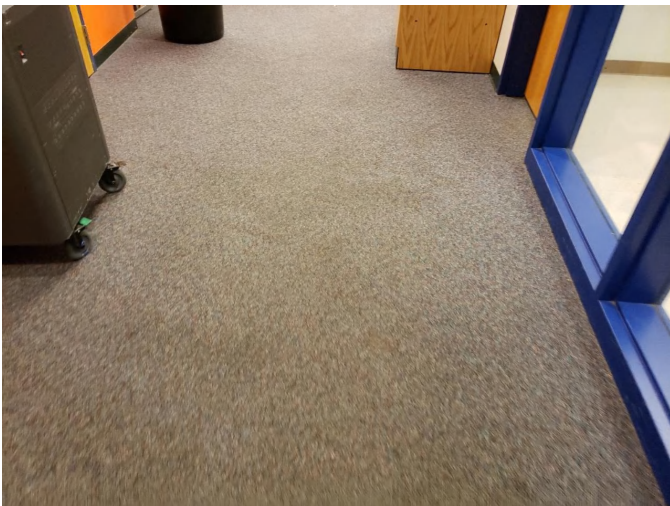
**System: C3020901 - Carpet**

**Location:** Throughout Building  
**Distress:** Beyond Expected Life  
**Category:** Deferred Maintenance  
**Priority:** 3 - Necessary (Years 2-5)  
**Correction:** Renew System  
**Qty:** 8,555.00  
**Unit of Measure:** S.F.  
**Estimate:** \$70,579.00  
**Assessor Name:** Jejuan Hall  
**Date Created:** 01/29/2020

**Notes:** The carpet is stained, showing signs of early failure and should be replaced.

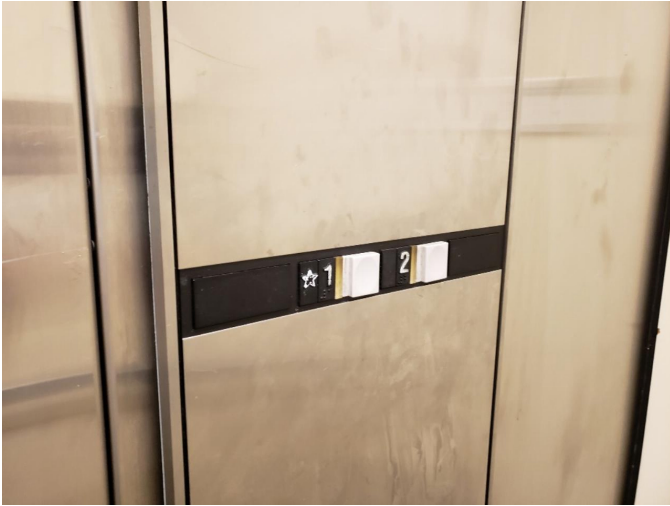
**System: D1010 - Elevators and Lifts**

**Location:** Elevator  
**Distress:** Beyond Expected Life  
**Category:** Deferred Maintenance  
**Priority:** 3 - Necessary (Years 2-5)  
**Correction:** Modernize or upgrade the elevator cab or to comply with ADA - exact scope of work estimate not available  
**Qty:** 1.00  
**Unit of Measure:** Ea.  
**Estimate:** \$19,264.04  
**Assessor Name:** Jejuan Hall  
**Date Created:** 02/08/2020

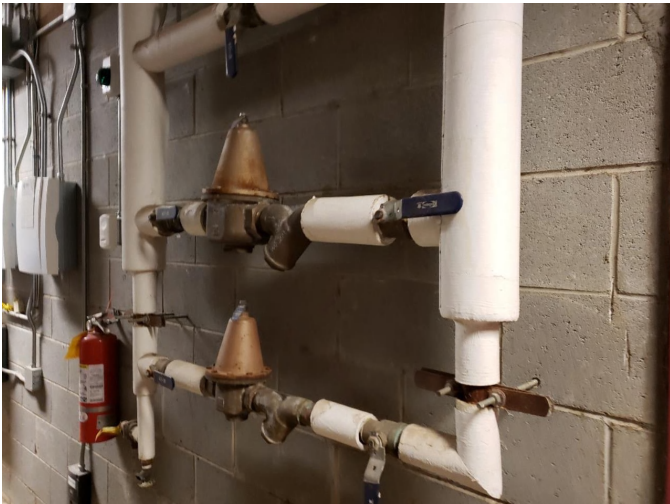
**System: D2020 - Domestic Water Distribution**

**Location:** Throughout Building  
**Distress:** Beyond Expected Life  
**Category:** Deferred Maintenance  
**Priority:** 3 - Necessary (Years 2-5)  
**Correction:** Renew System  
**Qty:** 60,418.00  
**Unit of Measure:** S.F.  
**Estimate:** \$47,851.00  
**Assessor Name:** Jejuan Hall  
**Date Created:** 09/11/2013

**Notes:** The domestic water distribution system is aged and should be replaced.

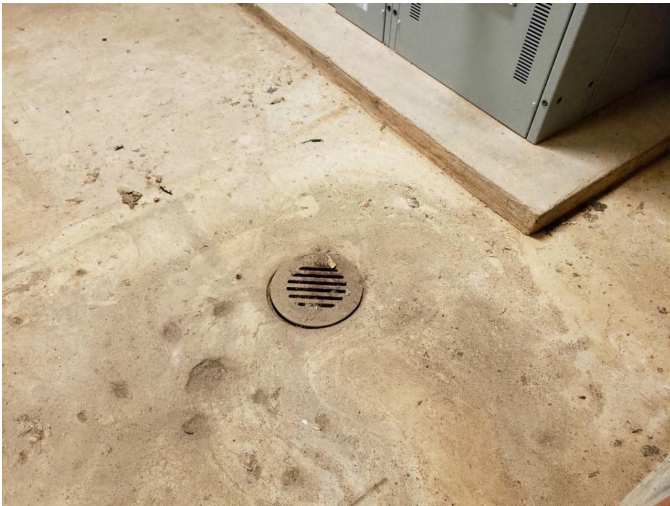
**System: D2030 - Sanitary Waste**

**Location:** Throughout Building  
**Distress:** Beyond Expected Life  
**Category:** Deferred Maintenance  
**Priority:** 3 - Necessary (Years 2-5)  
**Correction:** Renew System  
**Qty:** 60,418.00  
**Unit of Measure:** S.F.  
**Estimate:** \$112,317.00  
**Assessor Name:** Jejuan Hall  
**Date Created:** 09/11/2013

**Notes:** The sanitary waste system is aged, has reported periodic failures, and should be replaced.

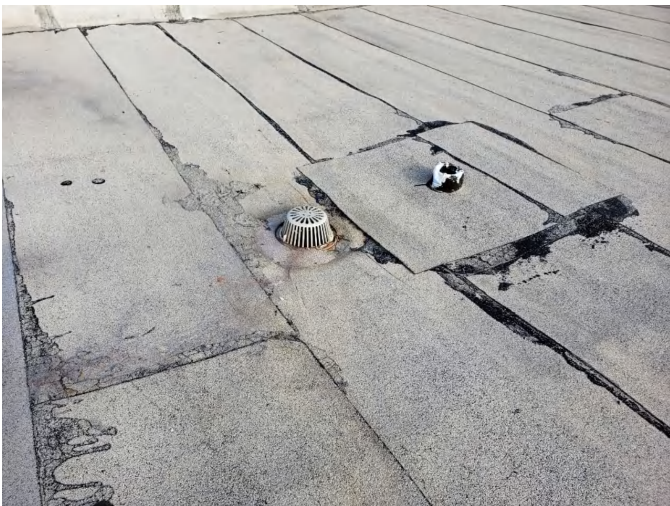
**System: D2040 - Rain Water Drainage**

**Location:** Roof  
**Distress:** Beyond Expected Life  
**Category:** Deferred Maintenance  
**Priority:** 3 - Necessary (Years 2-5)  
**Correction:** Renew System  
**Qty:** 60,418.00  
**Unit of Measure:** S.F.  
**Estimate:** \$26,584.00  
**Assessor Name:** Jejuan Hall  
**Date Created:** 09/11/2013

**Notes:** The rainwater drainage system is aged, in marginal condition, and should be replaced.

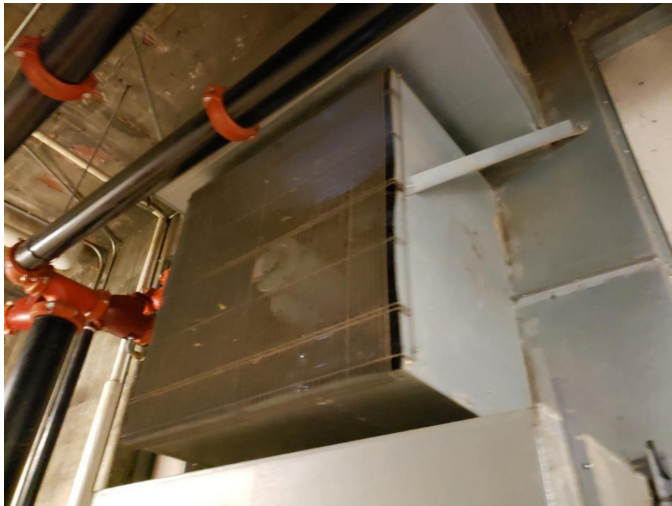
**System: D3040 - Distribution Systems**

**Location:** Throughout Building  
**Distress:** Beyond Expected Life  
**Category:** Deferred Maintenance  
**Priority:** 3 - Necessary (Years 2-5)  
**Correction:** Renew System  
**Qty:** 60,418.00  
**Unit of Measure:** S.F.  
**Estimate:** \$705,803.00  
**Assessor Name:** Jejuan Hall  
**Date Created:** 02/02/2020

**Notes:** The distribution system is aged, becoming logistically unsupportable, and should be replaced.

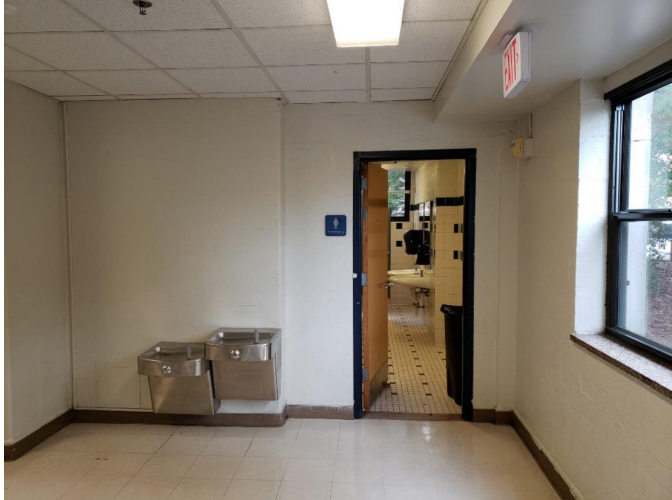
**System: C1020 - Interior Doors**

**Location:** Girls Restroom, East 202  
**Distress:** Failing  
**Category:** ADA Compliance  
**Priority:** 4 - Recommended (Years 6-10)  
**Correction:** Change door swing for code compliance  
**Qty:** 1.00  
**Unit of Measure:** Ea.  
**Estimate:** \$482.15  
**Assessor Name:** Jejuan Hall  
**Date Created:** 02/08/2020

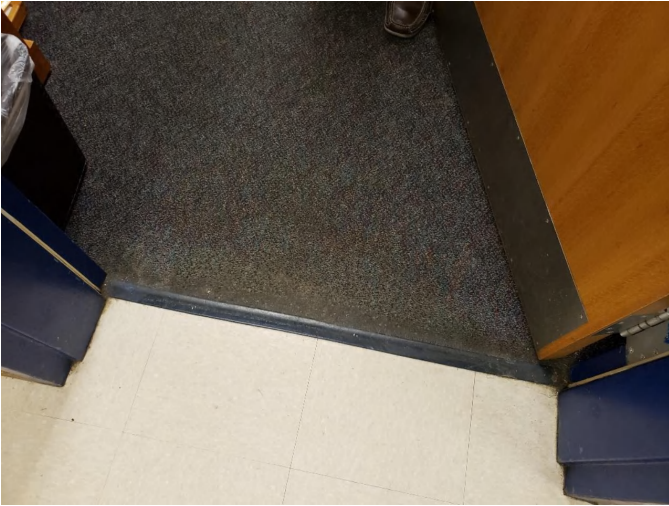
#### System: C3020901 - Carpet

**Location:** Throughout Building  
**Distress:** Beyond Expected Life  
**Category:** Deferred Maintenance  
**Priority:** 3 - Necessary (Years 2-5)  
**Correction:** Renew System  
**Qty:** 165.00  
**Unit of Measure:** S.F.  
**Estimate:** \$1,361.00  
**Assessor Name:** Eduardo Lopez  
**Date Created:** 01/29/2020

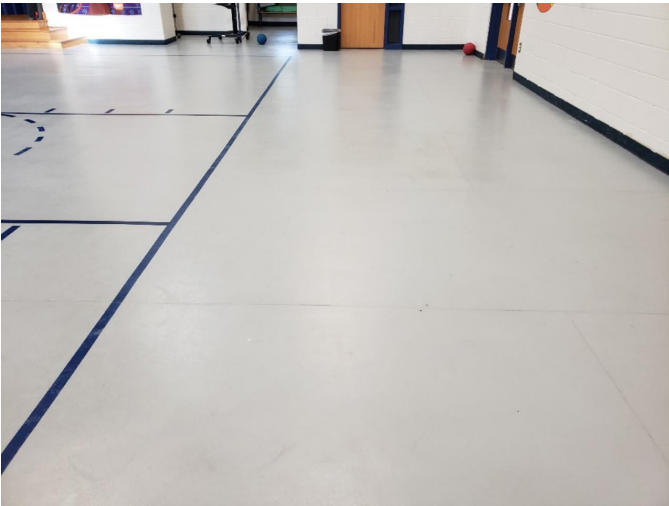
#### System: C3020999 - Other - Rubber or Neoprene

**Location:** Throughout Building  
**Distress:** Beyond Expected Life  
**Category:** Deferred Maintenance  
**Priority:** 3 - Necessary (Years 2-5)  
**Correction:** Renew System  
**Qty:** 4,508.00  
**Unit of Measure:** S.F.  
**Estimate:** \$132,251.00  
**Assessor Name:** Eduardo Lopez  
**Date Created:** 01/29/2020

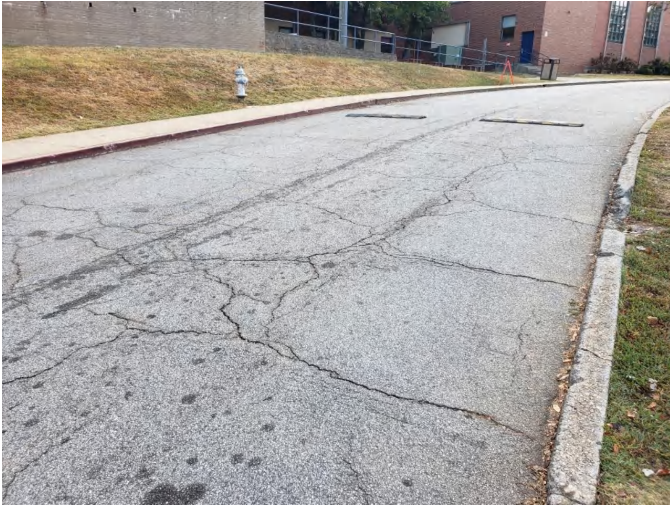
#### System: G2010 - Roadways

**Location:** Site  
**Distress:** Beyond Expected Life  
**Category:** Deferred Maintenance  
**Priority:** 3 - Necessary (Years 2-5)  
**Correction:** Renew System  
**Qty:** 78,232.00  
**Unit of Measure:** S.F.  
**Estimate:** \$203,951.00  
**Assessor Name:** Eduardo Lopez  
**Date Created:** 01/29/2020

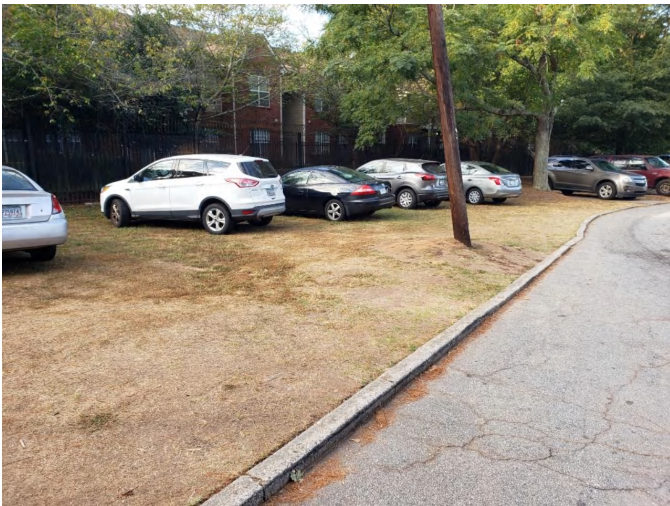
#### System: G2020 - Parking Lots

**Location:** Site  
**Distress:** Beyond Expected Life  
**Category:** Deferred Maintenance  
**Priority:** 3 - Necessary (Years 2-5)  
**Correction:** Renew System  
**Qty:** 78,232.00  
**Unit of Measure:** S.F.  
**Estimate:** \$688,442.00  
**Assessor Name:** Eduardo Lopez  
**Date Created:** 01/29/2020

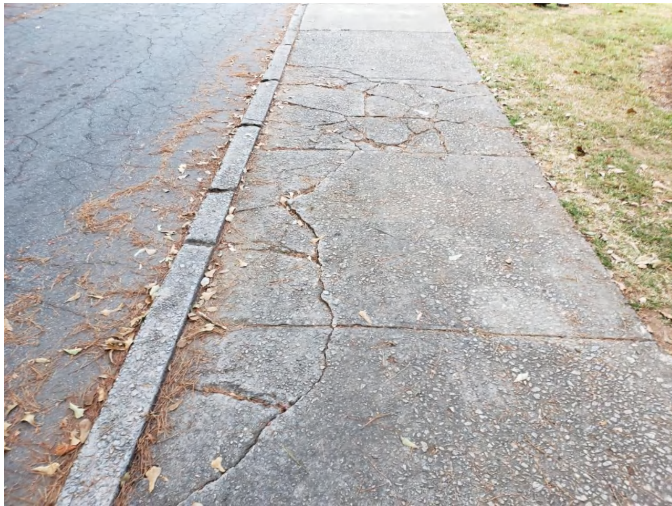
### **System: G2030 - Pedestrian Paving**

**Location:** Site  
**Distress:** Beyond Expected Life  
**Category:** ADA Compliance  
**Priority:** 3 - Necessary (Years 2-5)  
**Correction:** Renew System  
**Qty:** 78,232.00  
**Unit of Measure:** S.F.  
**Estimate:** \$200,509.00  
**Assessor Name:** Jejuan Hall  
**Date Created:** 01/29/2020

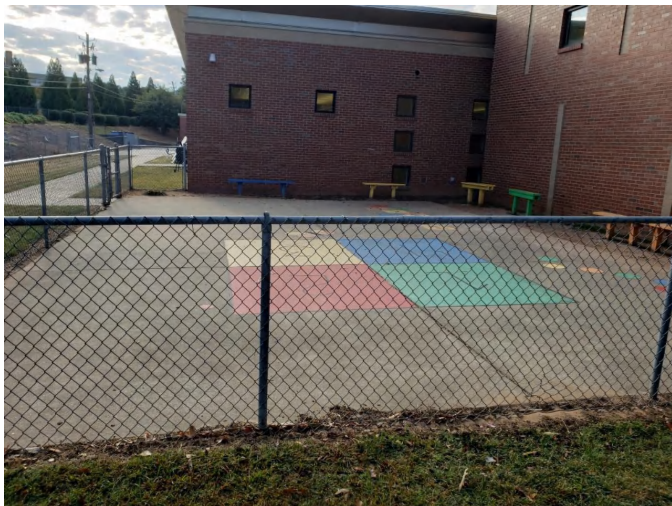
### **System: G2040950 - Hard Surface Play Area**

**Location:** Site  
**Distress:** Beyond Expected Life  
**Category:** Deferred Maintenance  
**Priority:** 3 - Necessary (Years 2-5)  
**Correction:** Renew System  
**Qty:** 78,232.00  
**Unit of Measure:** S.F.  
**Estimate:** \$61,099.00  
**Assessor Name:** Eduardo Lopez  
**Date Created:** 01/29/2020
