Atlanta Public Schools/Charter Schools

Slaton ES (Atlanta Neighborhood Charter)

School Assessment Report

November 10, 2020

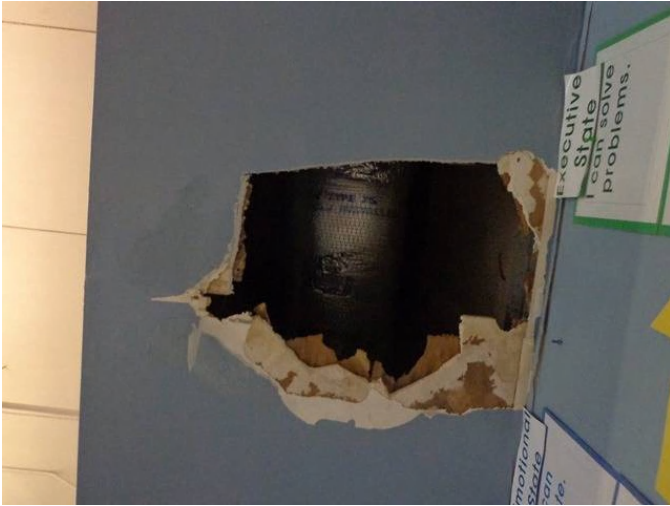
System: C3030 - Ceiling Finishes

Location: Throughout Building
Distress: Damaged
Category: Mission Integrity
Priority: 2 - Trending Critical (Year 1)
Correction: Replace Drywall Ceiling
Qty: 200.00
Unit of Measure: S.F.
Estimate: \$719.35
Assessor Name: Hayden Collins
Date Created: 10/23/2014

Notes: There was some work performed above the ceiling and the holes were not repaired. This condition was reported to be like this for several years in classrooms 306, 312 & 309.

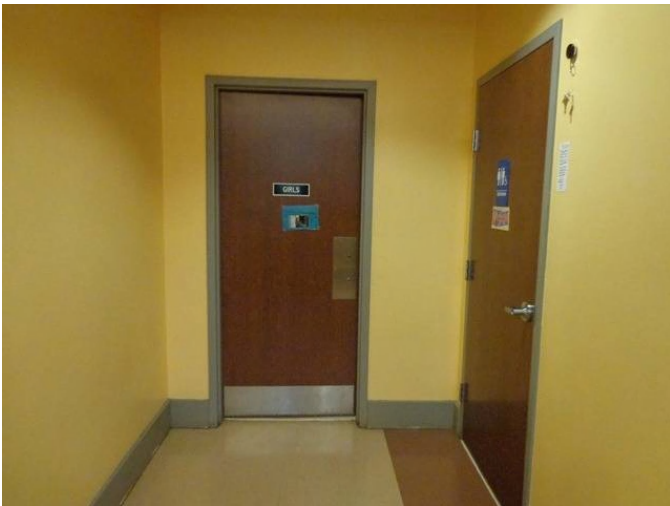
System: E2010 - Fixed Furnishings

Location: Throughout Building
Distress: Missing
Category: ADA Compliance
Priority: 2 - Trending Critical (Year 1)
Correction: Replace Identifying Devices
Qty: 100.00
Unit of Measure: Ea.
Estimate: \$7,659.30
Assessor Name: Hayden Collins
Date Created: 10/23/2014

Notes: ADA Signage are missing for each room. Provide Signage to comply with code.

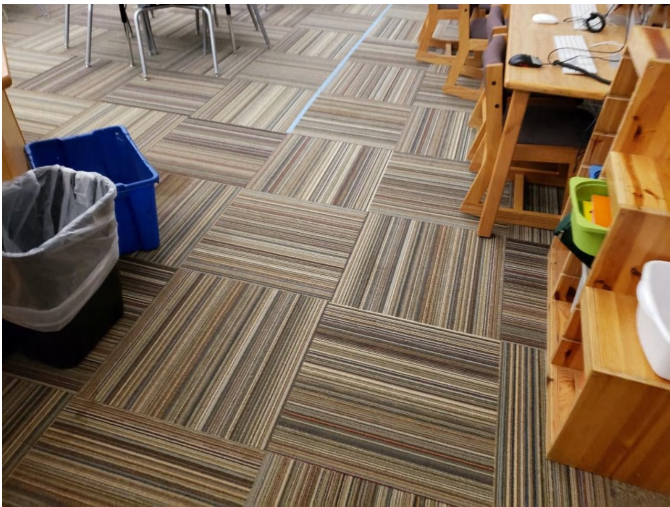
System: C3020901 - Carpet

Location: Media Center and Main office
Distress: Beyond Expected Life
Category: Deferred Maintenance
Priority: 3 - Necessary (Years 2-5)
Correction: Renew System
Qty: 3,235.00
Unit of Measure: S.F.
Estimate: \$26,689.00
Assessor Name: Hayden Collins
Date Created: 01/13/2020

Notes: The carpet is aged, worn and stained, and should be replaced.

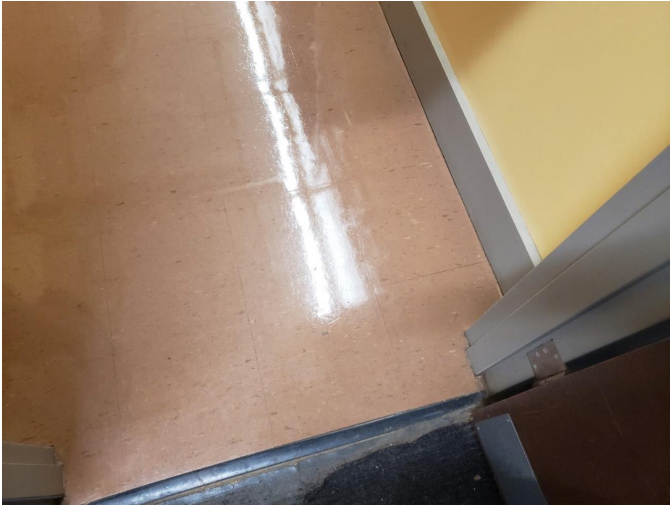
System: C3020903 - VCT

Location: Throughout Building
Distress: Beyond Expected Life
Category: Deferred Maintenance
Priority: 3 - Necessary (Years 2-5)
Correction: Renew System
Qty: 34,667.00
Unit of Measure: S.F.
Estimate: \$186,994.00
Assessor Name: Hayden Collins
Date Created: 01/13/2020

Notes: The VCT floor finish is beyond its expected service life, faded and stained, and should be replaced.

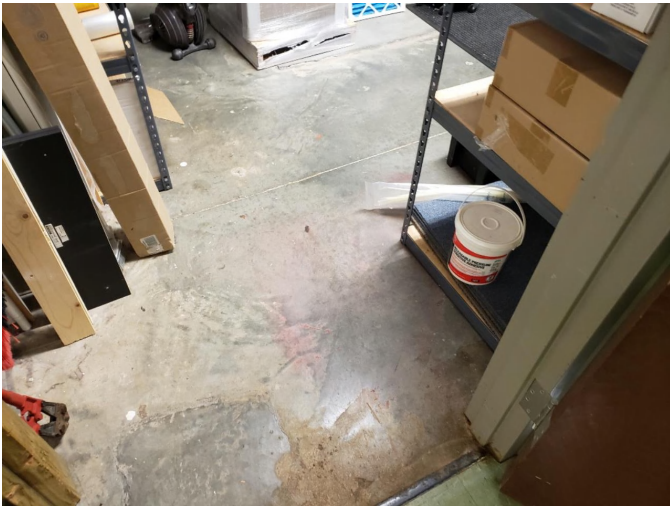
System: C3020999 - Other - Concrete Finish w/Sealer

Location: Throughout Building
Distress: Beyond Expected Life
Category: Deferred Maintenance
Priority: 3 - Necessary (Years 2-5)
Correction: Renew System
Qty: 4,500.00
Unit of Measure: S.F.
Estimate: \$34,007.00
Assessor Name: Hayden Collins
Date Created: 01/13/2020

Notes: The concrete finish is worn and should be resealed.

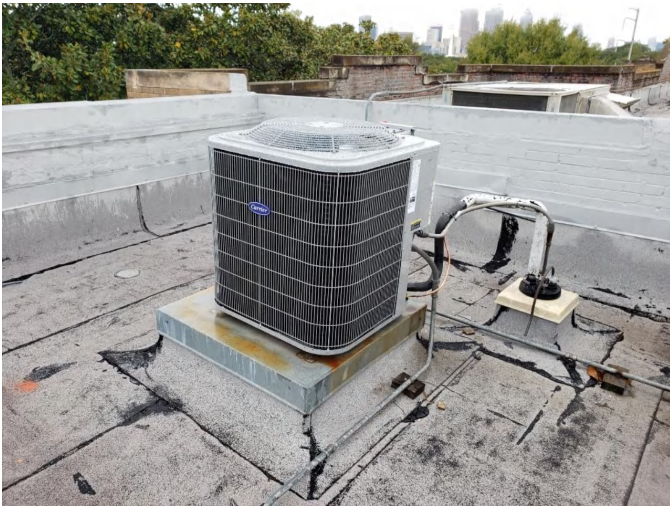
System: D3050 - Terminal & Package Units

Location: Rooftop and Exterior Elevation
Distress: Beyond Expected Life
Category: Deferred Maintenance
Priority: 3 - Necessary (Years 2-5)
Correction: Renew System
Qty: 47,320.00
Unit of Measure: S.F.
Estimate: \$806,285.00
Assessor Name: Hayden Collins
Date Created: 10/01/2019

Notes: The terminal and package units are at the end of their useful life. The system is functional however upgrades are warranted.

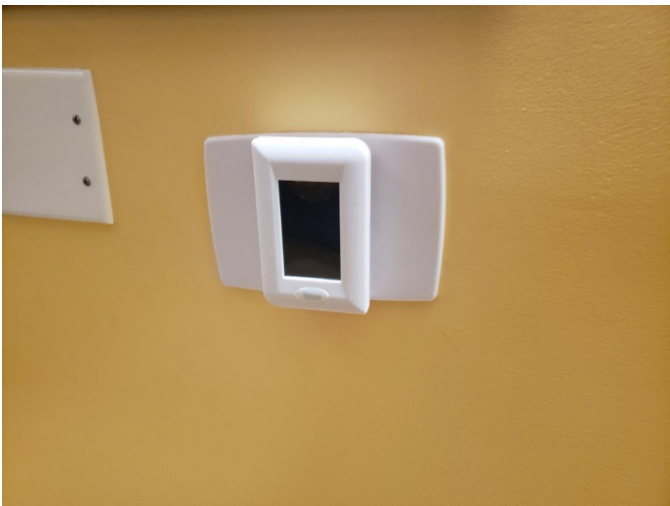
System: D3060 - Controls & Instrumentation

Location: Throughout Building
Distress: Beyond Expected Life
Category: Deferred Maintenance
Priority: 3 - Necessary (Years 2-5)
Correction: Renew System
Qty: 47,320.00
Unit of Measure: S.F.
Estimate: \$114,514.00
Assessor Name: Hayden Collins
Date Created: 10/01/2019

Notes: The Controls Instrumentation for the building automation systems are beyond its expected life.

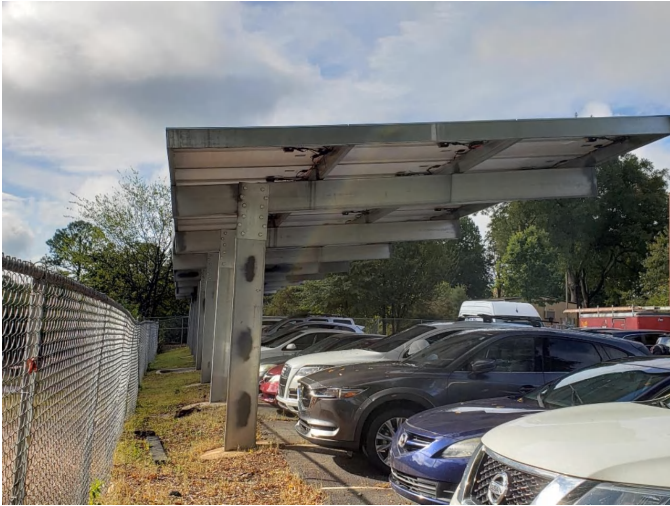
System: G2020 - Parking Lots

Location: Site
Distress: Beyond Expected Life
Category: Deferred Maintenance
Priority: 3 - Necessary (Years 2-5)
Correction: Renew System
Qty: 47,320.00
Unit of Measure: S.F.
Estimate: \$416,416.00
Assessor Name: Hayden Collins
Date Created: 02/22/2020

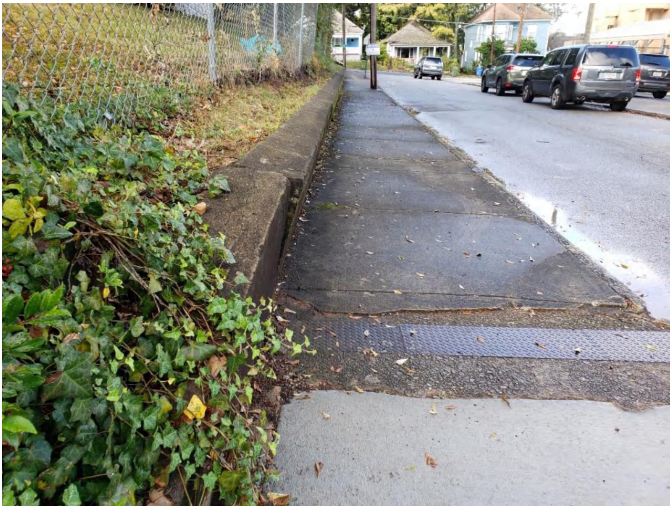
System: G2030 - Pedestrian Paving

Location: Site
Distress: Beyond Expected Life
Category: ADA Compliance
Priority: 3 - Necessary (Years 2-5)
Correction: Renew System
Qty: 47,320.00
Unit of Measure: S.F.
Estimate: \$121,281.00
Assessor Name: Jejuan Hall
Date Created: 02/22/2020

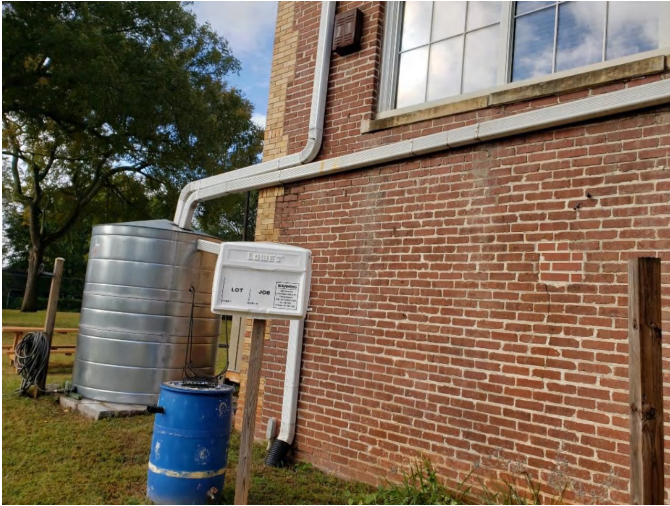
System: G3010 - Water Supply

Location: Site
Distress: Beyond Expected Life
Category: Deferred Maintenance
Priority: 3 - Necessary (Years 2-5)
Correction: Renew System
Qty: 47,320.00
Unit of Measure: S.F.
Estimate: \$56,737.00
Assessor Name: Hayden Collins
Date Created: 01/13/2020

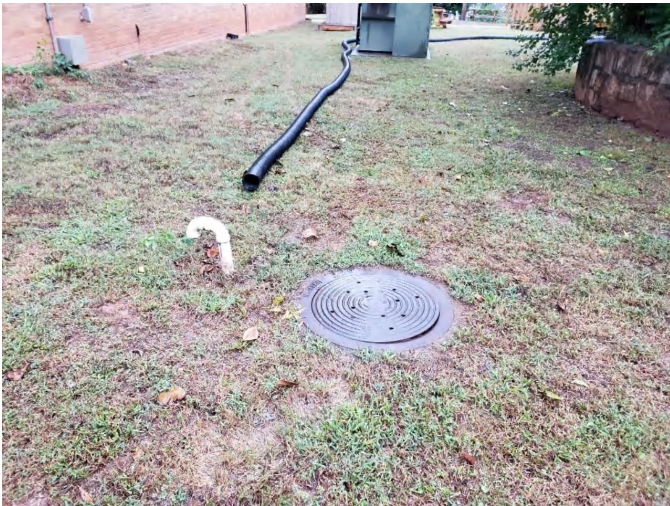
System: G3020 - Sanitary Sewer

Location: Site
Distress: Beyond Expected Life
Category: Deferred Maintenance
Priority: 3 - Necessary (Years 2-5)
Correction: Renew System
Qty: 47,320.00
Unit of Measure: S.F.
Estimate: \$114,514.00
Assessor Name: Hayden Collins
Date Created: 01/13/2020

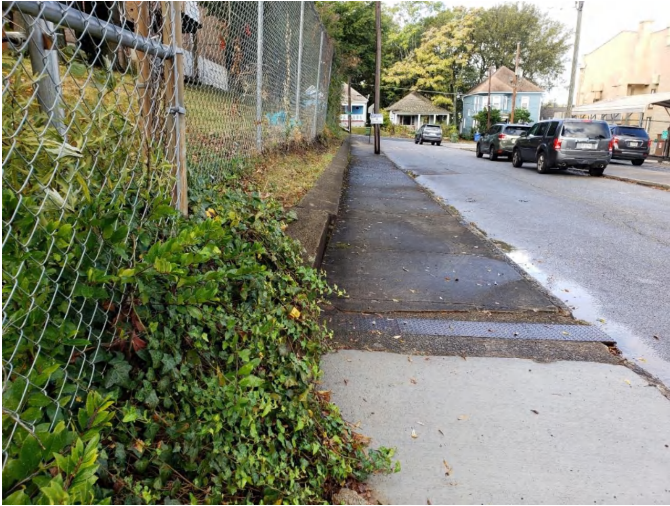
System: G3030 - Storm Sewer

Location: Site
Distress: Beyond Expected Life
Category: Deferred Maintenance
Priority: 3 - Necessary (Years 2-5)
Correction: Renew System
Qty: 47,320.00
Unit of Measure: S.F.
Estimate: \$65,065.00
Assessor Name: Hayden Collins
Date Created: 02/22/2020
