Atlanta Public Schools/ N. Atlanta Cluster

Smith, Sara Primary

School Assessment Report

November 10, 2020

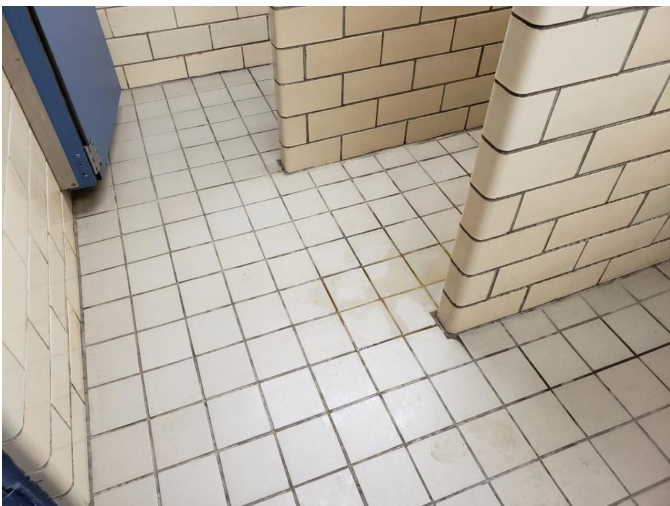
System: C3010220 - Tile

Location: Restrooms
Distress: Beyond Expected Life
Category: Deferred Maintenance
Priority: 3 - Necessary (Years 2-5)
Correction: Renew System
Qty: 2,000.00
Unit of Measure: S.F.
Estimate: \$27,750.00
Assessor Name: Homero Guerrero
Date Created: 01/27/2020

Notes: The Tile floor finish is beyond its expected service life, worn and damaged, and is recommended for replacement.

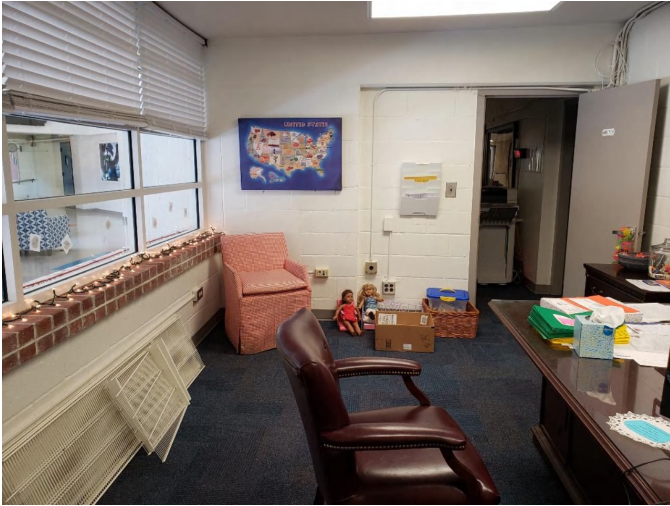
System: C3020901 - Carpet

Location: Office
Distress: Beyond Expected Life
Category: Deferred Maintenance
Priority: 3 - Necessary (Years 2-5)
Correction: Renew System
Qty: 3,000.00
Unit of Measure: S.F.
Estimate: \$37,257.00
Assessor Name: Homero Guerrero
Date Created: 01/27/2020

Notes: The carpet floor finish is beyond its expected service life, worn and damaged, and is recommended for replacement.

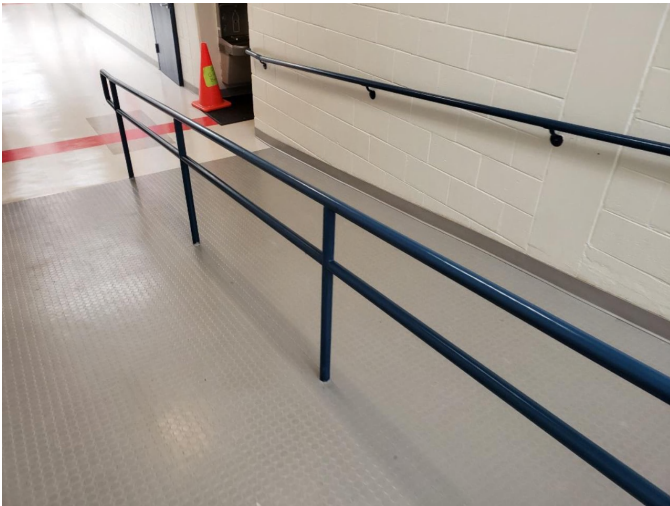
System: C3020999 - Other - Rubber or Neoprene

Location: Hall
Distress: Beyond Expected Life
Category: Deferred Maintenance
Priority: 3 - Necessary (Years 2-5)
Correction: Renew System
Qty: 2,000.00
Unit of Measure: S.F.
Estimate: \$58,674.00
Assessor Name: Homero Guerrero
Date Created: 01/27/2020

Notes: The Rubber or Neoprene floor finish is beyond its expected service life, worn and damaged, and is recommended for replacement.

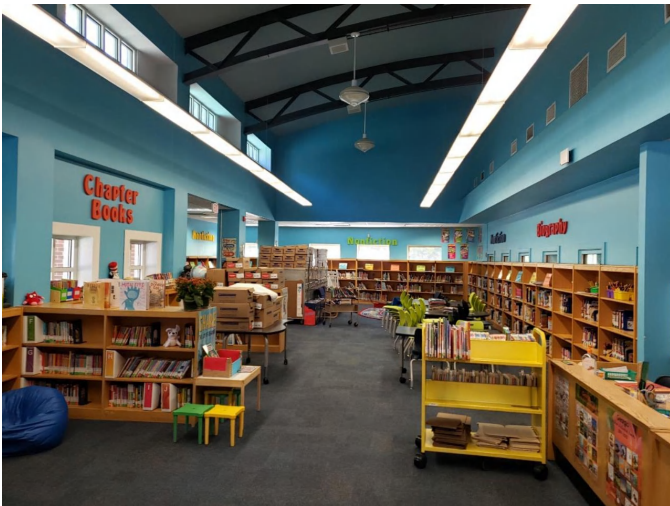
System: C3020901 - Carpet

Location: Media Center
Distress: Beyond Expected Life
Category: Deferred Maintenance
Priority: 3 - Necessary (Years 2-5)
Correction: Renew System
Qty: 2,000.00
Unit of Measure: S.F.
Estimate: \$16,500.00
Assessor Name: Hayden Collins
Date Created: 01/27/2020

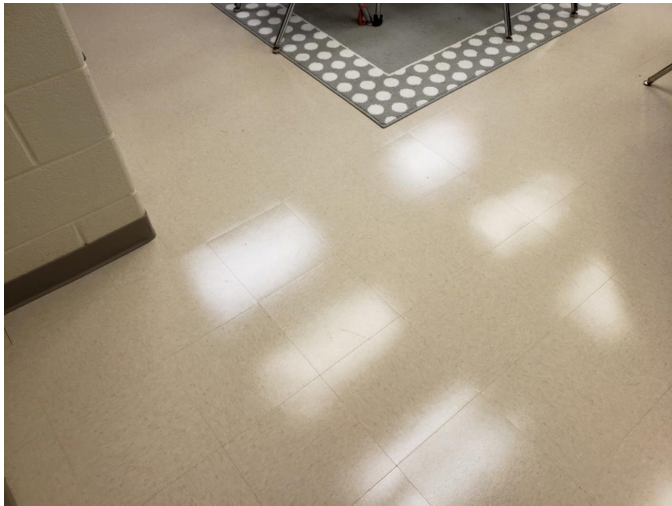
System: C3020903 - VCT

Location: Throughout Building
Distress: Beyond Expected Life
Category: Deferred Maintenance
Priority: 3 - Necessary (Years 2-5)
Correction: Renew System
Qty: 11,092.00
Unit of Measure: S.F.
Estimate: \$59,830.00
Assessor Name: Hayden Collins
Date Created: 01/27/2020

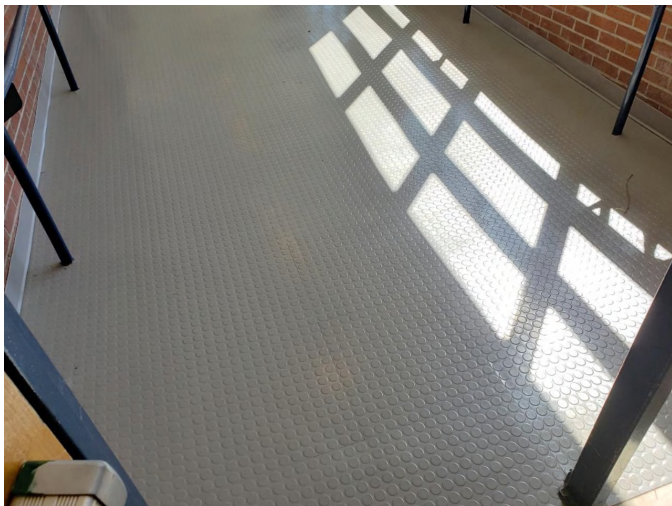
System: C3020999 - Other - Rubber or Neoprene

Location: Hall
Distress: Beyond Expected Life
Category: Deferred Maintenance
Priority: 3 - Necessary (Years 2-5)
Correction: Renew System
Qty: 2,000.00
Unit of Measure: S.F.
Estimate: \$58,674.00
Assessor Name: Hayden Collins
Date Created: 01/27/2020

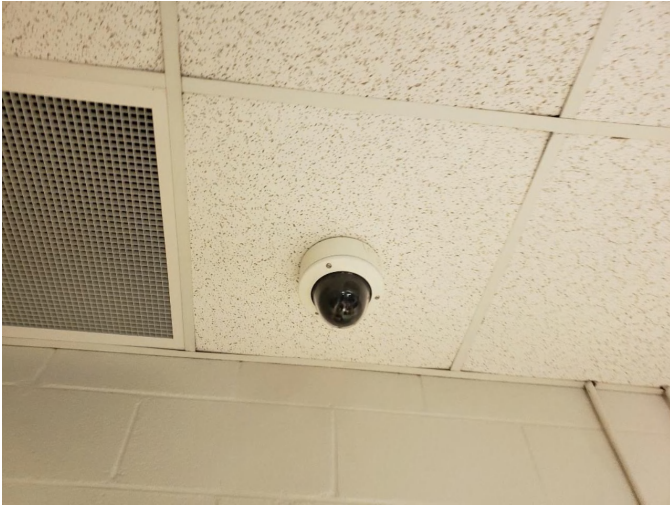
System: C3030 - Ceiling Finishes

Location: Throughout Building
Distress: Beyond Expected Life
Category: Deferred Maintenance
Priority: 3 - Necessary (Years 2-5)
Correction: Renew System
Qty: 16,092.00
Unit of Measure: S.F.
Estimate: \$161,966.00
Assessor Name: Hayden Collins
Date Created: 09/17/2015

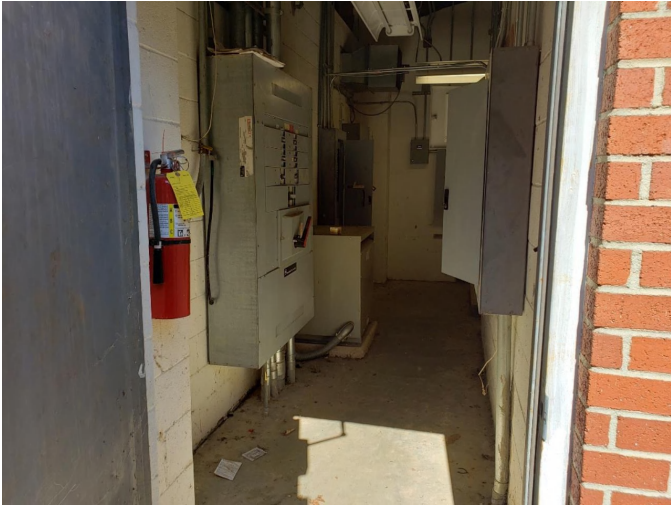
System: D5010 - Electrical Service/Distribution

Location: Roof
Distress: Beyond Expected Life
Category: Deferred Maintenance
Priority: 3 - Necessary (Years 2-5)
Correction: Renew System
Qty: 16,092.00
Unit of Measure: S.F.
Estimate: \$41,421.00
Assessor Name: Hayden Collins
Date Created: 08/13/2014

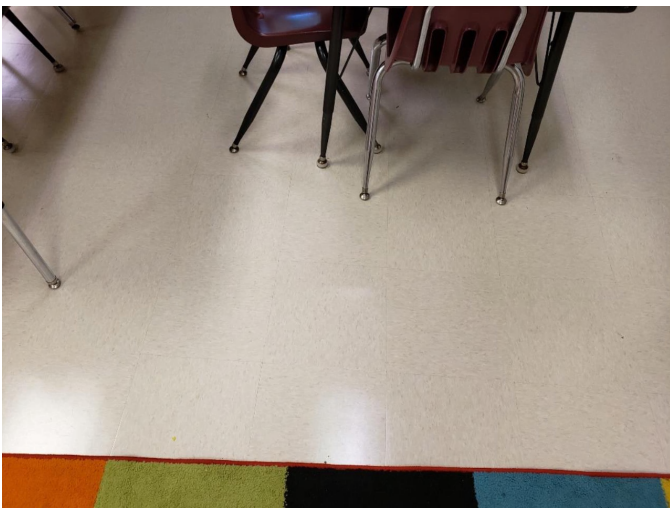
System: C3020903 - VCT

Location: Throughout Building
Distress: Beyond Expected Life
Category: Deferred Maintenance
Priority: 3 - Necessary (Years 2-5)
Correction: Renew System
Qty: 7,733.00
Unit of Measure: S.F.
Estimate: \$41,712.00
Assessor Name: Homero Guerrero
Date Created: 01/27/2020

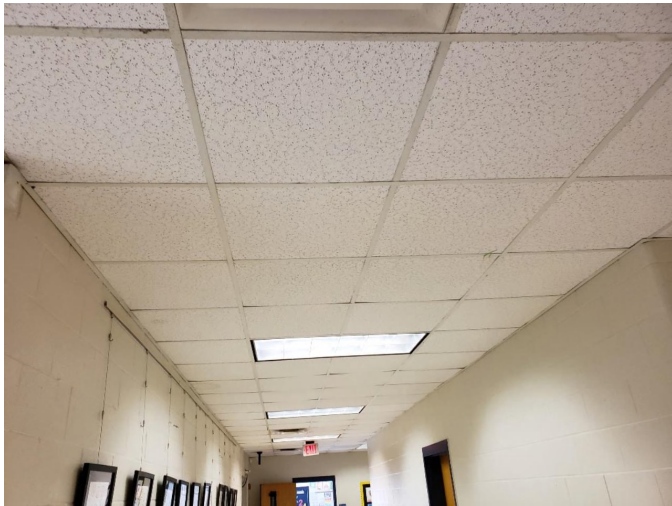
System: C3030 - Ceiling Finishes

Location: Throughout Building
Distress: Beyond Expected Life
Category: Deferred Maintenance
Priority: 3 - Necessary (Years 2-5)
Correction: Renew System
Qty: 11,733.00
Unit of Measure: S.F.
Estimate: \$136,549.00
Assessor Name: Homero Guerrero
Date Created: 10/01/2019

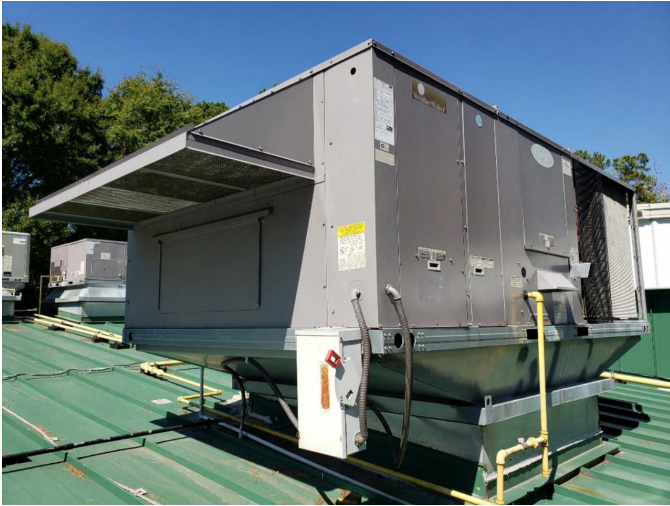
System: D3020 - Heat Generating Systems

Location: Throughout Building
Distress: Beyond Expected Life
Category: Deferred Maintenance
Priority: 3 - Necessary (Years 2-5)
Correction: Renew System
Qty: 11,733.00
Unit of Measure: S.F.
Estimate: \$54,465.00
Assessor Name: Homero Guerrero
Date Created: 01/27/2020

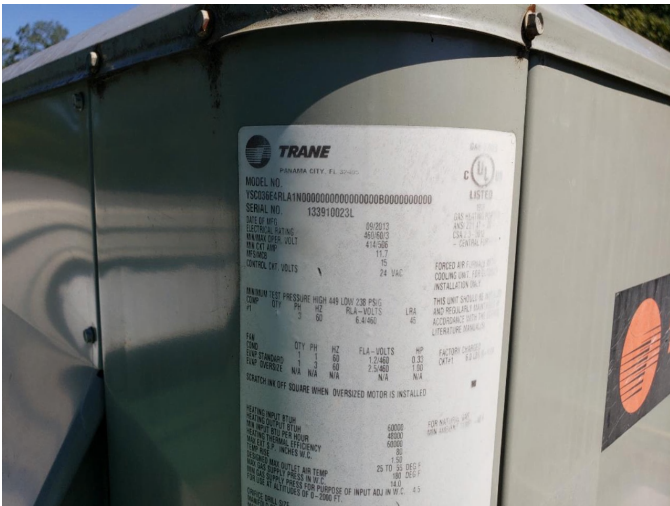
System: D3030 - Cooling Generating Systems

Location: Roof
Distress: Beyond Expected Life
Category: Deferred Maintenance
Priority: 3 - Necessary (Years 2-5)
Correction: Renew System
Qty: 11,733.00
Unit of Measure: S.F.
Estimate: \$92,796.00
Assessor Name: Homero Guerrero
Date Created: 01/27/2020

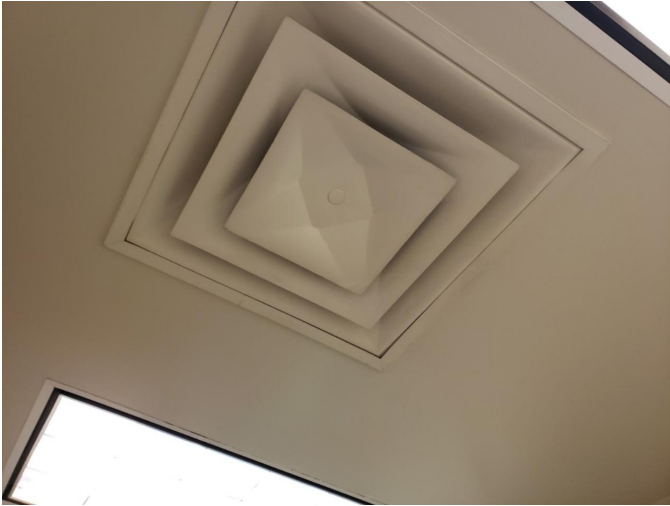
System: D3040 - Distribution Systems

Location: Throughout Building
Distress: Beyond Expected Life
Category: Deferred Maintenance
Priority: 3 - Necessary (Years 2-5)
Correction: Renew System
Qty: 11,733.00
Unit of Measure: S.F.
Estimate: \$161,458.00
Assessor Name: Homero Guerrero
Date Created: 10/01/2019

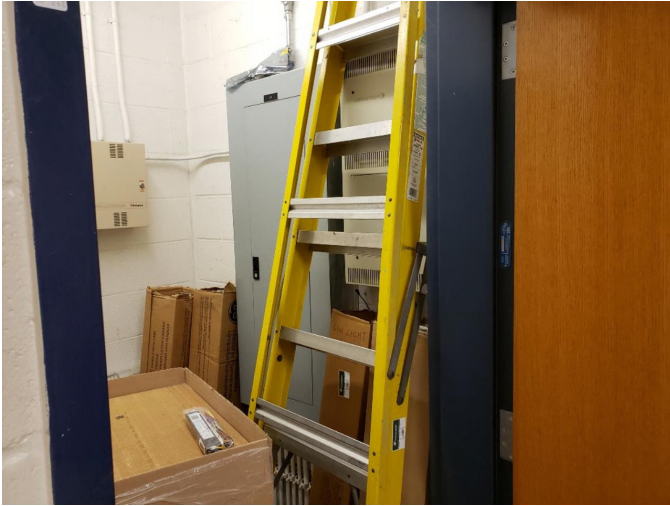
System: D5020 - Branch Wiring

Location: Electrical Room
Distress: Beyond Expected Life
Category: Deferred Maintenance
Priority: 3 - Necessary (Years 2-5)
Correction: Renew System
Qty: 11,733.00
Unit of Measure: S.F.
Estimate: \$68,274.00
Assessor Name: Homero Guerrero
Date Created: 10/01/2019

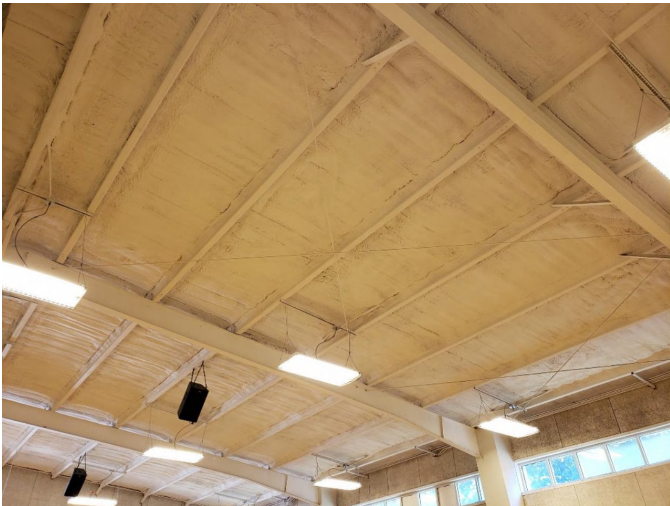
System: D5020 - Lighting

Location: Throughout Building
Distress: Beyond Expected Life
Category: Deferred Maintenance
Priority: 3 - Necessary (Years 2-5)
Correction: Renew System
Qty: 11,733.00
Unit of Measure: S.F.
Estimate: \$102,476.00
Assessor Name: Homero Guerrero
Date Created: 10/31/2019
