Atlanta Public Schools/ Grady Cluster

# Springdale Park Elementary School

## School Assessment Report

November 10, 2020

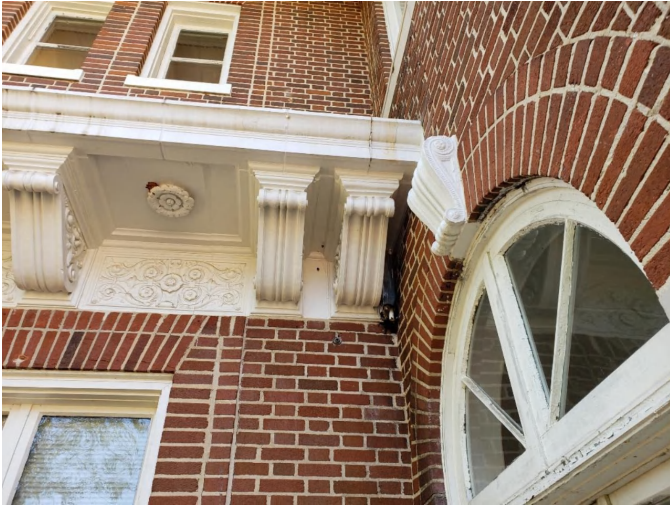
#### System: B2020 - Exterior Windows

**Location:** Exterior Walls  
**Distress:** Beyond Expected Life  
**Category:** Deferred Maintenance  
**Priority:** 2 - Trending Critical (Year 1)  
**Correction:** Renew System  
**Qty:** 7,746.00  
**Unit of Measure:** S.F.  
**Estimate:** \$71,999.00  
**Assessor Name:** Homero Guerrero  
**Date Created:** 02/03/2020

**Notes:** The wood frame are in deteriorating conditions and should be restored.

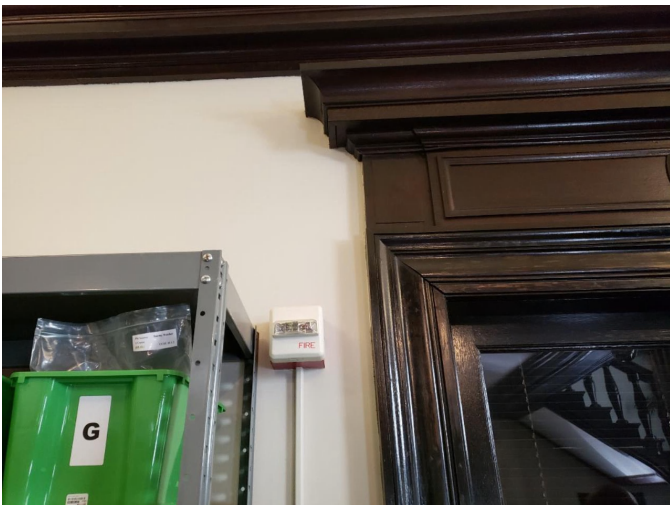
#### System: C3010902 - Wood Paneling

**Location:** Throughout Building  
**Distress:** Beyond Expected Life  
**Category:** Deferred Maintenance  
**Priority:** 3 - Necessary (Years 2-5)  
**Correction:** Renew System  
**Qty:** 2,323.00  
**Unit of Measure:** S.F.  
**Estimate:** \$19,184.00  
**Assessor Name:** Homero Guerrero  
**Date Created:** 02/20/2020

**Notes:** The wood panel wall finish has exceeded its expected life cycle and is recommended for upgrade.

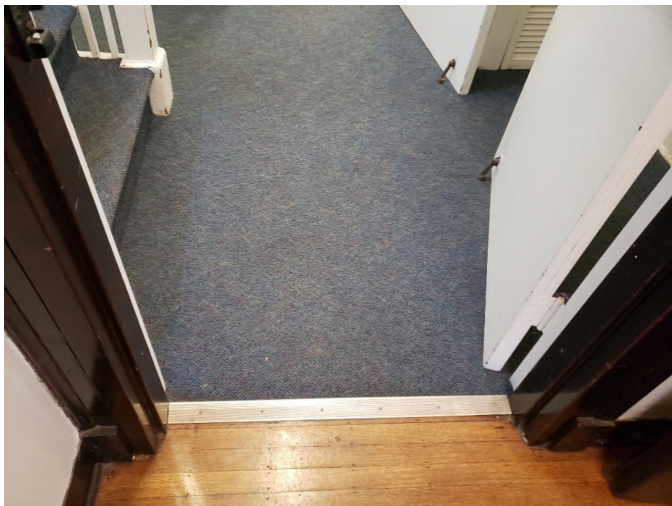
**System: C3020901 - Carpet**

**Location:** Throughout Building  
**Distress:** Beyond Expected Life  
**Category:** Deferred Maintenance  
**Priority:** 3 - Necessary (Years 2-5)  
**Correction:** Renew System  
**Qty:** 4,535.00  
**Unit of Measure:** S.F.  
**Estimate:** \$37,414.00  
**Assessor Name:** Homero Guerrero  
**Date Created:** 02/05/2020

**Notes:** The carpet is showing signs of early failure and should be replaced.

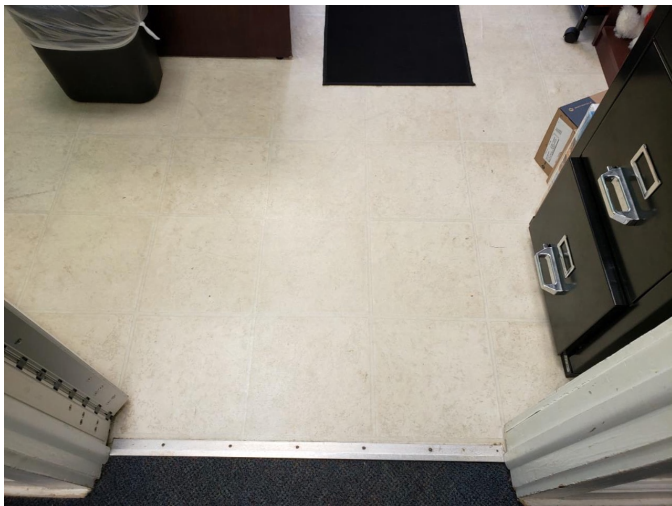
**System: C3020903 - VCT**

**Location:** Throughout Building  
**Distress:** Beyond Expected Life  
**Category:** Deferred Maintenance  
**Priority:** 3 - Necessary (Years 2-5)  
**Correction:** Renew System  
**Qty:** 1,865.00  
**Unit of Measure:** S.F.  
**Estimate:** \$10,060.00  
**Assessor Name:** Homero Guerrero  
**Date Created:** 02/05/2020

**Notes:** The VCT flooring is in poor conditions, with different areas separating from the substrate, and should be replaced.

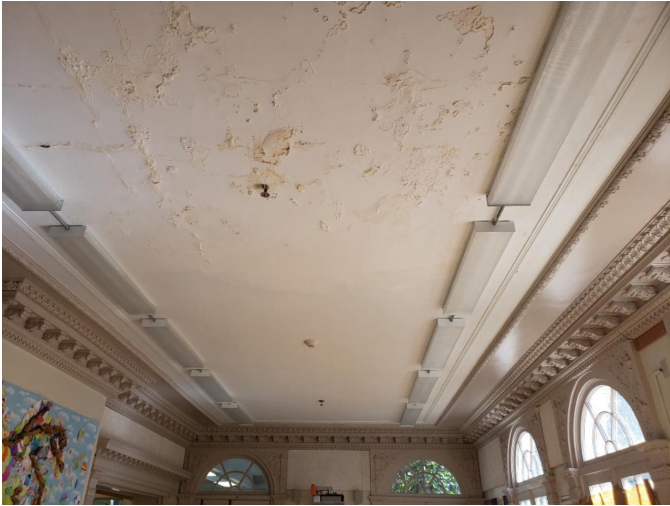
#### System: C3030 - Ceiling Finishes

**Location:** Music Suite H103  
**Distress:** Damaged  
**Category:** Appearance  
**Priority:** 1 - Critical Immediate Need  
**Correction:** Refinish plaster ceiling  
**Qty:** 200.00  
**Unit of Measure:** S.Y.  
**Estimate:** \$4,898.33  
**Assessor Name:** Homero Guerrero  
**Date Created:** 02/14/2020

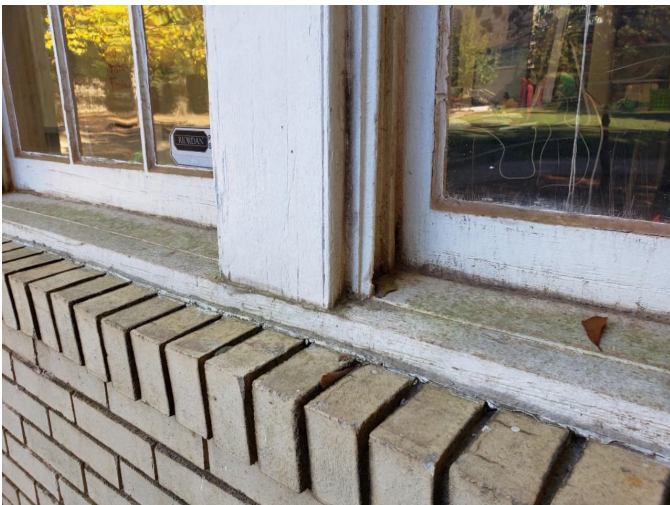
#### System: B2020 - Exterior Windows

**Location:** Exterior Walls  
**Distress:** Beyond Expected Life  
**Category:** Deferred Maintenance  
**Priority:** 2 - Trending Critical (Year 1)  
**Correction:** Renew System  
**Qty:** 5,487.00  
**Unit of Measure:** S.F.  
**Estimate:** \$52,692.00  
**Assessor Name:** Homero Guerrero  
**Date Created:** 08/20/2013

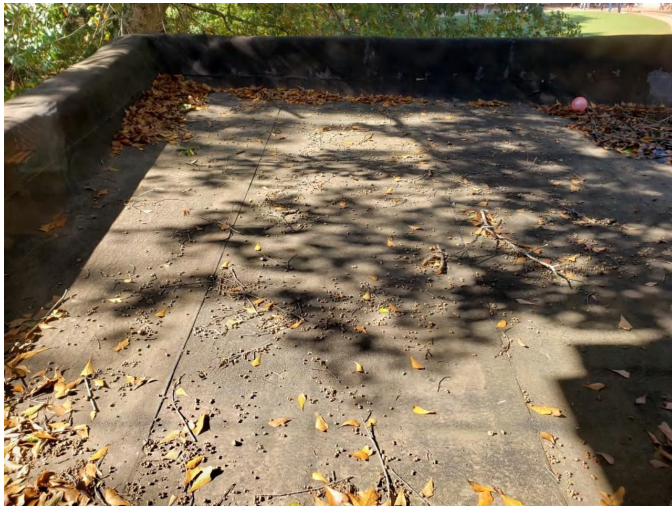
**System: B3010105 - Built-Up**

**Location:** Roof  
**Distress:** Beyond Expected Life  
**Category:** Deferred Maintenance  
**Priority:** 3 - Necessary (Years 2-5)  
**Correction:** Renew System  
**Qty:** 683.00  
**Unit of Measure:** S.F.  
**Estimate:** \$7,667.00  
**Assessor Name:** Homero Guerrero  
**Date Created:** 02/14/2020

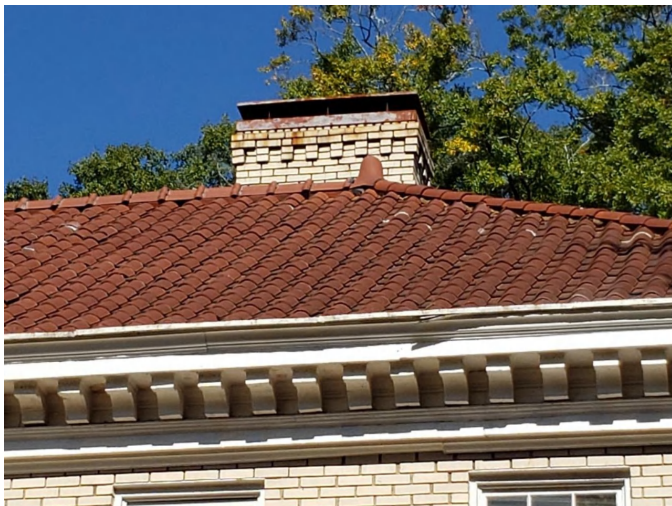
**System: B3010140 - Clay Tile**

**Location:** Roof  
**Distress:** Beyond Expected Life  
**Category:** Deferred Maintenance  
**Priority:** 3 - Necessary (Years 2-5)  
**Correction:** Renew System  
**Qty:** 3,648.00  
**Unit of Measure:** S.F.  
**Estimate:** \$20,519.00  
**Assessor Name:** Homero Guerrero  
**Date Created:** 02/20/2020

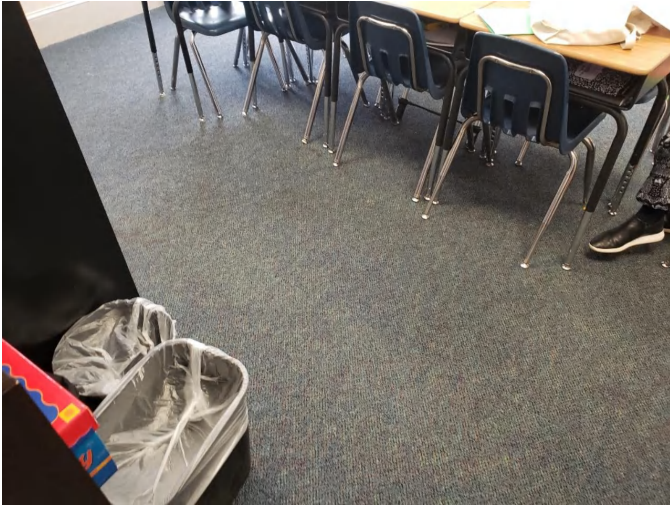
**System: C3020901 - Carpet**

**Location:** Throughout Building  
**Distress:** Beyond Expected Life  
**Category:** Deferred Maintenance  
**Priority:** 3 - Necessary (Years 2-5)  
**Correction:** Renew System  
**Qty:** 1,950.00  
**Unit of Measure:** S.F.  
**Estimate:** \$16,088.00  
**Assessor Name:** Homero Guerrero  
**Date Created:** 01/30/2020

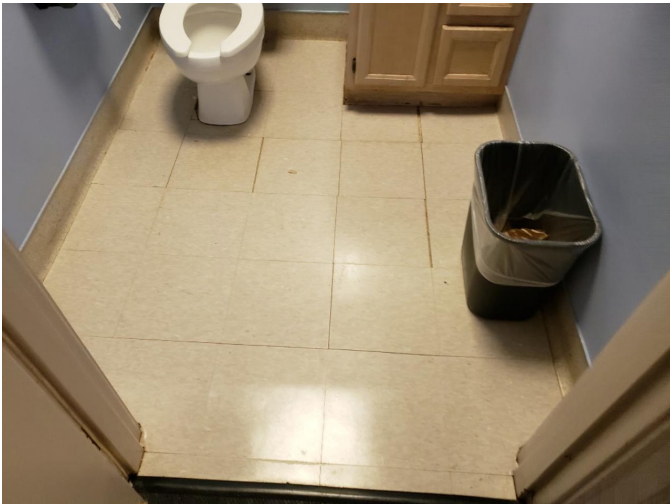
**System: C3020903 - VCT**

**Location:** Throughout Building  
**Distress:** Beyond Expected Life  
**Category:** Deferred Maintenance  
**Priority:** 3 - Necessary (Years 2-5)  
**Correction:** Renew System  
**Qty:** 1,747.00  
**Unit of Measure:** S.F.  
**Estimate:** \$9,423.00  
**Assessor Name:** Homero Guerrero  
**Date Created:** 01/30/2020
