Atlanta Public Schools/ Douglass Cluster

# Stanton, F. L. Elementary School

## School Assessment Report

November 10, 2020

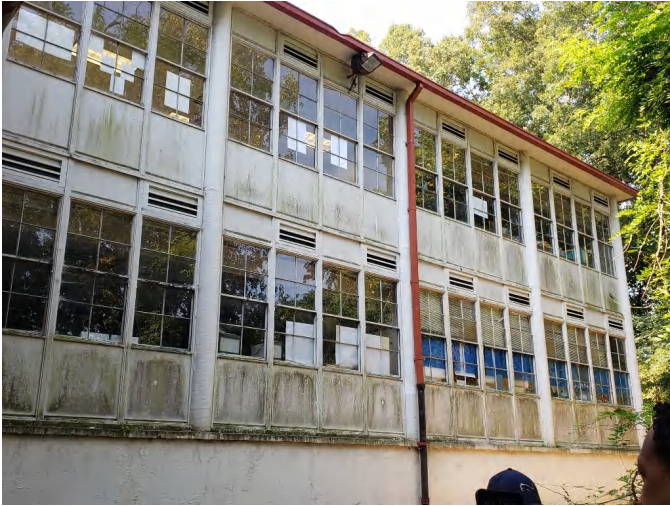
#### System: B2020 - Exterior Windows (1)

**Location:** Exterior Walls  
**Distress:** Beyond Expected Life  
**Category:** Deferred Maintenance  
**Priority:** 2 - Trending Critical (Year 1)  
**Correction:** Renew System  
**Qty:** 41,559.00  
**Unit of Measure:** S.F.  
**Estimate:** \$200,688.00  
**Assessor Name:** Eduardo Lopez  
**Date Created:** 10/06/2020

**Notes:** The exterior windows in the rear side are in poor condition, not energy efficient, beyond its expected service life and should be scheduled for replacement.

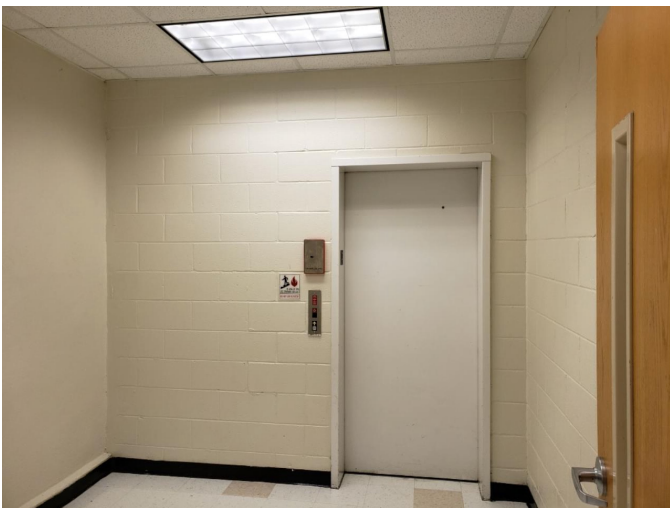
**Location:** Elevator  
**Distress:** Non Compliant  
**Category:** Code Compliance  
**Priority:** 2 - Trending Critical (Year 1)  
**Correction:** Upgrade elevator cab and controls to meet code  
**Qty:** 1.00  
**Unit of Measure:** Ea.  
**Estimate:** \$14,614.48  
**Assessor Name:** Eduardo Lopez  
**Date Created:** 01/26/2020

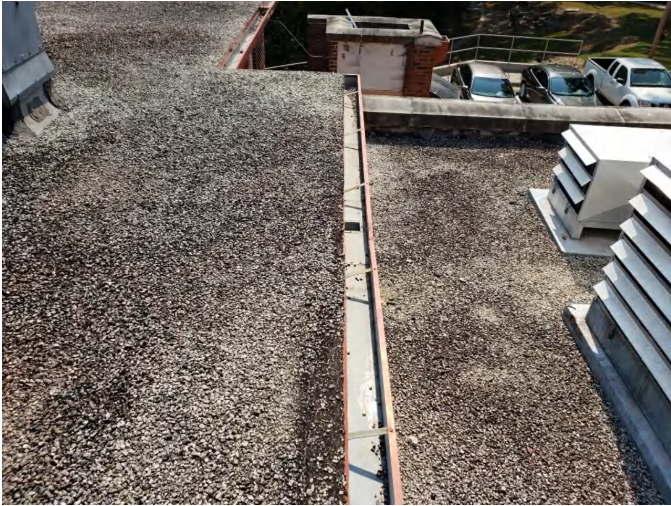
**Location:** Roof  
**Distress:** Beyond Expected Life  
**Category:** Deferred Maintenance  
**Priority:** 3 - Necessary (Years 2-5)  
**Correction:** Renew System  
**Qty:** 20,770.00  
**Unit of Measure:** S.F.  
**Estimate:** \$233,154.00  
**Assessor Name:** Eduardo Lopez  
**Date Created:** 01/26/2020

**Notes:** The built-up roof covering is in deteriorating conditions, beyond its expected life and should be scheduled for replacement.

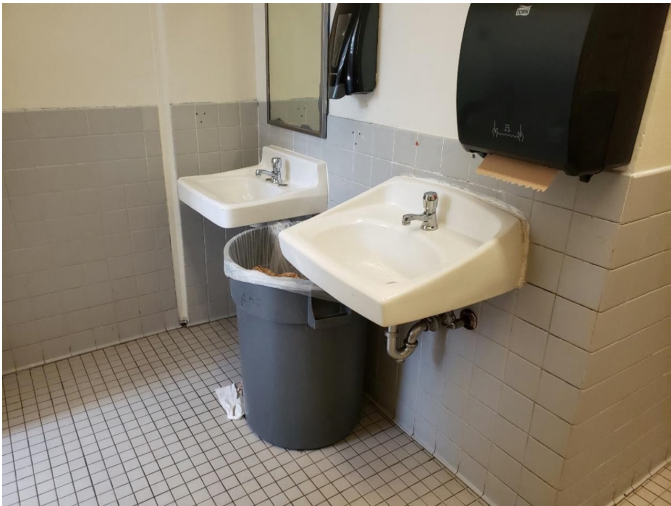
**System: C3010220 - Tile**

**Location:** Throughout Building  
**Distress:** Beyond Expected Life  
**Category:** Deferred Maintenance  
**Priority:** 3 - Necessary (Years 2-5)  
**Correction:** Renew System  
**Qty:** 3,470.00  
**Unit of Measure:** S.F.  
**Estimate:** \$48,146.00  
**Assessor Name:** Eduardo Lopez  
**Date Created:** 10/06/2020

**Notes:** The tile system is beyond its expected service life and should be scheduled for replacement.

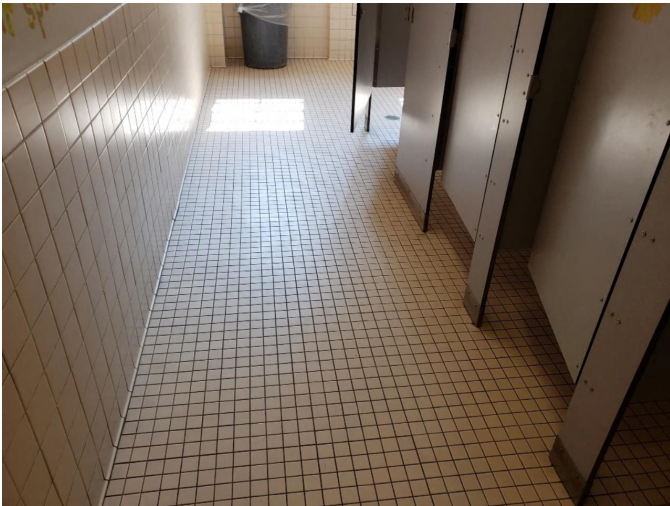
**Location:** Throughout Building  
**Distress:** Beyond Expected Life  
**Category:** Deferred Maintenance  
**Priority:** 3 - Necessary (Years 2-5)  
**Correction:** Renew System  
**Qty:** 3,470.00  
**Unit of Measure:** S.F.  
**Estimate:** \$87,080.00  
**Assessor Name:** Eduardo Lopez  
**Date Created:** 10/06/2020

**Notes:** The ceramic tile is beyond its expected service life and should be scheduled for replacement.

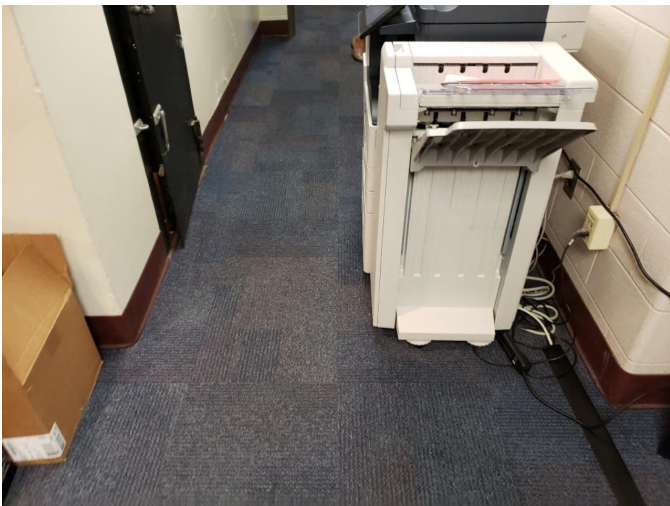
**Location:** Throughout Building  
**Distress:** Beyond Expected Life  
**Category:** Deferred Maintenance  
**Priority:** 3 - Necessary (Years 2-5)  
**Correction:** Renew System  
**Qty:** 1,551.00  
**Unit of Measure:** S.F.  
**Estimate:** \$12,796.00  
**Assessor Name:** Eduardo Lopez  
**Date Created:** 01/24/2020

**Notes:** The carpet is showing signs of early failure and should be replaced.

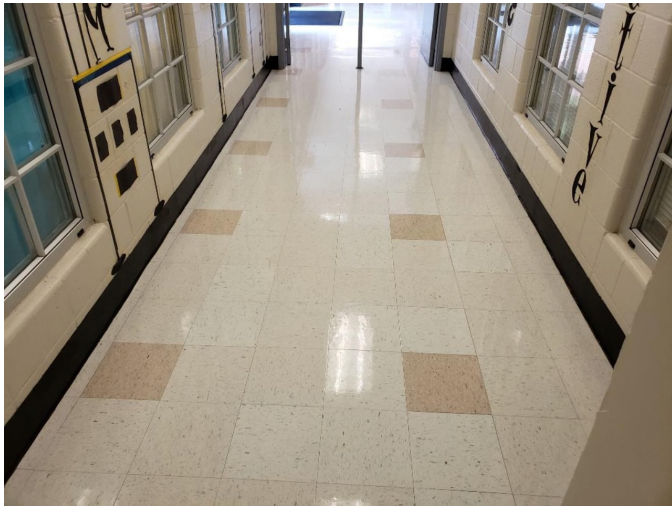
**Location:** Throughout Building  
**Distress:** Beyond Expected Life  
**Category:** Deferred Maintenance  
**Priority:** 3 - Necessary (Years 2-5)  
**Correction:** Renew System  
**Qty:** 33,343.00  
**Unit of Measure:** S.F.  
**Estimate:** \$179,852.00  
**Assessor Name:** Eduardo Lopez  
**Date Created:** 01/24/2020

**Notes:** The VCT flooring is in poor conditions, with different areas separating from the substrate, and should be replaced.

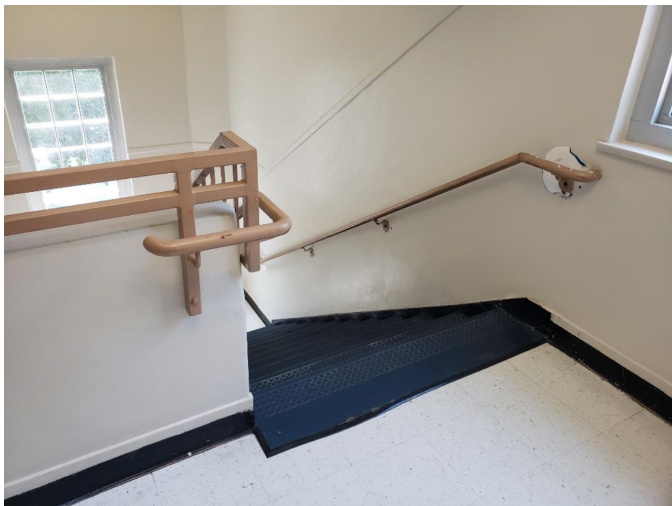
**Location:** Throughout Building  
**Distress:** Beyond Expected Life  
**Category:** Deferred Maintenance  
**Priority:** 3 - Necessary (Years 2-5)  
**Correction:** Renew System  
**Qty:** 707.00  
**Unit of Measure:** S.F.  
**Estimate:** \$20,741.00  
**Assessor Name:** Eduardo Lopez  
**Date Created:** 01/24/2020

**Notes:** The rubber flooring system is beyond its expected service life and should be scheduled for replacement.

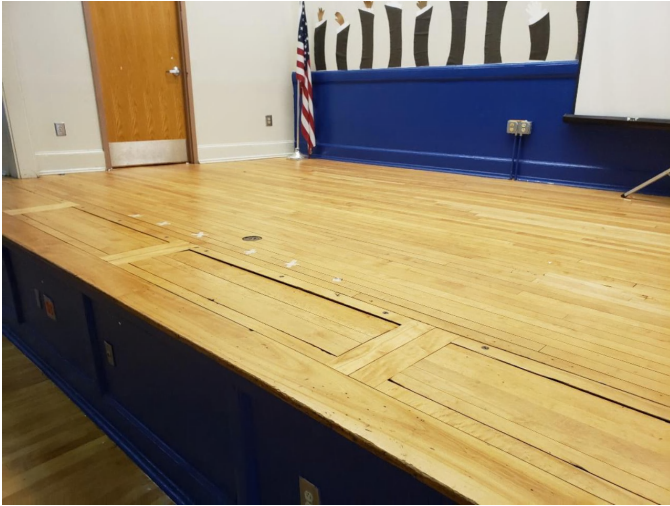
**Location:** Throughout Building  
**Distress:** Beyond Expected Life  
**Category:** Deferred Maintenance  
**Priority:** 3 - Necessary (Years 2-5)  
**Correction:** Renew System  
**Qty:** 2,488.00  
**Unit of Measure:** S.F.  
**Estimate:** \$47,004.00  
**Assessor Name:** Eduardo Lopez  
**Date Created:** 01/24/2020

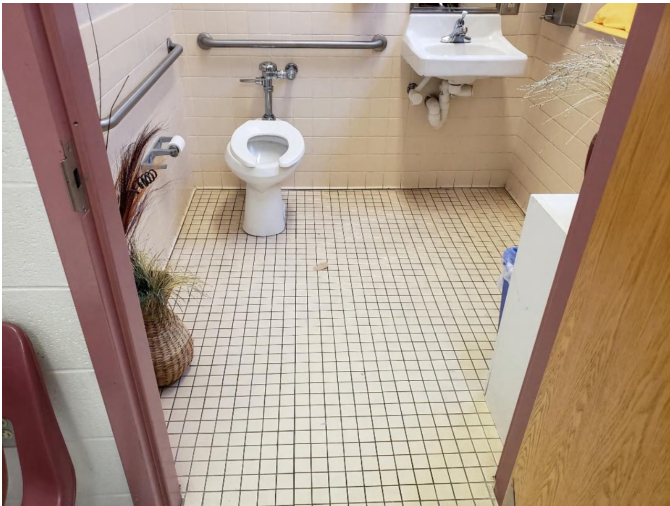
**Location:** Throughout Building  
**Distress:** Beyond Expected Life  
**Category:** Deferred Maintenance  
**Priority:** 3 - Necessary (Years 2-5)  
**Correction:** Renew System  
**Qty:** 41,559.00  
**Unit of Measure:** S.F.  
**Estimate:** \$296,690.00  
**Assessor Name:** Eduardo Lopez  
**Date Created:** 10/06/2020

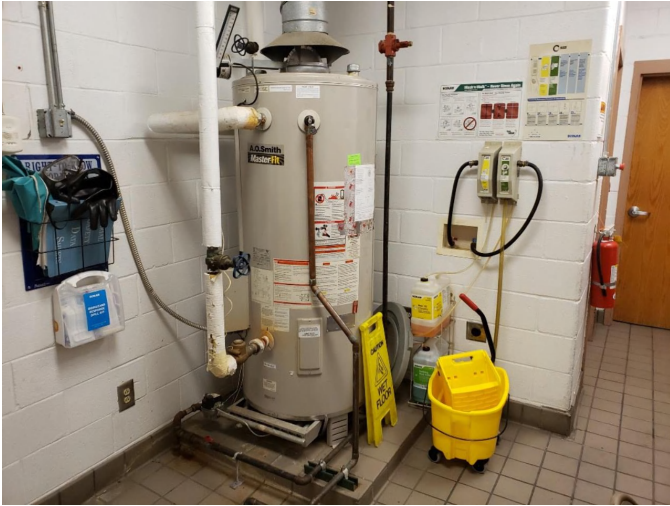
**Location:** Throughout Building  
**Distress:** Beyond Expected Life  
**Category:** Deferred Maintenance  
**Priority:** 3 - Necessary (Years 2-5)  
**Correction:** Renew System  
**Qty:** 41,559.00  
**Unit of Measure:** S.F.  
**Estimate:** \$34,286.00  
**Assessor Name:** Eduardo Lopez  
**Date Created:** 10/06/2020

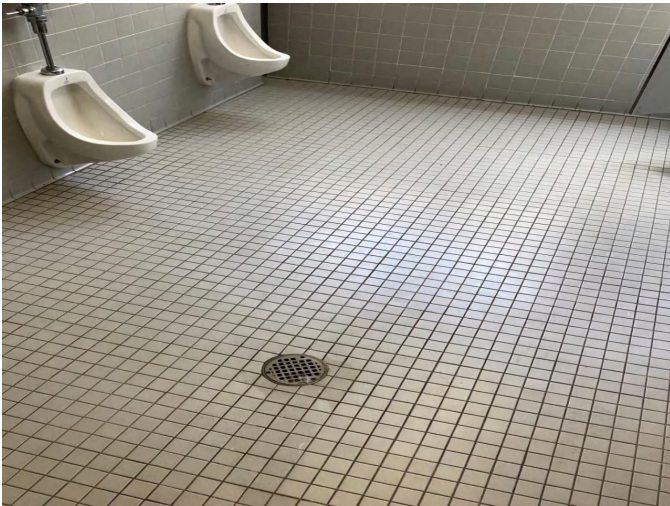
**Location:** Throughout Building  
**Distress:** Beyond Expected Life  
**Category:** Deferred Maintenance  
**Priority:** 3 - Necessary (Years 2-5)  
**Correction:** Renew System  
**Qty:** 41,559.00  
**Unit of Measure:** S.F.  
**Estimate:** \$80,001.00  
**Assessor Name:** Eduardo Lopez  
**Date Created:** 08/27/2013

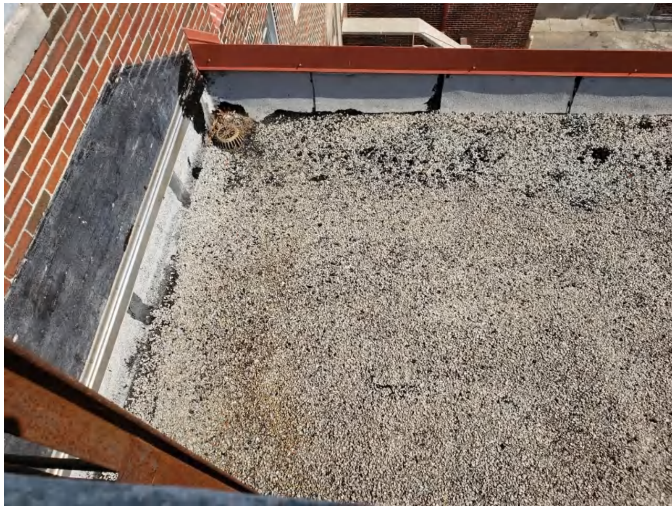
**Location:** Roof  
**Distress:** Beyond Expected Life  
**Category:** Deferred Maintenance  
**Priority:** 3 - Necessary (Years 2-5)  
**Correction:** Renew System  
**Qty:** 41,559.00  
**Unit of Measure:** S.F.  
**Estimate:** \$18,743.00  
**Assessor Name:** Eduardo Lopez  
**Date Created:** 10/06/2020

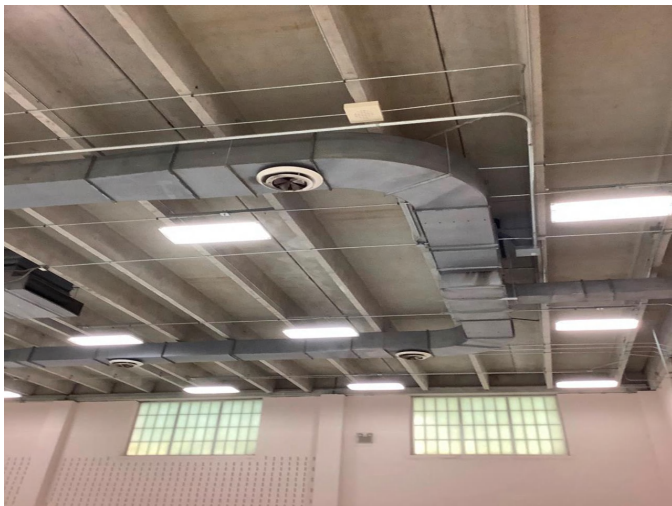
**Location:** Throughout Building  
**Distress:** Beyond Expected Life  
**Category:** Deferred Maintenance  
**Priority:** 3 - Necessary (Years 2-5)  
**Correction:** Renew System  
**Qty:** 41,559.00  
**Unit of Measure:** S.F.  
**Estimate:** \$456,235.00  
**Assessor Name:** Eduardo Lopez  
**Date Created:** 10/06/2020

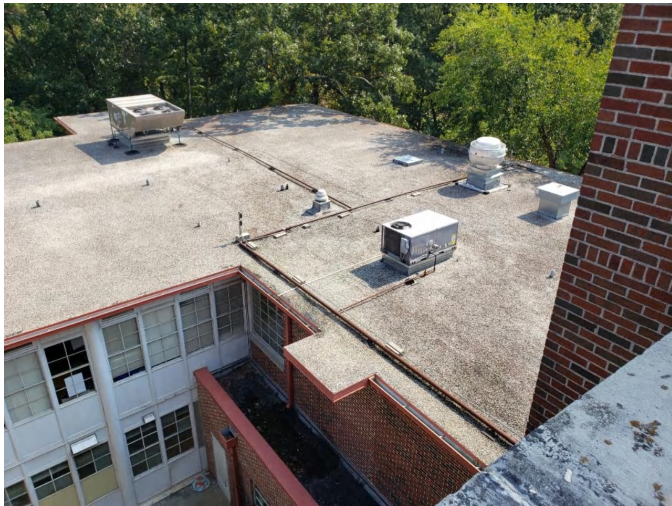
**Location:** Throughout Building  
**Distress:** Beyond Expected Life  
**Category:** Deferred Maintenance  
**Priority:** 3 - Necessary (Years 2-5)  
**Correction:** Renew System  
**Qty:** 41,559.00  
**Unit of Measure:** S.F.  
**Estimate:** \$600,237.00  
**Assessor Name:** Eduardo Lopez  
**Date Created:** 09/17/2015

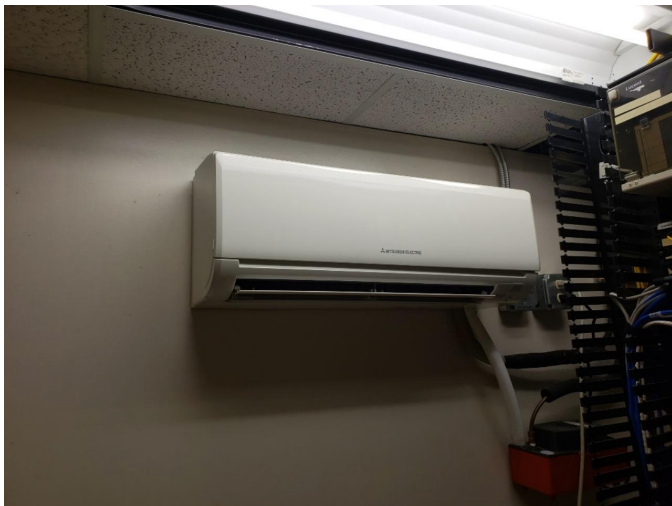
**Location:** Throughout Building  
**Distress:** Beyond Expected Life  
**Category:** Deferred Maintenance  
**Priority:** 3 - Necessary (Years 2-5)  
**Correction:** Renew System  
**Qty:** 41,559.00  
**Unit of Measure:** S.F.  
**Estimate:** \$103,316.00  
**Assessor Name:** Eduardo Lopez  
**Date Created:** 09/17/2015

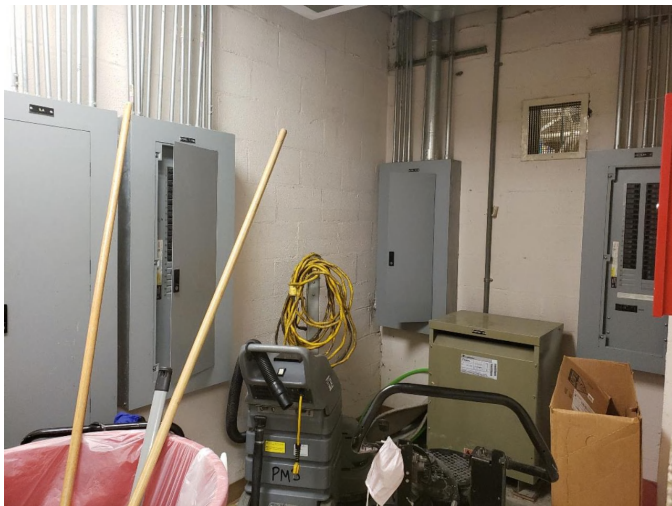
**Location:** Throughout Building  
**Distress:** Beyond Expected Life  
**Category:** Deferred Maintenance  
**Priority:** 3 - Necessary (Years 2-5)  
**Correction:** Renew System  
**Qty:** 41,559.00  
**Unit of Measure:** S.F.  
**Estimate:** \$208,003.00  
**Assessor Name:** Eduardo Lopez  
**Date Created:** 10/06/2020

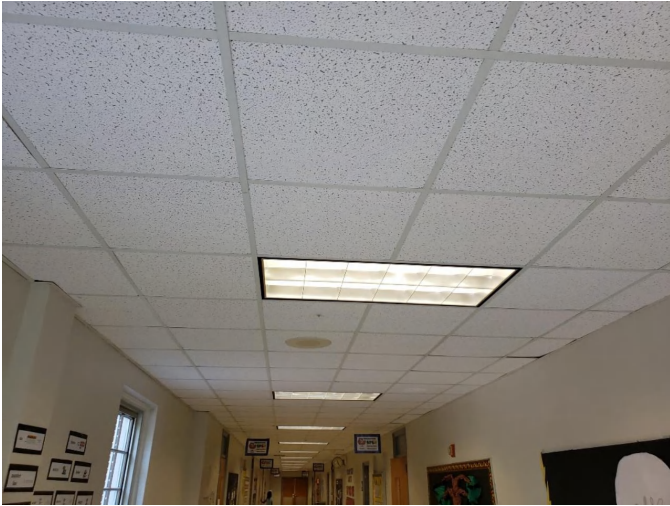
**Location:** Throughout Building  
**Distress:** Beyond Expected Life  
**Category:** Deferred Maintenance  
**Priority:** 3 - Necessary (Years 2-5)  
**Correction:** Renew System  
**Qty:** 41,559.00  
**Unit of Measure:** S.F.  
**Estimate:** \$312,233.00  
**Assessor Name:** Eduardo Lopez  
**Date Created:** 10/06/2020

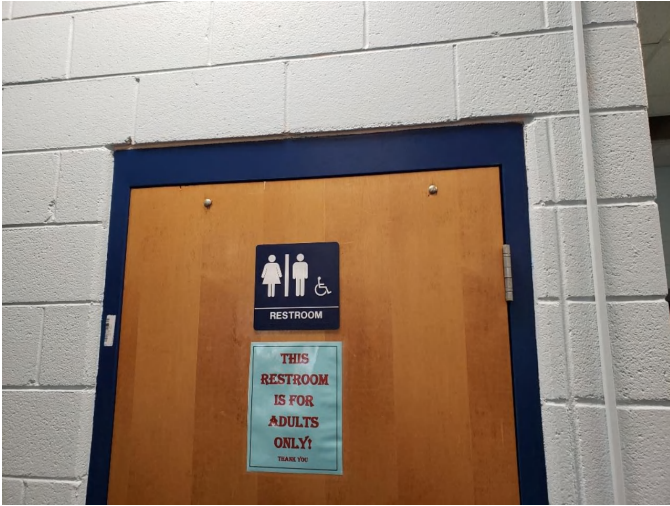
**Location:** Throughout Building  
**Distress:** Beyond Expected Life  
**Category:** ADA Compliance  
**Priority:** 2 - Trending Critical (Year 1)  
**Correction:** Renew System  
**Qty:** 2,897.00  
**Unit of Measure:** S.F.  
**Estimate:** \$8,955.00  
**Assessor Name:** Eduardo Lopez  
**Date Created:** 01/25/2020

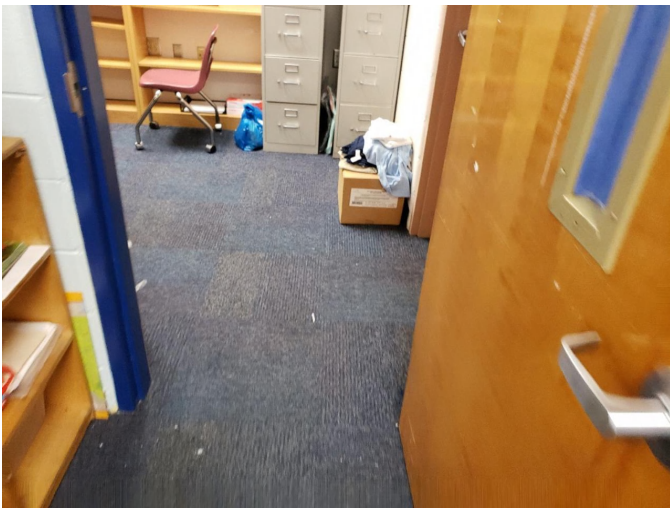
**Location:** Throughout Building  
**Distress:** Beyond Expected Life  
**Category:** Deferred Maintenance  
**Priority:** 3 - Necessary (Years 2-5)  
**Correction:** Renew System  
**Qty:** 2,484.00  
**Unit of Measure:** S.F.  
**Estimate:** \$20,493.00  
**Assessor Name:** Eduardo Lopez  
**Date Created:** 01/24/2020

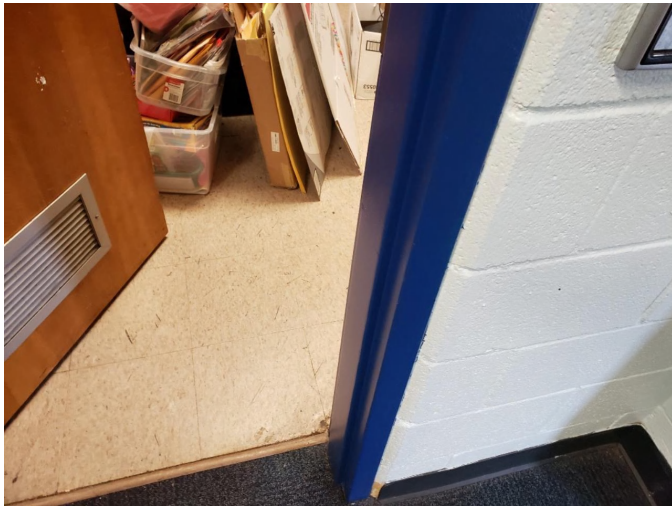
**Location:** Throughout Building  
**Distress:** Beyond Expected Life  
**Category:** Deferred Maintenance  
**Priority:** 3 - Necessary (Years 2-5)  
**Correction:** Renew System  
**Qty:** 413.00  
**Unit of Measure:** S.F.  
**Estimate:** \$2,228.00  
**Assessor Name:** Eduardo Lopez  
**Date Created:** 01/24/2020

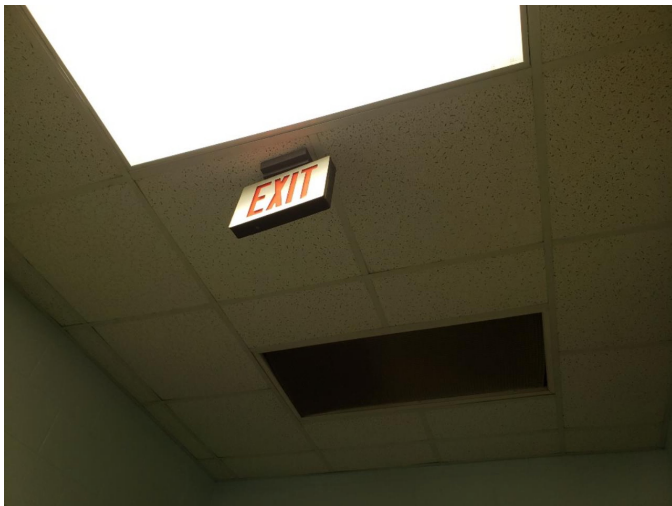
**Location:** Throughout Building  
**Distress:** Beyond Expected Life  
**Category:** Deferred Maintenance  
**Priority:** 3 - Necessary (Years 2-5)  
**Correction:** Renew System  
**Qty:** 2,897.00  
**Unit of Measure:** S.F.  
**Estimate:** \$30,401.00  
**Assessor Name:** Eduardo Lopez  
**Date Created:** 01/25/2020

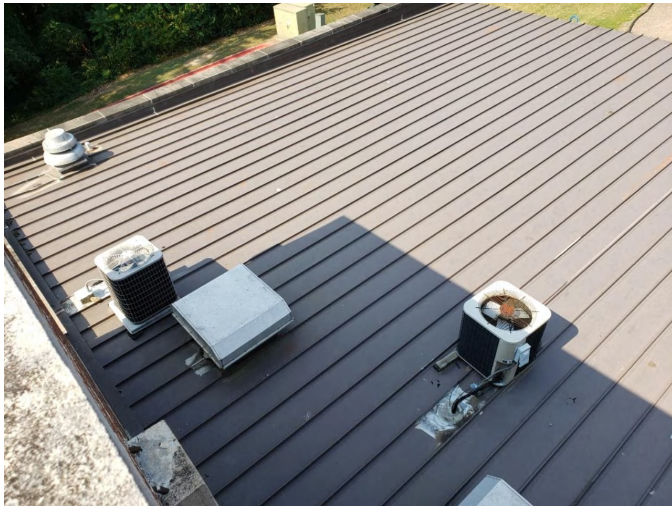
**Location:** Roof  
**Distress:** Beyond Expected Life  
**Category:** Deferred Maintenance  
**Priority:** 3 - Necessary (Years 2-5)  
**Correction:** Renew System  
**Qty:** 2,897.00  
**Unit of Measure:** S.F.  
**Estimate:** \$55,098.00  
**Assessor Name:** Eduardo Lopez  
**Date Created:** 09/17/2015

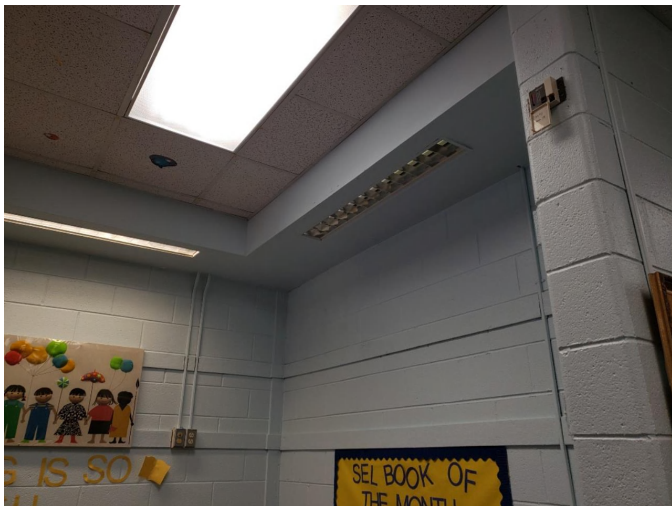
**Location:** Throughout Building  
**Distress:** Beyond Expected Life  
**Category:** Deferred Maintenance  
**Priority:** 3 - Necessary (Years 2-5)  
**Correction:** Renew System  
**Qty:** 2,897.00  
**Unit of Measure:** S.F.  
**Estimate:** \$7,457.00  
**Assessor Name:** Eduardo Lopez  
**Date Created:** 09/17/2015

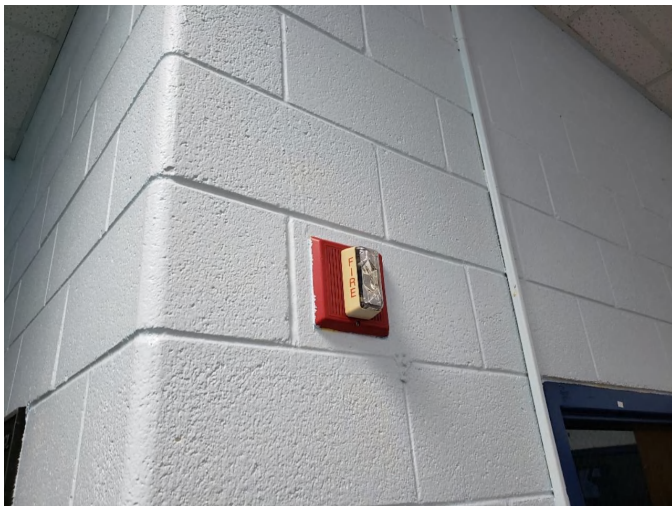
**Location:** Throughout Building  
**Distress:** Beyond Expected Life  
**Category:** Deferred Maintenance  
**Priority:** 3 - Necessary (Years 2-5)  
**Correction:** Renew System  
**Qty:** 2,897.00  
**Unit of Measure:** S.F.  
**Estimate:** \$8,732.00  
**Assessor Name:** Eduardo Lopez  
**Date Created:** 01/19/2020

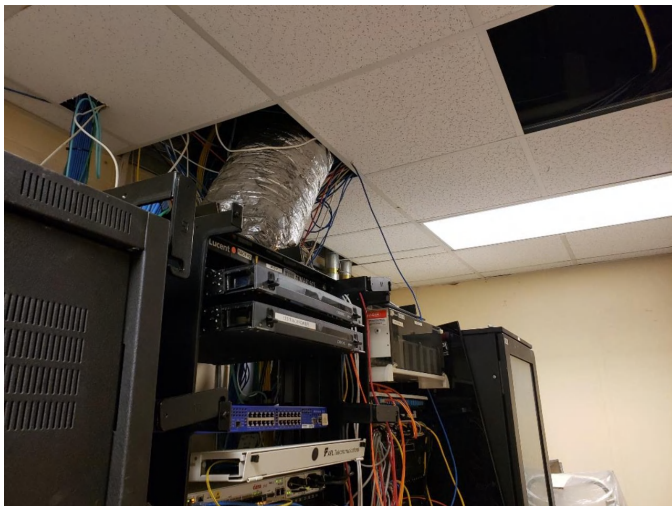
**Location:** Throughout Building  
**Distress:** Beyond Expected Life  
**Category:** Deferred Maintenance  
**Priority:** 3 - Necessary (Years 2-5)  
**Correction:** Renew System  
**Qty:** 2,897.00  
**Unit of Measure:** S.F.  
**Estimate:** \$11,345.00  
**Assessor Name:** Eduardo Lopez  
**Date Created:** 01/19/2020

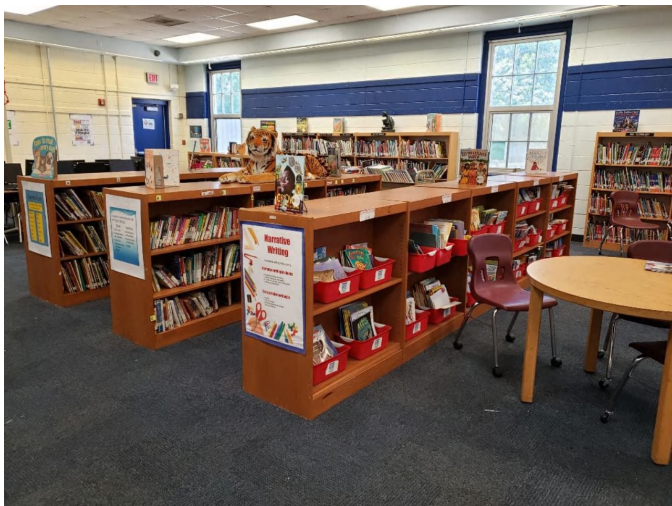
**Location:** Throughout Building  
**Distress:** Beyond Expected Life  
**Category:** Deferred Maintenance  
**Priority:** 3 - Necessary (Years 2-5)  
**Correction:** Renew System  
**Qty:** 2,897.00  
**Unit of Measure:** S.F.  
**Estimate:** \$3,187.00  
**Assessor Name:** Eduardo Lopez  
**Date Created:** 01/25/2020

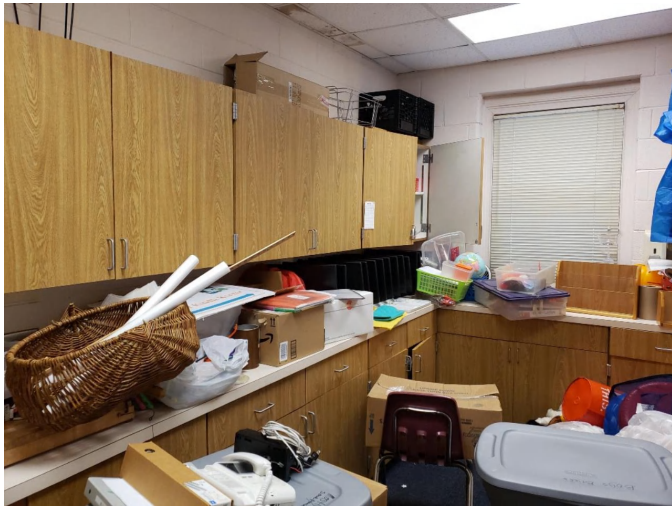
**Location:** Throughout Building  
**Distress:** Beyond Expected Life  
**Category:** Deferred Maintenance  
**Priority:** 3 - Necessary (Years 2-5)  
**Correction:** Renew System  
**Qty:** 2,897.00  
**Unit of Measure:** S.F.  
**Estimate:** \$6,501.00  
**Assessor Name:** Eduardo Lopez  
**Date Created:** 01/25/2020

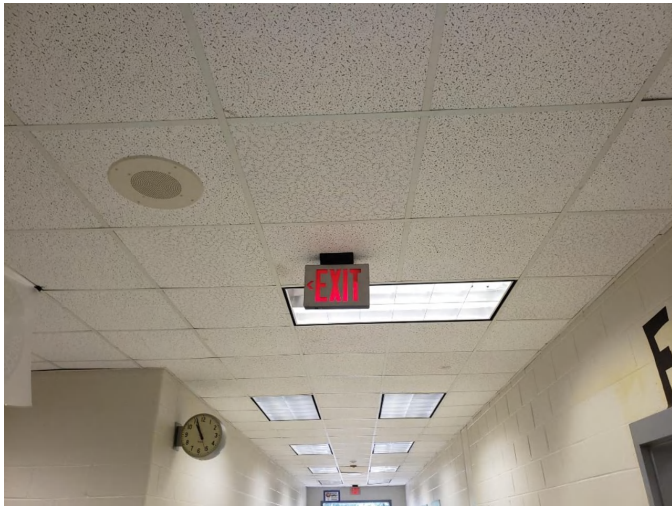
**Location:** Throughout building  
**Distress:** Beyond Expected Life  
**Category:** Deferred Maintenance  
**Priority:** 3 - Necessary (Years 2-5)  
**Correction:** Renew System  
**Qty:** 13,454.00  
**Unit of Measure:** S.F.  
**Estimate:** \$134,379.00  
**Assessor Name:** Eduardo Lopez  
**Date Created:** 09/30/2019

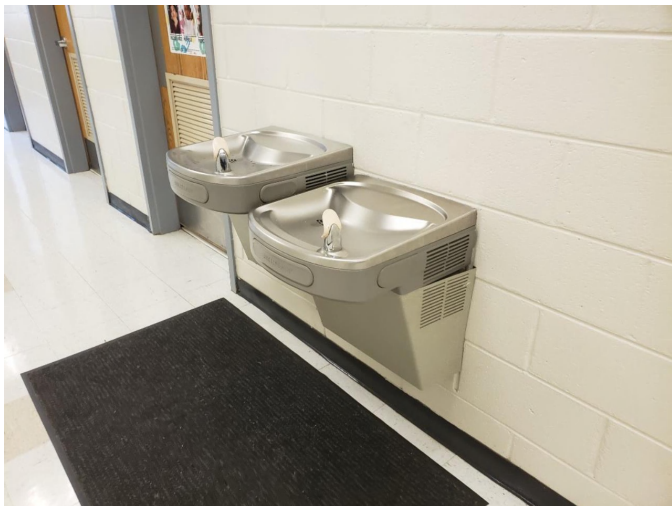
**Location:** Throughout building  
**Distress:** Beyond Expected Life  
**Category:** ADA Compliance  
**Priority:** 3 - Necessary (Years 2-5)  
**Correction:** Renew System  
**Qty:** 13,454.00  
**Unit of Measure:** S.F.  
**Estimate:** \$95,308.00  
**Assessor Name:** Eduardo Lopez  
**Date Created:** 09/30/2019

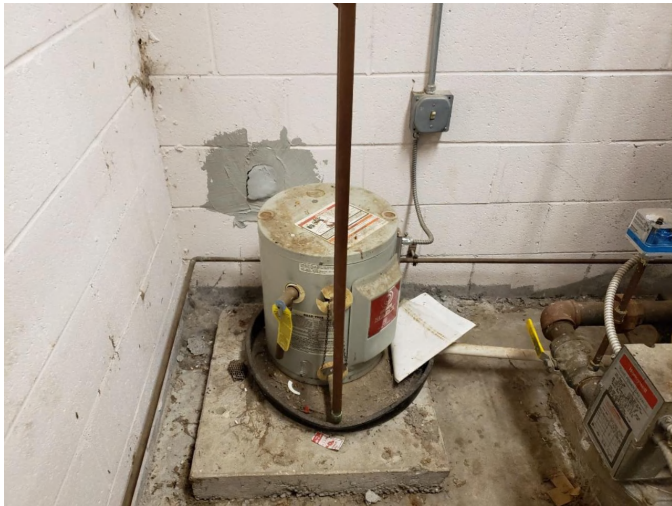
**Location:** Throughout Building  
**Distress:** Beyond Expected Life  
**Category:** Deferred Maintenance  
**Priority:** 3 - Necessary (Years 2-5)  
**Correction:** Renew System  
**Qty:** 13,454.00  
**Unit of Measure:** S.F.  
**Estimate:** \$11,100.00  
**Assessor Name:** Eduardo Lopez  
**Date Created:** 10/06/2020

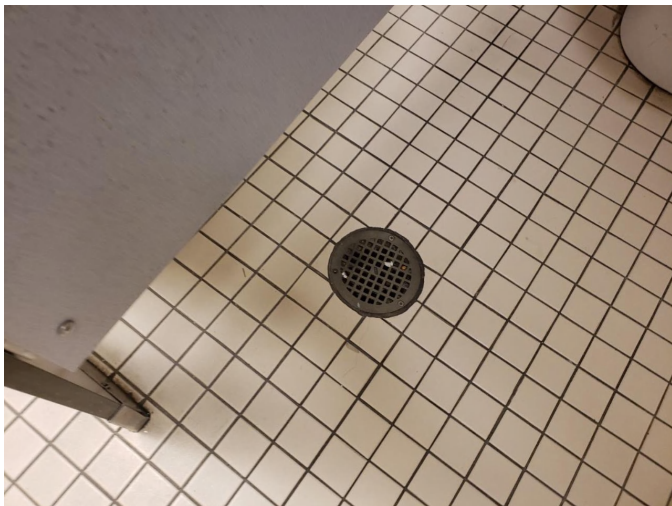
**Location:** Throughout Building  
**Distress:** Beyond Expected Life  
**Category:** Deferred Maintenance  
**Priority:** 3 - Necessary (Years 2-5)  
**Correction:** Renew System  
**Qty:** 13,454.00  
**Unit of Measure:** S.F.  
**Estimate:** \$25,455.00  
**Assessor Name:** Eduardo Lopez  
**Date Created:** 10/06/2020

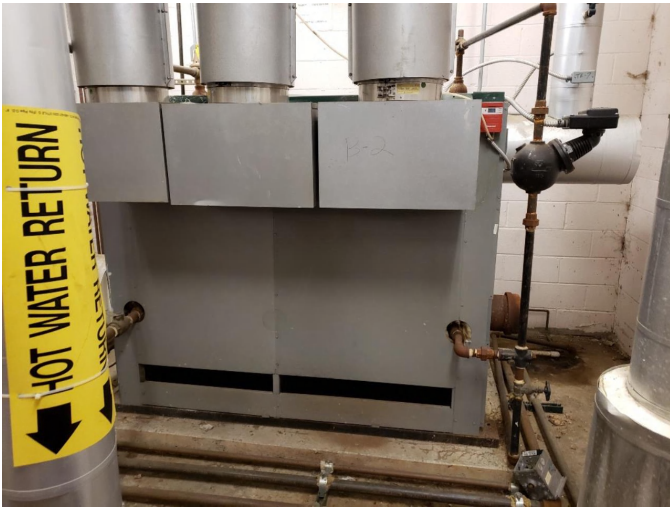
**Location:** Throughout building  
**Distress:** Beyond Expected Life  
**Category:** Deferred Maintenance  
**Priority:** 3 - Necessary (Years 2-5)  
**Correction:** Renew System  
**Qty:** 13,454.00  
**Unit of Measure:** S.F.  
**Estimate:** \$54,166.00  
**Assessor Name:** Eduardo Lopez  
**Date Created:** 01/25/2020

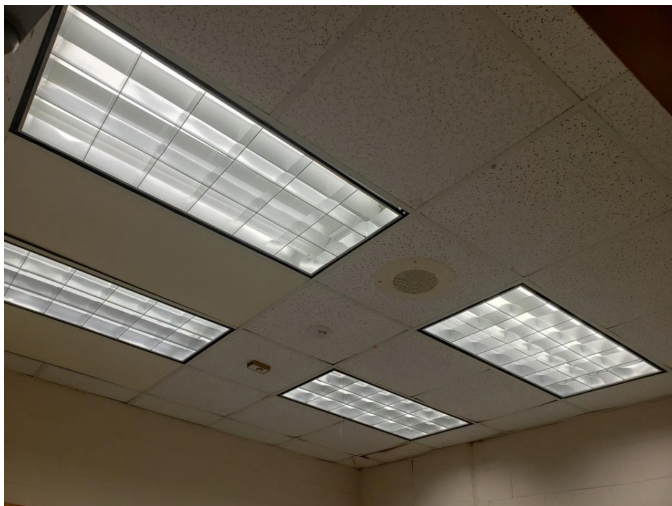
**Location:** Throughout building  
**Distress:** Beyond Expected Life  
**Category:** Deferred Maintenance  
**Priority:** 3 - Necessary (Years 2-5)  
**Correction:** Renew System  
**Qty:** 13,454.00  
**Unit of Measure:** S.F.  
**Estimate:** \$100,340.00  
**Assessor Name:** Eduardo Lopez  
**Date Created:** 09/30/2019

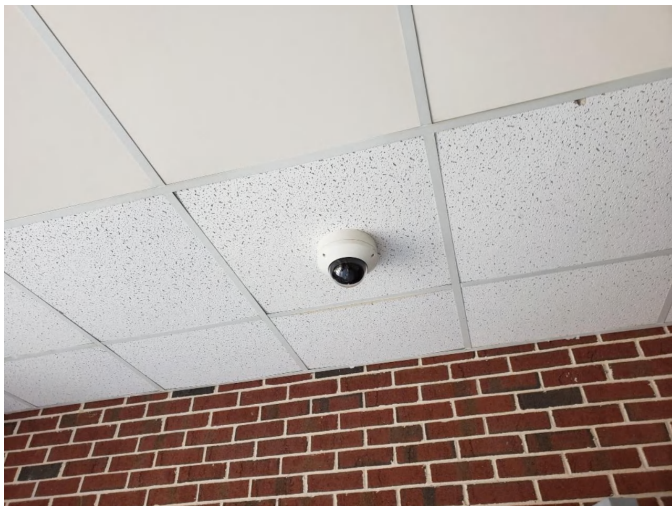
**Location:** Throughout building  
**Distress:** Beyond Expected Life  
**Category:** Deferred Maintenance  
**Priority:** 3 - Necessary (Years 2-5)  
**Correction:** Renew System  
**Qty:** 13,454.00  
**Unit of Measure:** S.F.  
**Estimate:** \$22,347.00  
**Assessor Name:** Eduardo Lopez  
**Date Created:** 01/24/2020

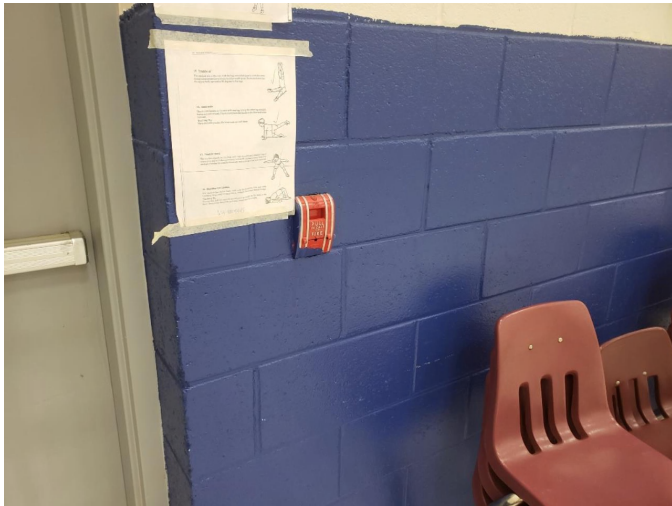
**Location:** Throughout building  
**Distress:** Beyond Expected Life  
**Category:** Deferred Maintenance  
**Priority:** 3 - Necessary (Years 2-5)  
**Correction:** Renew System  
**Qty:** 13,454.00  
**Unit of Measure:** S.F.  
**Estimate:** \$40,550.00  
**Assessor Name:** Eduardo Lopez  
**Date Created:** 01/24/2020

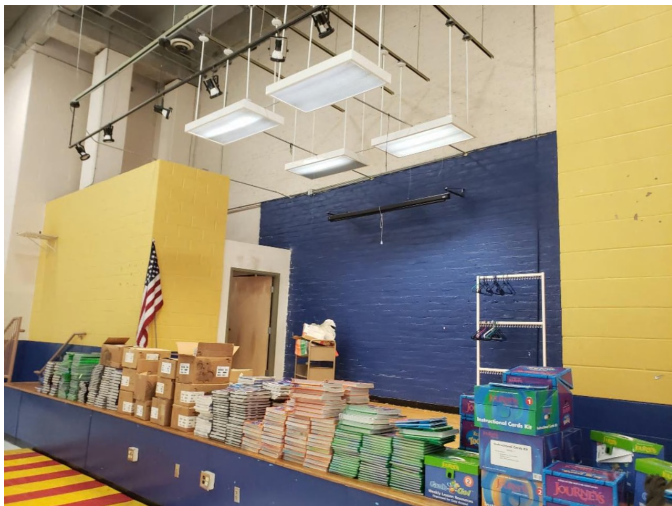
**Location:** Throughout building  
**Distress:** Beyond Expected Life  
**Category:** Deferred Maintenance  
**Priority:** 3 - Necessary (Years 2-5)  
**Correction:** Renew System  
**Qty:** 13,454.00  
**Unit of Measure:** S.F.  
**Estimate:** \$1,332.00  
**Assessor Name:** Eduardo Lopez  
**Date Created:** 01/24/2020

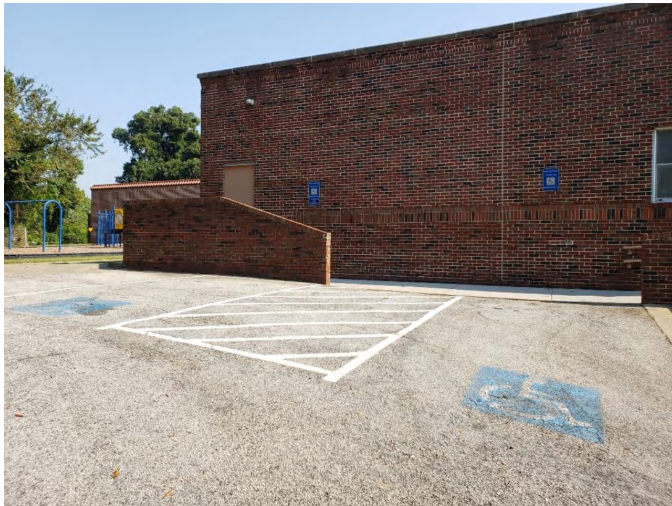
**Location:** Site  
**Distress:** Missing  
**Category:** ADA Compliance  
**Priority:** 2 - Trending Critical (Year 1)  
**Correction:** Add handicap parking sign and post  
**Qty:** 1.00  
**Unit of Measure:** Ea.  
**Estimate:** \$398.26  
**Assessor Name:** Eduardo Lopez  
**Date Created:** 01/24/2020
