Atlanta Public Schools/ N. Atlanta Cluster

Sutton Sixth Grade Academy

School Assessment Report

November 10, 2020

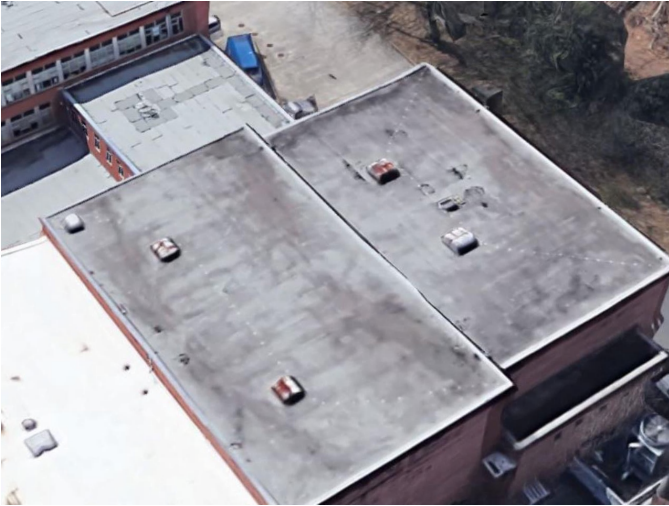
System: B3010105 - Built-Up

Location: Roof
Distress: Beyond Expected Life
Category: Deferred Maintenance
Priority: 3 - Necessary (Years 2-5)
Correction: Renew System
Qty: 40,352.00
Unit of Measure: S.F.
Estimate: \$452,971.00
Assessor Name: Eduardo Lopez
Date Created: 01/24/2020

Notes: The roofing system is a Built-Up system that was reported to be original to the buildings construction. This system has exceeded its expected life cycle and is recommended for replacement.

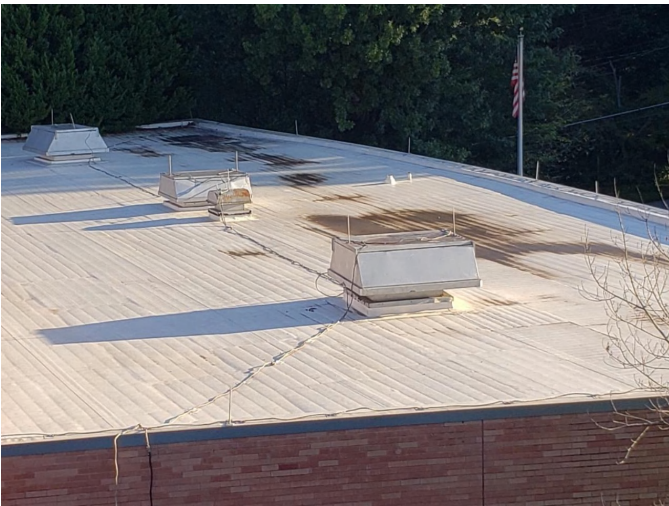
System: B3010130 - Preformed Metal Roofing

Location: Roof
Distress: Beyond Expected Life
Category: Deferred Maintenance
Priority: 3 - Necessary (Years 2-5)
Correction: Renew System
Qty: 3,000.00
Unit of Measure: S.F.
Estimate: \$36,465.00
Assessor Name: Eduardo Lopez
Date Created: 01/24/2020

Notes: The roofing is Preformed Metal Roofing system that was reported to be original to the buildings construction. This system has exceeded its expected life cycle and is recommended for replacement.

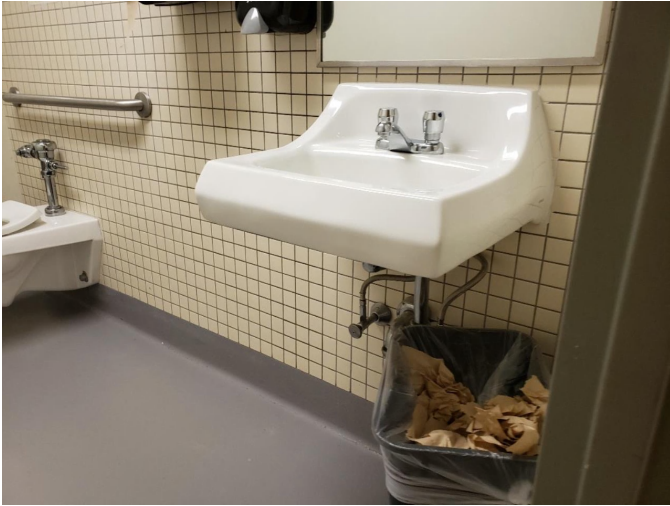
System: C3010220 - Tile

Location: Restrooms
Distress: Beyond Expected Life
Category: Deferred Maintenance
Priority: 3 - Necessary (Years 2-5)
Correction: Renew System
Qty: 5,000.00
Unit of Measure: S.F.
Estimate: \$69,375.00
Assessor Name: Eduardo Lopez
Date Created: 01/24/2020

Notes: The tile floor finish is beyond its expected service life, worn and damaged, and is recommended for replacement.

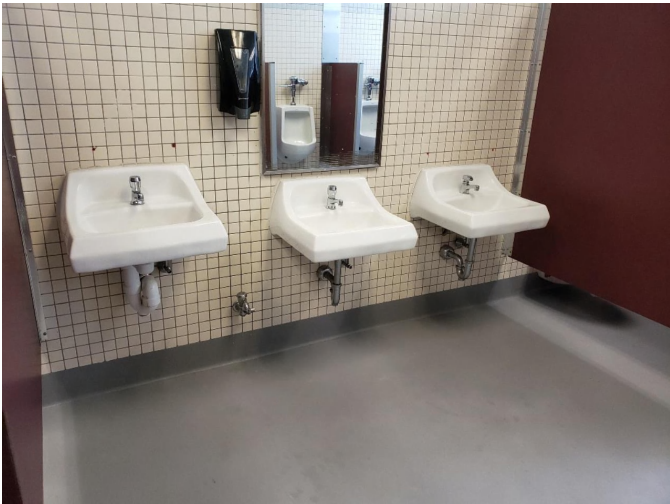
System: C3020405 - Epoxy

Location: Restrooms
Distress: Beyond Expected Life
Category: Deferred Maintenance
Priority: 3 - Necessary (Years 2-5)
Correction: Renew System
Qty: 2,500.00
Unit of Measure: S.F.
Estimate: \$51,035.00
Assessor Name: Eduardo Lopez
Date Created: 01/24/2020

Notes: The epoxy floor finish is beyond its expected service life, worn and damaged, and is recommended for replacement.

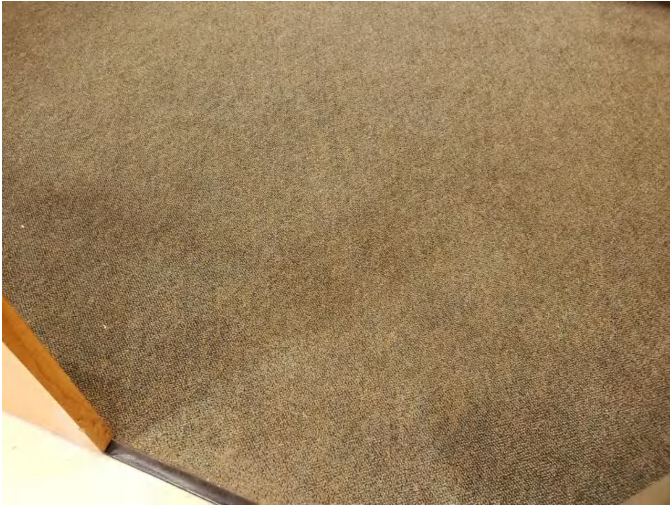
System: C3020901 - Carpet

Location: Media Center
Distress: Beyond Expected Life
Category: Deferred Maintenance
Priority: 3 - Necessary (Years 2-5)
Correction: Renew System
Qty: 2,500.00
Unit of Measure: S.F.
Estimate: \$19,223.00
Assessor Name: Eduardo Lopez
Date Created: 01/24/2020

Notes: The Carpet floor finish is beyond its expected service life, worn and damaged, and is recommended for replacement.

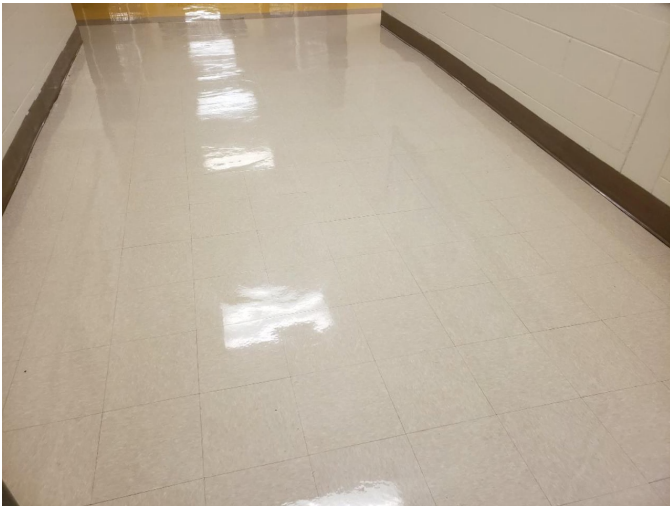
System: C3020903 - VCT

Location: Throughout Building
Distress: Beyond Expected Life
Category: Deferred Maintenance
Priority: 3 - Necessary (Years 2-5)
Correction: Renew System
Qty: 100,753.00
Unit of Measure: S.F.
Estimate: \$543,462.00
Assessor Name: Eduardo Lopez
Date Created: 01/24/2020

Notes: The VCT floor finish is beyond its expected service life, worn and damaged, and is recommended for replacement.

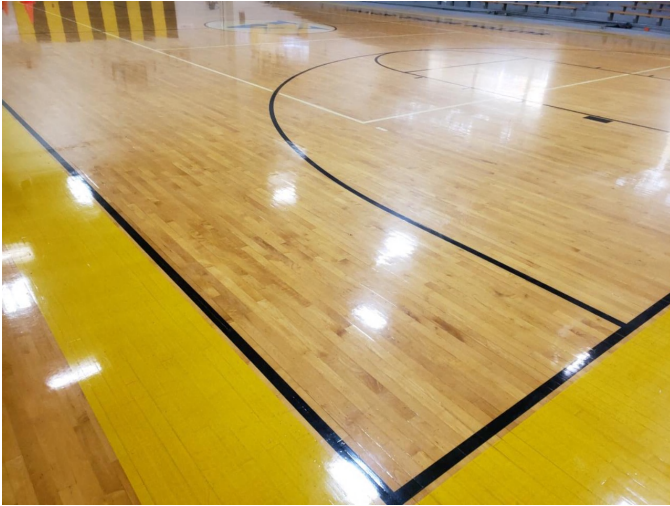
System: C3020999 - Other - Wood

Location: Gym
Distress: Beyond Expected Life
Category: Deferred Maintenance
Priority: 3 - Necessary (Years 2-5)
Correction: Renew System
Qty: 5,000.00
Unit of Measure: S.F.
Estimate: \$94,462.00
Assessor Name: Eduardo Lopez
Date Created: 01/24/2020

Notes: The wood floor finish is beyond its expected service life, worn and damaged, and is recommended for replacement.

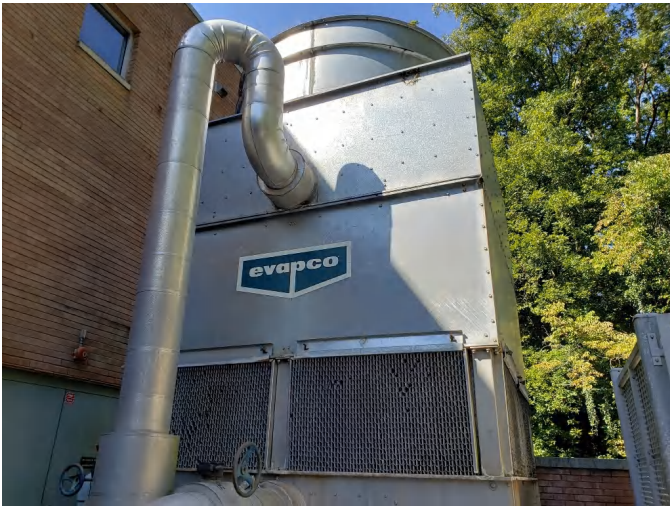
System: D3030 - Cooling Generating Systems

Location: Throughout Building
Distress: Beyond Expected Life
Category: Deferred Maintenance
Priority: 3 - Necessary (Years 2-5)
Correction: Renew System
Qty: 110,753.00
Unit of Measure: S.F.
Estimate: \$771,173.00
Assessor Name: Eduardo Lopez
Date Created: 10/06/2020

Notes: The cooling generating system is beyond its expected service life and should be scheduled for replacement.

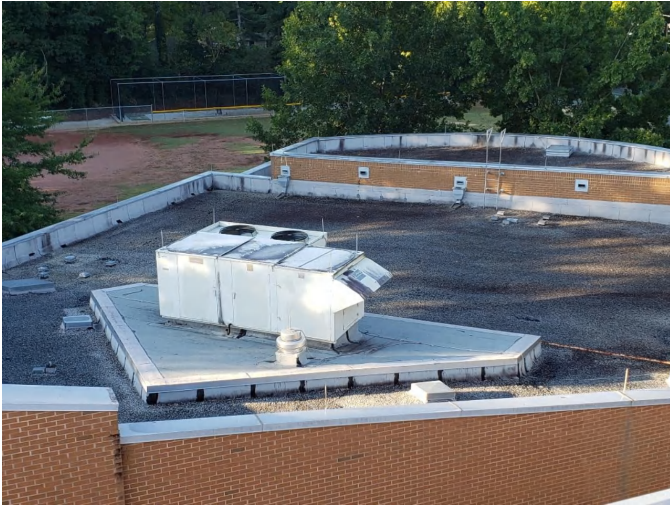
System: B3010105 - Built-Up

Location: Roof
Distress: Beyond Expected Life
Category: Deferred Maintenance
Priority: 3 - Necessary (Years 2-5)
Correction: Renew System
Qty: 5,288.00
Unit of Measure: S.F.
Estimate: \$59,360.00
Assessor Name: Homero Guerrero
Date Created: 01/24/2020

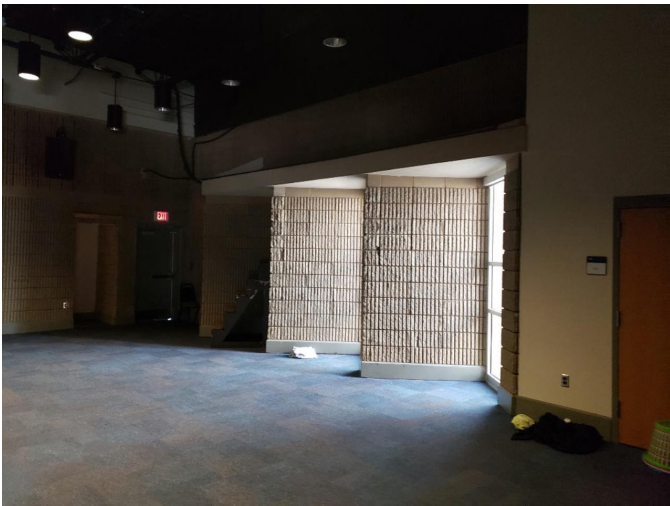
System: C3020901 - Carpet

Location: Auditorium
Distress: Beyond Expected Life
Category: Deferred Maintenance
Priority: 3 - Necessary (Years 2-5)
Correction: Renew System
Qty: 1,000.00
Unit of Measure: S.F.
Estimate: \$7,689.00
Assessor Name: Homero Guerrero
Date Created: 01/24/2020

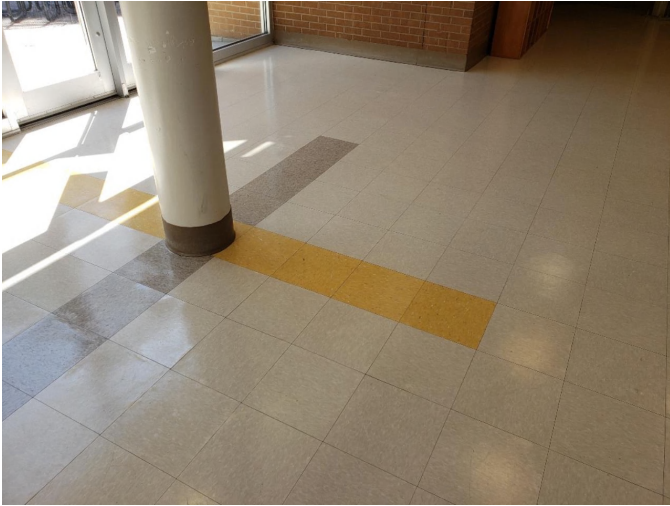
System: C3020903 - VCT

Location: Throughout Building
Distress: Beyond Expected Life
Category: Deferred Maintenance
Priority: 3 - Necessary (Years 2-5)
Correction: Renew System
Qty: 2,288.00
Unit of Measure: S.F.
Estimate: \$12,341.00
Assessor Name: Homero Guerrero
Date Created: 01/24/2020

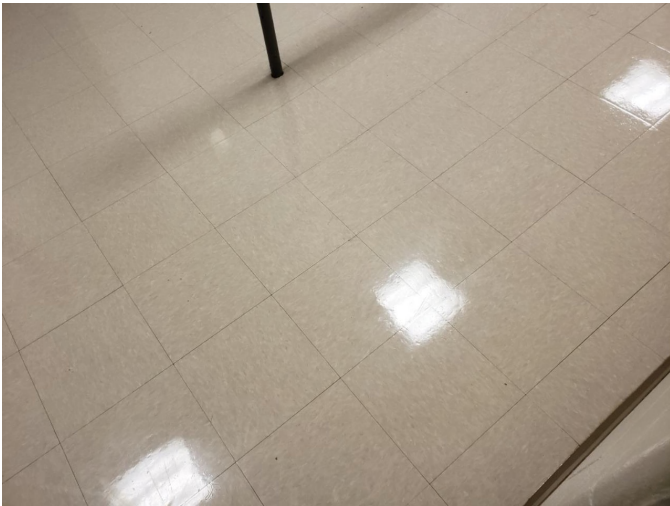
System: C3020903 - VCT

Location: Throughout Building
Distress: Beyond Expected Life
Category: Deferred Maintenance
Priority: 3 - Necessary (Years 2-5)
Correction: Renew System
Qty: 30,782.00
Unit of Measure: S.F.
Estimate: \$166,038.00
Assessor Name: Eduardo Lopez
Date Created: 01/24/2020

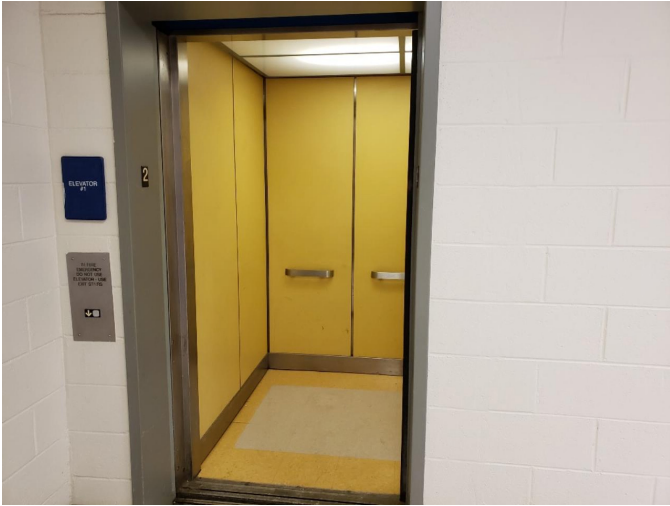
System: D1010 - Elevators and Lifts

Location: Throughout Building
Distress: Beyond Expected Life
Category: Deferred Maintenance
Priority: 3 - Necessary (Years 2-5)
Correction: Renew System
Qty: 33,782.00
Unit of Measure: S.F.
Estimate: \$52,024.00
Assessor Name: Eduardo Lopez
Date Created: 11/19/2019

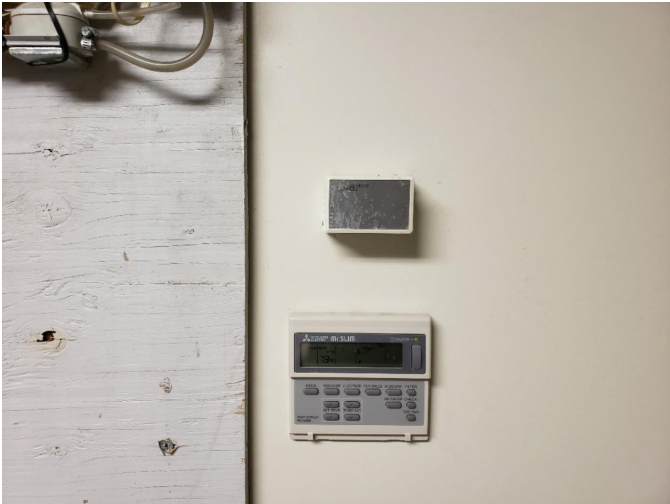
System: D5030810 - Security & Detection Systems

Location: Throughout Building
Distress: Beyond Expected Life
Category: Deferred Maintenance
Priority: 3 - Necessary (Years 2-5)
Correction: Renew System
Qty: 33,782.00
Unit of Measure: S.F.
Estimate: \$56,112.00
Assessor Name: Eduardo Lopez
Date Created: 01/24/2020

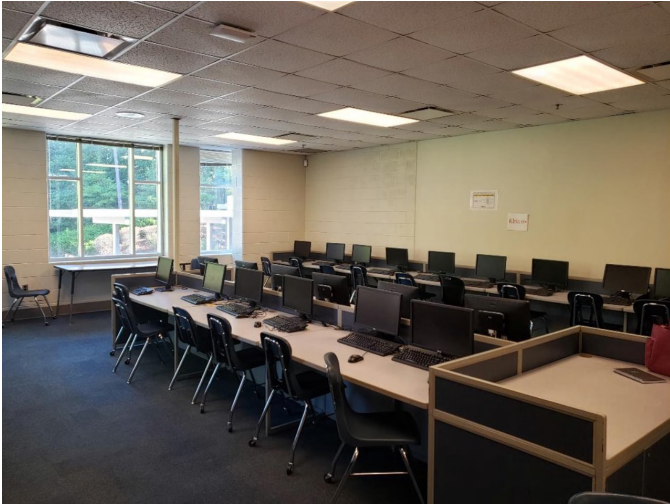
System: C3020901 - Carpet

Location: Computer Lab
Distress: Beyond Expected Life
Category: Deferred Maintenance
Priority: 3 - Necessary (Years 2-5)
Correction: Renew System
Qty: 1,500.00
Unit of Measure: S.F.
Estimate: \$11,534.00
Assessor Name: Homero Guerrero
Date Created: 01/24/2020
