Atlanta Public Schools/ Therrell Cluster

# Therrell High School

## School Assessment Report

November 10, 2020

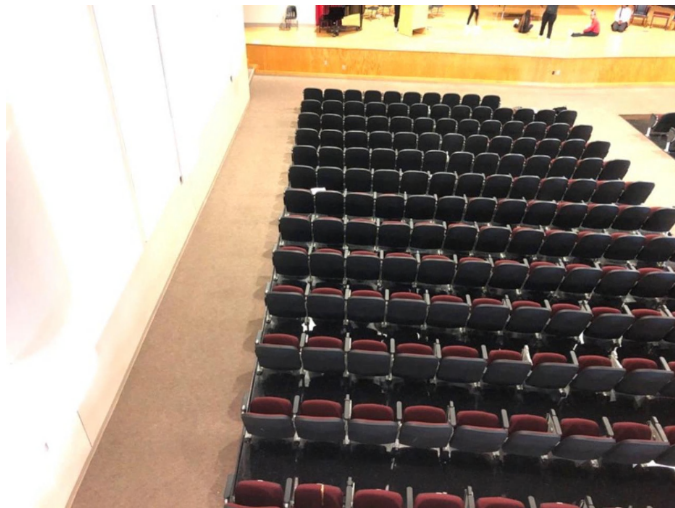
#### **System: C3020901 - Carpet**

**Location:** Theater  
**Distress:** Beyond Expected Life  
**Category:** Deferred Maintenance  
**Priority:** 3 - Necessary (Years 2-5)  
**Correction:** Renew System  
**Qty:** 5,600.00  
**Unit of Measure:** S.F.  
**Estimate:** \$46,200.00  
**Assessor Name:** Eduardo Lopez  
**Date Created:** 01/29/2020

**Notes:** The carpet is aged beyond its expected life and should be replaced.

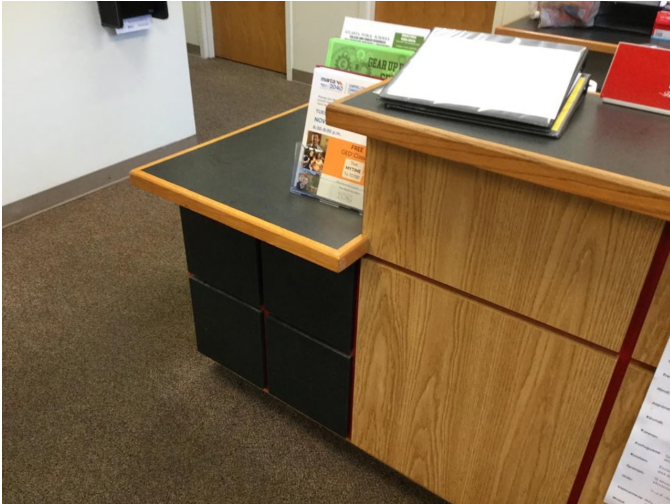
#### **System: C3020901 - Carpet**

**Location:** Main Office  
**Distress:** Beyond Expected Life  
**Category:** Deferred Maintenance  
**Priority:** 3 - Necessary (Years 2-5)  
**Correction:** Renew System  
**Qty:** 6,530.00  
**Unit of Measure:** S.F.  
**Estimate:** \$53,873.00  
**Assessor Name:** Eduardo Lopez  
**Date Created:** 01/30/2020

**Notes:** The carpet is aged beyond its expected life and should be replaced.

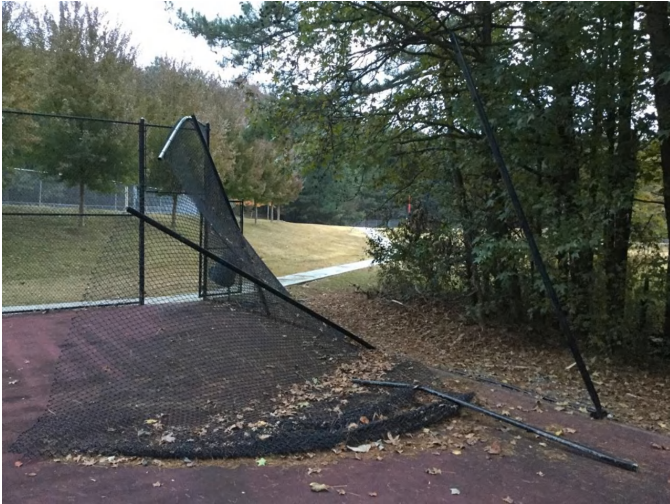
#### **System: G2040105 - Fence & Guardrails**

**Location:** Tennis Courts  
**Distress:** Damaged  
**Category:** Sustainability  
**Priority:** 1 - Critical Immediate Need  
**Correction:** Replace and/or add fencing for security/appearance  
**Qty:** 125.00  
**Unit of Measure:** L.F.  
**Estimate:** \$9,873.31  
**Assessor Name:** Jejuan Hall  
**Date Created:** 01/30/2020
