School Assessment Report

School: Thomasville Heights Elementary School

Report: Nov 17, 2015

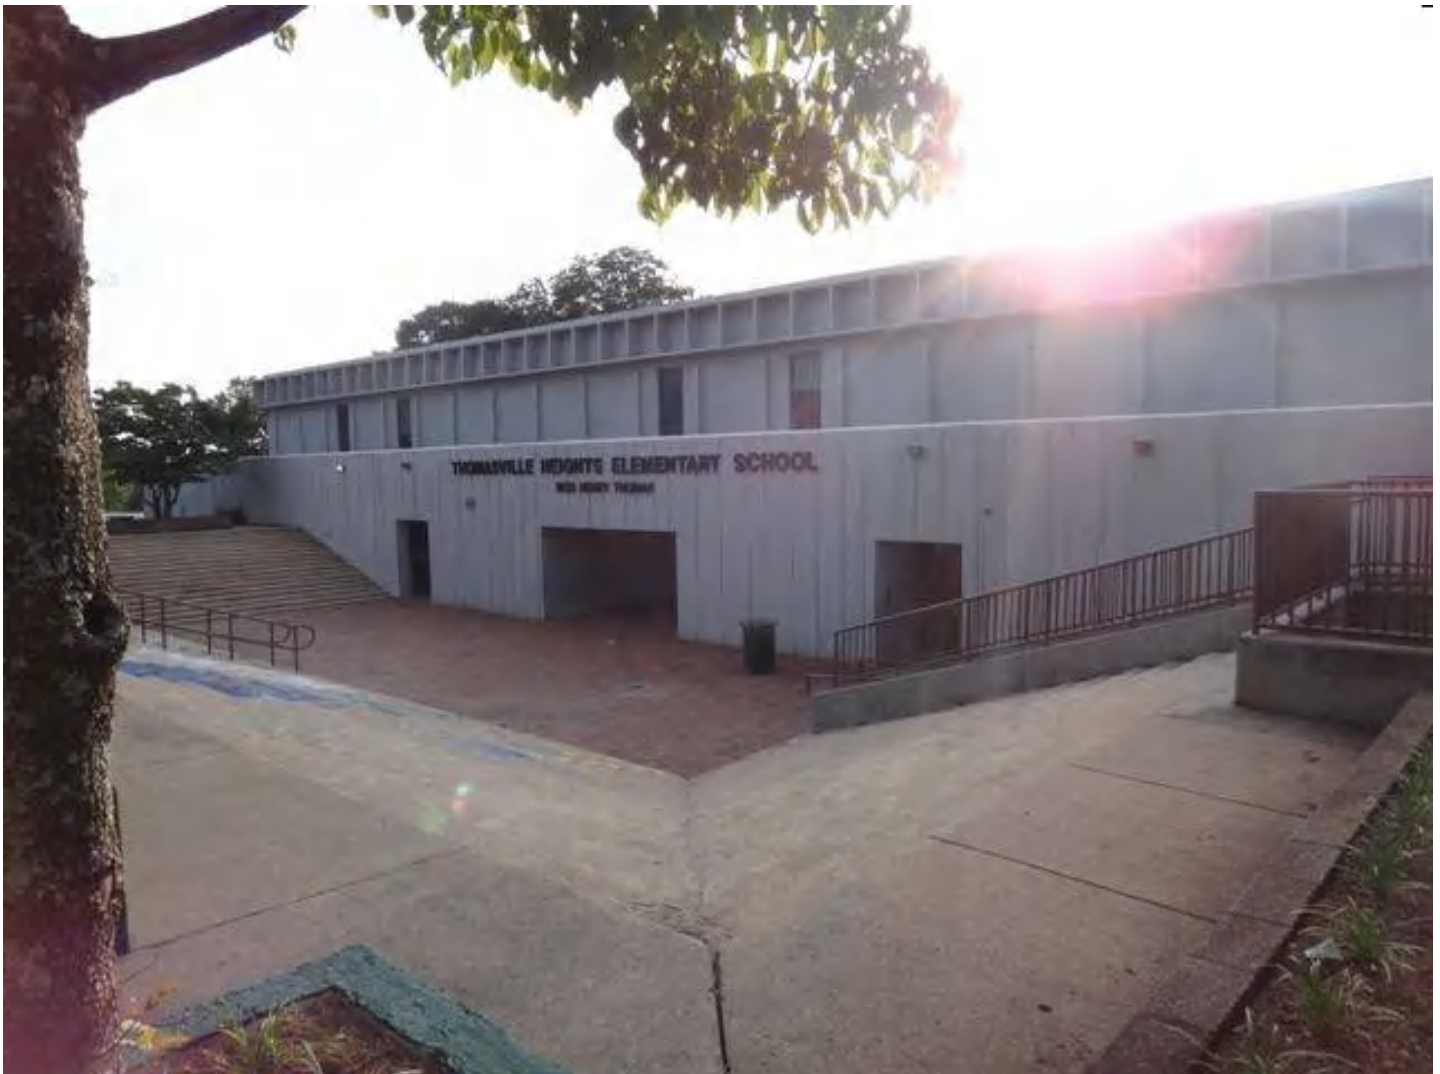
The superstructure is steel frame and concrete frame. Floor construction is slab on-grade. Roof construction is steel and concrete pan joist. The exterior enclosure is comprised of walls of precast tilt-up concrete panels and load bearing CMU construction. Exterior windows are aluminum frame with fixed panes. Exterior doors are hollow metal steel mostly with glazing. Roofing is typically low slope with built-up and is good condition with no reported leaks.

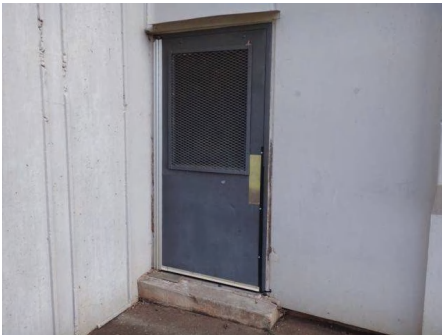
Analysis: The system age is either beyond expected life or does not meet its intended performance under the Guidelines. The system may be in service and functioning but it is recommended to be replaced due to probable increased condition budget needs, the potential failure of its components, or in order to meet the performance Guidelines for this system. The system was installed in 1971. It has a 30-year service life which expired in 2001.

Recomm.: The system should be replaced.

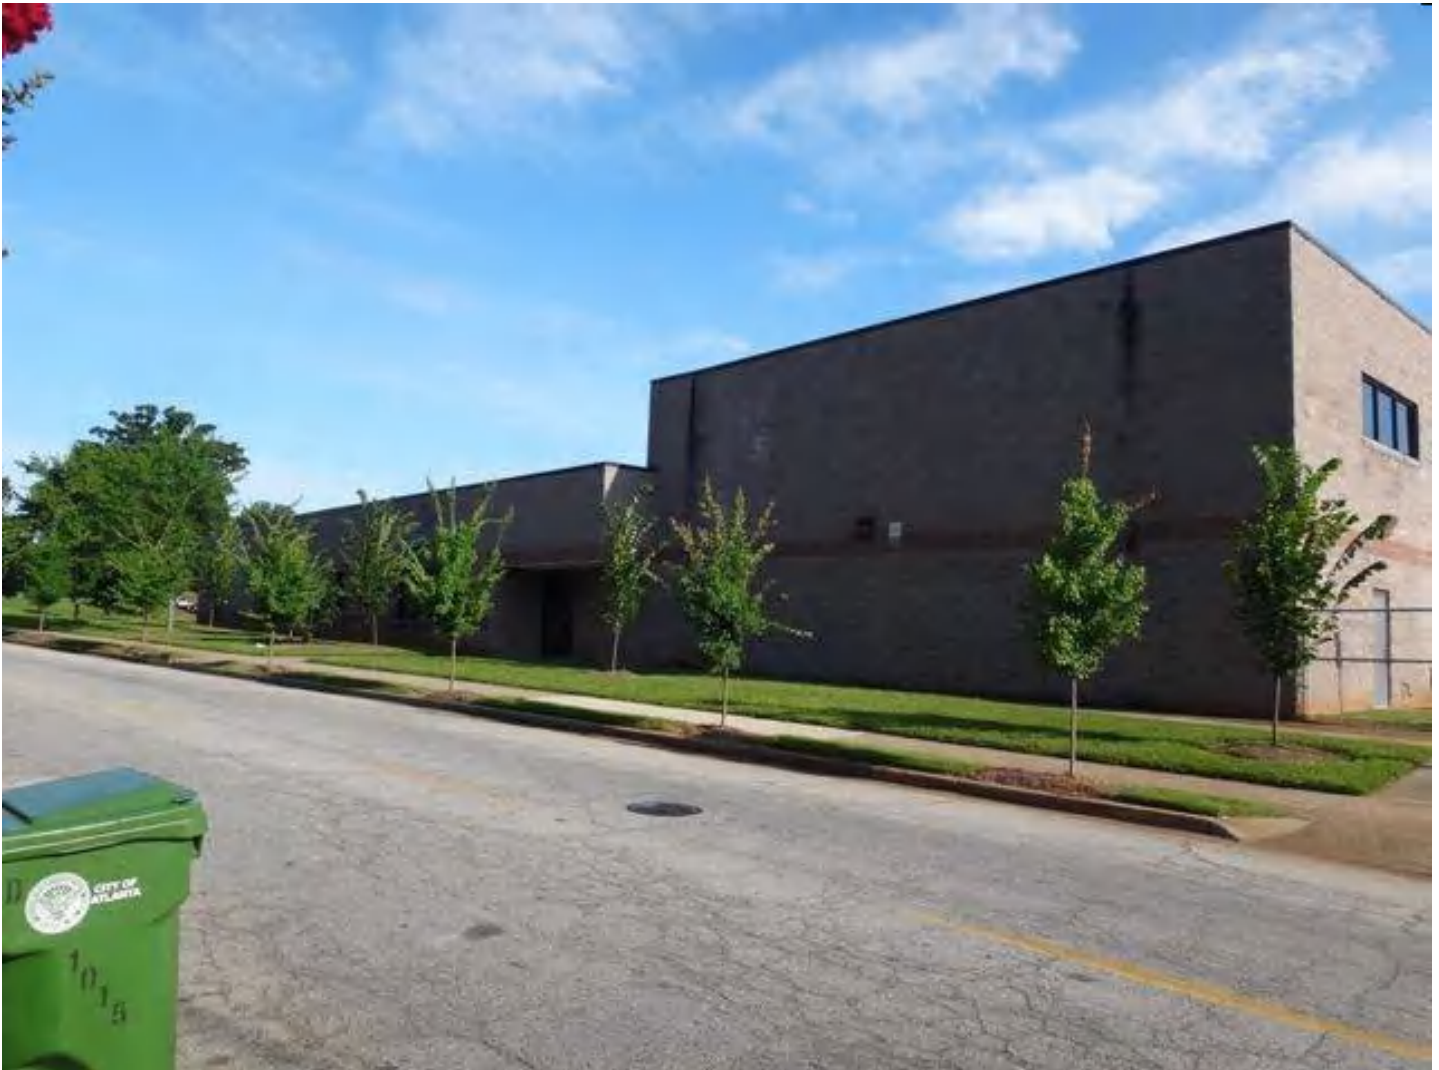
The superstructure is concrete frame and steel frame. Floor construction is slab on-grade. Roof construction is metal pan deck with lightweight fill and steel. The exterior enclosure is comprised of walls of brick veneer over CMU. Exterior windows are aluminum frame with fixed panes. Exterior doors are hollow metal steel mostly with glazing. Roofing is equally low slope and sloped with built-up and standing seam metal and is good condition with no reported leaks.

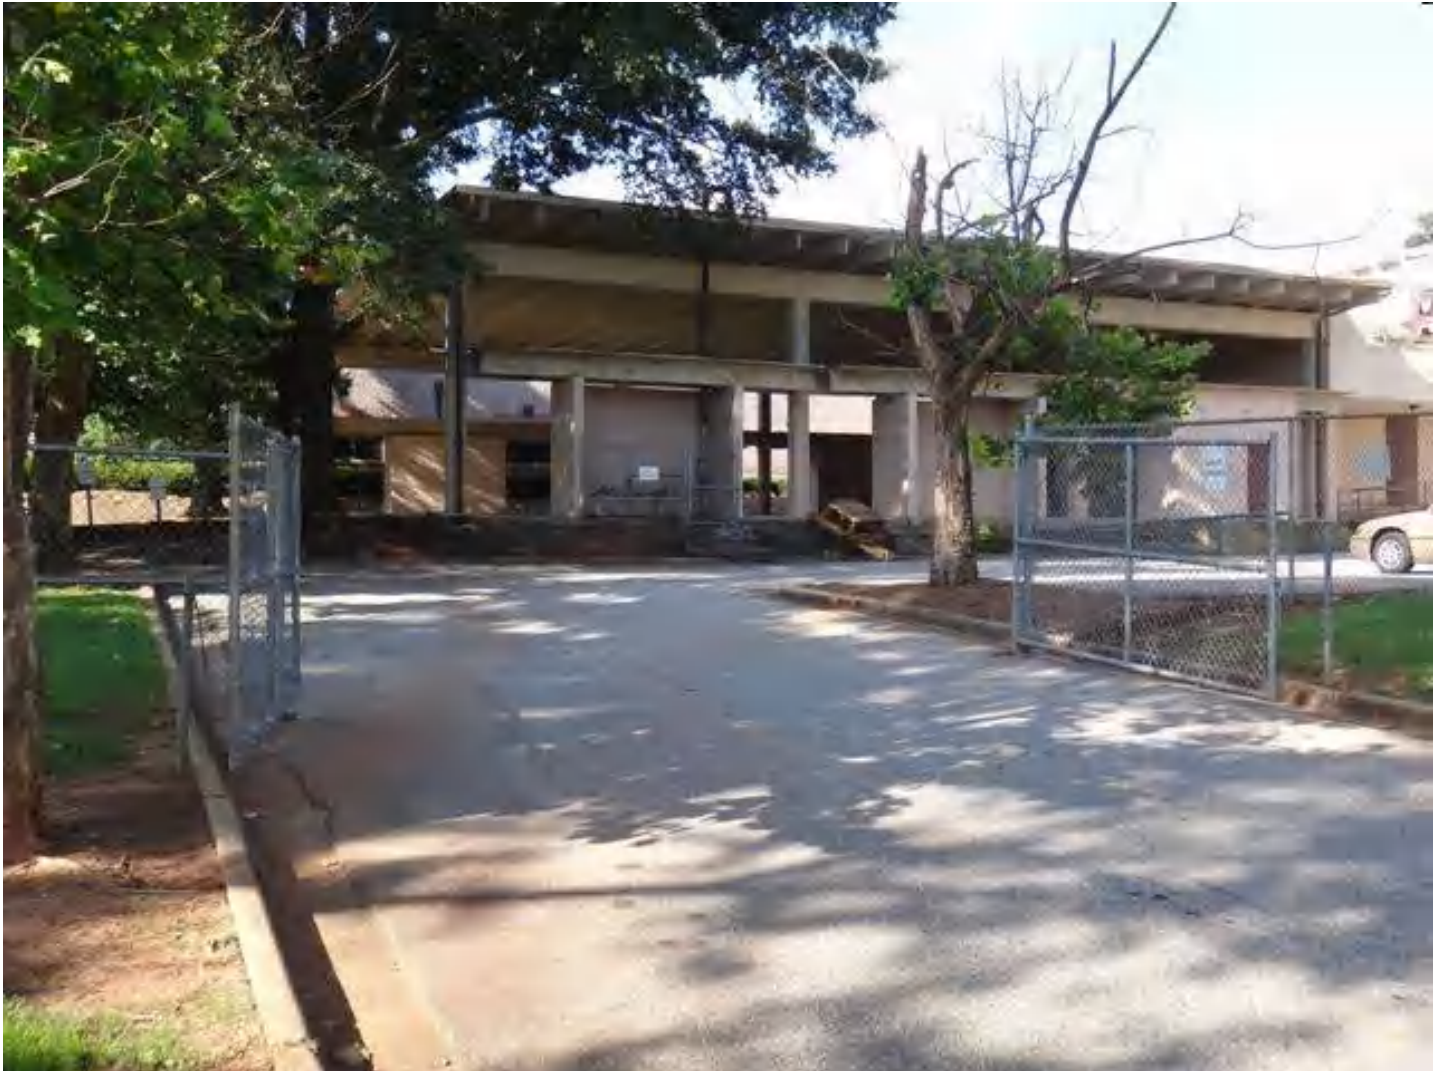
The covered play area is a concrete framed open structure with a concrete pan joist roof. The roof covering is built-up. Roof leaks occur and the roof is in poor condition. Finishes are limited to concrete sealants and elastomeric coating on some of the concrete columns.
