Atlanta Public Schools/Relocation Sites

Towns Elementary School

School Assessment Report

November 10, 2020

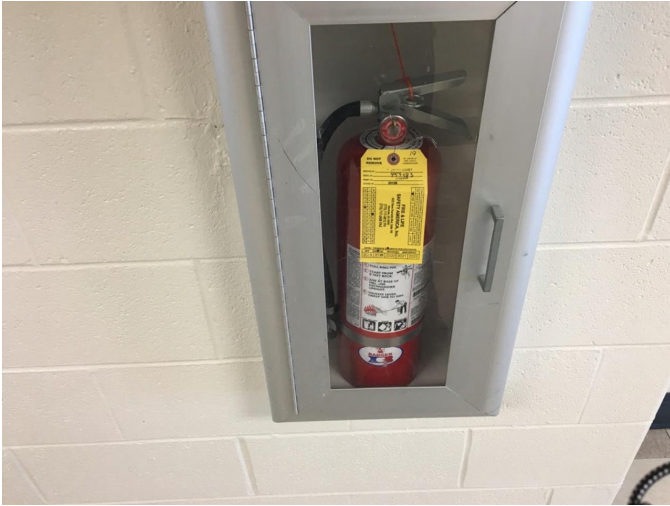
System: D4030 - Fire Protection Specialties

Location: Throughout building
Distress: Beyond Expected Life
Category: Deferred Maintenance
Priority: 1 - Critical Immediate Need
Correction: Renew System
Qty: 43,380.00
Unit of Measure: S.F.
Estimate: \$4,295.00
Assessor Name: Jejuan Hall
Date Created: 12/04/2019

Notes: The fire extinguishers and cabinets are from original construction and do not include modern designs for ease of use. Upgrades are recommended to include all new aspects of design for ease of use.

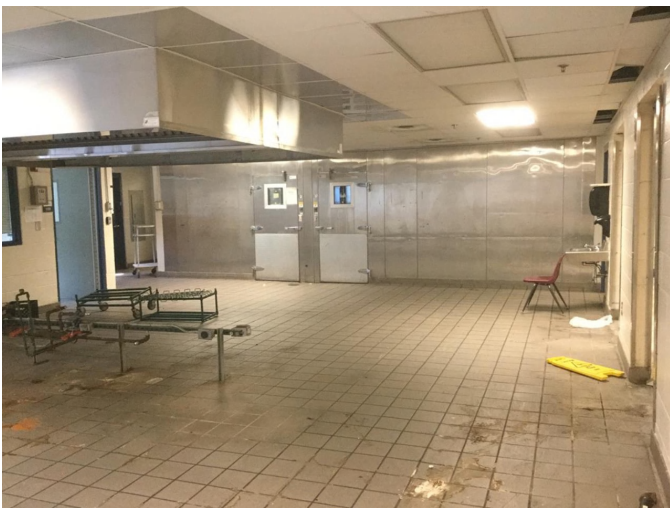
System: D4090 - Other Fire Protection Systems

Location: Kitchen
Distress: Beyond Expected Life
Category: Deferred Maintenance
Priority: 1 - Critical Immediate Need
Correction: Renew System
Qty: 43,380.00
Unit of Measure: S.F.
Estimate: \$31,494.00
Assessor Name: Jejuan Hall
Date Created: 09/17/2015

Notes: The kitchen exhaust hood fire protection system is original. This system is no longer supported and upgrades are warranted. This deficiency provides a budgetary consideration for universal upgrades to the fire alarm system.

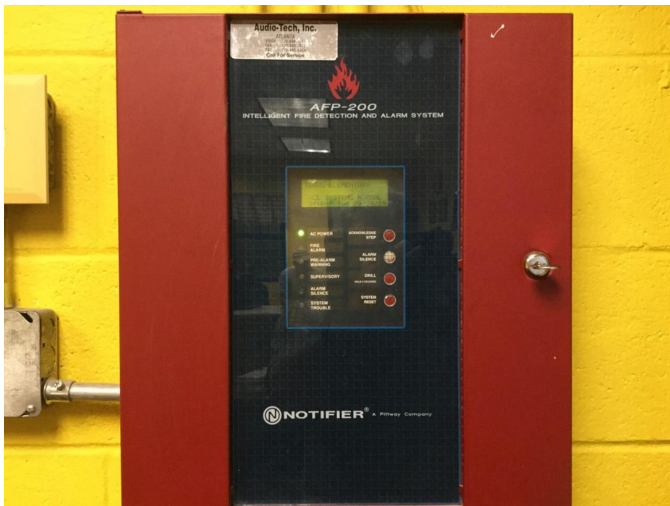
System: D5030910 - Fire Alarm Systems

Location: Throughout building
Distress: Beyond Expected Life
Category: Deferred Maintenance
Priority: 1 - Critical Immediate Need
Correction: Renew System
Qty: 43,380.00
Unit of Measure: S.F.
Estimate: \$130,747.00
Assessor Name: Jejuan Hall
Date Created: 12/04/2019

Notes: The AFP-200 Notifier Fire Alarm System appears to be from original construction. There are components such as push stations, lights and alarm bells installed to support the fire life safety for this building. This system is no longer supported and upgrades are warranted. This deficiency provides a budgetary consideration for universal upgrades to the fire alarm system.

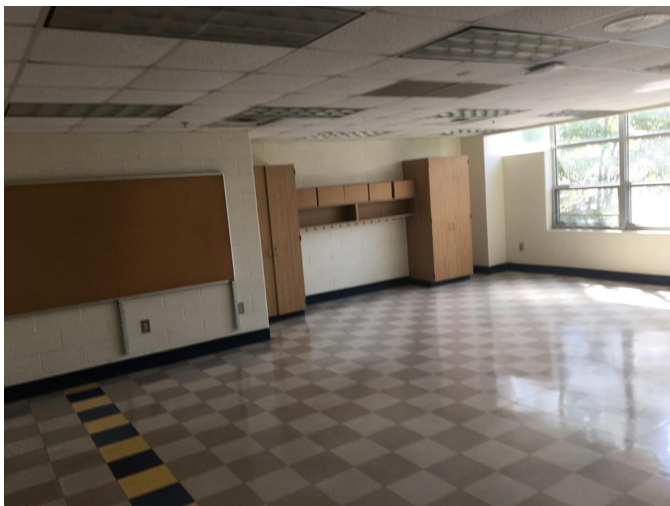
System: E2010 - Fixed Furnishings

Location: Throughout building
Distress: Beyond Expected Life
Category: Deferred Maintenance
Priority: 2 - Trending Critical (Year 1)
Correction: Renew System
Qty: 43,380.00
Unit of Measure: S.F.
Estimate: \$106,888.00
Assessor Name: Jejuan Hall
Date Created: 12/04/2019

Notes: Fittings include chalkboards; marker boards; tack boards; interior signage; metal lockers; toilet accessories and wood/metal/marble toilet partitions and fixed storage shelving. The system is nearing the end of its useful life and universal upgrades are recommended.

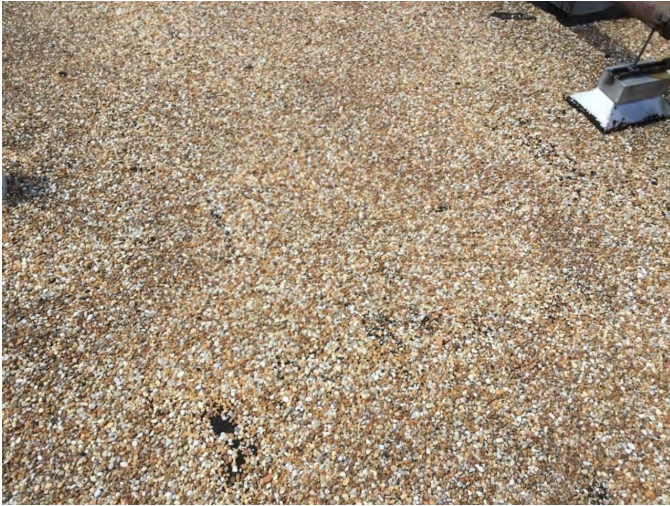
System: B3010105 - Built-Up

Location: Roof
Distress: Beyond Expected Life
Category: Deferred Maintenance
Priority: 3 - Necessary (Years 2-5)
Correction: Renew System
Qty: 38,380.00
Unit of Measure: S.F.
Estimate: \$430,835.00
Assessor Name: Jejuan Hall
Date Created: 12/05/2019

Notes: The roof is from the 2000 roof upgrade project. There is evidence of water stains and damaged ceiling tiles. However, considering that the school is abandoned its either a HVAC or roof issue. This deficiency provides a budgetary consideration for future replacement of this system. This deficiency is expected to be completed with the recommended HVAC upgrades.

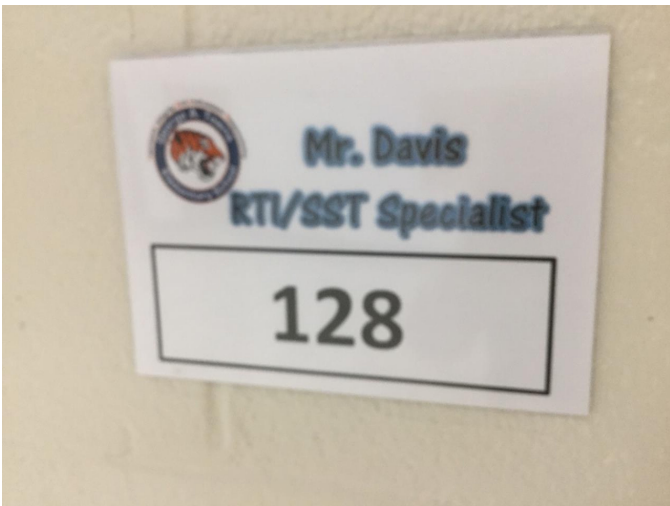
System: C1030 - Fittings

Location: Throughout building
Distress: Beyond Expected Life
Category: ADA Compliance
Priority: 3 - Necessary (Years 2-5)
Correction: Renew System
Qty: 43,380.00
Unit of Measure: S.F.
Estimate: \$148,403.00
Assessor Name: Jejuan Hall
Date Created: 12/05/2019

Notes: Fittings, such as toilet partitions, lockers, signage and railing, are beyond their expected service life, worn and damaged in areas, and should be replaced and upgraded for compliance with ADA standards.

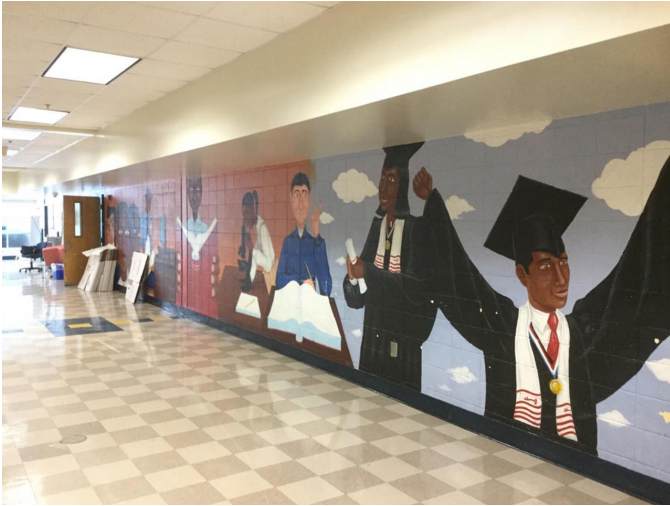
System: C3010230 - Paint & Covering

Location: Throughout building
Distress: Beyond Expected Life
Category: Deferred Maintenance
Priority: 3 - Necessary (Years 2-5)
Correction: Renew System
Qty: 43,380.00
Unit of Measure: S.F.
Estimate: \$70,145.00
Assessor Name: Jejuan Hall
Date Created: 12/04/2019

Notes: The applied finish is aged, worn and chipped, and should be replaced.

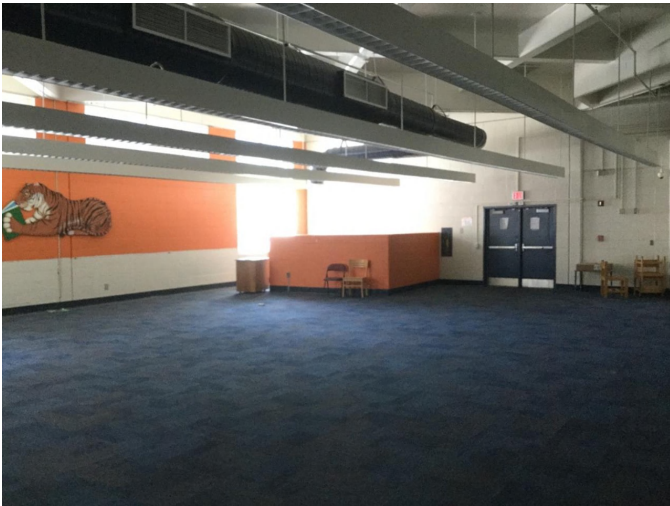
System: C3020901 - Carpet

Location: Throughout building
Distress: Beyond Expected Life
Category: Deferred Maintenance
Priority: 3 - Necessary (Years 2-5)
Correction: Renew System
Qty: 3,000.00
Unit of Measure: S.F.
Estimate: \$24,750.00
Assessor Name: Jejuan Hall
Date Created: 12/04/2019

Notes: The carpet system has not been cleaned on a regular basis. Stains from existing roof leaks or failing HVAC systems are apparent. Considering the current status of the school this deficiency provides a budgetary consideration for a general distribution system renewal prior to the school reopening.

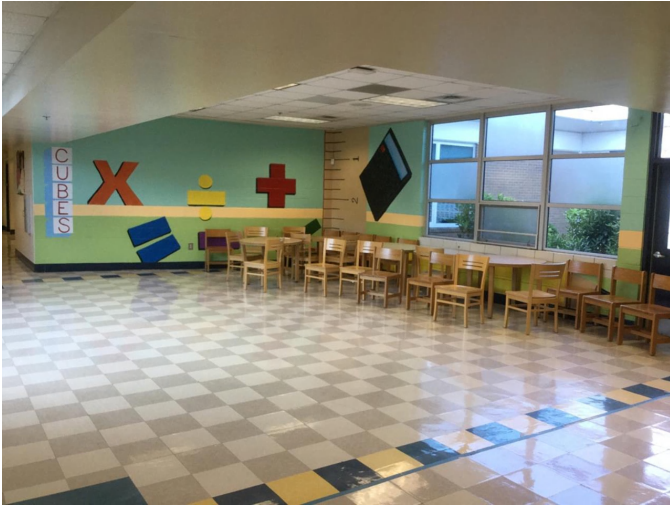
System: C3020903 - VCT

Location: Throughout building
Distress: Beyond Expected Life
Category: Deferred Maintenance
Priority: 3 - Necessary (Years 2-5)
Correction: Renew System
Qty: 35,000.00
Unit of Measure: S.F.
Estimate: \$188,790.00
Assessor Name: Jejuan Hall
Date Created: 12/04/2019

Notes: The VCT floor finish is beyond its expected service life, worn and damaged, and is recommended for replacement.

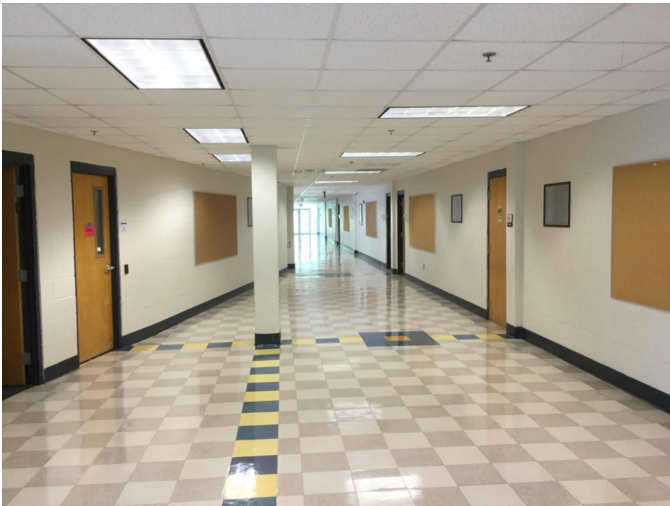
System: C3030 - Ceiling Finishes

Location: Throughout building
Distress: Beyond Expected Life
Category: Deferred Maintenance
Priority: 3 - Necessary (Years 2-5)
Correction: Renew System
Qty: 43,380.00
Unit of Measure: S.F.
Estimate: \$502,471.00
Assessor Name: Jejuan Hall
Date Created: 12/05/2019

Notes: The acoustic ceilings are aged and stained and should be scheduled for replacement.

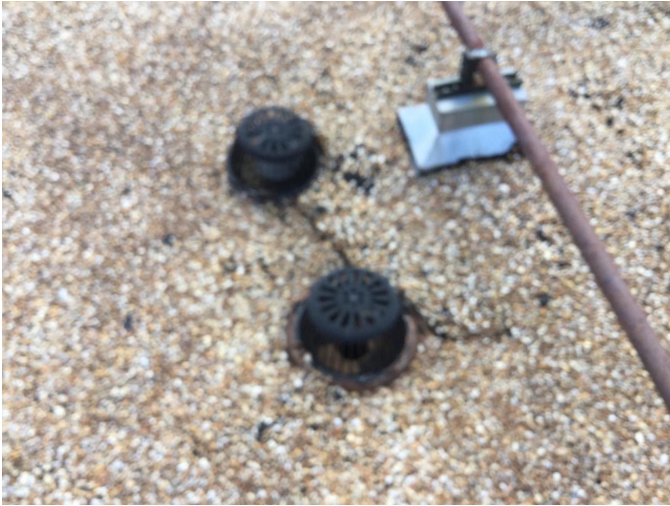
System: D2040 - Rain Water Drainage

Location: Roof
Distress: Beyond Expected Life
Category: Deferred Maintenance
Priority: 3 - Necessary (Years 2-5)
Correction: Renew System
Qty: 43,380.00
Unit of Measure: S.F.
Estimate: \$22,427.00
Assessor Name: Jejuan Hall
Date Created: 09/13/2013

Notes: The roof drains, insulation and fittings that support the water run off from this roof are damaged. The insulation is damaged from leaks and the drains have developed leaks. This deficiency provides a budgetary consideration for a new rainwater drainage system. This is expected to be completed as part of an overall effort to upgrade the roof and should be completed as part of the recommended roof upgrade also in this report.

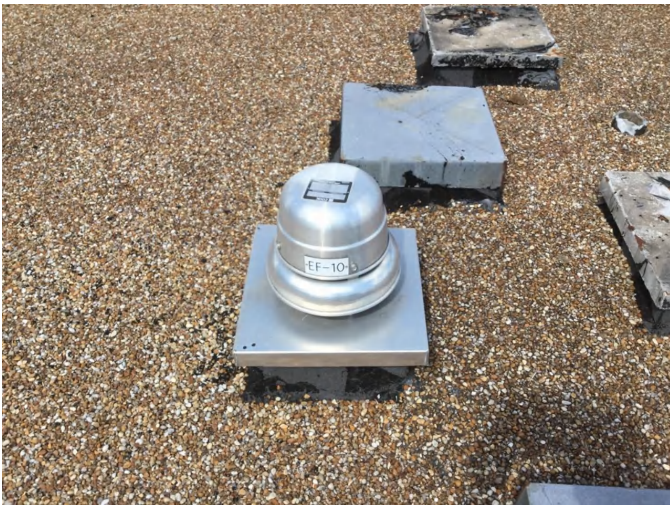
System: D3040 - Distribution Systems

Location: Throughout building
Distress: Beyond Expected Life
Category: Deferred Maintenance
Priority: 3 - Necessary (Years 2-5)
Correction: Renew System
Qty: 43,380.00
Unit of Measure: S.F.
Estimate: \$592,658.00
Assessor Name: Jejuan Hall
Date Created: 12/04/2019

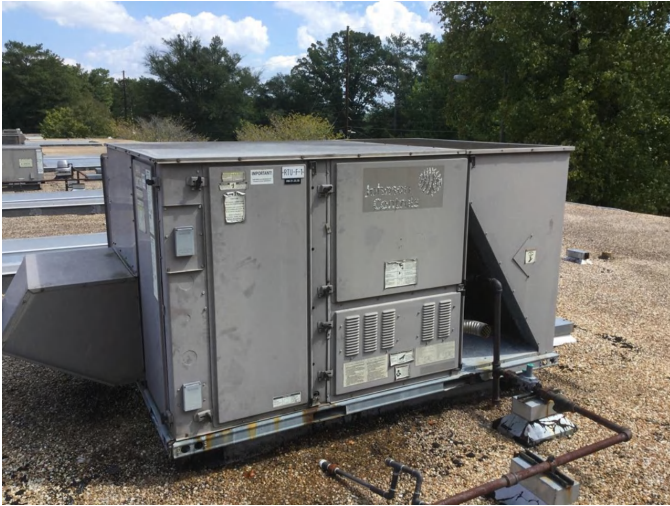
System: D3050 - Terminal & Package Units

Location: Roof
Distress: Beyond Expected Life
Category: Deferred Maintenance
Priority: 3 - Necessary (Years 2-5)
Correction: Renew System
Qty: 43,380.00
Unit of Measure: S.F.
Estimate: \$956,746.00
Assessor Name: Jejuan Hall
Date Created: 12/04/2019

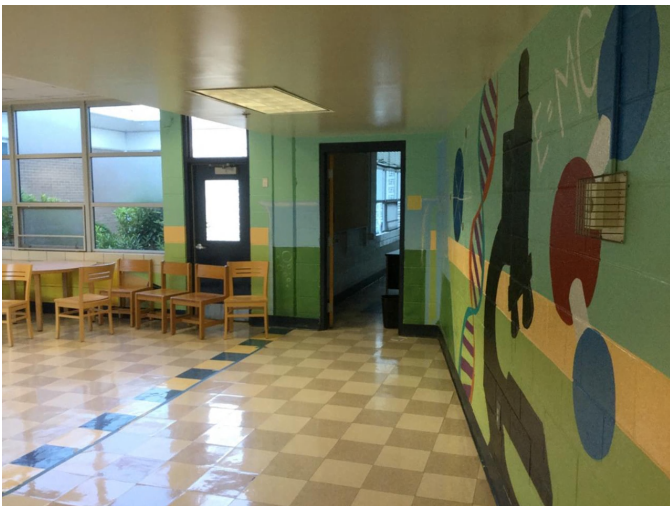
System: D3060 - Controls & Instrumentation

Location: Throughout building
Distress: Beyond Expected Life
Category: Deferred Maintenance
Priority: 3 - Necessary (Years 2-5)
Correction: Renew System
Qty: 43,380.00
Unit of Measure: S.F.
Estimate: \$124,067.00
Assessor Name: Jejuan Hall
Date Created: 09/17/2015

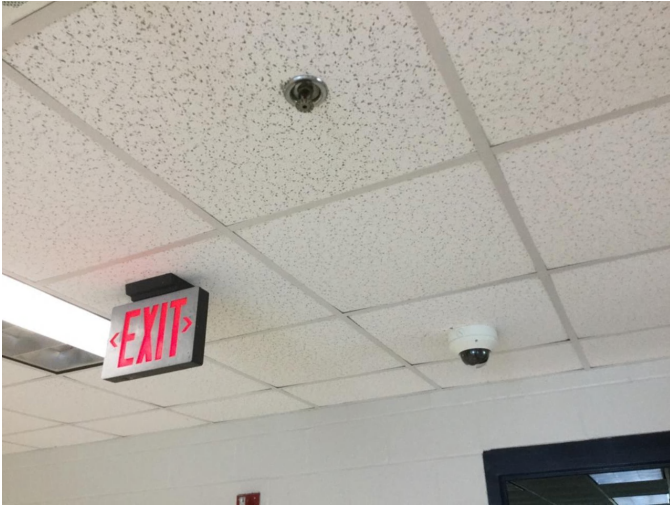
System: D5030810 - Security & Detection Systems

Location: Throughout building
Distress: Beyond Expected Life
Category: Deferred Maintenance
Priority: 3 - Necessary (Years 2-5)
Correction: Renew System
Qty: 43,380.00
Unit of Measure: S.F.
Estimate: \$72,054.00
Assessor Name: Jejuan Hall
Date Created: 12/04/2019

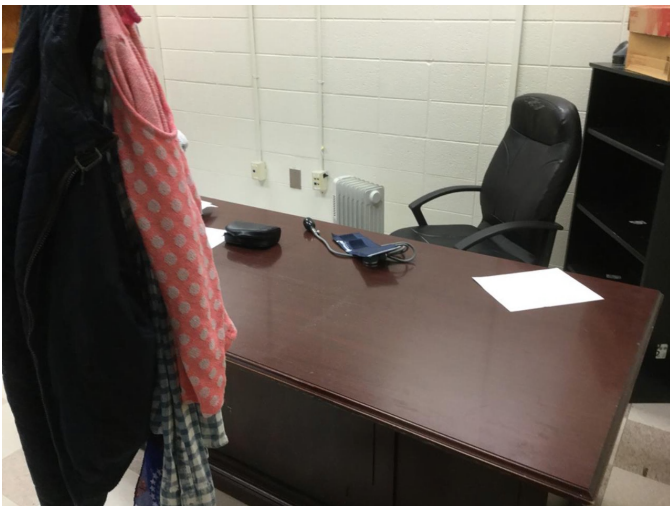
System: D5030920 - Data Communication

Location: Throughout building
Distress: Beyond Expected Life
Category: Deferred Maintenance
Priority: 3 - Necessary (Years 2-5)
Correction: Renew System
Qty: 43,380.00
Unit of Measure: S.F.
Estimate: \$169,876.00
Assessor Name: Jejuan Hall
Date Created: 12/04/2019

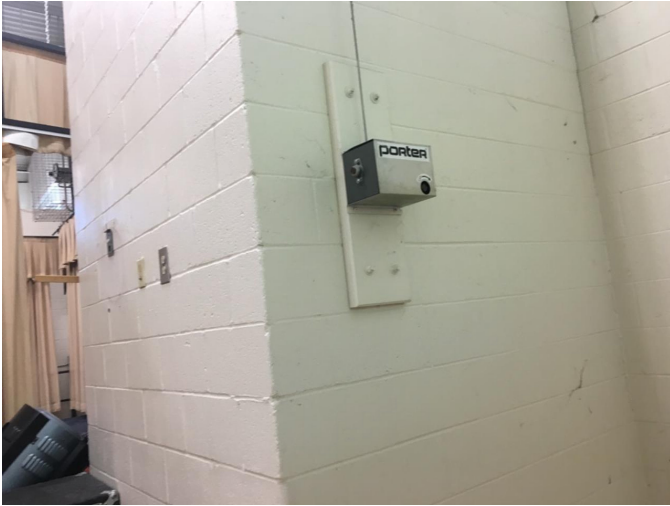
System: E1020 - Institutional Equipment

Location: Throughout building
Distress: Beyond Expected Life
Category: Deferred Maintenance
Priority: 3 - Necessary (Years 2-5)
Correction: Renew System
Qty: 43,380.00
Unit of Measure: S.F.
Estimate: \$4,772.00
Assessor Name: Jejuan Hall
Date Created: 12/04/2019

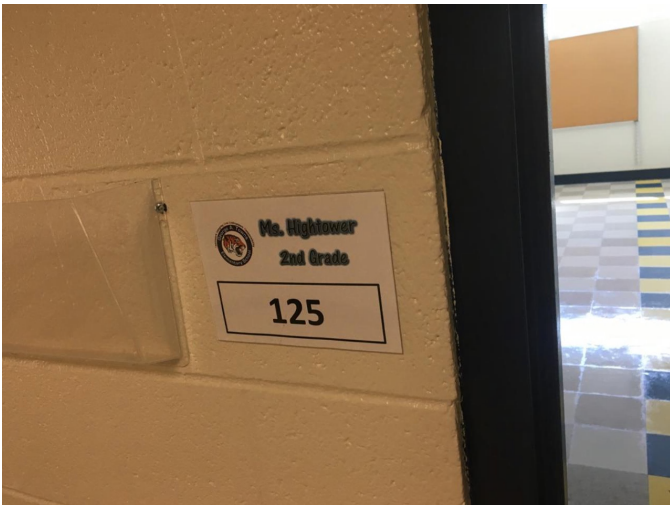
System: C1030 - Fittings

Location: Throughout building
Distress: Beyond Expected Life
Category: ADA Compliance
Priority: 3 - Necessary (Years 2-5)
Correction: Renew System
Qty: 26,704.00
Unit of Measure: S.F.
Estimate: \$91,648.00
Assessor Name: Eduardo Lopez
Date Created: 12/04/2019

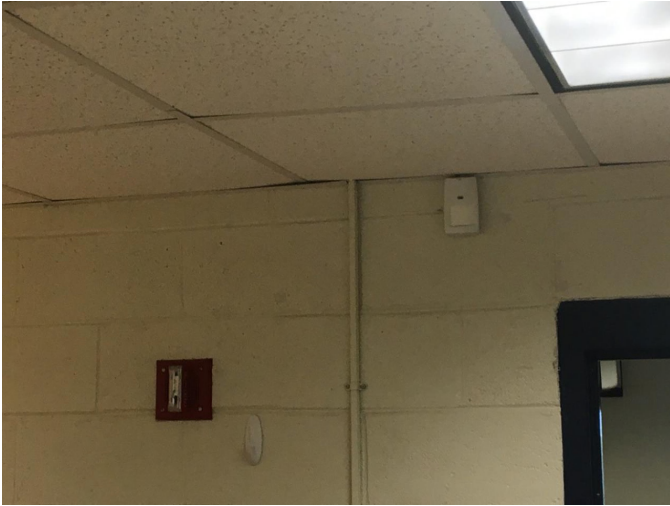
System: C3010230 - Paint & Covering

Location: Throughout building
Distress: Beyond Expected Life
Category: Deferred Maintenance
Priority: 3 - Necessary (Years 2-5)
Correction: Renew System
Qty: 26,704.00
Unit of Measure: S.F.
Estimate: \$43,180.00
Assessor Name: Eduardo Lopez
Date Created: 12/04/2019

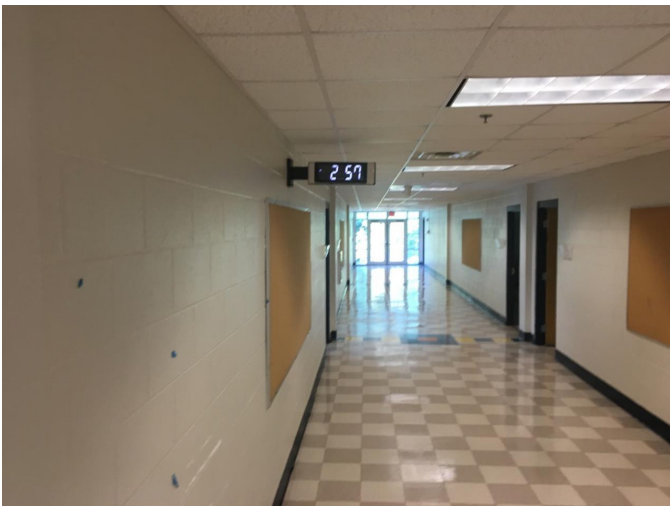
System: C3020903 - VCT

Location: Throughout building
Distress: Beyond Expected Life
Category: Deferred Maintenance
Priority: 3 - Necessary (Years 2-5)
Correction: Renew System
Qty: 20,000.00
Unit of Measure: S.F.
Estimate: \$107,880.00
Assessor Name: Eduardo Lopez
Date Created: 12/04/2019

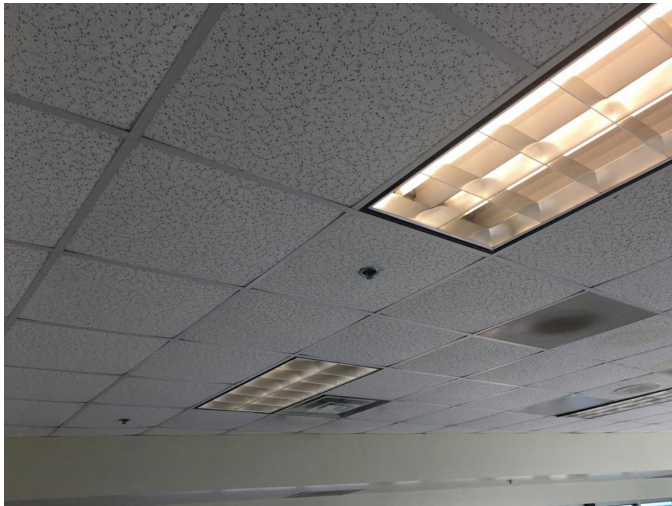
Location: Throughout building
Distress: Beyond Expected Life
Category: Deferred Maintenance
Priority: 3 - Necessary (Years 2-5)
Correction: Renew System
Qty: 26,704.00
Unit of Measure: S.F.
Estimate: \$310,194.00
Assessor Name: Eduardo Lopez
Date Created: 12/04/2019

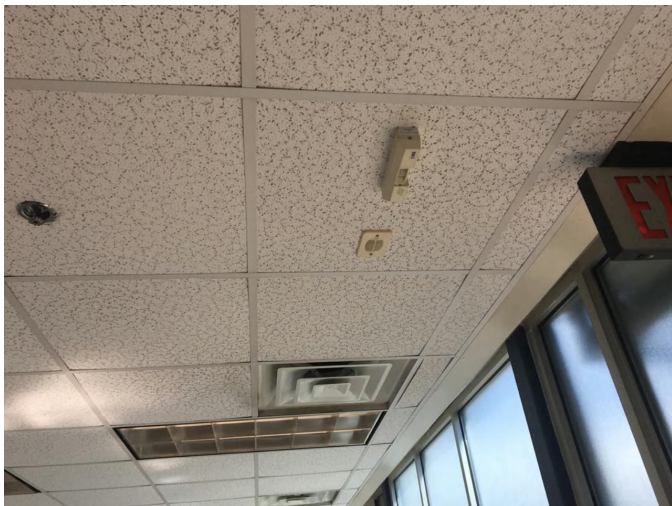
Location: Throughout Building
Distress: Beyond Expected Life
Category: Deferred Maintenance
Priority: 3 - Necessary (Years 2-5)
Correction: Renew System
Qty: 26,704.00
Unit of Measure: S.F.
Estimate: \$366,886.00
Assessor Name: Eduardo Lopez
Date Created: 10/06/2020

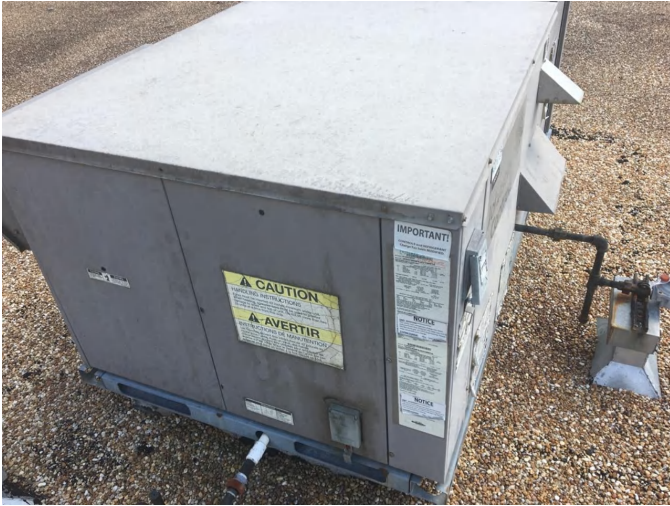
Location: Roof
Distress: Beyond Expected Life
Category: Deferred Maintenance
Priority: 3 - Necessary (Years 2-5)
Correction: Renew System
Qty: 26,704.00
Unit of Measure: S.F.
Estimate: \$592,482.00
Assessor Name: Eduardo Lopez
Date Created: 12/04/2019

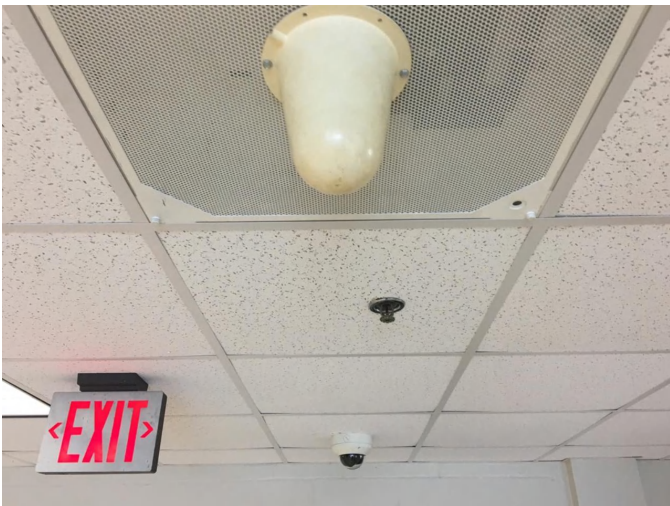
Location: Throughout building
Distress: Beyond Expected Life
Category: Deferred Maintenance
Priority: 3 - Necessary (Years 2-5)
Correction: Renew System
Qty: 26,704.00
Unit of Measure: S.F.
Estimate: \$44,355.00
Assessor Name: Eduardo Lopez
Date Created: 12/05/2019

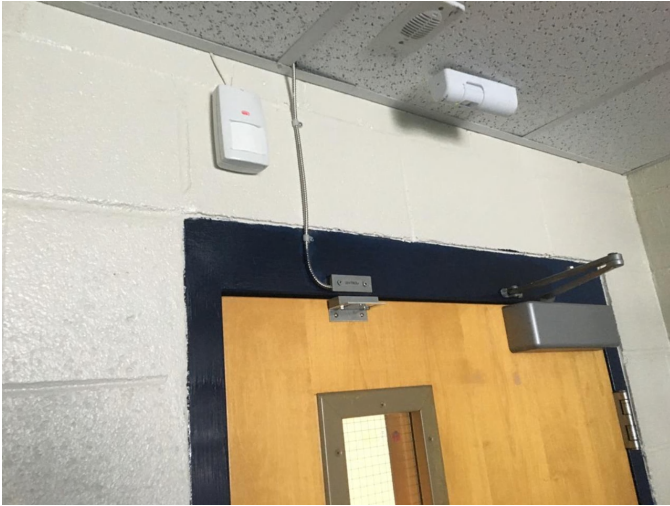
Location: Throughout building
Distress: Beyond Expected Life
Category: Deferred Maintenance
Priority: 3 - Necessary (Years 2-5)
Correction: Renew System
Qty: 26,704.00
Unit of Measure: S.F.
Estimate: \$80,486.00
Assessor Name: Eduardo Lopez
Date Created: 12/05/2019

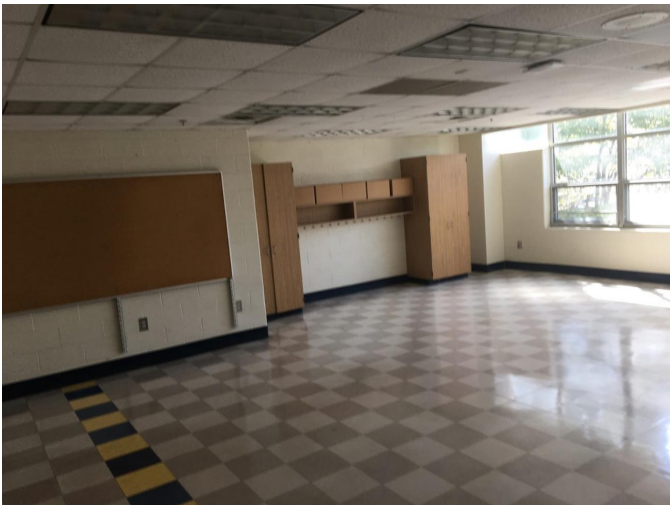
Location: Throughout building
Distress: Beyond Expected Life
Category: Deferred Maintenance
Priority: 3 - Necessary (Years 2-5)
Correction: Renew System
Qty: 26,704.00
Unit of Measure: S.F.
Estimate: \$104,573.00
Assessor Name: Eduardo Lopez
Date Created: 12/05/2019

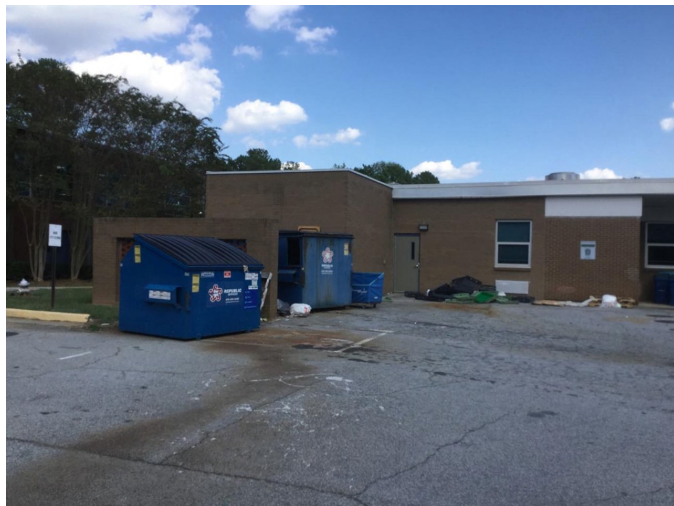
Location: Parking lot
Distress: Inadequate
Category: Code Compliance
Priority: 2 - Trending Critical (Year 1)
Correction: Build secure trash dumpster enclosure
Qty: 1.00
Unit of Measure: Ea.
Estimate: \$10,670.41
Assessor Name: Eduardo Lopez
Date Created: 12/05/2019

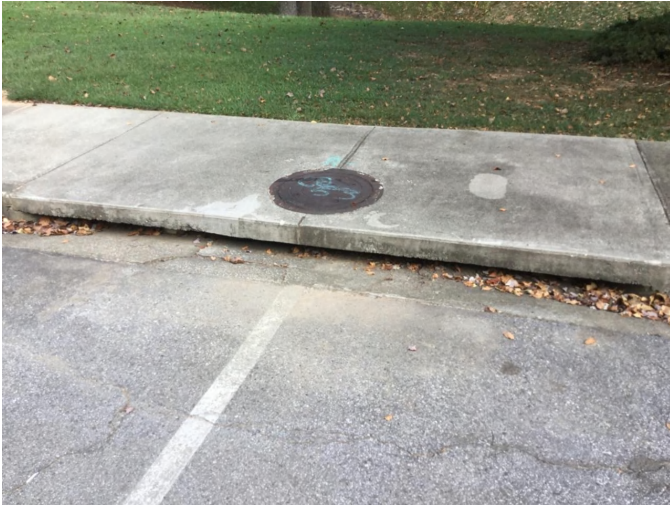
Location: Parking lot
Distress: Beyond Expected Life
Category: Deferred Maintenance
Priority: 3 - Necessary (Years 2-5)
Correction: Renew System
Qty: 70,084.00
Unit of Measure: S.F.
Estimate: \$616,739.00
Assessor Name: Hayden Collins
Date Created: 12/05/2019

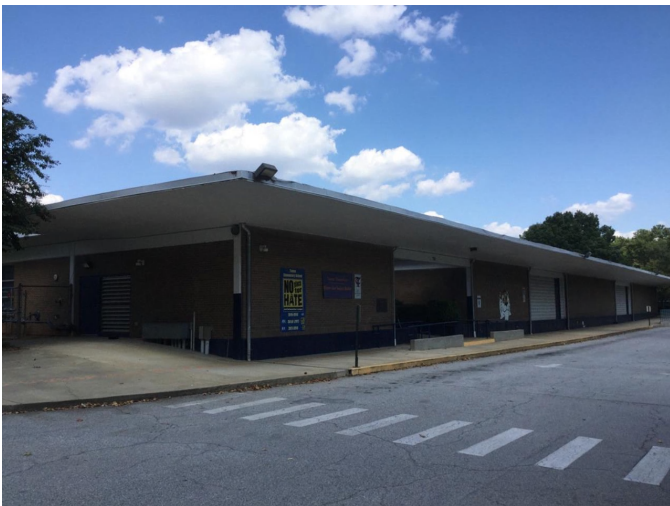
Location: Site
Distress: Beyond Expected Life
Category: Deferred Maintenance
Priority: 3 - Necessary (Years 2-5)
Correction: Renew System
Qty: 70,084.00
Unit of Measure: S.F.
Estimate: \$98,678.00
Assessor Name: Hayden Collins
Date Created: 12/05/2019
