Atlanta Public Schools/Charter Schools

Turner MS (KIPP Atlanta Collegiate)

School Assessment Report

March 12, 2021

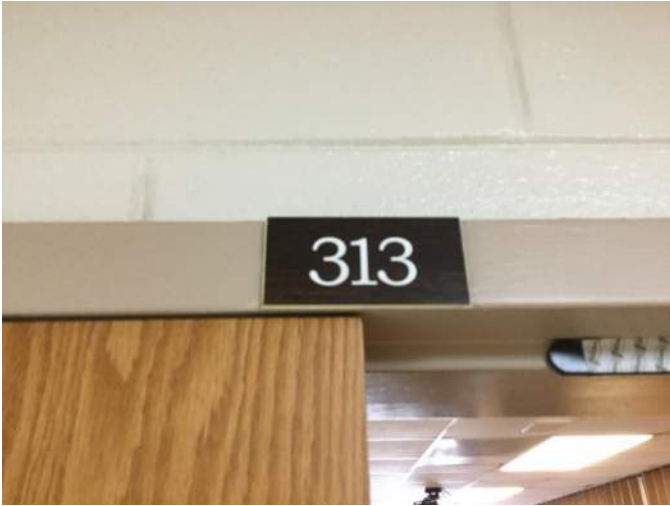
System: C1030 - Fittings

Location: Throughout building
Distress: Beyond Expected Life
Category: ADA Compliance
Priority: 3 - Necessary (Years 2-5)
Correction: Renew System
Qty: 103,864.00
Unit of Measure: S.F.
Estimate: \$302,764.00
Assessor Name: Eduardo Lopez
Date Created: 09/30/2019

Notes: Fittings, such as toilet partitions, lockers, signage and railing, are beyond their expected service life, worn and damaged in areas, and should be replaced and upgraded for compliance with ADA standards.

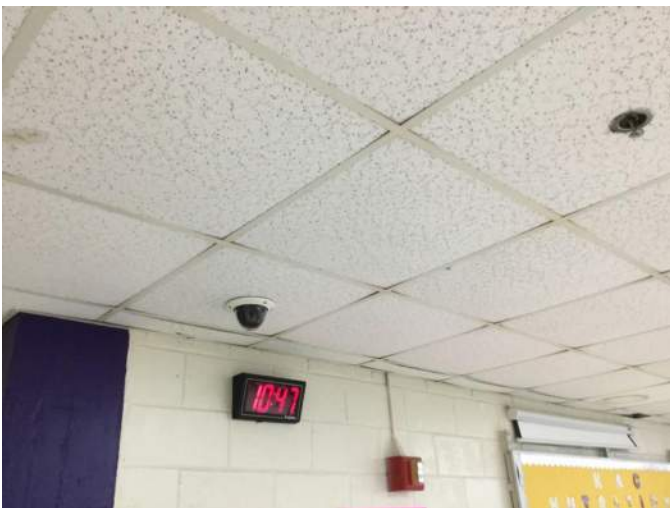
System: C3030 - Ceiling Finishes

Location: Throughout building
Distress: Beyond Expected Life
Category: Deferred Maintenance
Priority: 3 - Necessary (Years 2-5)
Correction: Renew System
Qty: 51,932.00
Unit of Measure: S.F.
Estimate: \$517,554.00
Assessor Name: Eduardo Lopez
Date Created: 09/30/2019

Notes: The acoustical ceiling tile finish in classrooms is beyond its expected service life and is recommended for replacement in conjunction with other recommended renovations.

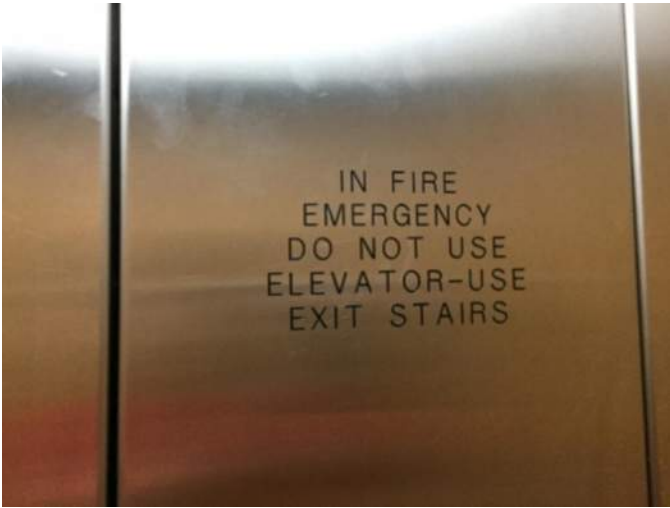
System: D1010 - Elevators and Lifts

Location: Throughout building
Distress: Beyond Expected Life
Category: Deferred Maintenance
Priority: 3 - Necessary (Years 2-5)
Correction: Renew System
Qty: 103,864.00
Unit of Measure: S.F.
Estimate: \$142,813.00
Assessor Name: Eduardo Lopez
Date Created: 09/30/2019

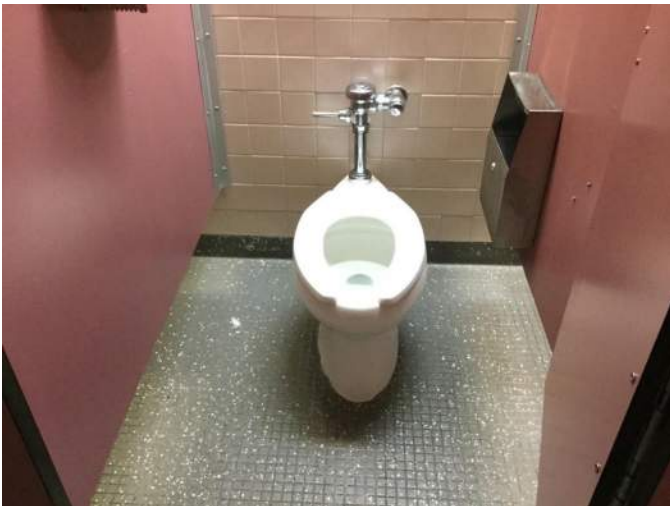
System: D2010 - Plumbing Fixtures

Location: Restroom
Distress: Beyond Expected Life
Category: ADA Compliance
Priority: 3 - Necessary (Years 2-5)
Correction: Renew System
Qty: 103,864.00
Unit of Measure: S.F.
Estimate: \$731,203.00
Assessor Name: Eduardo Lopez
Date Created: 09/30/2019

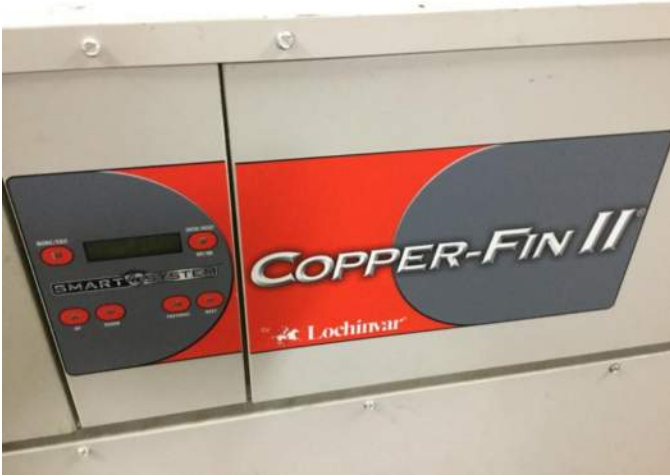
System: D3020 - Heat Generating Systems

Location: Throughout building
Distress: Beyond Expected Life
Category: Deferred Maintenance
Priority: 3 - Necessary (Years 2-5)
Correction: Renew System
Qty: 103,864.00
Unit of Measure: S.F.
Estimate: \$413,586.00
Assessor Name: Eduardo Lopez
Date Created: 09/30/2019

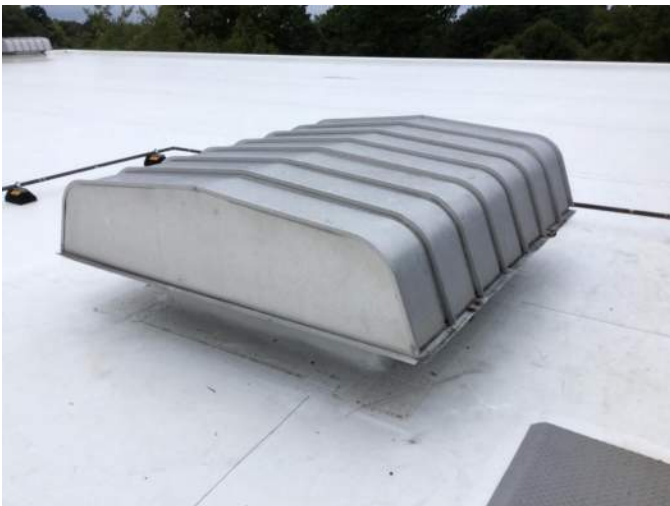
System: D3040 - Distribution Systems

Location: Throughout building
Distress: Beyond Expected Life
Category: Deferred Maintenance
Priority: 3 - Necessary (Years 2-5)
Correction: Renew System
Qty: 103,864.00
Unit of Measure: S.F.
Estimate: \$1,223,622.00
Assessor Name: Eduardo Lopez
Date Created: 09/30/2019

Notes: The distribution system is beyond its expected service life and should be scheduled for replacement.

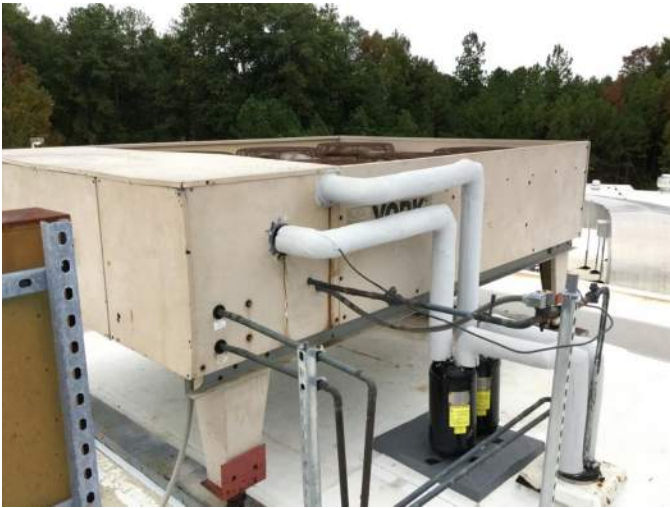
System: D3050 - Terminal & Package Units

Location: Throughout building
Distress: Beyond Expected Life
Category: Deferred Maintenance
Priority: 3 - Necessary (Years 2-5)
Correction: Renew System
Qty: 103,864.00
Unit of Measure: S.F.
Estimate: \$134,815.00
Assessor Name: Eduardo Lopez
Date Created: 02/22/2020

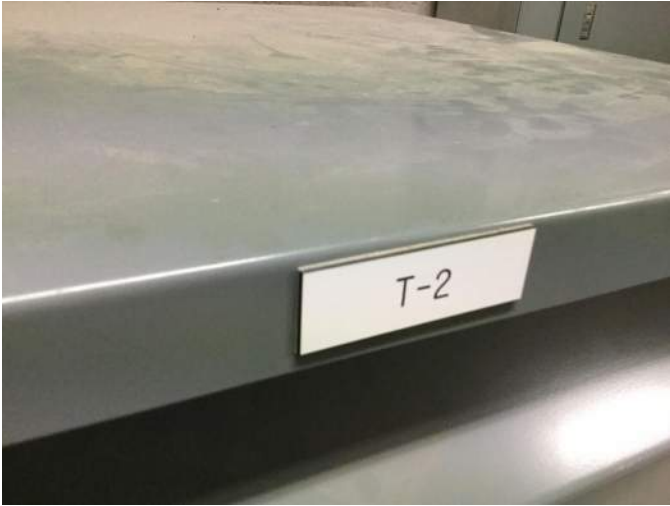
System: D5010 - Electrical Service/Distribution

Location: Throughout building
Distress: Beyond Expected Life
Category: Deferred Maintenance
Priority: 3 - Necessary (Years 2-5)
Correction: Renew System
Qty: 103,864.00
Unit of Measure: S.F.
Estimate: \$267,346.00
Assessor Name: Eduardo Lopez
Date Created: 09/30/2019

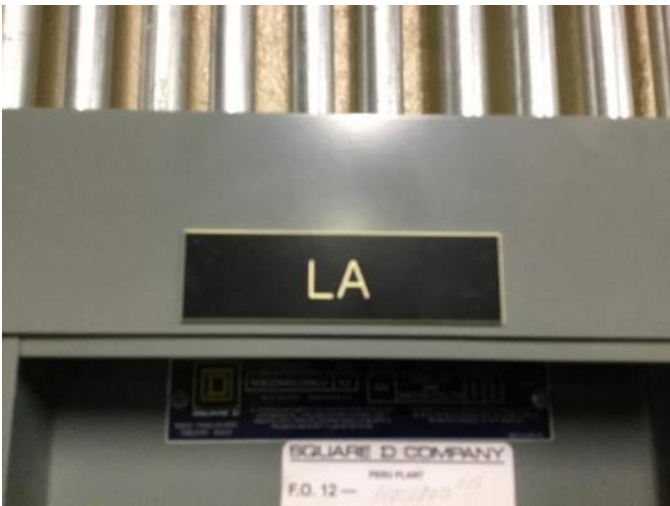
System: D5020 - Branch Wiring

Location: Throughout building
Distress: Beyond Expected Life
Category: Deferred Maintenance
Priority: 3 - Necessary (Years 2-5)
Correction: Renew System
Qty: 103,864.00
Unit of Measure: S.F.
Estimate: \$612,382.00
Assessor Name: Eduardo Lopez
Date Created: 01/20/2020

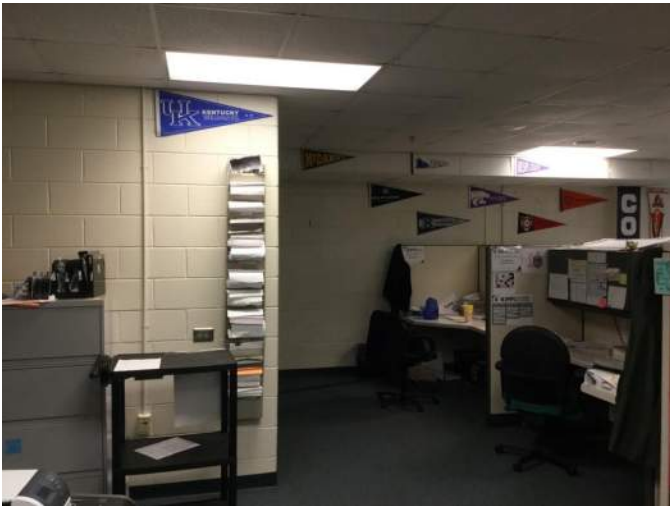
System: D5020 - Lighting

Location: Classroom Area
Distress: Beyond Expected Life
Category: Deferred Maintenance
Priority: 3 - Necessary (Years 2-5)
Correction: Renew System
Qty: 51,932.00
Unit of Measure: S.F.
Estimate: \$341,193.00
Assessor Name: Eduardo Lopez
Date Created: 03/11/2021

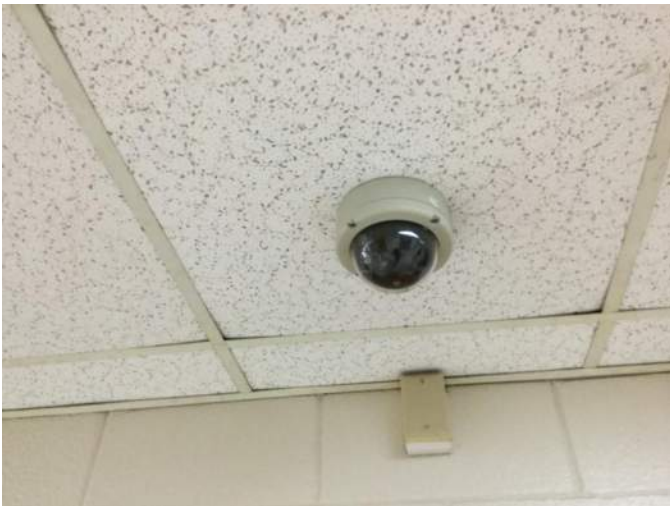
System: D5030810 - Security & Detection Systems

Location: Throughout building
Distress: Beyond Expected Life
Category: Deferred Maintenance
Priority: 3 - Necessary (Years 2-5)
Correction: Renew System
Qty: 103,864.00
Unit of Measure: S.F.
Estimate: \$172,518.00
Assessor Name: Eduardo Lopez
Date Created: 01/20/2020

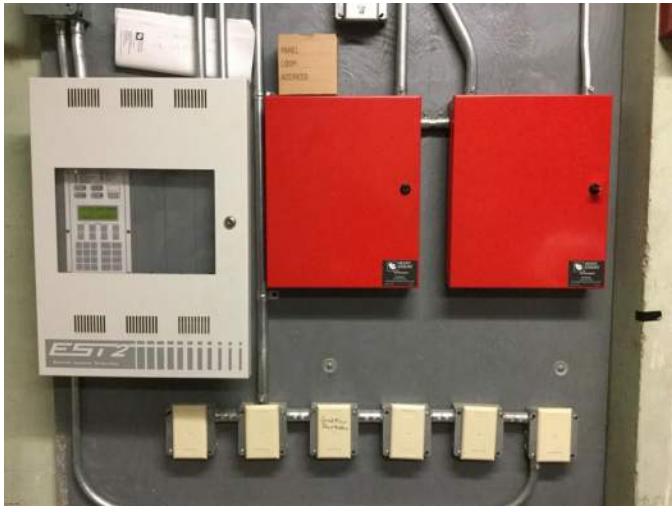
System: D5030910 - Fire Alarm Systems

Location: Throughout Building
Distress: Beyond Expected Life
Category: Deferred Maintenance
Priority: 3 - Necessary (Years 2-5)
Correction: Renew System
Qty: 103,864.00
Unit of Measure: S.F.
Estimate: \$313,046.00
Assessor Name: Eduardo Lopez
Date Created: 03/11/2021

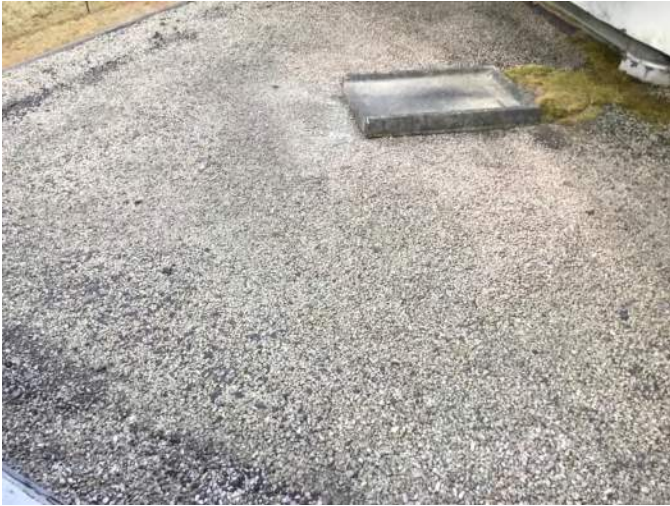
System: B3020 - Roof Openings

Location: Roof
Distress: Beyond Expected Life
Category: Deferred Maintenance
Priority: 3 - Necessary (Years 2-5)
Correction: Renew System
Qty: 31,216.00
Unit of Measure: S.F.
Estimate: \$14,078.00
Assessor Name: Eduardo Lopez
Date Created: 01/20/2020

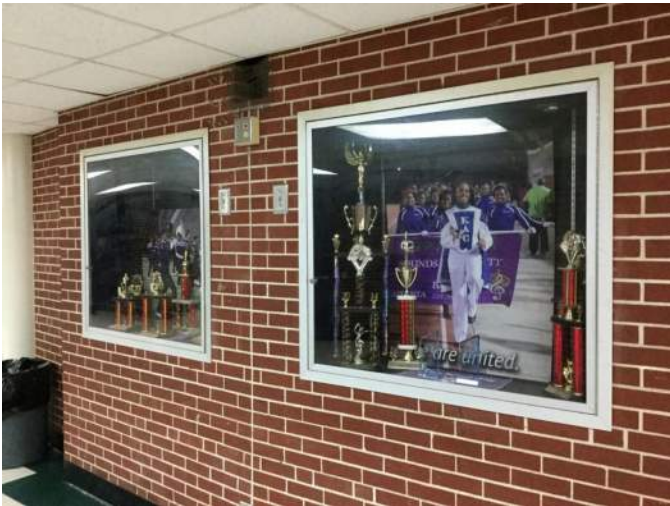
Location: Throughout building
Distress: Beyond Expected Life
Category: ADA Compliance
Priority: 3 - Necessary (Years 2-5)
Correction: Renew System
Qty: 31,216.00
Unit of Measure: S.F.
Estimate: \$152,334.00
Assessor Name: Eduardo Lopez
Date Created: 02/22/2020

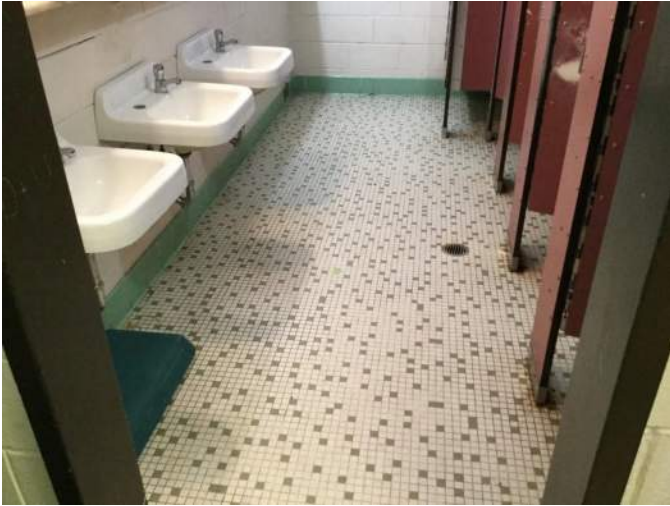
Location: Throughout building
Distress: Beyond Expected Life
Category: Deferred Maintenance
Priority: 3 - Necessary (Years 2-5)
Correction: Renew System
Qty: 2,000.00
Unit of Measure: S.F.
Estimate: \$50,220.00
Assessor Name: Eduardo Lopez
Date Created: 01/20/2020

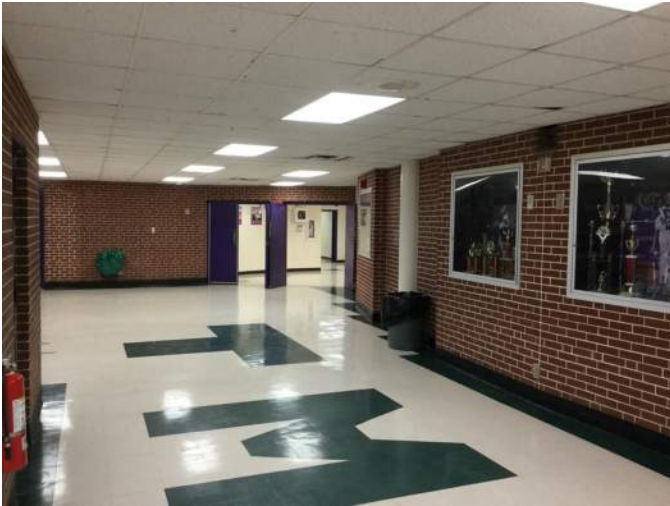
Location: Throughout building
Distress: Beyond Expected Life
Category: Deferred Maintenance
Priority: 3 - Necessary (Years 2-5)
Correction: Renew System
Qty: 12,216.00
Unit of Measure: S.F.
Estimate: \$65,893.00
Assessor Name: Eduardo Lopez
Date Created: 01/20/2020

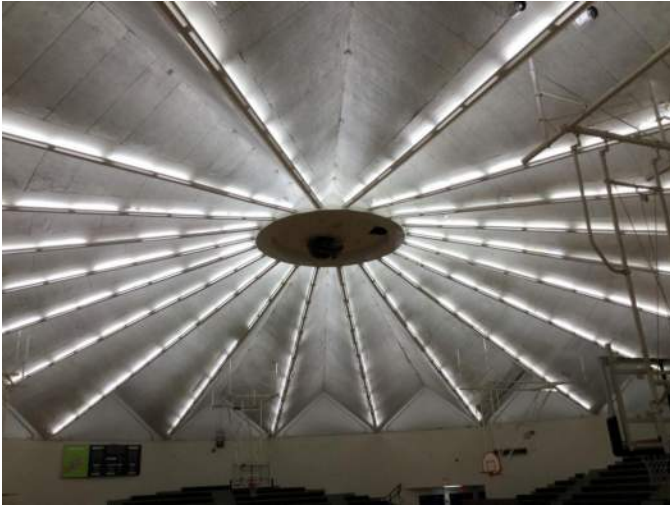
Location: Throughout building
Distress: Beyond Expected Life
Category: Deferred Maintenance
Priority: 3 - Necessary (Years 2-5)
Correction: Renew System
Qty: 31,216.00
Unit of Measure: S.F.
Estimate: \$180,116.00
Assessor Name: Eduardo Lopez
Date Created: 02/22/2020

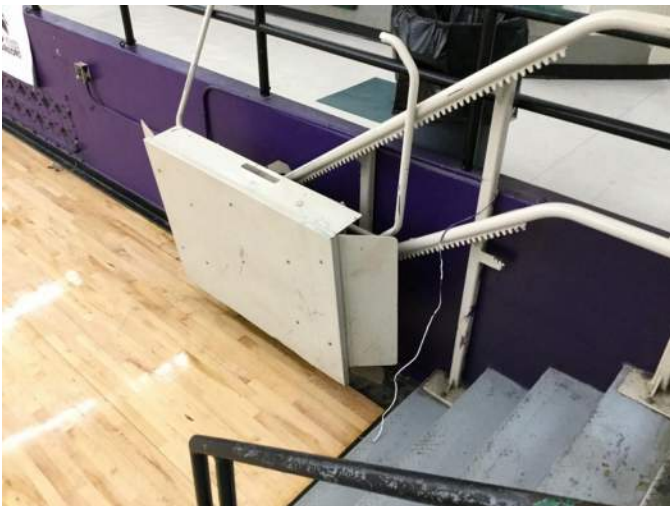
Location: Gym
Distress: Beyond Expected Life
Category: ADA Compliance
Priority: 3 - Necessary (Years 2-5)
Correction: Renew System
Qty: 31,216.00
Unit of Measure: S.F.
Estimate: \$23,006.00
Assessor Name: Eduardo Lopez
Date Created: 02/22/2020

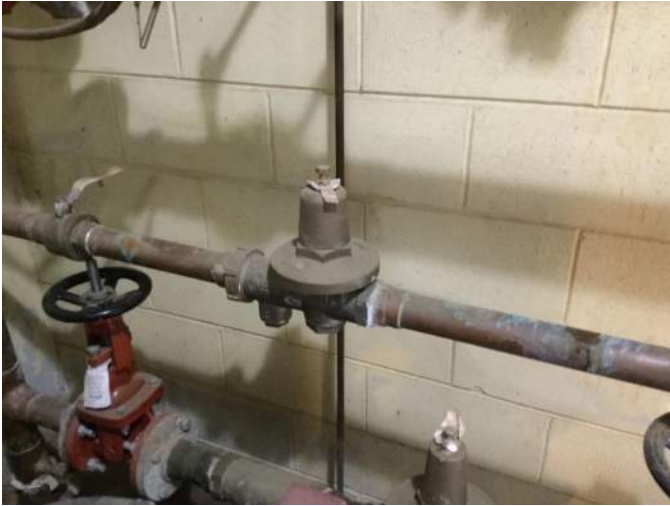
Location: Throughout building
Distress: Beyond Expected Life
Category: Deferred Maintenance
Priority: 3 - Necessary (Years 2-5)
Correction: Renew System
Qty: 31,216.00
Unit of Measure: S.F.
Estimate: \$153,146.00
Assessor Name: Eduardo Lopez
Date Created: 02/22/2020

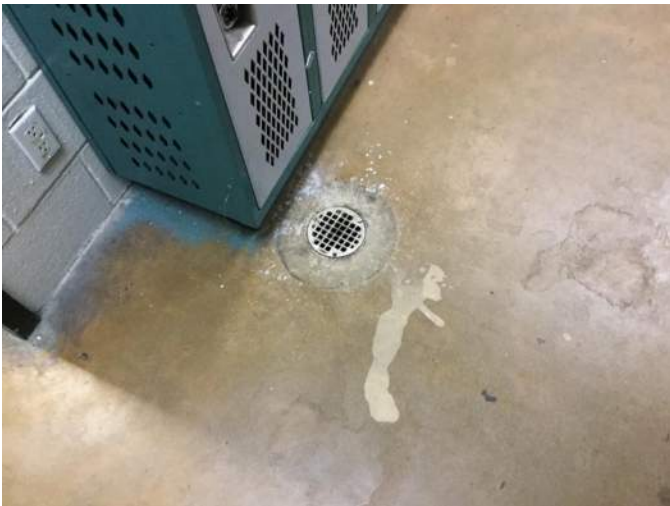
Location: Throughout building
Distress: Beyond Expected Life
Category: Deferred Maintenance
Priority: 3 - Necessary (Years 2-5)
Correction: Renew System
Qty: 31,216.00
Unit of Measure: S.F.
Estimate: \$109,194.00
Assessor Name: Eduardo Lopez
Date Created: 02/22/2020

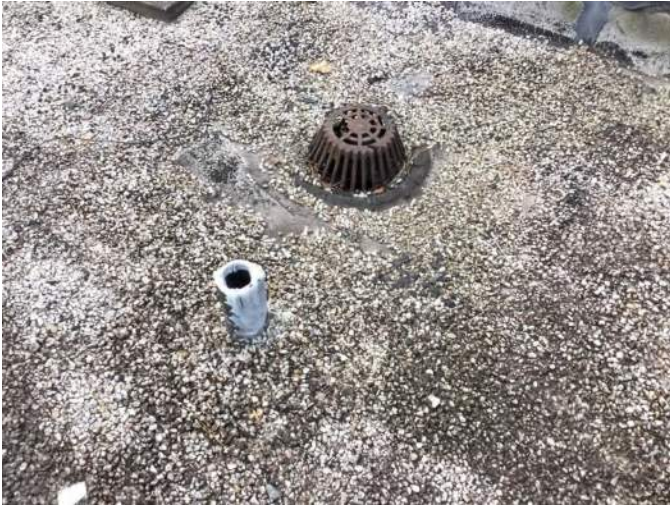
Location: Roof
Distress: Beyond Expected Life
Category: Deferred Maintenance
Priority: 3 - Necessary (Years 2-5)
Correction: Renew System
Qty: 31,216.00
Unit of Measure: S.F.
Estimate: \$45,326.00
Assessor Name: Eduardo Lopez
Date Created: 02/22/2020

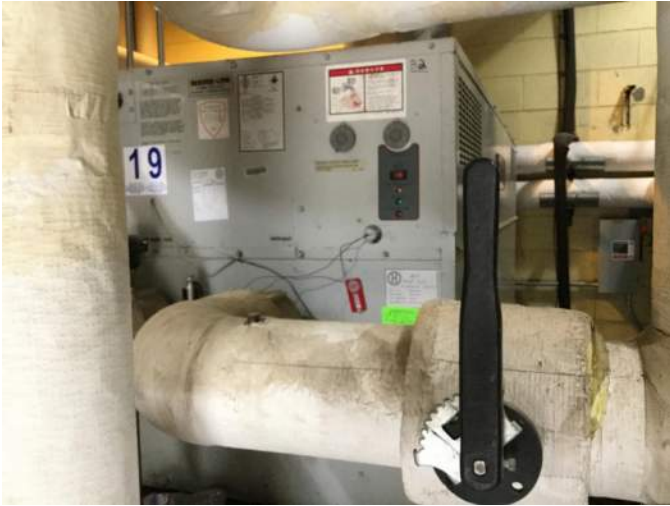
Location: Throughout building
Distress: Beyond Expected Life
Category: Deferred Maintenance
Priority: 3 - Necessary (Years 2-5)
Correction: Renew System
Qty: 31,216.00
Unit of Measure: S.F.
Estimate: \$589,233.00
Assessor Name: Eduardo Lopez
Date Created: 02/22/2020

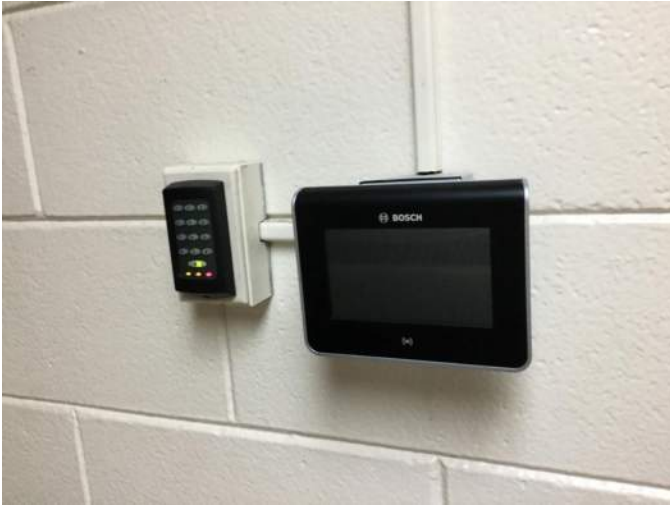
Location: Throughout building
Distress: Beyond Expected Life
Category: Deferred Maintenance
Priority: 3 - Necessary (Years 2-5)
Correction: Renew System
Qty: 31,216.00
Unit of Measure: S.F.
Estimate: \$99,267.00
Assessor Name: Eduardo Lopez
Date Created: 02/22/2020

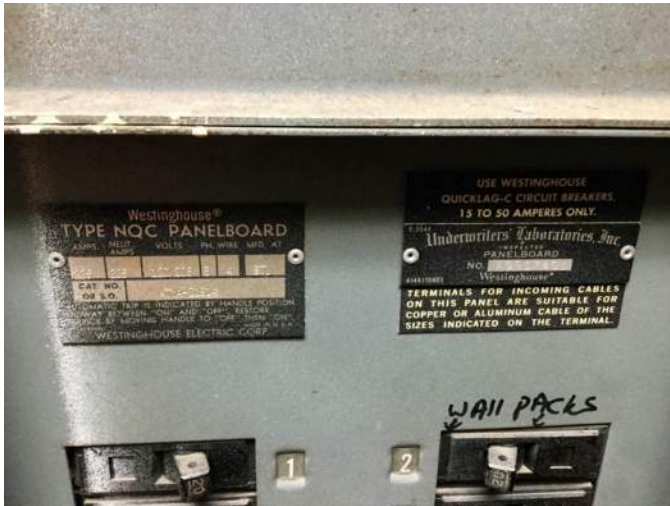
Location: Throughout building
Distress: Beyond Expected Life
Category: Deferred Maintenance
Priority: 3 - Necessary (Years 2-5)
Correction: Renew System
Qty: 31,216.00
Unit of Measure: S.F.
Estimate: \$241,612.00
Assessor Name: Eduardo Lopez
Date Created: 01/20/2020

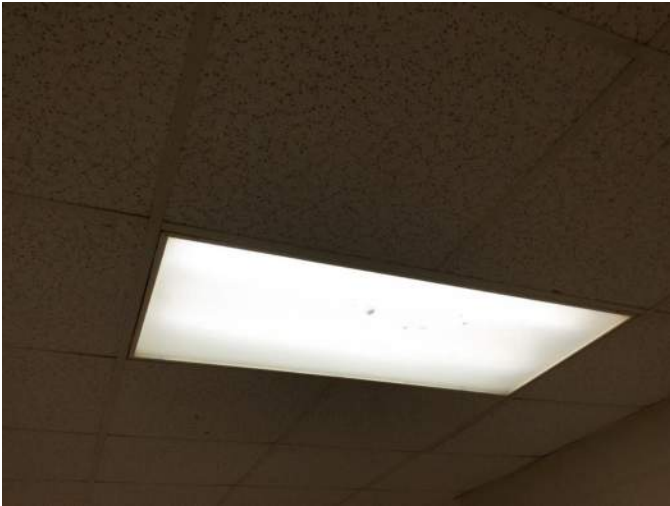
Location: Throughout building
Distress: Beyond Expected Life
Category: Deferred Maintenance
Priority: 3 - Necessary (Years 2-5)
Correction: Renew System
Qty: 31,216.00
Unit of Measure: S.F.
Estimate: \$384,893.00
Assessor Name: Eduardo Lopez
Date Created: 02/22/2020

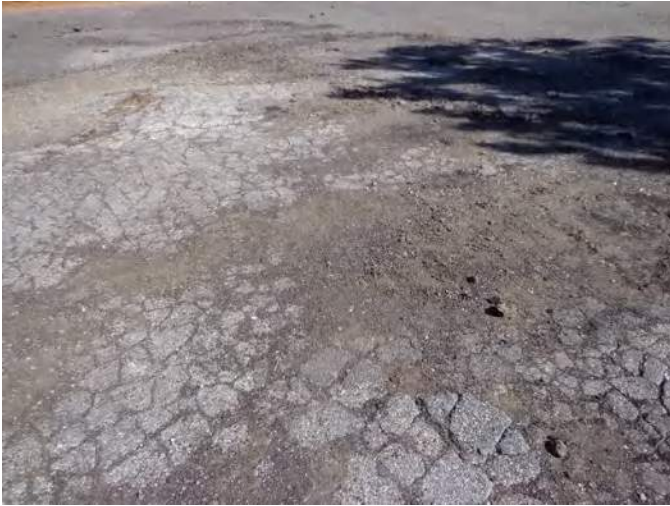
Location: Site
Distress: Damaged
Category: Deferred Maintenance
Priority: 3 - Necessary (Years 2-5)
Correction: Resurface asphalt paving and restripe.
Qty: 9,400.00
Unit of Measure: S.Y.
Estimate: \$21,645.43
Assessor Name: Hayden Collins
Date Created: 10/30/2014

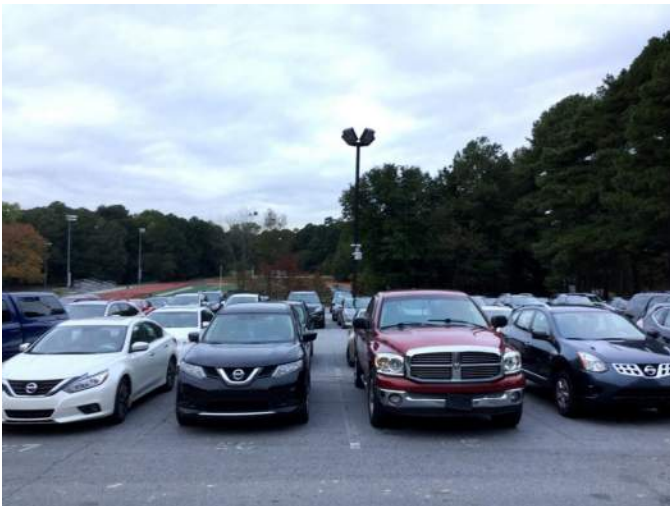
Location: Site
Distress: Beyond Expected Life
Category: Deferred Maintenance
Priority: 3 - Necessary (Years 2-5)
Correction: Renew System
Qty: 135,080.00
Unit of Measure: S.F.
Estimate: \$442,792.00
Assessor Name: Hayden Collins
Date Created: 02/22/2020

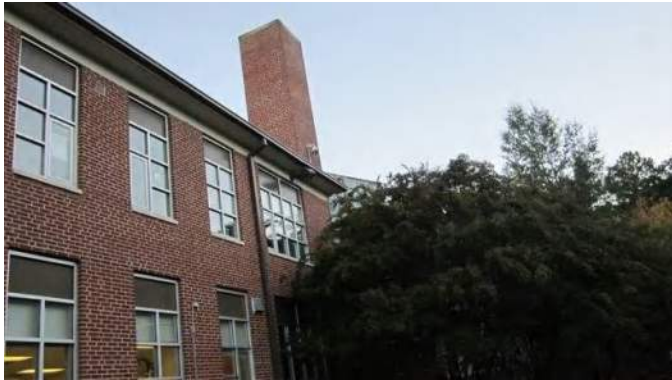
Location: Site
Distress: Inadequate
Category: Mission Integrity
Priority: 3 - Necessary (Years 2-5)
Correction: Renew System
Qty: 135,080.00
Unit of Measure: S.F.
Estimate: \$190,193.00
Assessor Name: Hayden Collins
Date Created: 10/17/2014

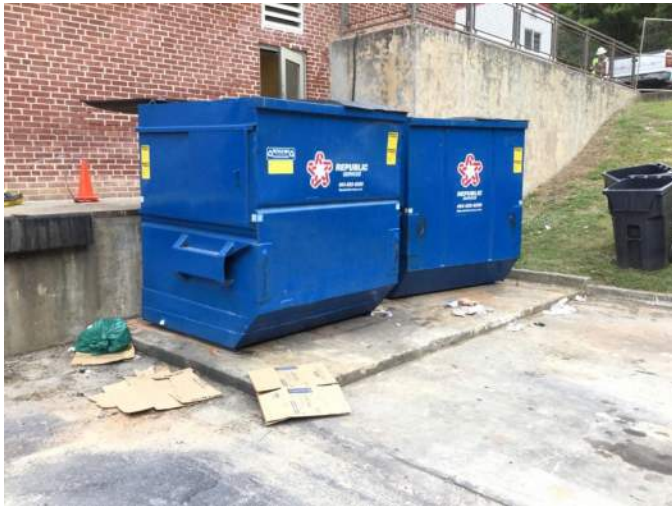
Location: Loading dock
Distress: Inadequate
Category: Code Compliance
Priority: 4 - Recommended (Years 6-10)
Correction: Build secure trash dumpster enclosure
Qty: 1.00
Unit of Measure: Ea.
Estimate: \$10,670.41
Assessor Name: Hayden Collins
Date Created: 01/21/2020
