Atlanta Public Schools/ Douglass Cluster

Usher-Collier Heights Elementary School

School Assessment Report

November 10, 2020

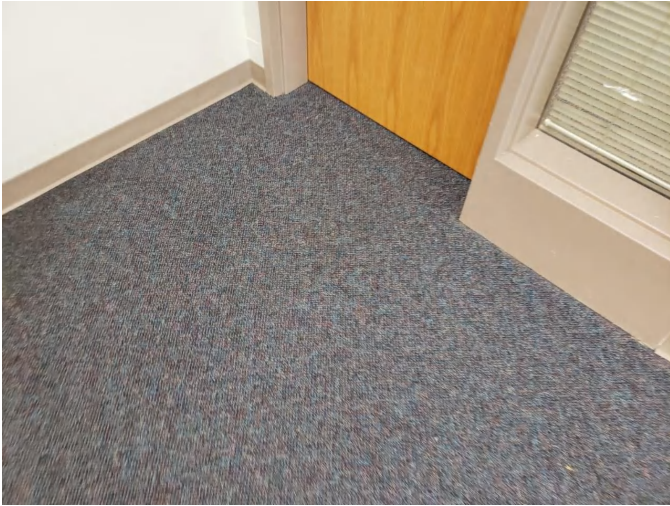
System: C3020901 - Carpet

Location: Administration Area
Distress: Beyond Expected Life
Category: Deferred Maintenance
Priority: 3 - Necessary (Years 2-5)
Correction: Renew System
Qty: 5,000.00
Unit of Measure: S.F.
Estimate: \$41,250.00
Assessor Name: Eduardo Lopez
Date Created: 11/15/2019

Notes: The carpet is aged, worn and stained, and should be replaced.

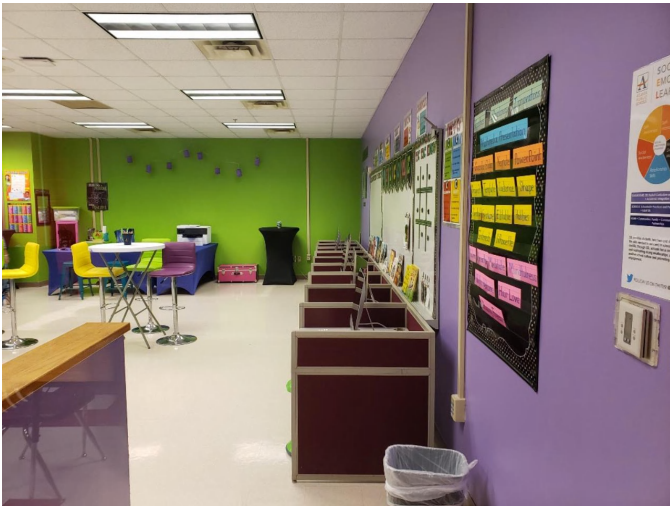
System: C3020903 - VCT

Location: Throughout building
Distress: Beyond Expected Life
Category: Deferred Maintenance
Priority: 3 - Necessary (Years 2-5)
Correction: Renew System
Qty: 50,000.00
Unit of Measure: S.F.
Estimate: \$269,700.00
Assessor Name: Eduardo Lopez
Date Created: 11/15/2019

Notes: The VCT floor finish is beyond its expected service life, worn and damaged, and is recommended for replacement.

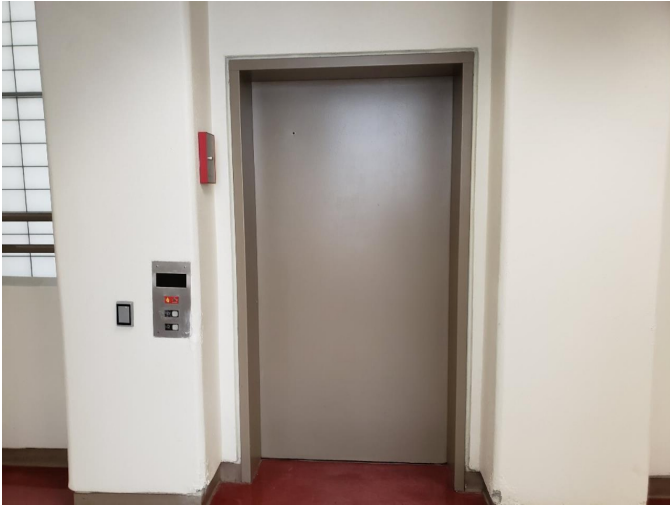
System: D1010 - Elevators and Lifts

Location: Throughout building
Distress: Beyond Expected Life
Category: Deferred Maintenance
Priority: 3 - Necessary (Years 2-5)
Correction: Renew System
Qty: 69,131.00
Unit of Measure: S.F.
Estimate: \$103,420.00
Assessor Name: Eduardo Lopez
Date Created: 08/13/2014

Notes: The elevator system is from original construction. The elevator system has exceeded its life cycle and recommended for upgrade. All aspects of the current ADA standards are expected to be included in the new installation.

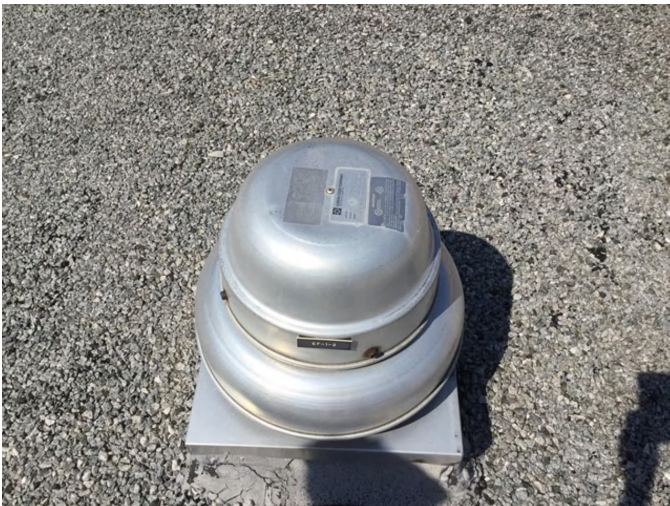
System: D3040 - Distribution Systems

Location: Throughout Building
Distress: Beyond Expected Life
Category: Deferred Maintenance
Priority: 3 - Necessary (Years 2-5)
Correction: Renew System
Qty: 69,131.00
Unit of Measure: S.F.
Estimate: \$860,819.00
Assessor Name: Eduardo Lopez
Date Created: 10/06/2020

Notes: The distribution system is beyond its expected service life and should be scheduled for replacement.

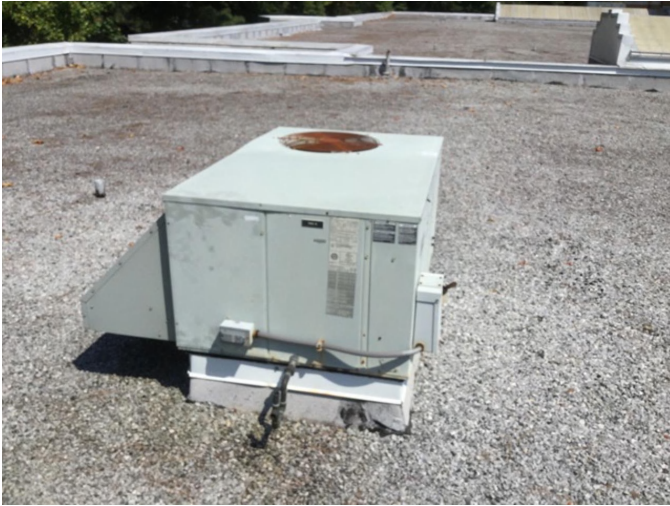
System: D3050 - Terminal & Package Units

Location: Roof
Distress: Beyond Expected Life
Category: Deferred Maintenance
Priority: 3 - Necessary (Years 2-5)
Correction: Renew System
Qty: 69,131.00
Unit of Measure: S.F.
Estimate: \$539,153.00
Assessor Name: Eduardo Lopez
Date Created: 09/30/2019

Notes: The terminal and package units are at the end of their useful life. The system is functional however upgrades are warranted.

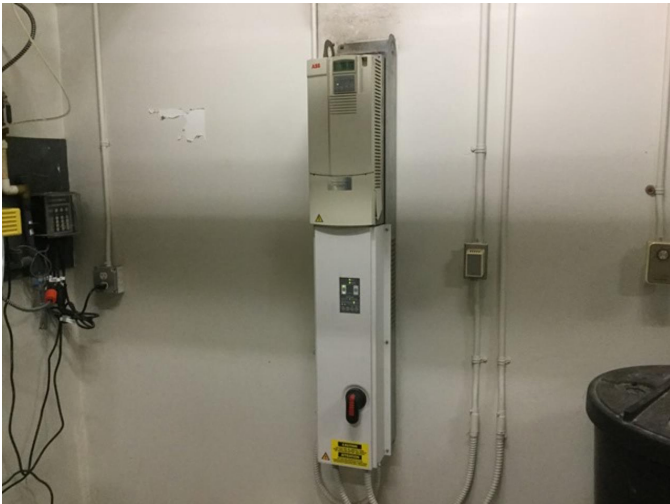
System: D3060 - Controls & Instrumentation

Location: Throughout building
Distress: Beyond Expected Life
Category: Deferred Maintenance
Priority: 3 - Necessary (Years 2-5)
Correction: Renew System
Qty: 69,131.00
Unit of Measure: S.F.
Estimate: \$178,704.00
Assessor Name: Eduardo Lopez
Date Created: 09/30/2019

Notes: The heating generation systems, exhaust and ventilation systems, energy monitoring and controls as well as the building automation systems are original. Several issues have surfaced over recent years and isolated upgrades have taken place to support the systems. This deficiency provides a budgetary consideration for a universal upgrade.

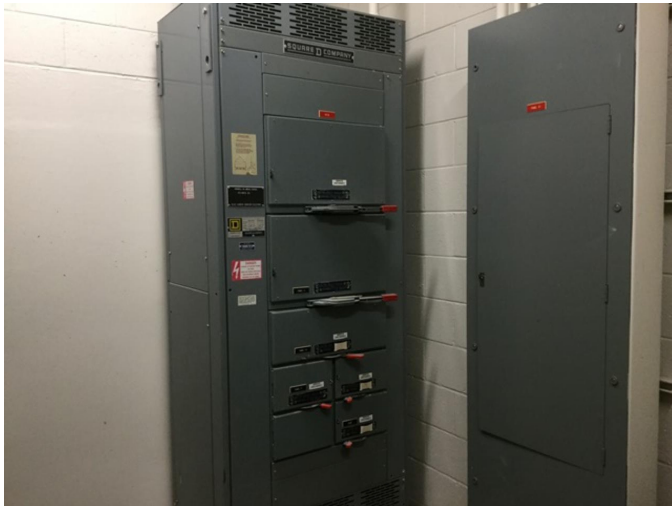
System: D5010 - Electrical Service/Distribution

Location: Throughout building
Distress: Beyond Expected Life
Category: Deferred Maintenance
Priority: 3 - Necessary (Years 2-5)
Correction: Renew System
Qty: 69,131.00
Unit of Measure: S.F.
Estimate: \$186,308.00
Assessor Name: Eduardo Lopez
Date Created: 08/13/2014

Notes: The electrical service/distribution system is aged and becoming logistically unsupportable and should be replaced.

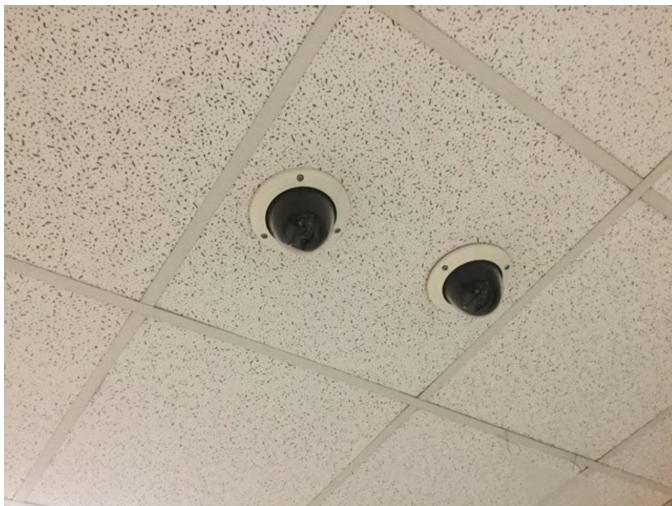
System: D5030810 - Security & Detection Systems

Location: Throughout building
Distress: Beyond Expected Life
Category: Deferred Maintenance
Priority: 3 - Necessary (Years 2-5)
Correction: Renew System
Qty: 69,131.00
Unit of Measure: S.F.
Estimate: \$114,827.00
Assessor Name: Eduardo Lopez
Date Created: 11/15/2019

Notes: Several cameras were reported to be out of service during the time of the inspection. Universal upgrades to the security system to include a new camera system is recommended.

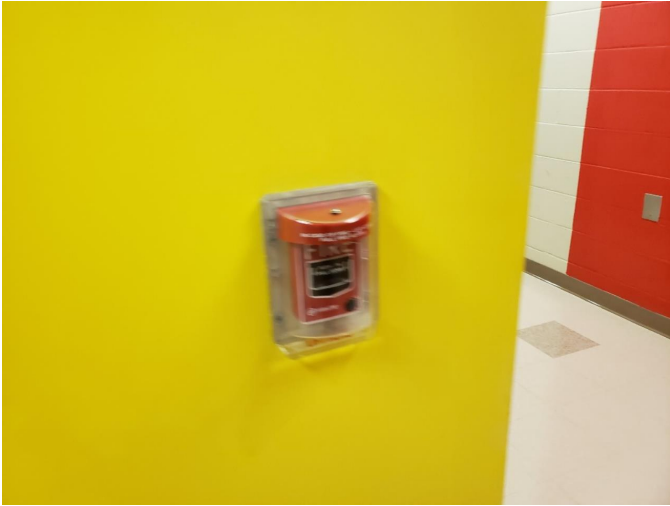
System: D5030910 - Fire Alarm Systems

Location: Throughout building
Distress: Beyond Expected Life
Category: Deferred Maintenance
Priority: 3 - Necessary (Years 2-5)
Correction: Renew System
Qty: 69,131.00
Unit of Measure: S.F.
Estimate: \$208,361.00
Assessor Name: Eduardo Lopez
Date Created: 11/15/2019

Notes: The main panel for the fire alarm system is in the office. This fire alarm system appears to be from 1989 construction. There are components such as push stations, lights and alarm bells installed to support the fire life safety for this building. Although several components have been replaced on an isolated basis. This system is nearing the end of its expected life and upgrades are warranted. This deficiency provides a budgetary consideration for universal upgrades to the fire alarm system.

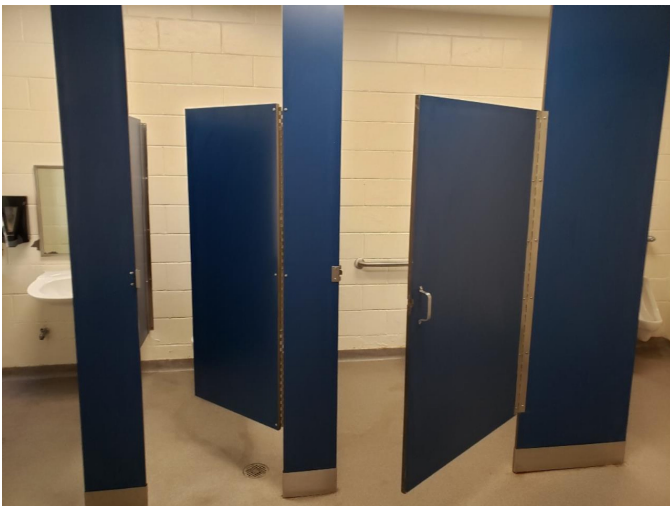
System: C3020405 - Epoxy

Location: Restrooms
Distress: Beyond Expected Life
Category: Deferred Maintenance
Priority: 4 - Recommended (Years 6-10)
Correction: Renew System
Qty: 4,131.00
Unit of Measure: S.F.
Estimate: \$84,330.00
Assessor Name: Eduardo Lopez
Date Created: 11/15/2019

Notes: The epoxy floor finish is worn and deteriorating and should be replaced.

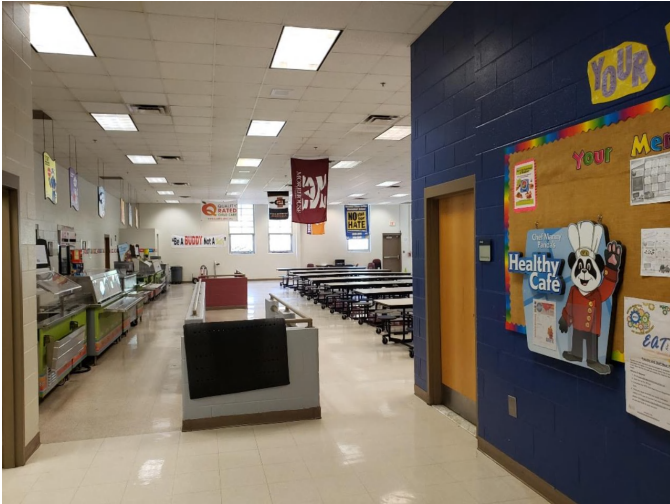
System: C3020903 - VCT

Location: 1989 Bldg 2012
Distress: Beyond Expected Life
Category: Deferred Maintenance
Priority: 3 - Necessary (Years 2-5)
Correction: Renew System
Qty: 27,000.00
Unit of Measure: S.F.
Estimate: \$145,638.00
Assessor Name: Eduardo Lopez
Date Created: 01/31/2020

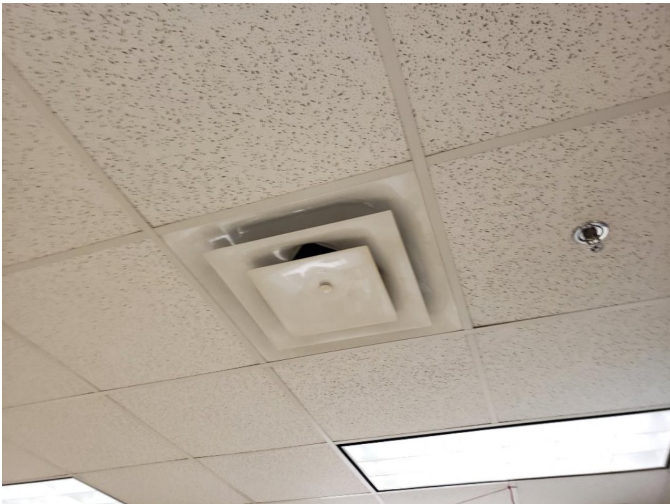
System: D3040 - Distribution Systems

Location: Throughout Building
Distress: Beyond Expected Life
Category: Deferred Maintenance
Priority: 3 - Necessary (Years 2-5)
Correction: Renew System
Qty: 33,831.00
Unit of Measure: S.F.
Estimate: \$404,889.00
Assessor Name: Eduardo Lopez
Date Created: 10/06/2020

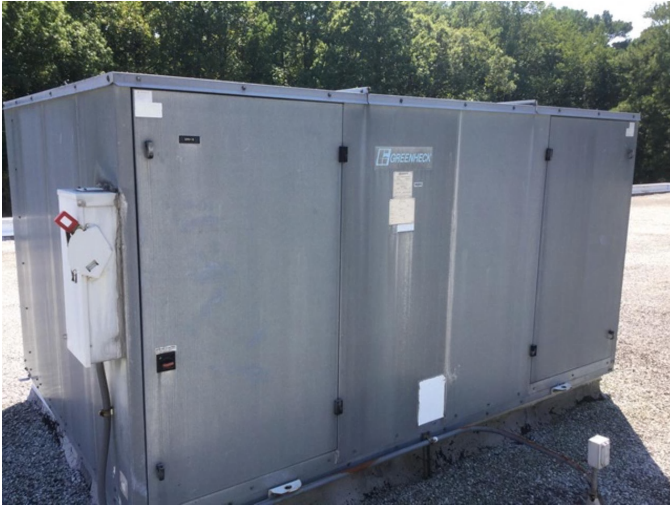
System: D3050 - Terminal & Package Units

Location: Roof
Distress: Beyond Expected Life
Category: Deferred Maintenance
Priority: 3 - Necessary (Years 2-5)
Correction: Renew System
Qty: 33,831.00
Unit of Measure: S.F.
Estimate: \$485,272.00
Assessor Name: Eduardo Lopez
Date Created: 09/30/2019

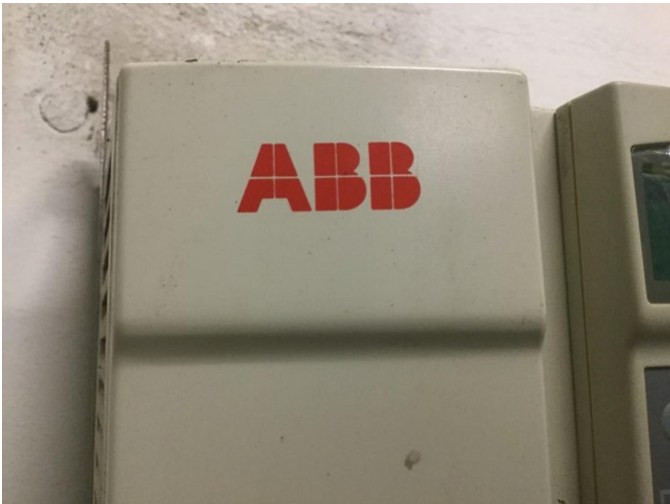
System: D3060 - Controls & Instrumentation

Location: Throughout building
Distress: Beyond Expected Life
Category: Deferred Maintenance
Priority: 3 - Necessary (Years 2-5)
Correction: Renew System
Qty: 33,831.00
Unit of Measure: S.F.
Estimate: \$84,848.00
Assessor Name: Eduardo Lopez
Date Created: 09/30/2019

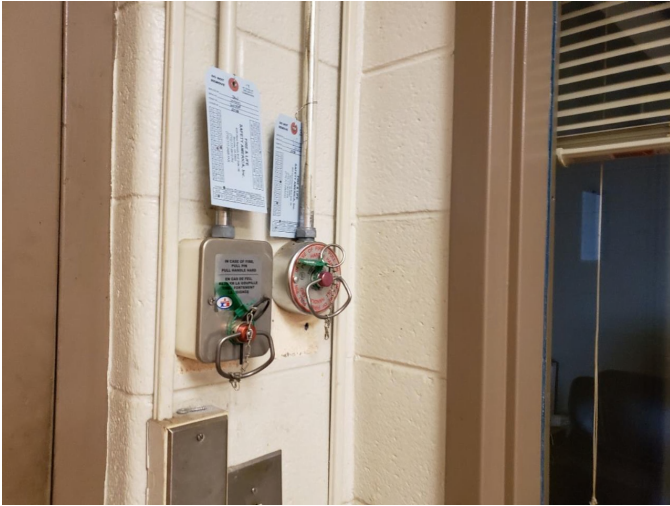
System: D4090 - Other Fire Protection Systems

Location: Kitchen
Distress: Beyond Expected Life
Category: Deferred Maintenance
Priority: 3 - Necessary (Years 2-5)
Correction: Renew System
Qty: 33,831.00
Unit of Measure: S.F.
Estimate: \$22,701.00
Assessor Name: Eduardo Lopez
Date Created: 09/30/2019

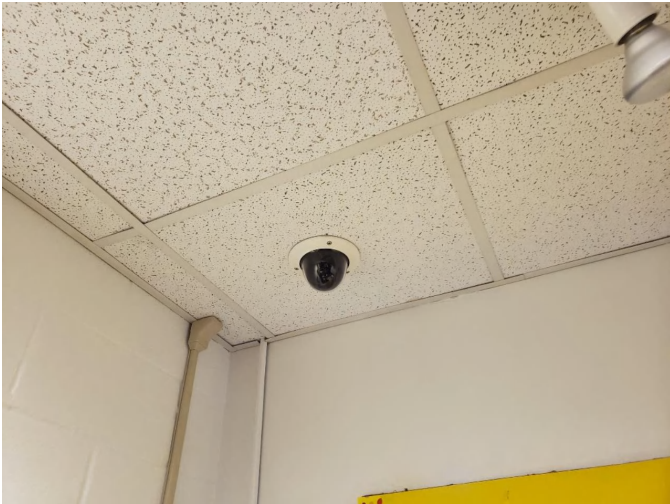
System: D5030810 - Security & Detection Systems

Location: Throughout building
Distress: Beyond Expected Life
Category: Deferred Maintenance
Priority: 3 - Necessary (Years 2-5)
Correction: Renew System
Qty: 33,831.00
Unit of Measure: S.F.
Estimate: \$56,193.00
Assessor Name: Eduardo Lopez
Date Created: 11/15/2019

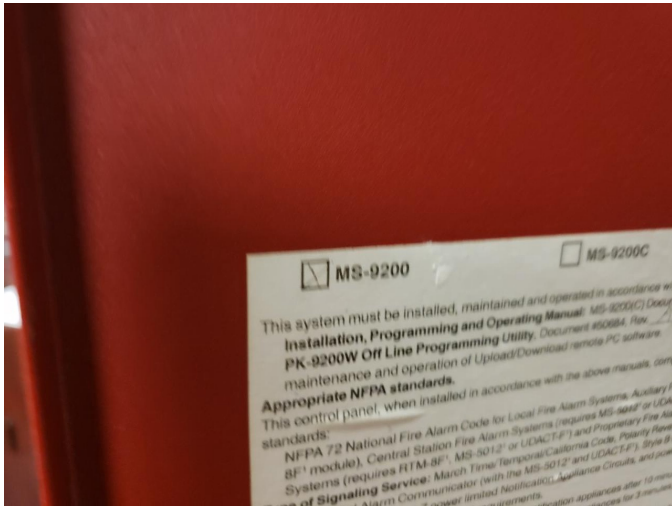
System: D5030910 - Fire Alarm Systems

Location: Throughout building
Distress: Beyond Expected Life
Category: Deferred Maintenance
Priority: 3 - Necessary (Years 2-5)
Correction: Renew System
Qty: 33,831.00
Unit of Measure: S.F.
Estimate: \$101,967.00
Assessor Name: Eduardo Lopez
Date Created: 11/15/2019

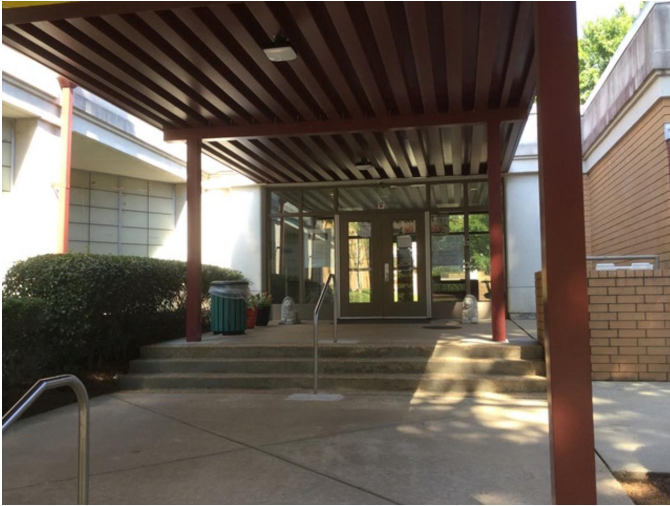
System: G2030 - Pedestrian Paving

Location: Front Entrance

Distress: Inadequate

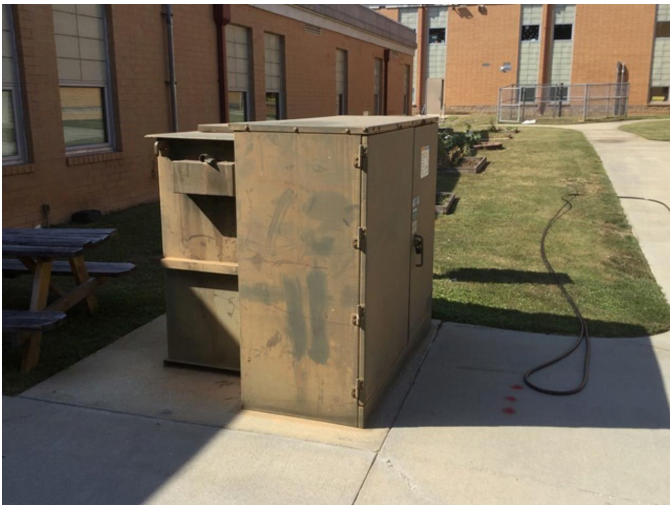
System: G4010 - Electrical Distribution

Location: Throughout building

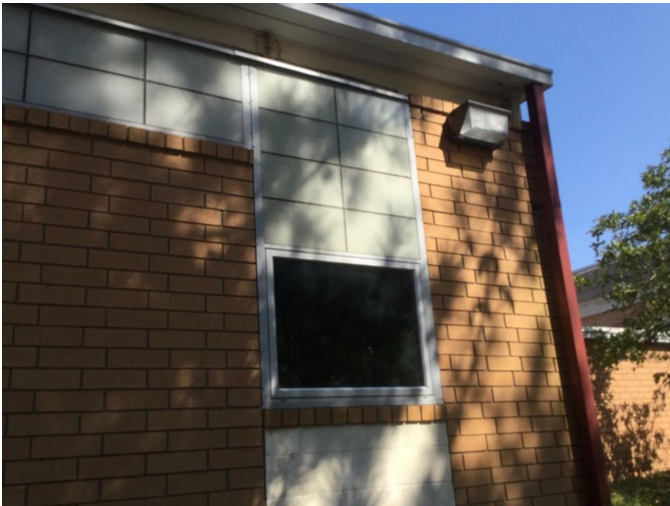
System: G4020 - Site Lighting

Location: Site
Distress: Beyond Expected Life
Category: Deferred Maintenance
Priority: 3 - Necessary (Years 2-5)
Correction: Renew System
Qty: 102,962.00
Unit of Measure: S.F.
Estimate: \$39,640.00
Assessor Name: Hayden Collins
Date Created: 02/19/2020

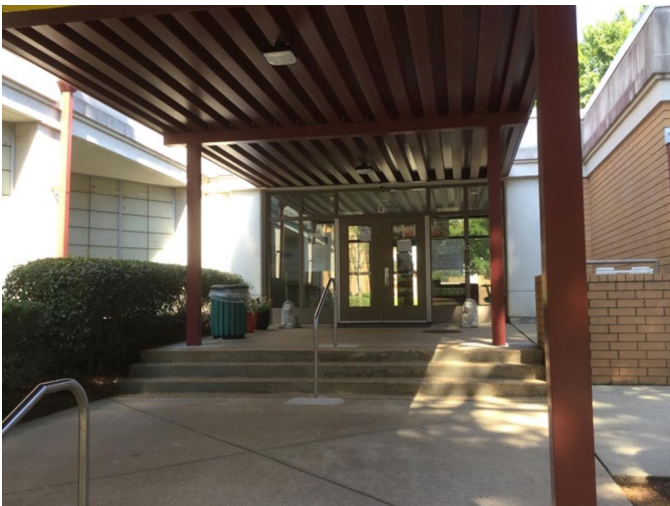
System: G4030 - Site Communication and Security

Location: Site
Distress: Beyond Expected Life
Category: Deferred Maintenance
Priority: 3 - Necessary (Years 2-5)
Correction: Renew System
Qty: 102,962.00
Unit of Measure: S.F.
Estimate: \$61,159.00
Assessor Name: Hayden Collins
Date Created: 02/19/2020
