Atlanta Public Schools/Other Facilities

Venetian Hills Elementary School

School Assessment Report

November 10, 2020

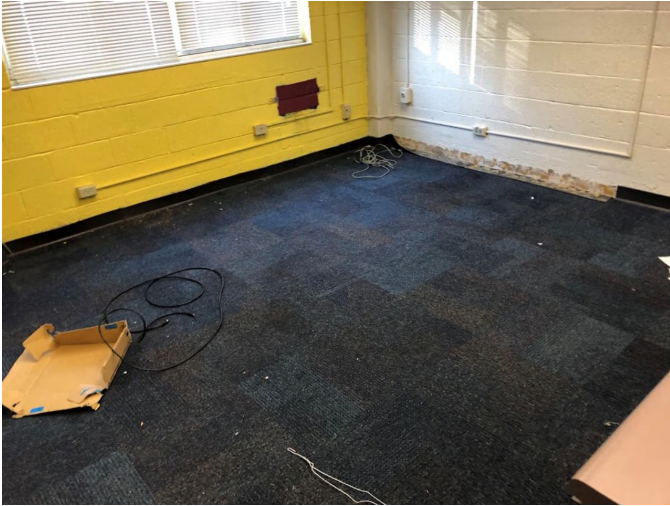
System: C3020901 - Carpet

Location: Throughout Building
Distress: Beyond Expected Life
Category: Deferred Maintenance
Priority: 3 - Necessary (Years 2-5)
Correction: Renew System
Qty: 1,000.00
Unit of Measure: S.F.
Estimate: \$8,250.00
Assessor Name: Eduardo Lopez
Date Created: 02/10/2020

Notes: This system should be scheduled for replacement. This school is abandoned and most systems are recommended for replacement. This deficiency is expected to be completed as part of an overall effort to renew the interior finishes.

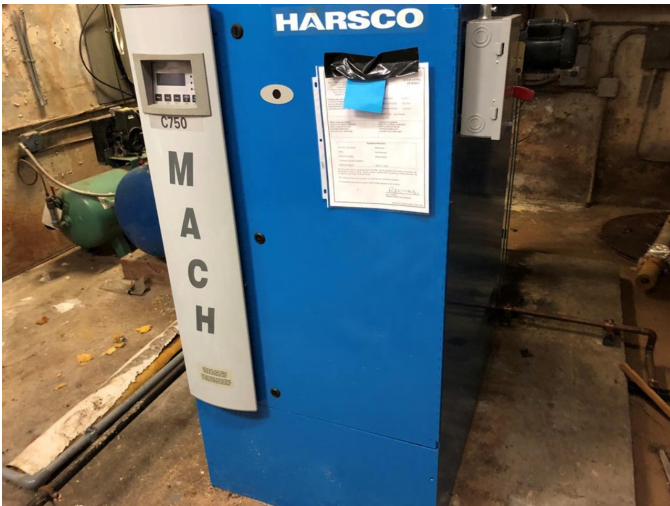
System: D3020 - Heat Generating Systems

Location: Mechanical room
Distress: Beyond Expected Life
Category: Deferred Maintenance
Priority: 3 - Necessary (Years 2-5)
Correction: Renew System
Qty: 30,301.00
Unit of Measure: S.F.
Estimate: \$135,991.00
Assessor Name: Eduardo Lopez
Date Created: 02/10/2020

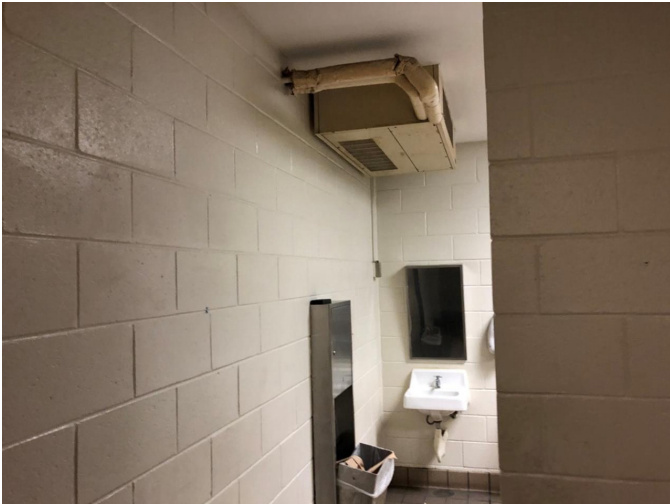
System: D3050 - Terminal & Package Units

Location: Throughout Building
Distress: Beyond Expected Life
Category: Deferred Maintenance
Priority: 3 - Necessary (Years 2-5)
Correction: Renew System
Qty: 30,301.00
Unit of Measure: S.F.
Estimate: \$440,304.00
Assessor Name: Eduardo Lopez
Date Created: 10/06/2020

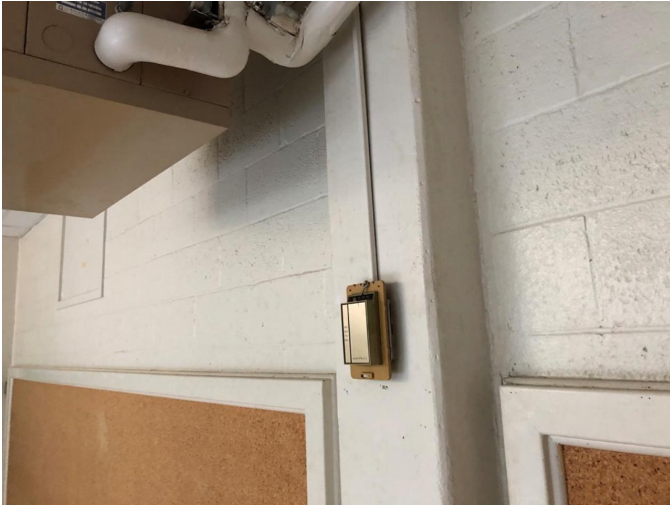
System: D3060 - Controls & Instrumentation

Location: Throughout Building
Distress: Beyond Expected Life
Category: Deferred Maintenance
Priority: 3 - Necessary (Years 2-5)
Correction: Renew System
Qty: 30,301.00
Unit of Measure: S.F.
Estimate: \$76,662.00
Assessor Name: Eduardo Lopez
Date Created: 10/06/2020

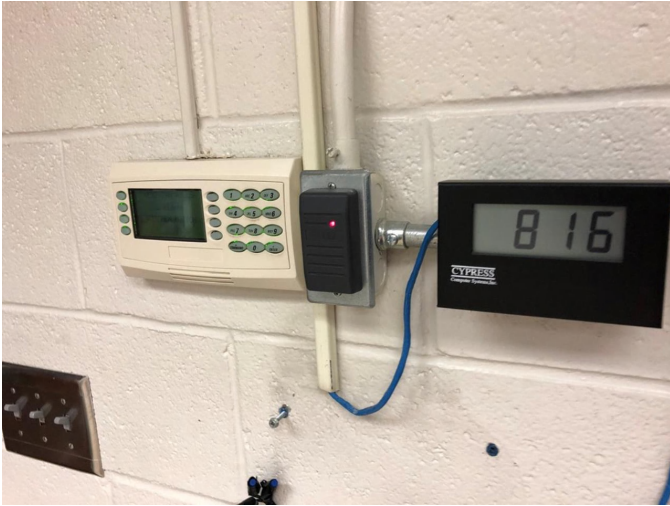
System: D5030810 - Security & Detection Systems

Location: Throughout Building
Distress: Beyond Expected Life
Category: Deferred Maintenance
Priority: 3 - Necessary (Years 2-5)
Correction: Renew System
Qty: 30,301.00
Unit of Measure: S.F.
Estimate: \$50,330.00
Assessor Name: Eduardo Lopez
Date Created: 02/10/2020

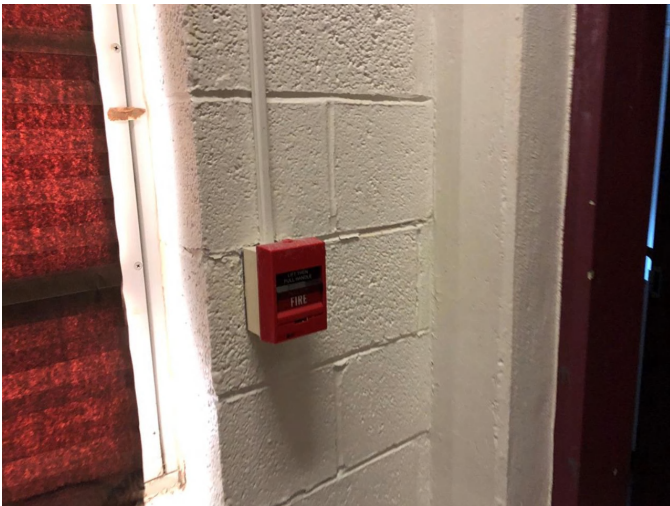
System: D5030910 - Fire Alarm Systems

Location: Throughout Building
Distress: Beyond Expected Life
Category: Deferred Maintenance
Priority: 3 - Necessary (Years 2-5)
Correction: Renew System
Qty: 30,301.00
Unit of Measure: S.F.
Estimate: \$91,327.00
Assessor Name: Eduardo Lopez
Date Created: 02/10/2020

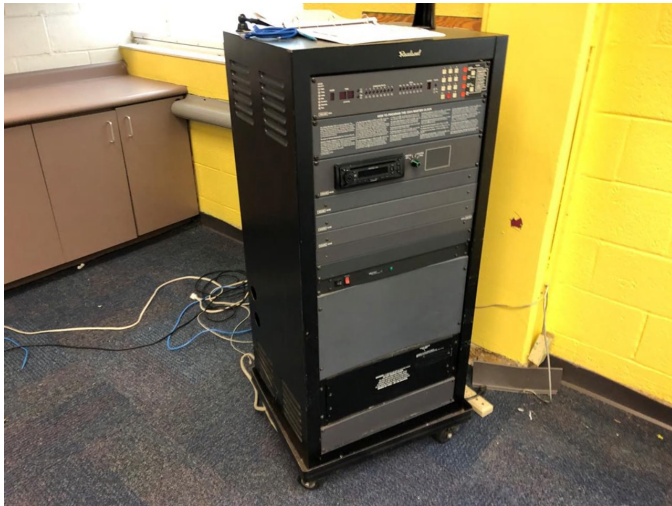
System: D5030920 - Data Communication

Location: Throughout Building
Distress: Beyond Expected Life
Category: Deferred Maintenance
Priority: 3 - Necessary (Years 2-5)
Correction: Renew System
Qty: 30,301.00
Unit of Measure: S.F.
Estimate: \$118,659.00
Assessor Name: Eduardo Lopez
Date Created: 02/10/2020

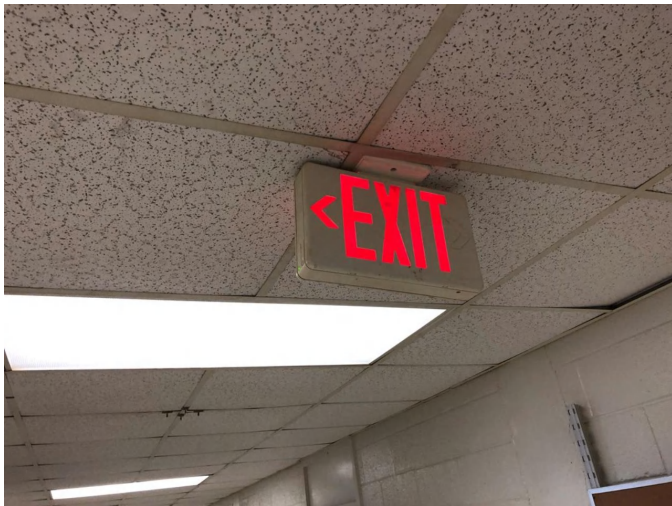
System: D5090 - Other Electrical Systems

Location: Throughout Building
Distress: Beyond Expected Life
Category: Deferred Maintenance
Priority: 3 - Necessary (Years 2-5)
Correction: Renew System
Qty: 30,301.00
Unit of Measure: S.F.
Estimate: \$42,664.00
Assessor Name: Eduardo Lopez
Date Created: 02/10/2020

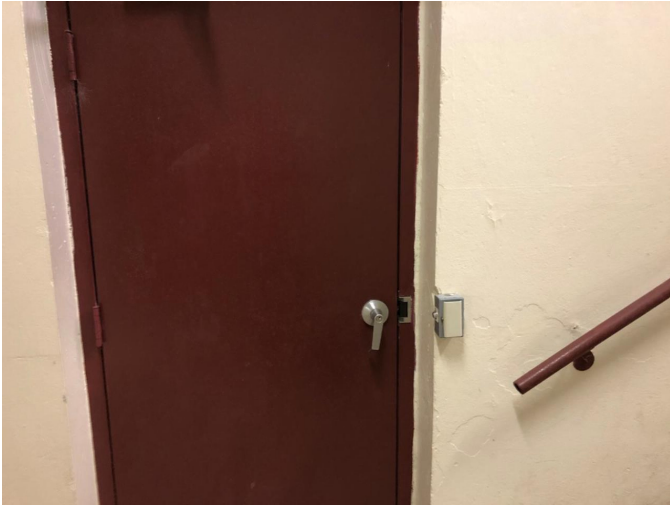
System: D1010 - Elevators and Lifts

Location: Throughout Building
Distress: Beyond Expected Life
Category: Deferred Maintenance
Priority: 3 - Necessary (Years 2-5)
Correction: Renew System
Qty: 18,126.00
Unit of Measure: S.F.
Estimate: \$27,914.00
Assessor Name: Hayden Collins
Date Created: 02/10/2020

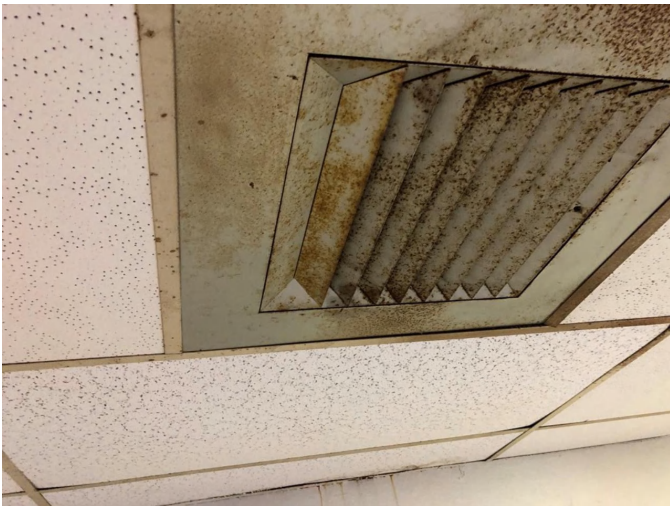
System: D3040 - Distribution Systems

Location: Throughout building
Distress: Beyond Expected Life
Category: Deferred Maintenance
Priority: 3 - Necessary (Years 2-5)
Correction: Renew System
Qty: 18,126.00
Unit of Measure: S.F.
Estimate: \$234,279.00
Assessor Name: Hayden Collins
Date Created: 02/22/2020

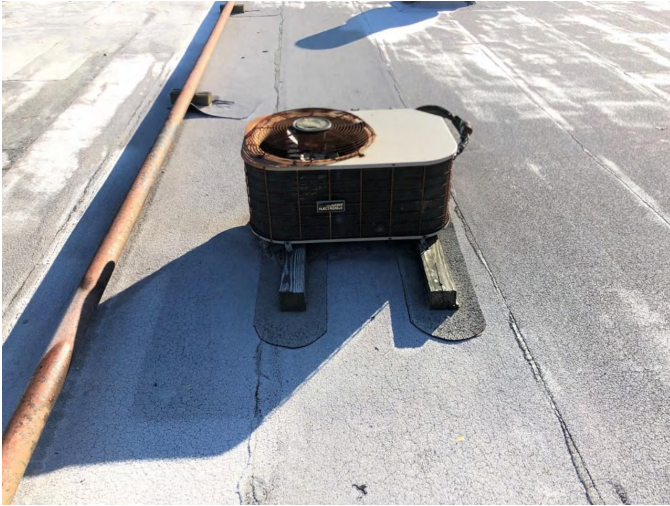
Location: Throughout building
Distress: Beyond Expected Life
Category: Deferred Maintenance
Priority: 3 - Necessary (Years 2-5)
Correction: Renew System
Qty: 18,126.00
Unit of Measure: S.F.
Estimate: \$364,478.00
Assessor Name: Hayden Collins
Date Created: 02/22/2020

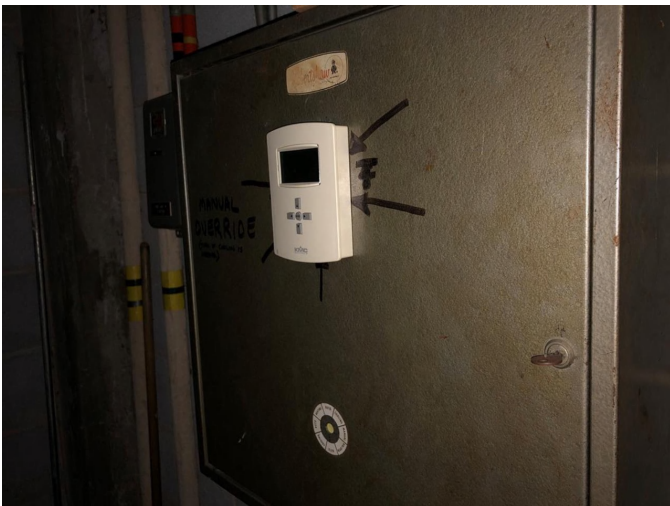
Location: Throughout building
Distress: Beyond Expected Life
Category: Deferred Maintenance
Priority: 3 - Necessary (Years 2-5)
Correction: Renew System
Qty: 18,126.00
Unit of Measure: S.F.
Estimate: \$48,850.00
Assessor Name: Hayden Collins
Date Created: 02/22/2020

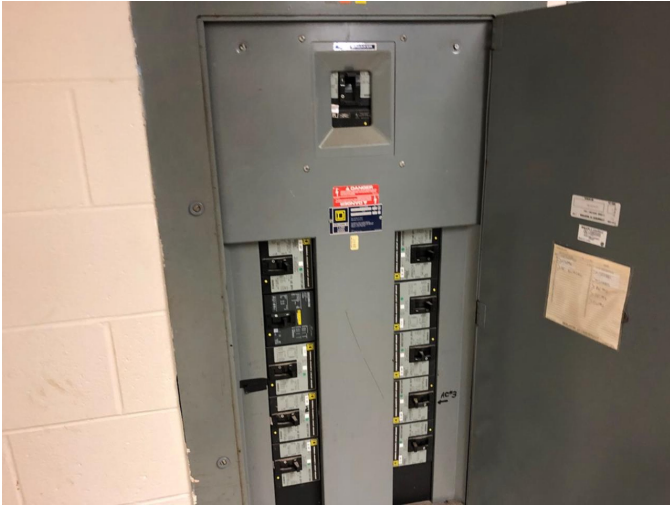
Location: Throughout building
Distress: Beyond Expected Life
Category: Deferred Maintenance
Priority: 3 - Necessary (Years 2-5)
Correction: Renew System
Qty: 18,126.00
Unit of Measure: S.F.
Estimate: \$50,843.00
Assessor Name: Hayden Collins
Date Created: 02/22/2020

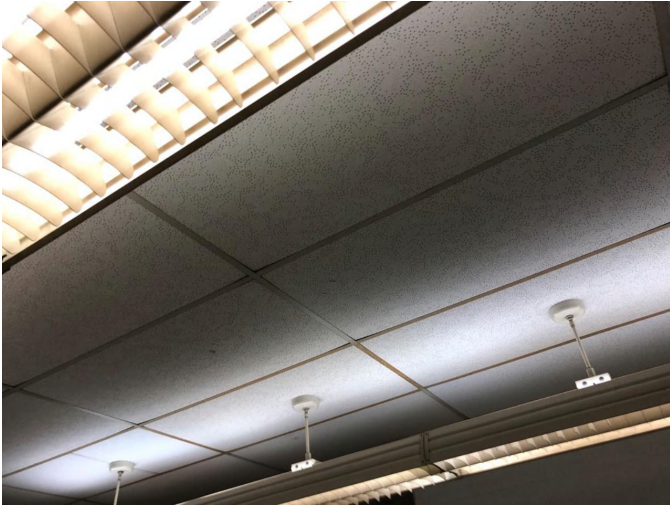
System: D5020 - Lighting

Location: Throughout building
Distress: Beyond Expected Life
Category: Deferred Maintenance
Priority: 3 - Necessary (Years 2-5)
Correction: Renew System
Qty: 18,126.00
Unit of Measure: S.F.
Estimate: \$140,368.00
Assessor Name: Hayden Collins
Date Created: 02/22/2020

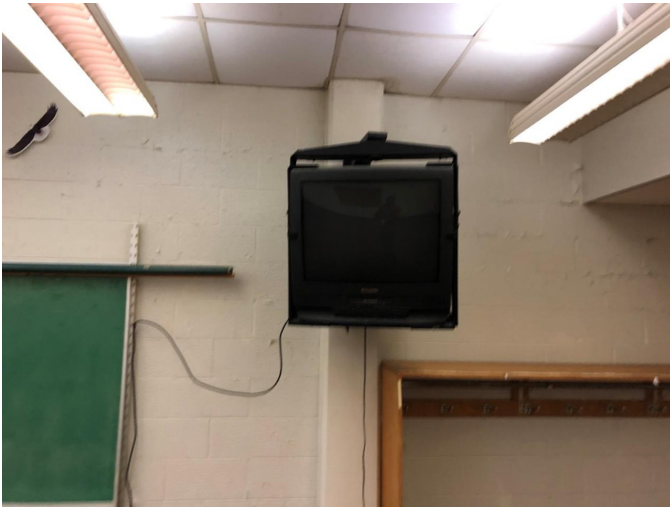
Location: Throughout Building
Distress: Beyond Expected Life
Category: Deferred Maintenance
Priority: 3 - Necessary (Years 2-5)
Correction: Renew System
Qty: 18,126.00
Unit of Measure: S.F.
Estimate: \$1,994.00
Assessor Name: Hayden Collins
Date Created: 02/10/2020

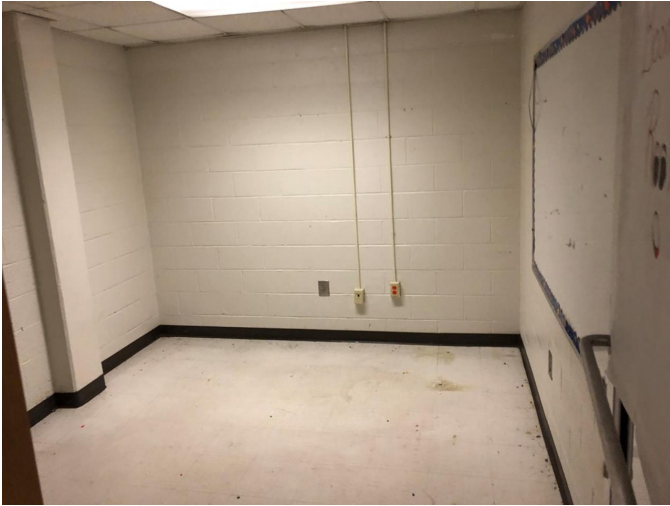
Location: Throughout Building
Distress: Beyond Expected Life
Category: Deferred Maintenance
Priority: 3 - Necessary (Years 2-5)
Correction: Renew System
Qty: 1,015.00
Unit of Measure: S.F.
Estimate: \$1,641.00
Assessor Name: Hayden Collins
Date Created: 02/10/2020

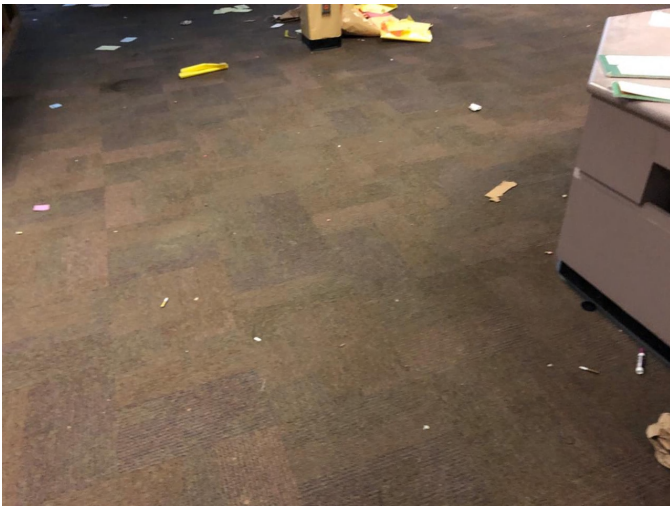
Location: Throughout Building
Distress: Beyond Expected Life
Category: Deferred Maintenance
Priority: 3 - Necessary (Years 2-5)
Correction: Renew System
Qty: 1,015.00
Unit of Measure: S.F.
Estimate: \$8,374.00
Assessor Name: Hayden Collins
Date Created: 02/10/2020

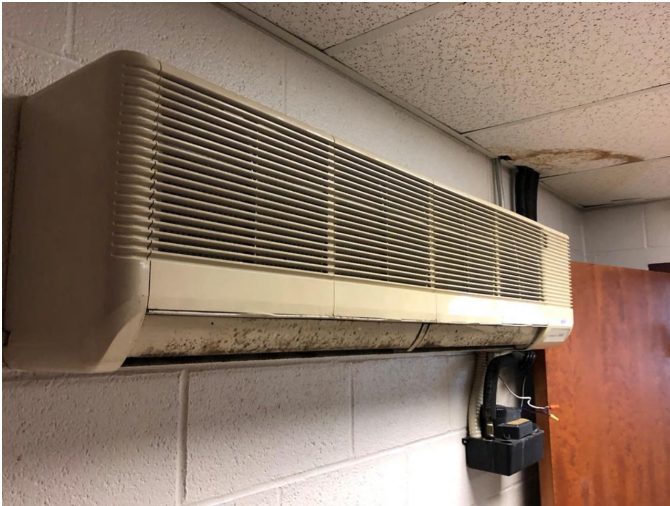
Location: Throughout Building
Distress: Beyond Expected Life
Category: Deferred Maintenance
Priority: 3 - Necessary (Years 2-5)
Correction: Renew System
Qty: 1,015.00
Unit of Measure: S.F.
Estimate: \$20,800.00
Assessor Name: Hayden Collins
Date Created: 02/10/2020

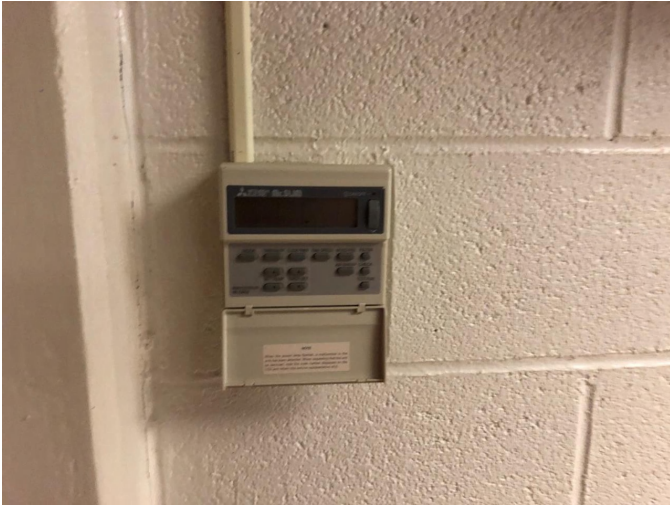
Location: Throughout building
Distress: Beyond Expected Life
Category: Deferred Maintenance
Priority: 3 - Necessary (Years 2-5)
Correction: Renew System
Qty: 1,015.00
Unit of Measure: S.F.
Estimate: \$2,758.00
Assessor Name: Hayden Collins
Date Created: 02/22/2020

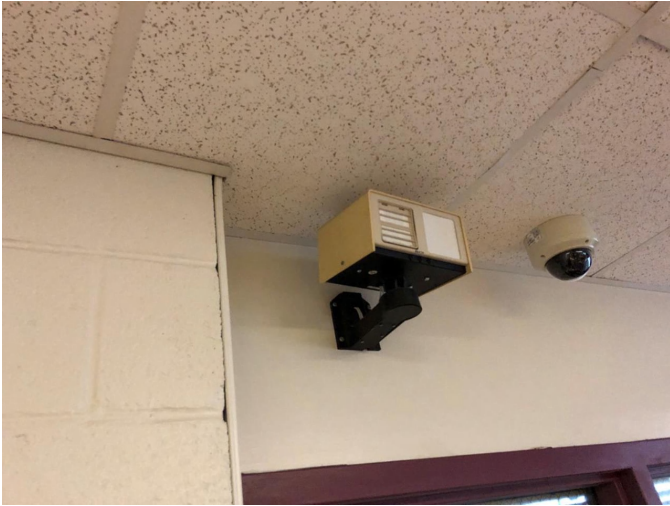
Location: Throughout Building
Distress: Beyond Expected Life
Category: Deferred Maintenance
Priority: 3 - Necessary (Years 2-5)
Correction: Renew System
Qty: 1,015.00
Unit of Measure: S.F.
Estimate: \$1,686.00
Assessor Name: Hayden Collins
Date Created: 02/10/2020

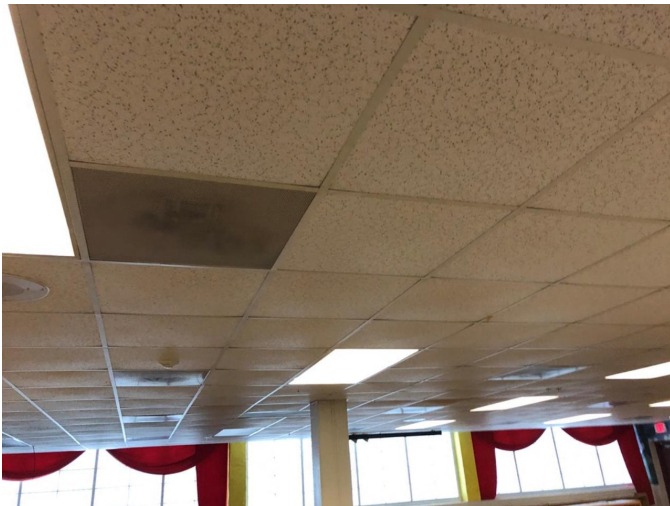
Location: Throughout Building
Distress: Beyond Expected Life
Category: Deferred Maintenance
Priority: 3 - Necessary (Years 2-5)
Correction: Renew System
Qty: 1,015.00
Unit of Measure: S.F.
Estimate: \$3,059.00
Assessor Name: Hayden Collins
Date Created: 02/10/2020

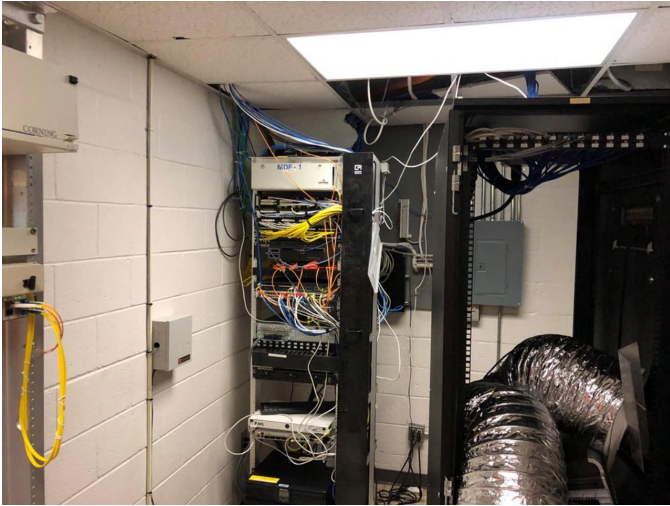
Location: Throughout Building
Distress: Beyond Expected Life
Category: Deferred Maintenance
Priority: 3 - Necessary (Years 2-5)
Correction: Renew System
Qty: 1,015.00
Unit of Measure: S.F.
Estimate: \$3,975.00
Assessor Name: Hayden Collins
Date Created: 02/10/2020

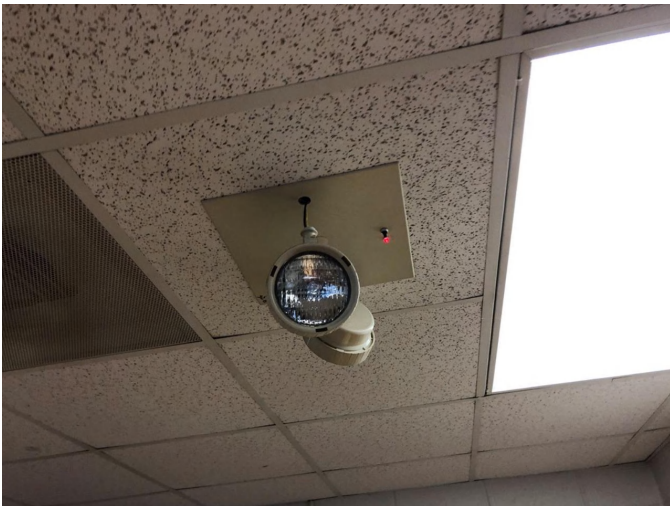
Location: Throughout Building
Distress: Beyond Expected Life
Category: Deferred Maintenance
Priority: 3 - Necessary (Years 2-5)
Correction: Renew System
Qty: 1,015.00
Unit of Measure: S.F.
Estimate: \$424.00
Assessor Name: Hayden Collins
Date Created: 02/10/2020

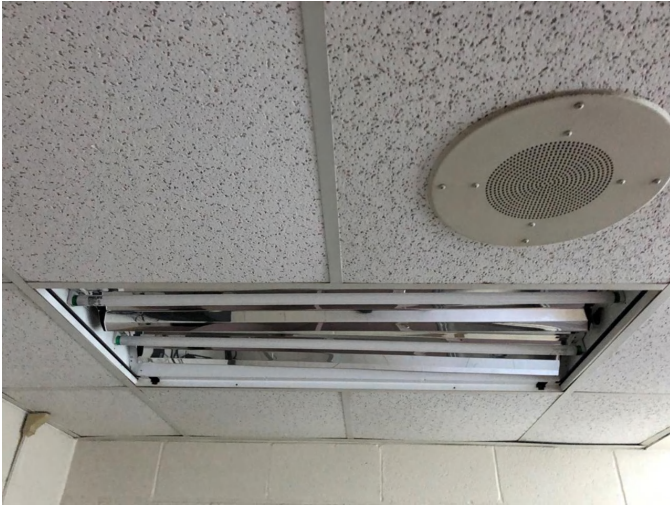
Location: Throughout Building
Distress: Beyond Expected Life
Category: Deferred Maintenance
Priority: 3 - Necessary (Years 2-5)
Correction: Renew System
Qty: 1,015.00
Unit of Measure: S.F.
Estimate: \$15,240.00
Assessor Name: Hayden Collins
Date Created: 02/10/2020

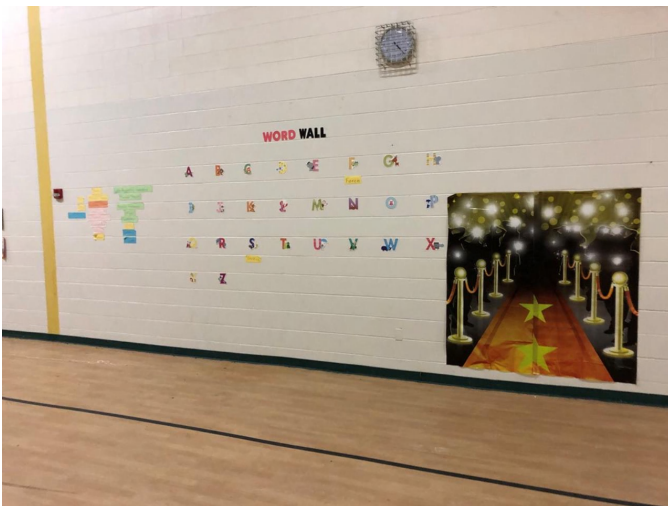
Location: Throughout Building
Distress: Beyond Expected Life
Category: Deferred Maintenance
Priority: 3 - Necessary (Years 2-5)
Correction: Renew System
Qty: 11,482.00
Unit of Measure: S.F.
Estimate: \$18,566.00
Assessor Name: Eduardo Lopez
Date Created: 02/10/2020

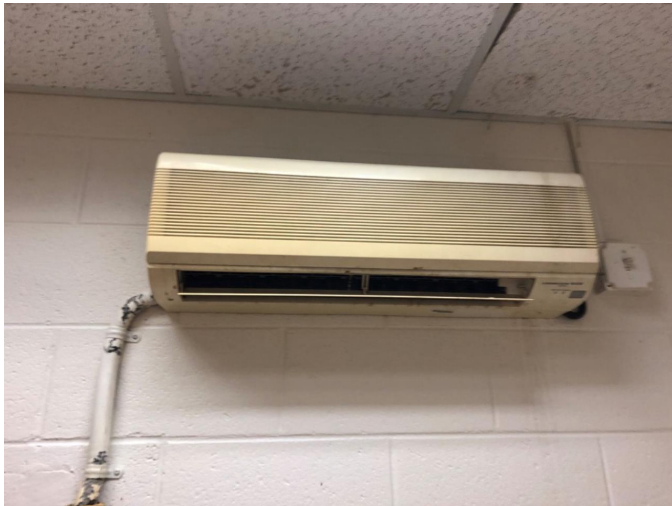
Location: Throughout Building
Distress: Beyond Expected Life
Category: Deferred Maintenance
Priority: 3 - Necessary (Years 2-5)
Correction: Renew System
Qty: 11,482.00
Unit of Measure: S.F.
Estimate: \$213,956.00
Assessor Name: Eduardo Lopez
Date Created: 10/06/2020

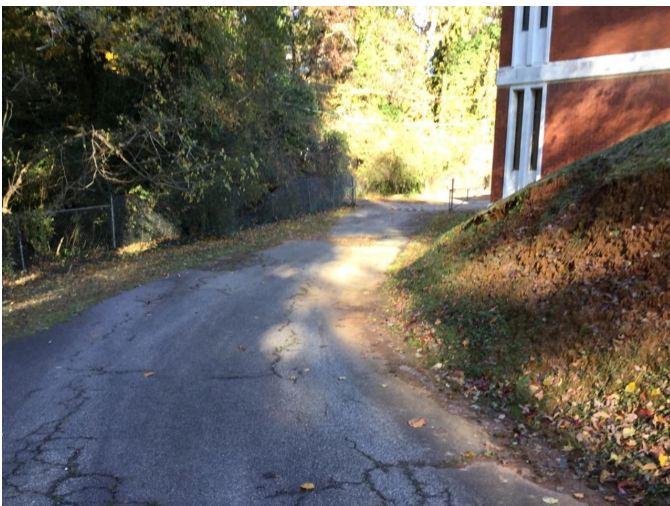
Location: Site
Distress: Beyond Expected Life
Category: Deferred Maintenance
Priority: 3 - Necessary (Years 2-5)
Correction: Renew System
Qty: 60,924.00
Unit of Measure: S.F.
Estimate: \$77,069.00
Assessor Name: Hayden Collins
Date Created: 02/07/2020

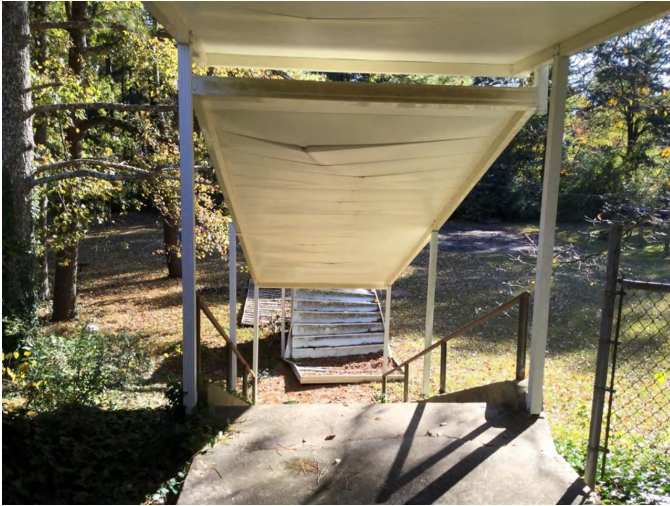
Location: Site
Distress: Beyond Expected Life
Category: Deferred Maintenance
Priority: 3 - Necessary (Years 2-5)
Correction: Renew System
Qty: 60,924.00
Unit of Measure: S.F.
Estimate: \$96,504.00
Assessor Name: Hayden Collins
Date Created: 02/07/2020
